CAMBRIAN MOUNTAINS ESA, HISTORIC MONITORING

BASELINE 1995

OS 1:1000 SHEET: SM /SN 78	GRID REF: SM /SN 7950 8545
PRN: 9177 SITE NAME: PLYNLIMON LEAD MINE	
AIR PHOTO No 650 - 164	LANDSCAPE TYPE: Ia
No GROUND PHOTOS: 17	
DATE SURVEYED: 26/10/95	SURVEYED BY: G. HOPWOOD
<p>ACCESS: Surveyed from footpaths. Access from Eisteddfu Gung along Plynlimon footpath / track.</p> <p>Owners - Mr & Mrs. Thomas. 01970 890 684</p>

CAMBRIAN MOUNTAINS ESA HISTORIC MONITORING RESURVEY 1999

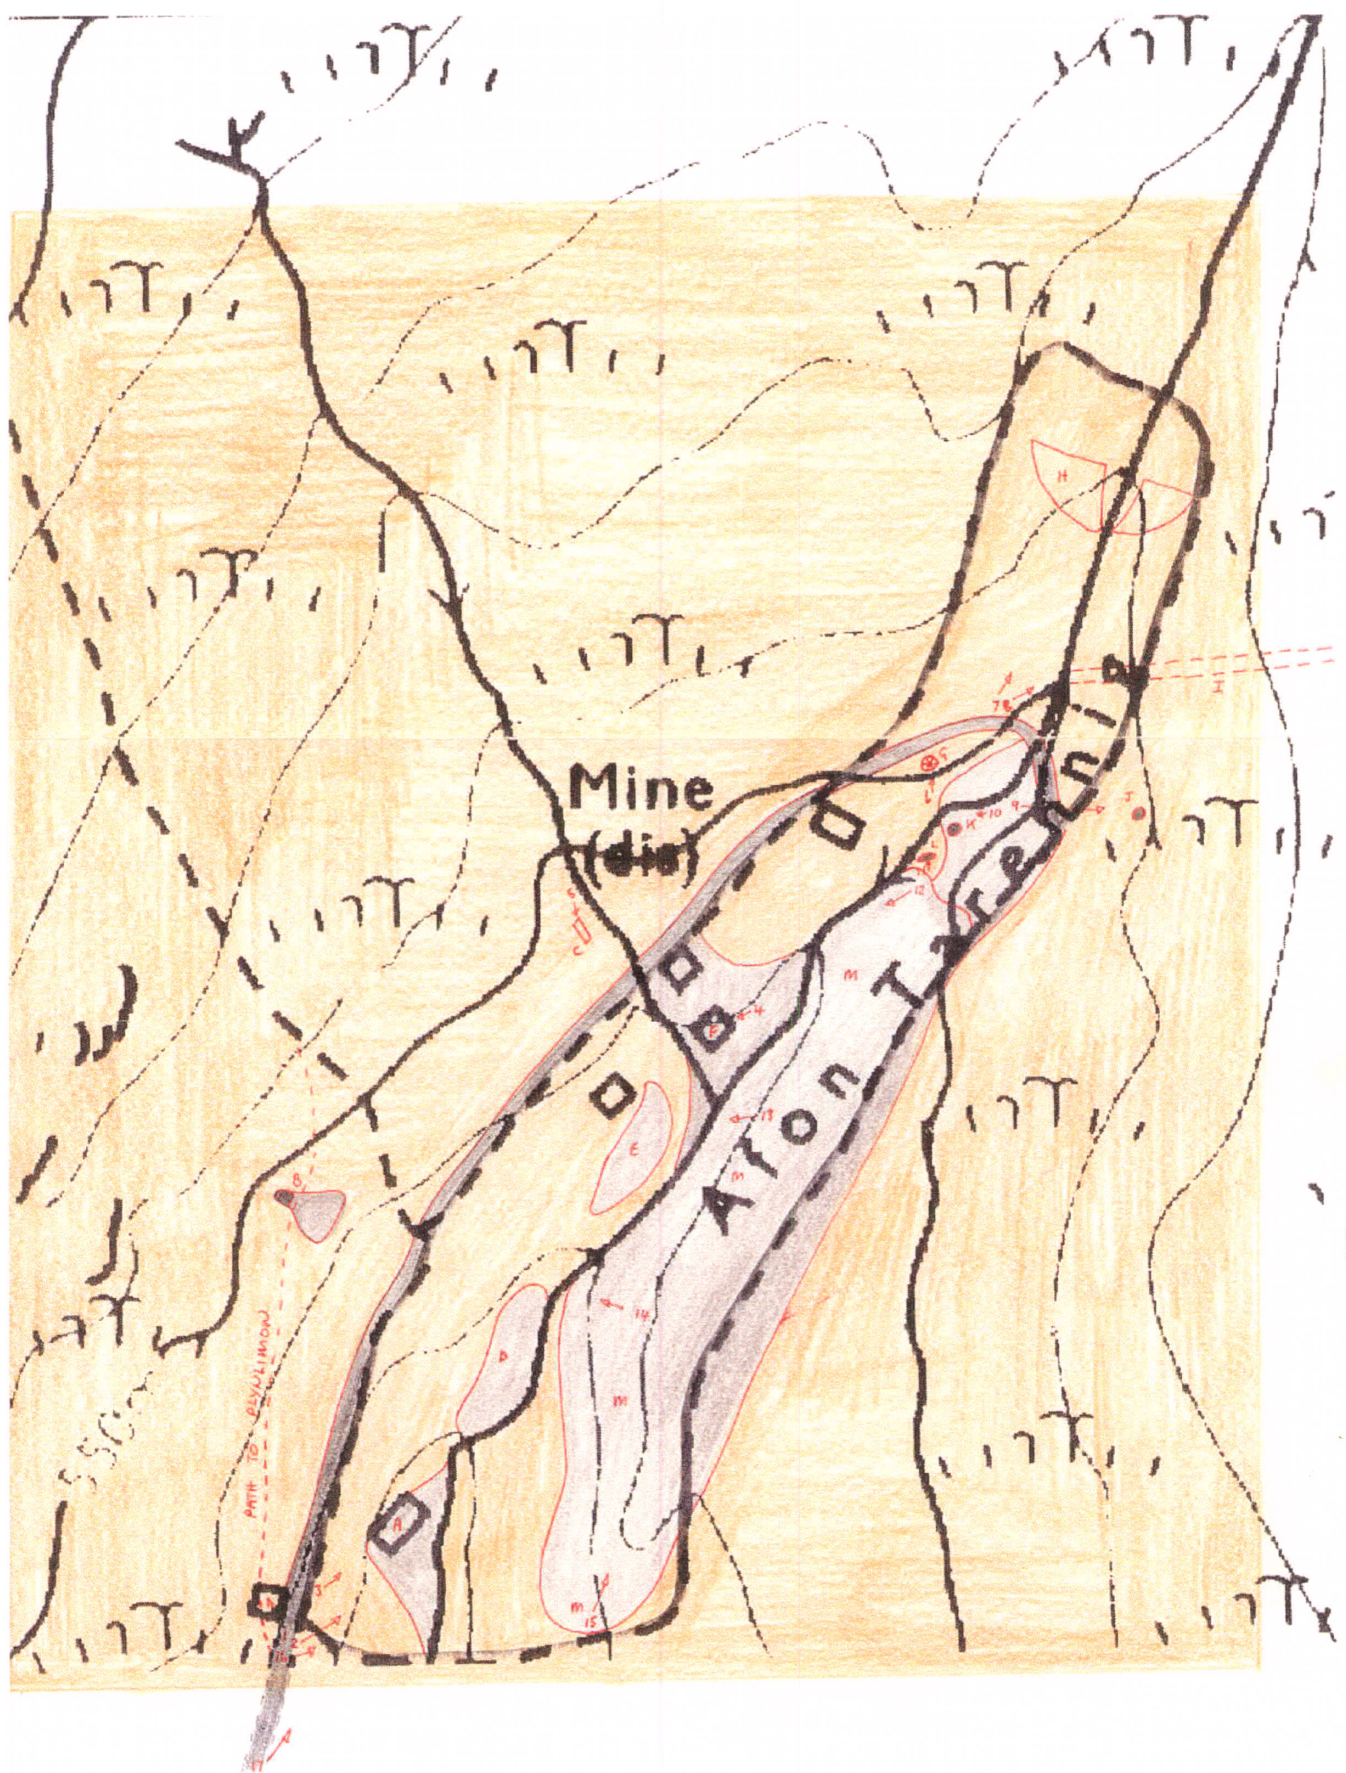
Site 9177

- A Large waterwheel pit
- B Adit with spoil tip
- C Small waterwheel pit - filled with rocks
- D Fine tailings from crushing mill?
- E Fine tailings from crushing mill?
- F Large waterwheel pit - partially filled with rubble. Timber frame and bolts visible.
- G Cast iron winding wheel - 1 - 1.5 m in diameter, intact and lying on its side.
- H Dam, now breached
- I Remains of incline from shaft higher up hill
- J Fenced off mine shaft
- K Filled in shaft with substantial wooden headgear still in situ
- L Exposed adit with timber stopes visible
- M Extensive area of spoil tips.
