CLWYDIAN ESA, HISTORIC MONITORING

BASELINE 1994

OS 1:10000 SHEET: SJ 25 NW	GRID REF: SJ 212 565
PRN: 100 011	SITE NAME: Highgate Enclosure
AIR PHOTO No 089	LANDSCAPE TYPE:
No GROUND PHOTOS: 7	Limestone Plateau
DATE SURVEYED: 2/2/95	SURVEYED BY: Dy Pears.
ACCESS: Public footpath from Graianrhyd to Gyrys road (opposite the house called Castell) leading to Graianrhyd. Land farmed by Mr Edwards Maes y droell allanarman yr Iat - (not contacted)

CLWYDIAN RANGE ESA HISTORIC MONITORING RESURVEY 1997/98

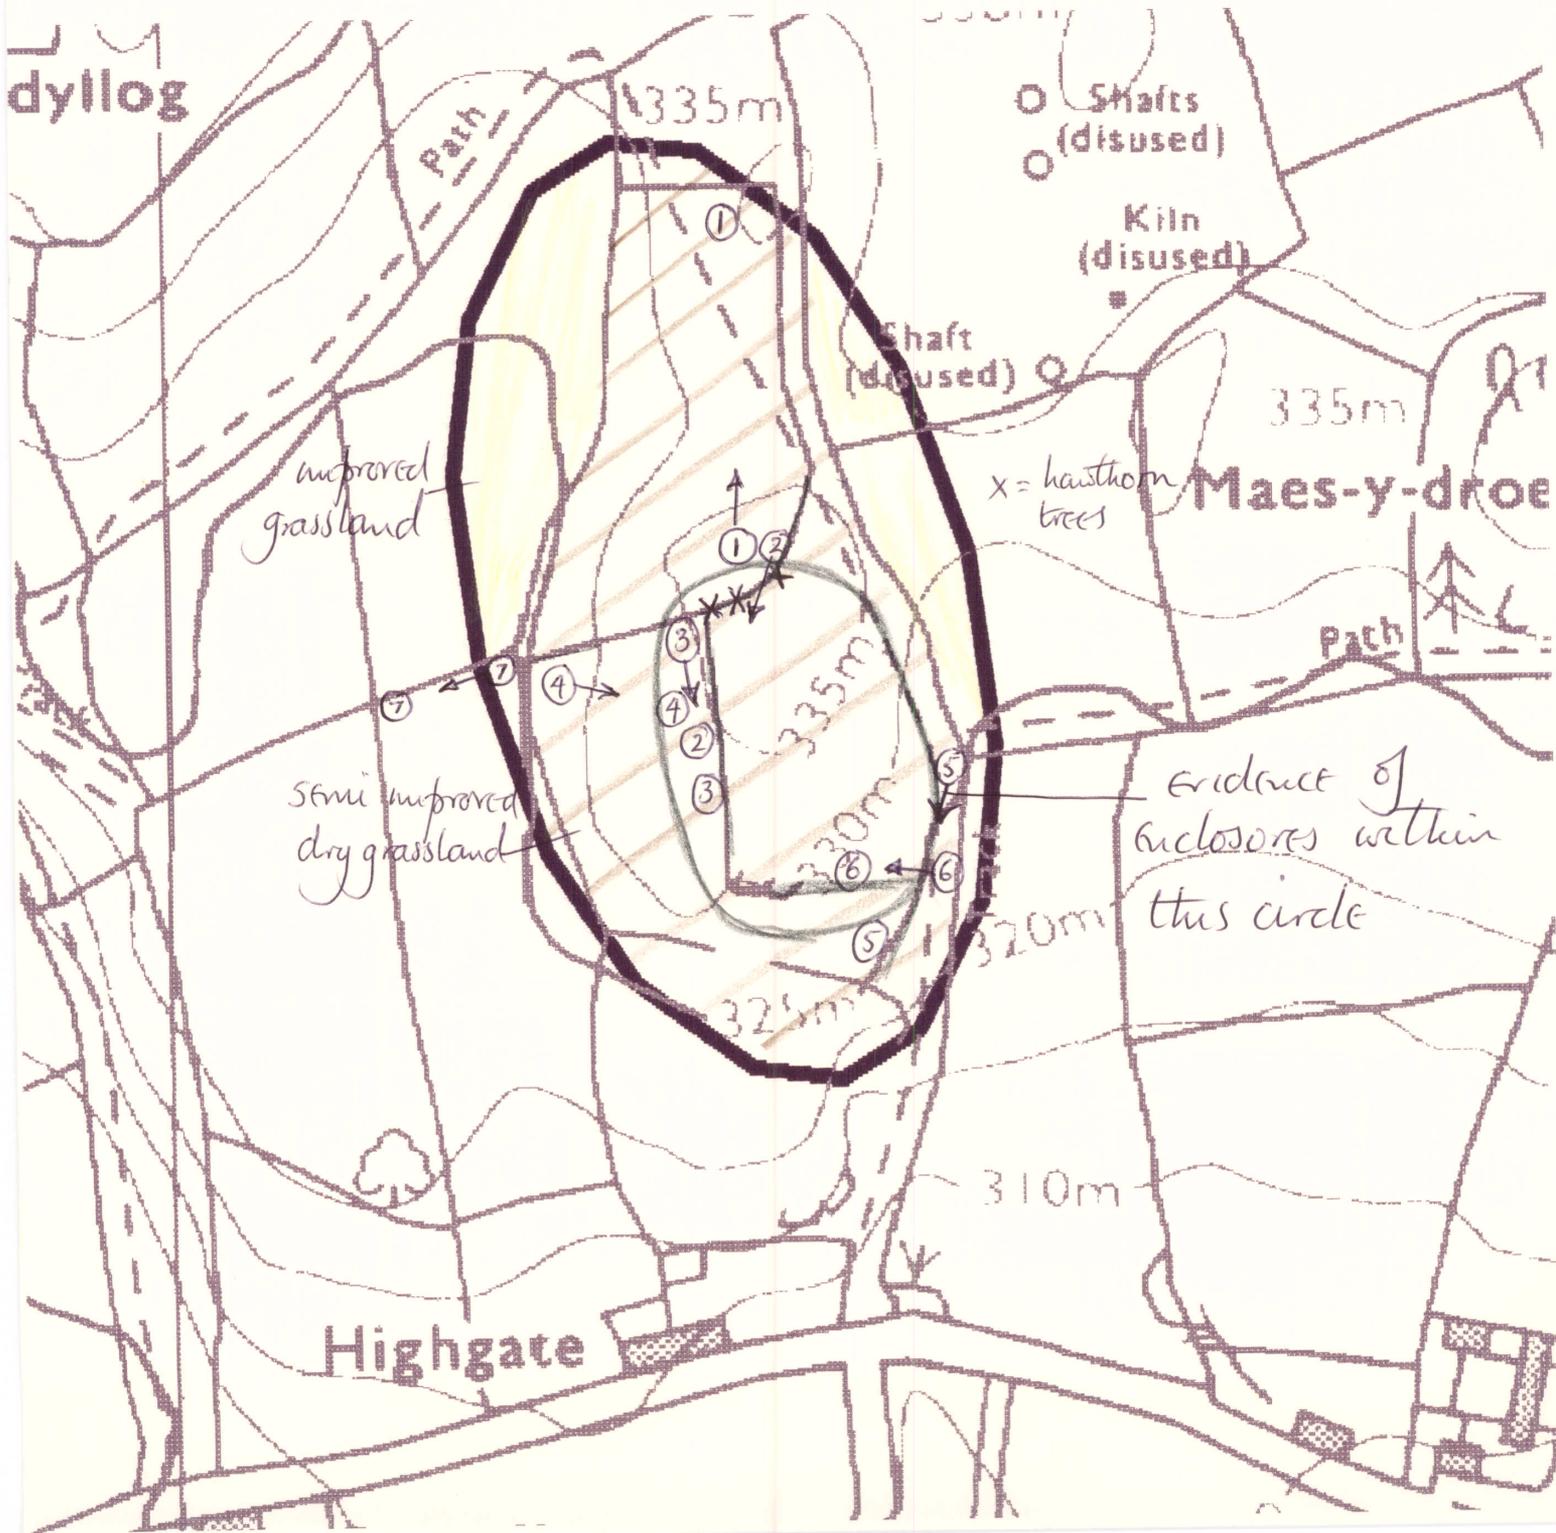
The feature is most obvious close to the 335m contour and consists of 'fieldlets' within boundaries which are linear mounds grass covered and about 0.5m in height. Boulders protrude in places (photo 3). They are largely grass/moss covered. Erosion is not a problem. Some hawthorns are growing on one boundary - see map.

A bridle path goes through the site but is unlikely to be a threat unless mountain bikes / scrambling bikes get onto the site. There is fairly extensive mole activity (see photo 2:3)
