BODFARI C

CLWYDIAN ESA, HISTORIC MONITORING

BASELINE 1994

OS 1:10000 SHEET: SJ 07 SE	GRID REF: SJ 0935 712
PRN: 101398 101399	SITE NAME: Gwern Hwlych 1 and 11
AIR PHOTO No 231	LANDSCAPE TYPE:
No GROUND PHOTOS: 3	Clwydian Edge
DATE SURVEYED: 18/11/95	SURVEYED BY:
ACCESS: Easy access from the road. The top part of the site is farmed by Mr Williams, Pistyll, Bodfari. The lower part of the site is the garden of Messrs McGregor, Gwern Hwlych.

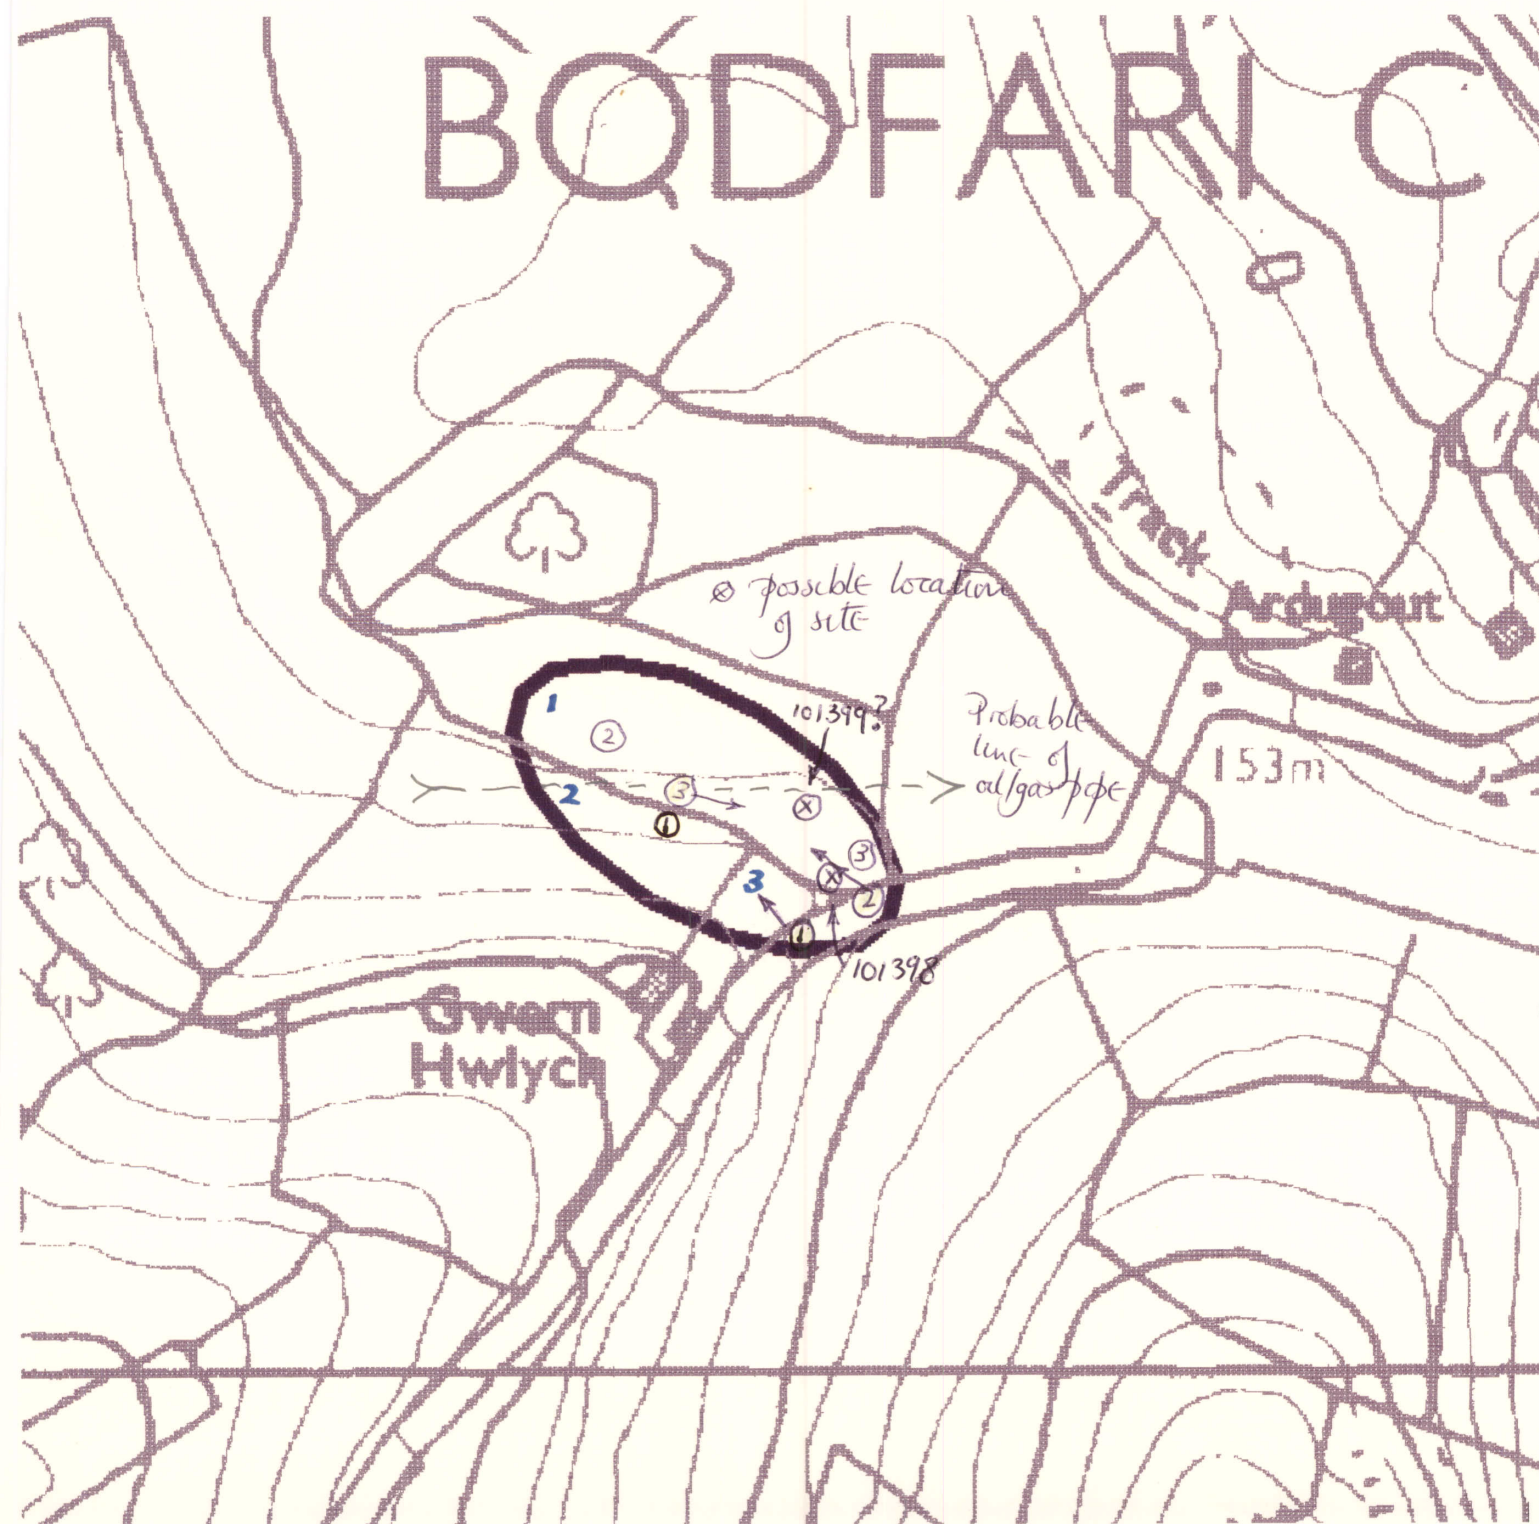
- 1 - Grassland (Mr Williams, Prestyll)
- 2 - Pony Paddock (Messrs McGregor, Gwern Hwlych)
- 3 - Garden

Neither of the two features are obvious because a gas/oil pipeline has gone through the site. Likely positions are marked on the map with the position of 101398 more obvious - see photo 3.
