102460 Moel y Parc Clwydian Range

## CLWYDIAN ESA, HISTORIC MONITORING

BASELINE 1994

CLWYDIAN RANGE ESA HISTORIC MONITORING RESURVEY 1997/98

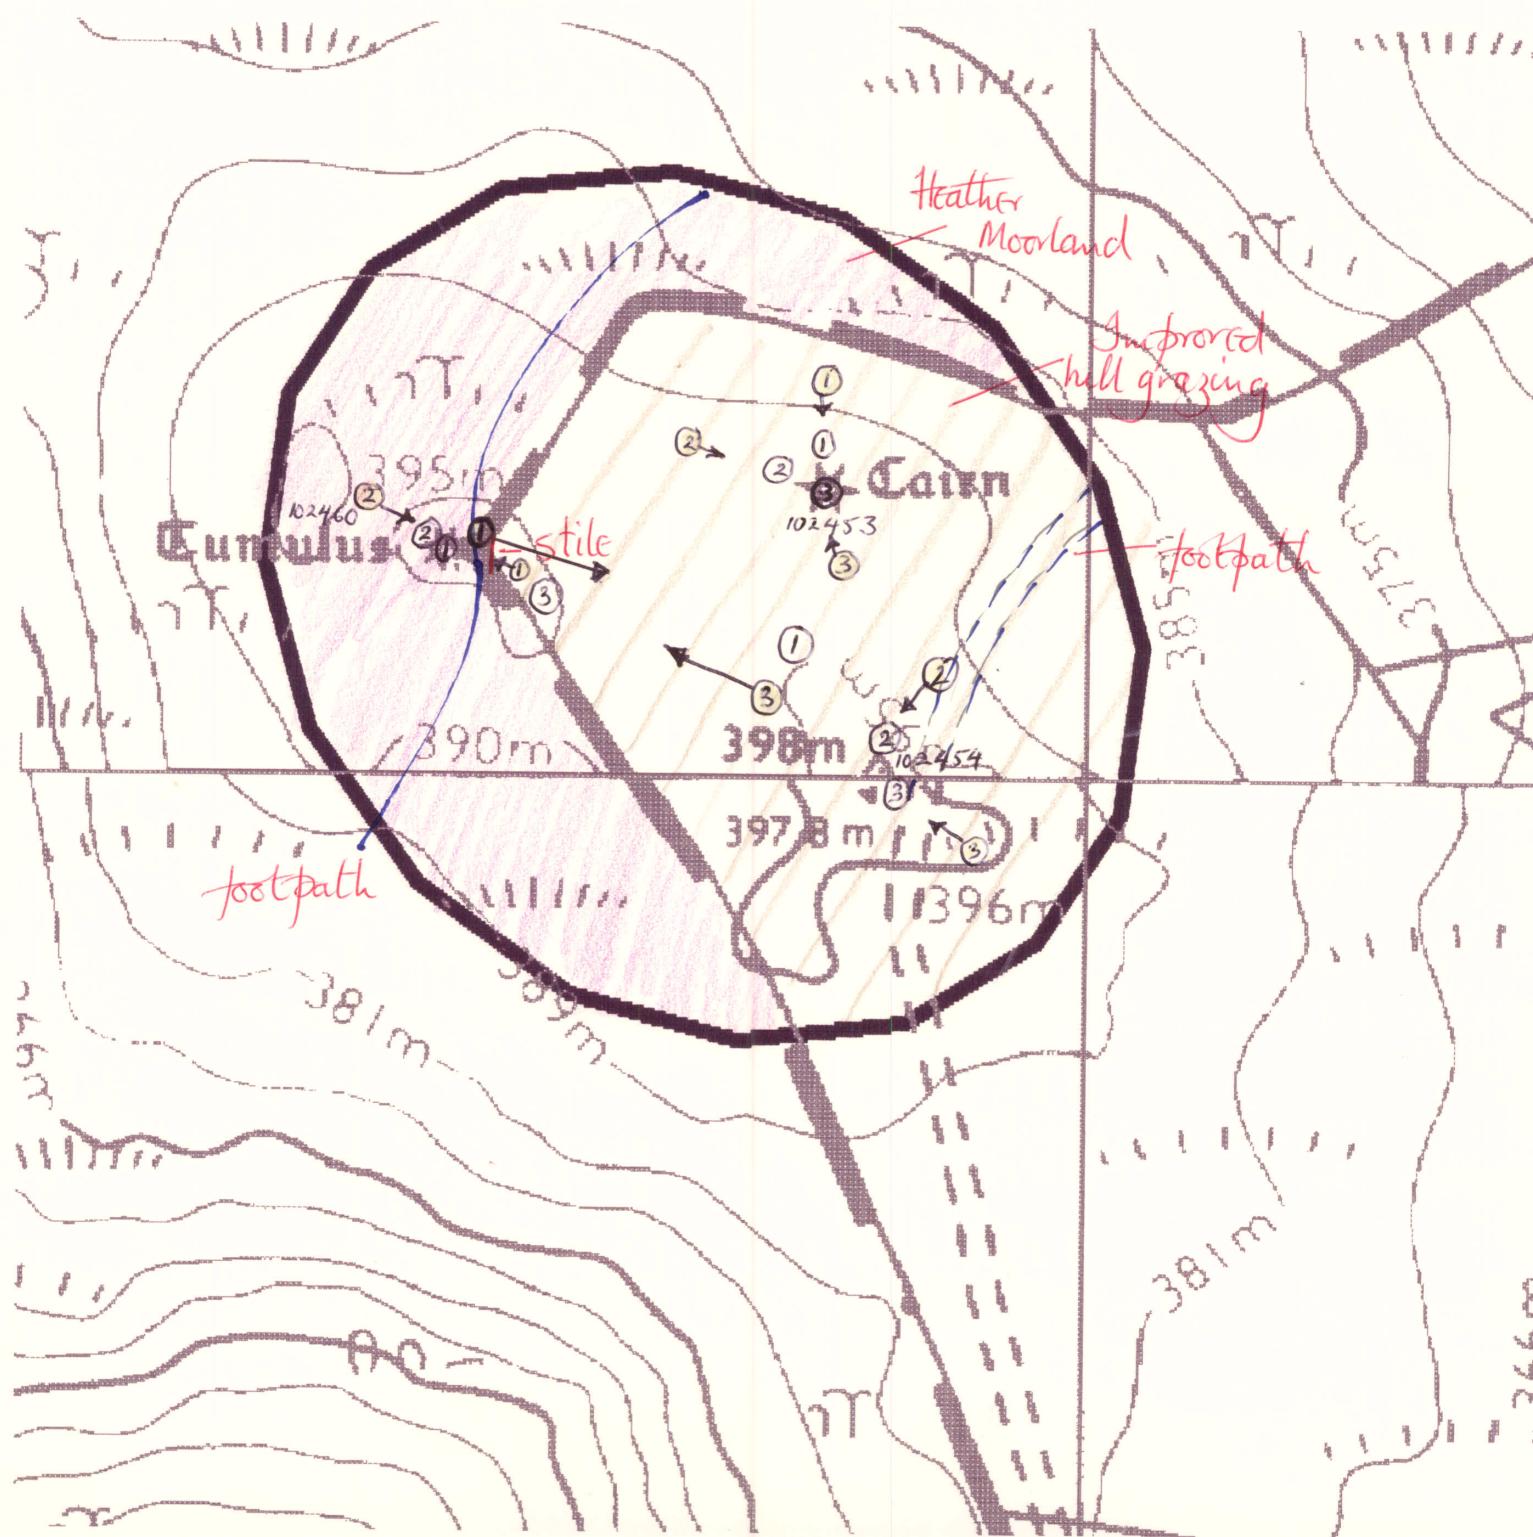
LAND COVER:
SITE: See map. Largely unimproved hill grazing on the SE of the boundary fence with heather moorland on the N and W.
HALO: As above

HALO: Well managed heather moorland although some evidence of over-burning in an area (obvious on the aerial photo) to the NW. Heavily grazed but not overgrazed grassland to the S and E.
