## CLWYDIAN ESA, HISTORIC MONITORING

BASELINE 1994

OS 1:10000 SHEET: SJ <i>16 NE</i>	GRID REF: SJ <i>(168 692)</i> <i>actual lime kiln surveyed</i>
PRN: <i>103126-8</i>	SITE NAME: <i>Big Wood lime Kiln (ref no. not known)</i> <i>at SJ 168 688</i>
AIR PHOTO No <i>146</i>	LANDSCAPE TYPE:
No GROUND PHOTOS: <i>6</i>	<i>Rolling farmland</i>
DATE SURVEYED: <i>16/2/95</i>	SURVEYED BY: <i>Dy Piers</i>
ACCESS: <i>Easy access from opposite Station Lodge just off A541 S. of Nannerch village. Woodland owned by Capt. Archdale, Penbedw. Mrs Archdale willingly agreed to a site visit.</i>

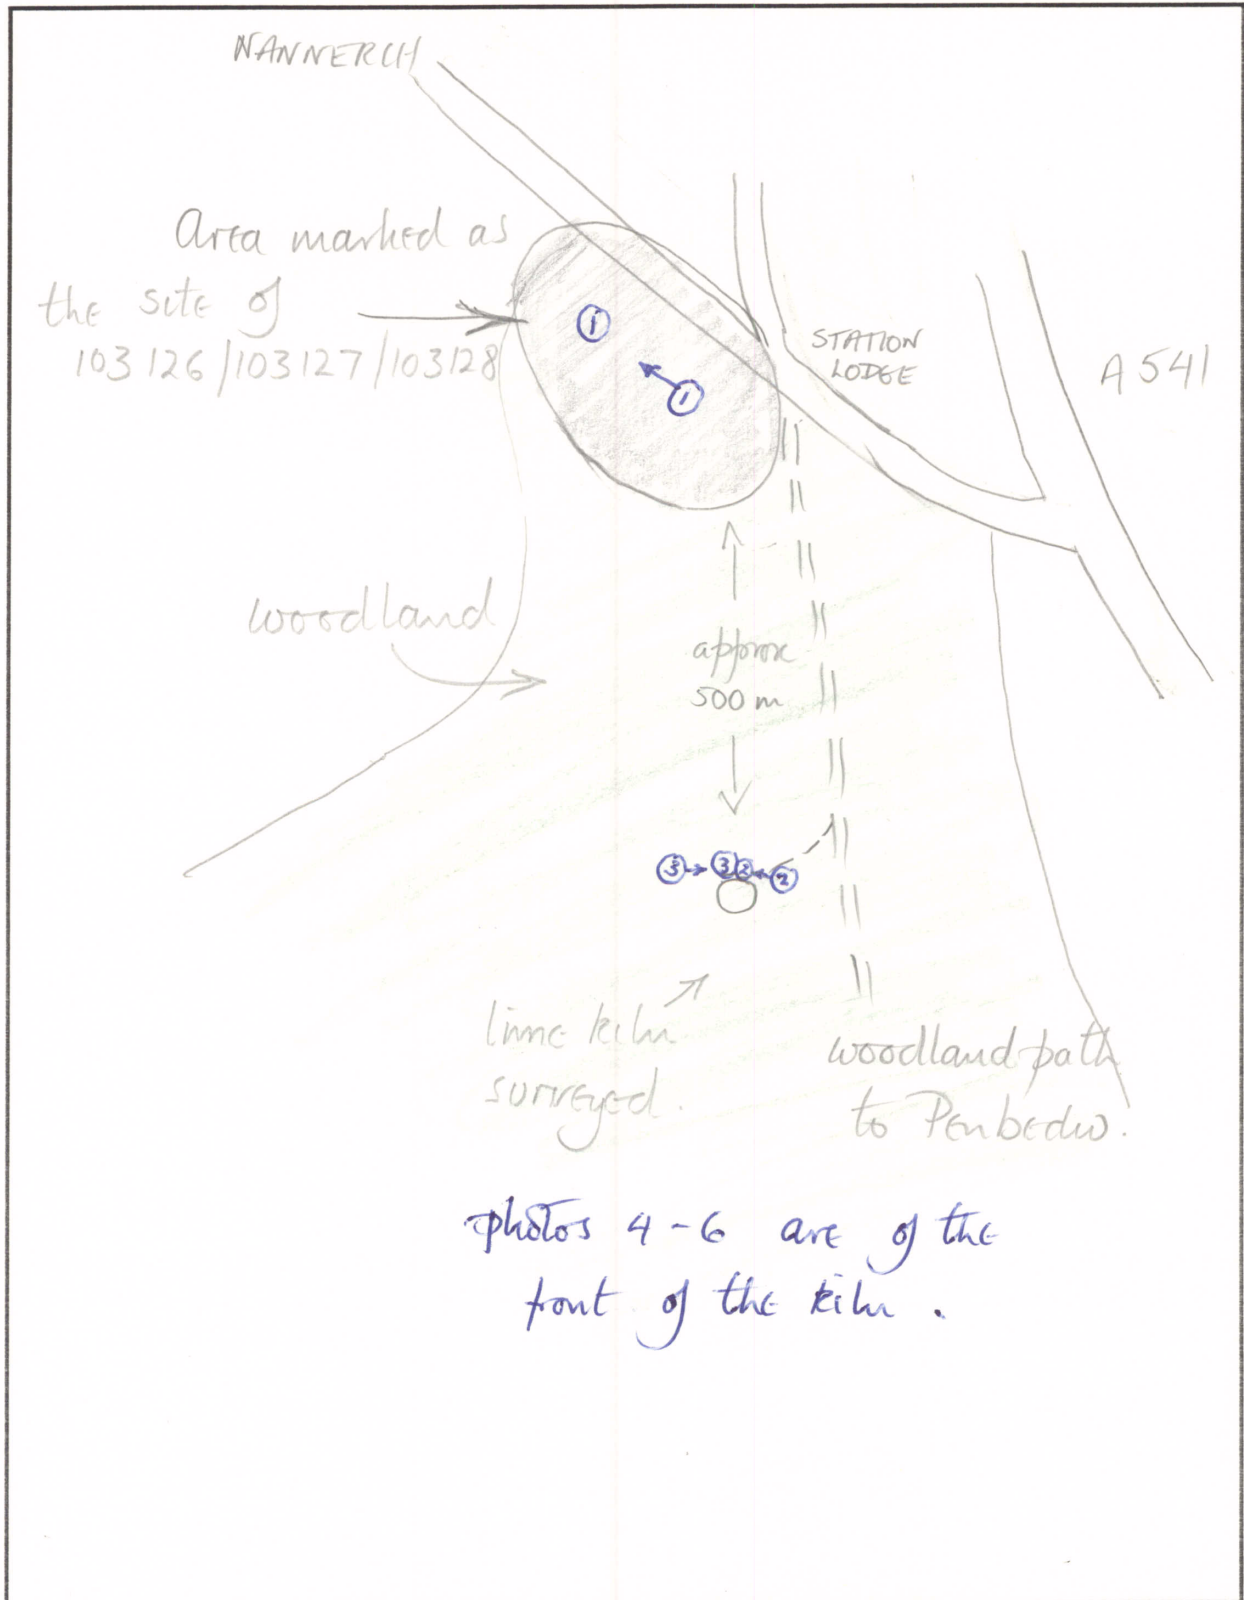
SUPPLEMENTARY NOTES TO FIELD SURVEYS PAGE ..... OF ..... PRN: 103126-8

There was no evidence of some Kilns I-III in the area marked. Local workmen from Penbedw were not aware of any kilns apart from one about 1/4 mile SW of the area. This is the one surveyed. (Photo 1 shows the area enclosed as containing the kilns. It is the site of limestone quarrying but now overgrown) The kiln surveyed is in particularly fine condition and clearly shown in the photos

A woodland path goes past the site but as the woodland is private it is unlikely to be threatened by visitors. The major threat is damage by tree routes - see photo 3 although some felling has taken place photos 2 and 3
