LLEYN PENINSULA ESA, HISTORIC MONITORING

BASELINE 1994

PRN: 1265

LLEYN PENINSULA ESA HISTORIC MONITORING RESURVEY 1998

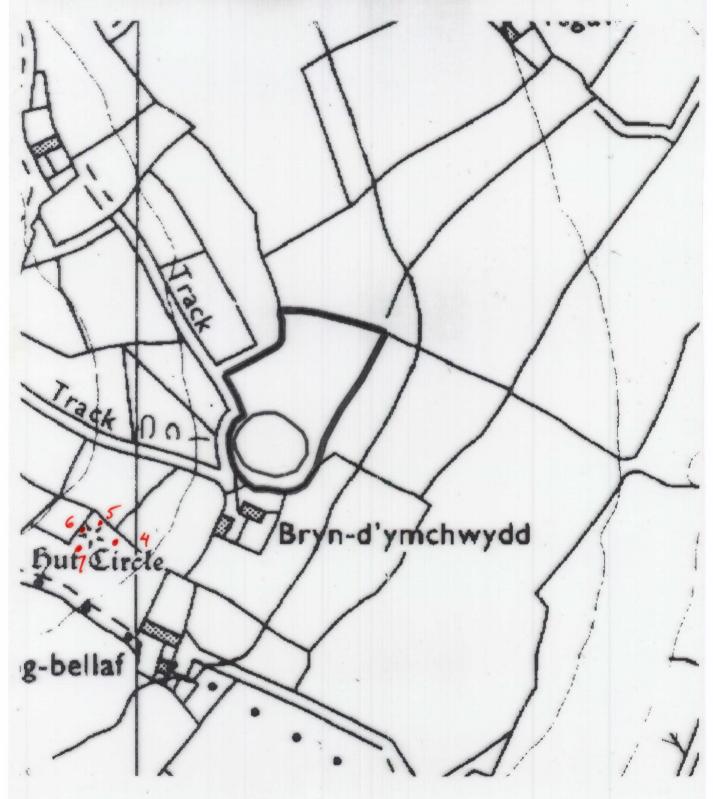
and across circle from which photos 4, 5,6 and 7 were taken.

An opportunity was taken to visit the hut arche made on the map SW of the USAM This is a much more significant and important maniment which is under threat from transpling of outwentived cattle. It is assumed that suce it was not asked to be sorrented at baseline that it is not a USAM. More theless it is an important feature which was photographed 1265 04, 05, 06 and 07 see map for locations). I suggest that this monument be looked at in a re-surry to

assess whether damage from cattle continues.
