LLEYN PENINSULA ESA, HISTORIC MONITORING

BASELINE 1994

OS 1:10000 SHEET: SH 34 SE	GRID REF: SH 3800 4281
PRN: 1283 SITE NAME: Hut group, NE of Cornugwech Jarr	
AIR PHOTO No 88 / 05 / 04	LANDSCAPE TYPE: C. Moorland Basin
No GROUND PHOTOS: 5	
DATE SURVEYED: 30 / 8 / 94	SURVEYED BY: Wyn Davies
ACCESS: Path @ Cornugwech Jarr Farm. Site to be approached via field gate. Site owned by Cornugwech Jarr Farm.

WLEYN PENINSULA ESA HISTORIC MONITORING RESURVEY 1998

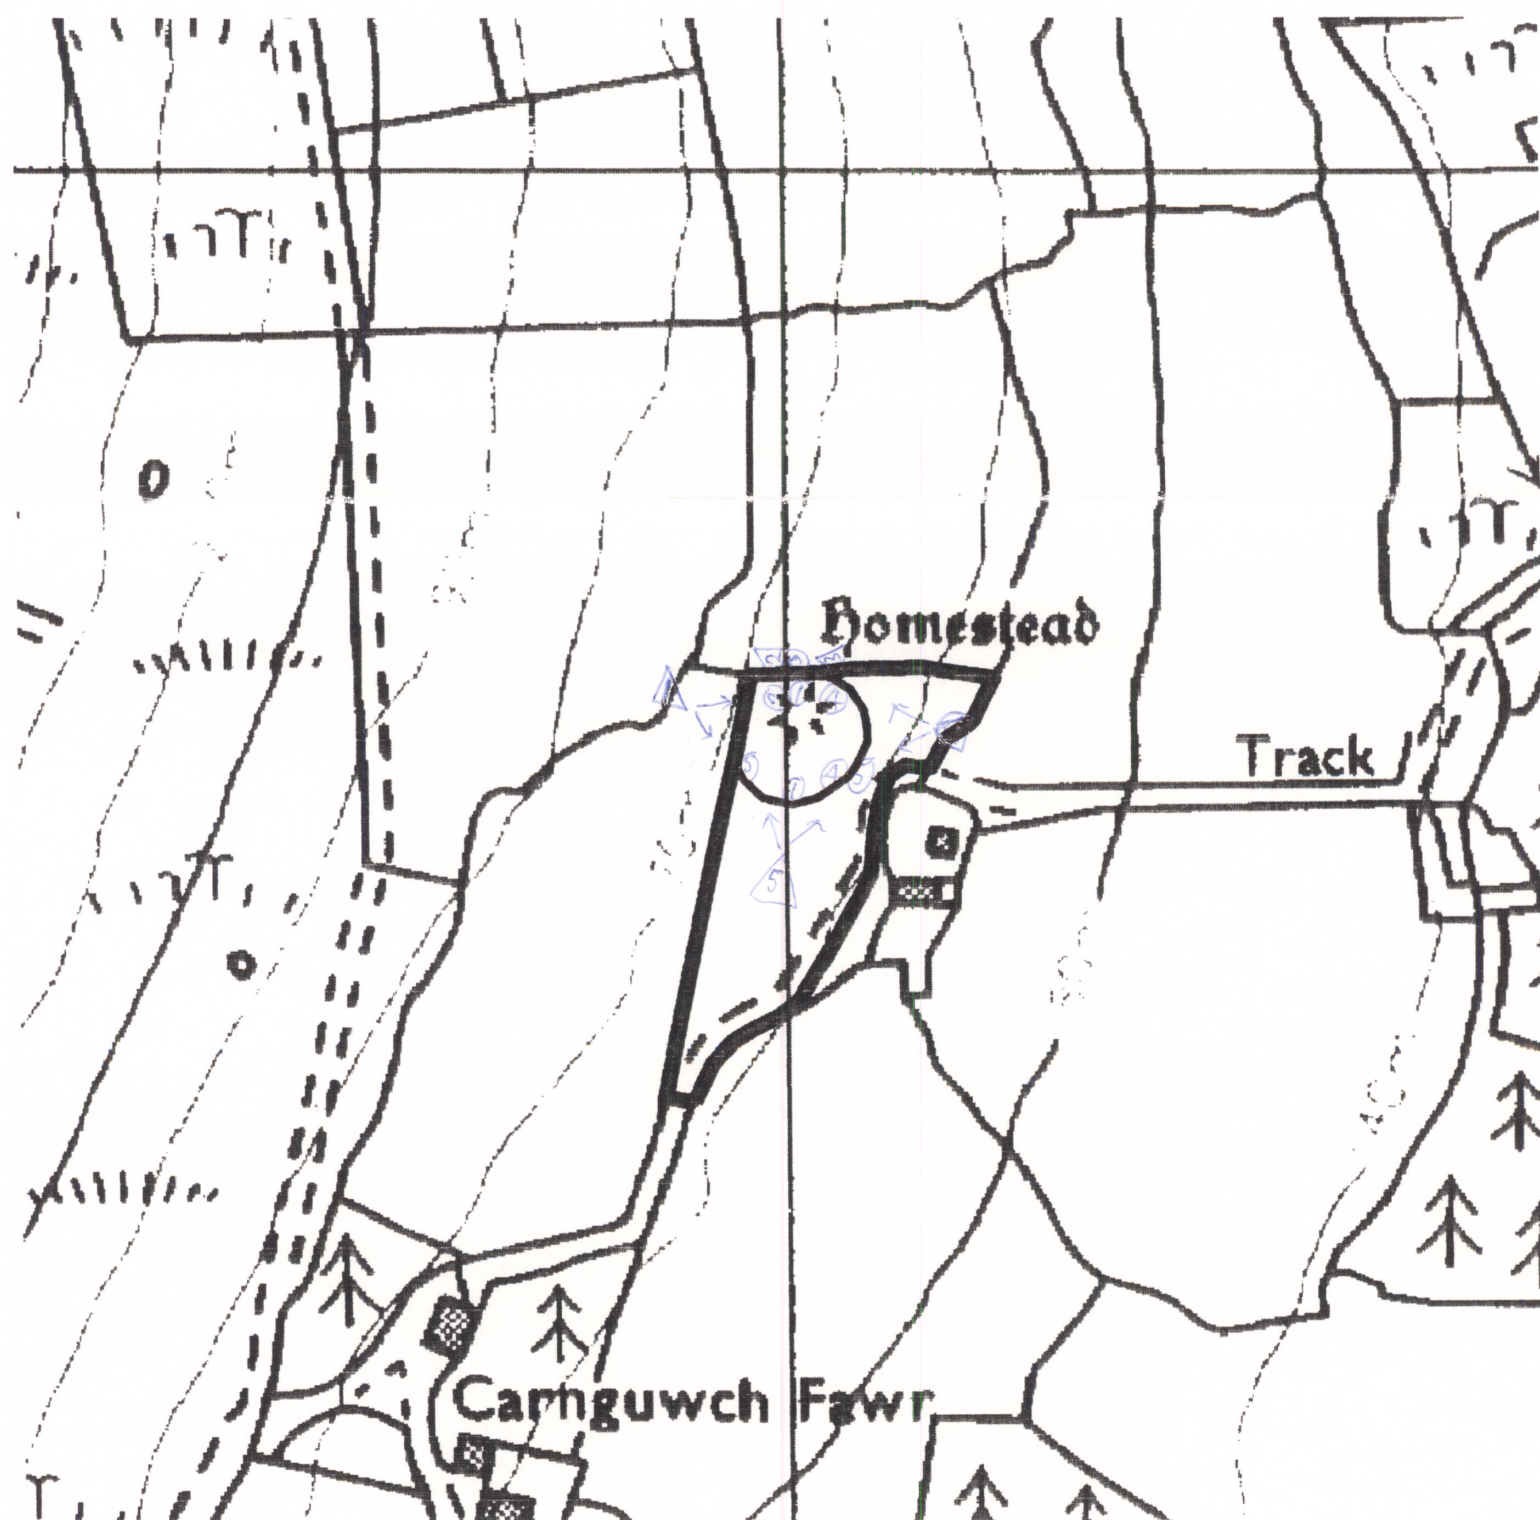
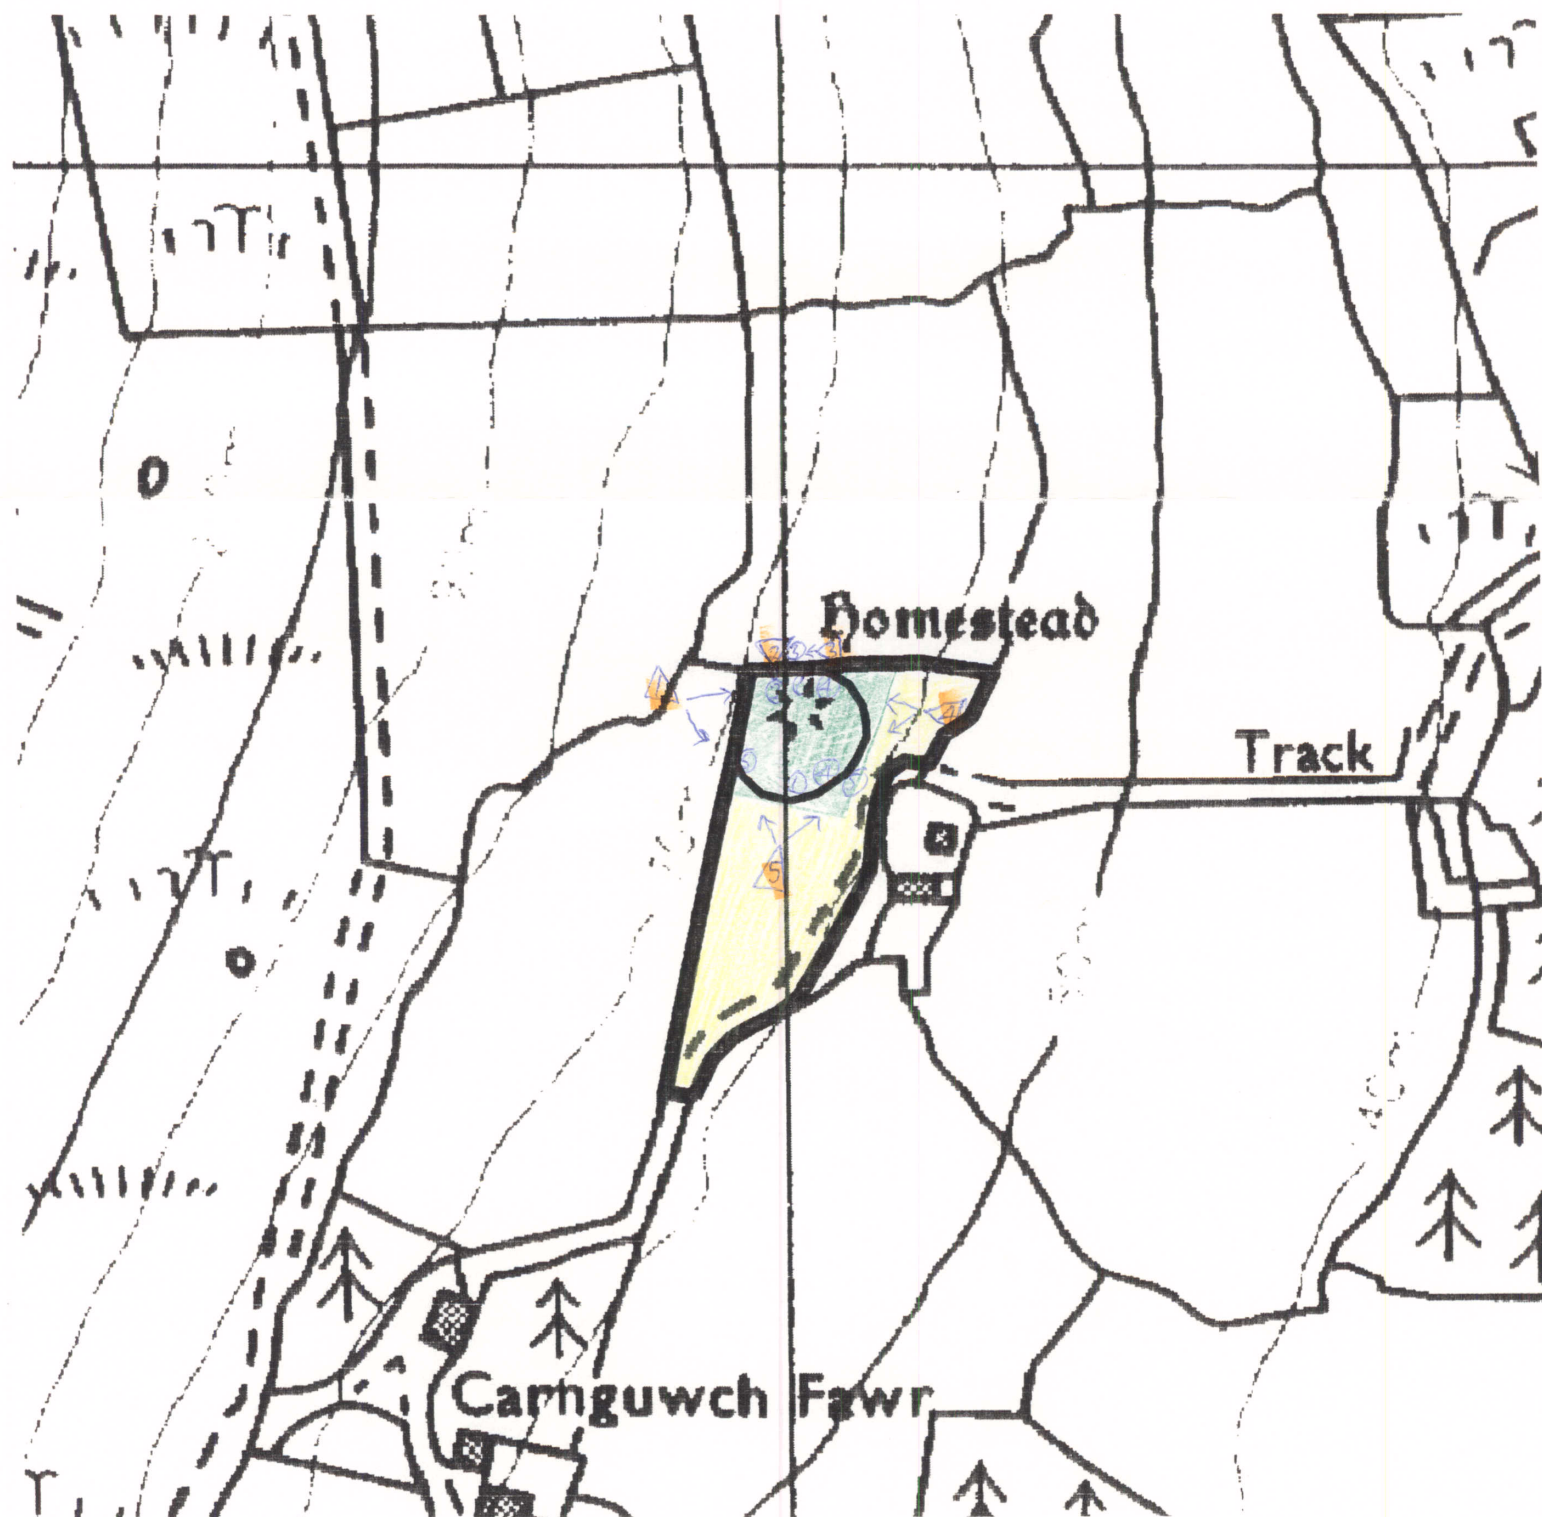
From what could be seen the monument appears in satisfactory condition for its age. The 3 huts have an elevation 1-1½ m above ground level.

Overall, from what could be seen a well preserved site. However, the planted trees are perceived through burrowing roots as a threat to the monument.

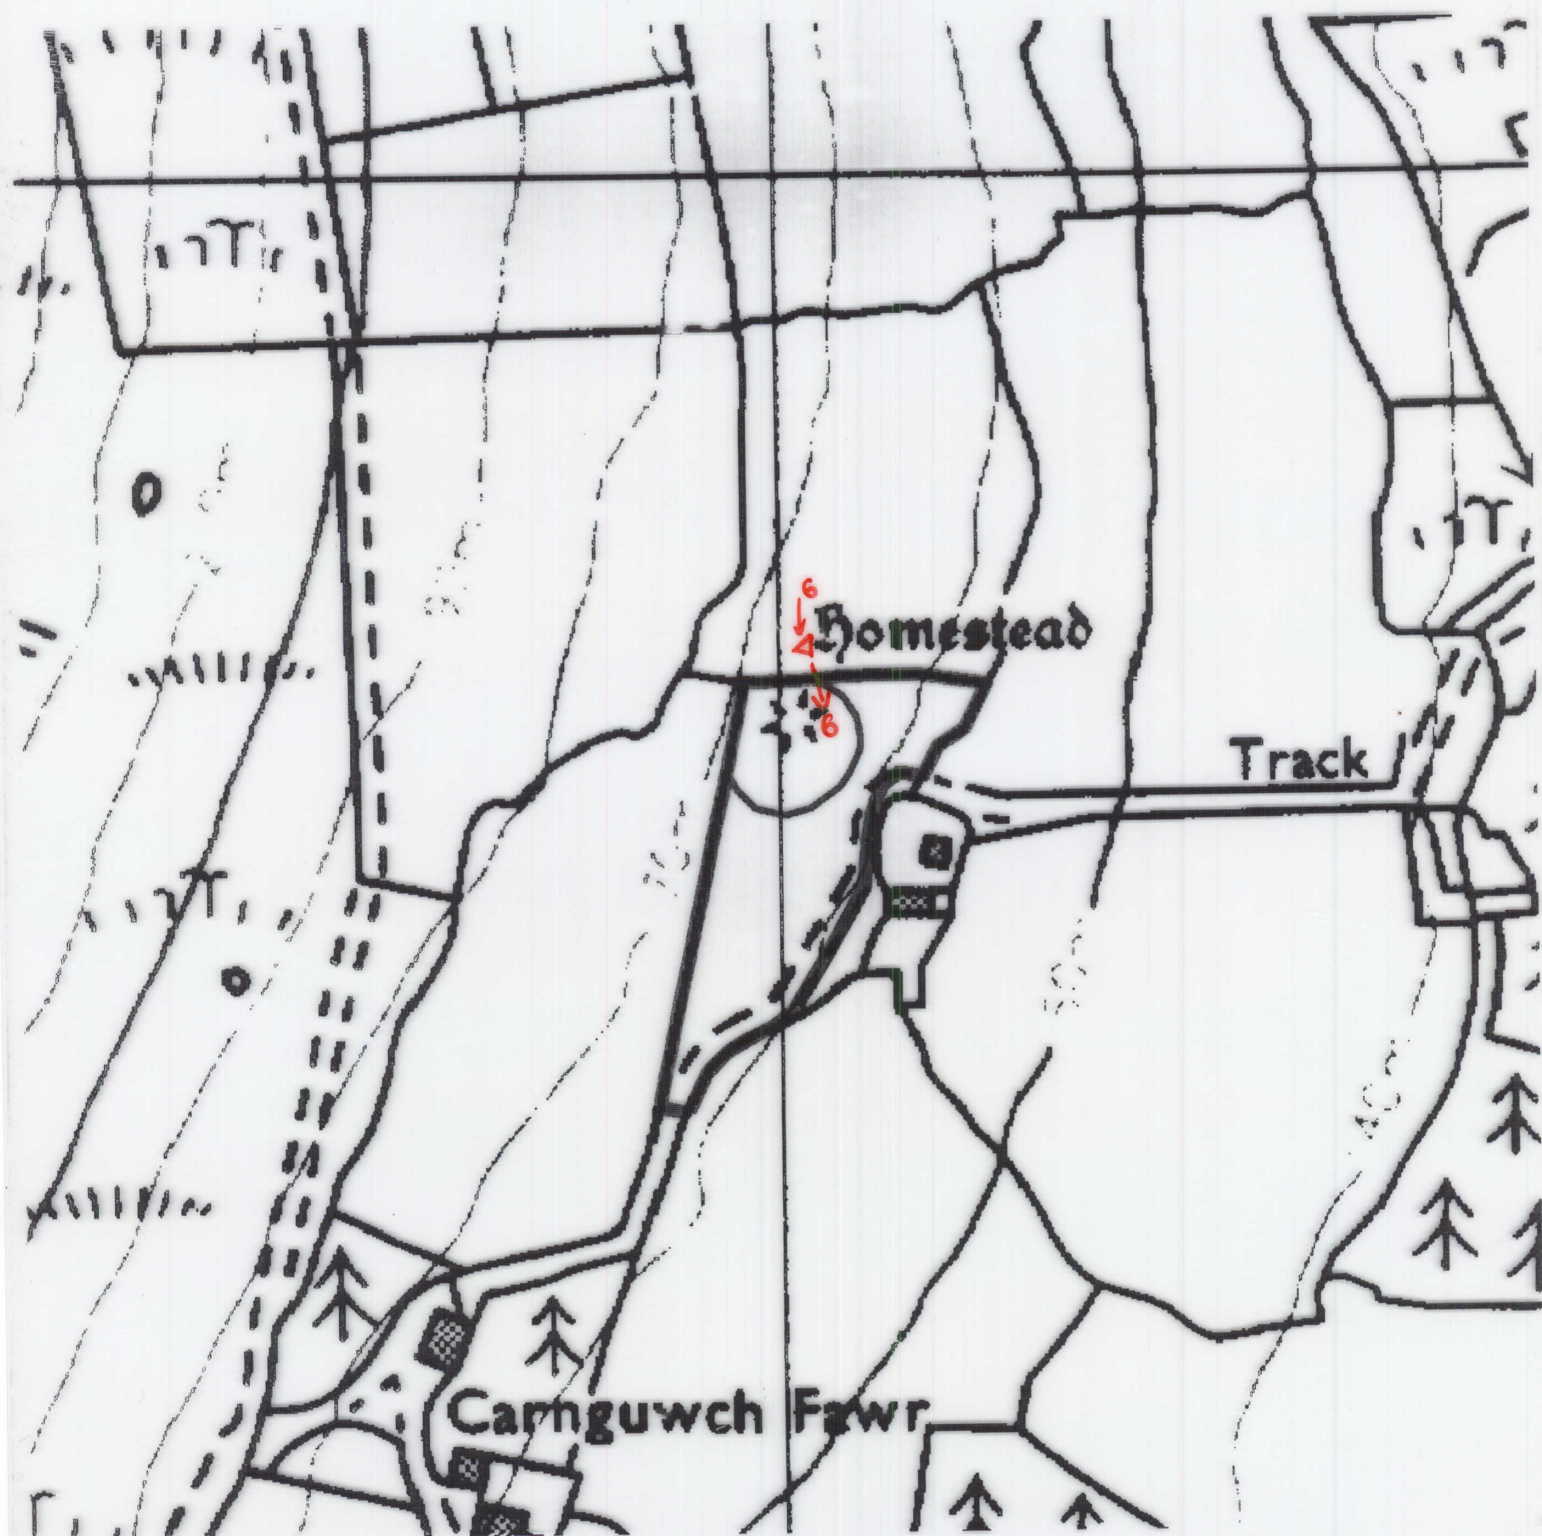
MR. WESLEY KINDLY SHOWED ME AROUND THE SITE. DUE TO DENSE BRACKEN GROWTH AT THIS TIME OF YEAR, THE HUTS COULD NOT BE LOCATED, HOWEVER, NEW PHOTO (12:53:06) SHOWS LOCATION OF ONE OF HUTS AT MR. WESLEY'S DIRECTIONS.

PHOTO 12:53:05 - IT IS THOUGHT THAT A BURIAL MOUND EXISTS ON THE LEFT ON THIS PHOTO IN FRONT OF THE FENCED AREA.
