LLEYN PENINSULA ESA, HISTORIC MONITORING

BASELINE 1994

OS 1:10000 SHEET: SH 44 SW	GRID REF: SH 4308 4444
PRN: 1311 SITE NAME: Coe Men, Lloyd starting stone, SW of Tyddyn Mawr	
AIR PHOTO No 88/04/01	LANDSCAPE TYPE: C. Moorland Basin
No GROUND PHOTOS: 4	
DATE SURVEYED: 30/8/94	SURVEYED BY: Wyn Davies
ACCESS: Path @ Tyddyn Mawr Farm-yard, & walk down to site via field track. Site owned by Messrs Jones, Tyddyn Mawr Farm.

LLEYN PENINSULA ESA HISTORIC MONITORING RESURVEY 1998

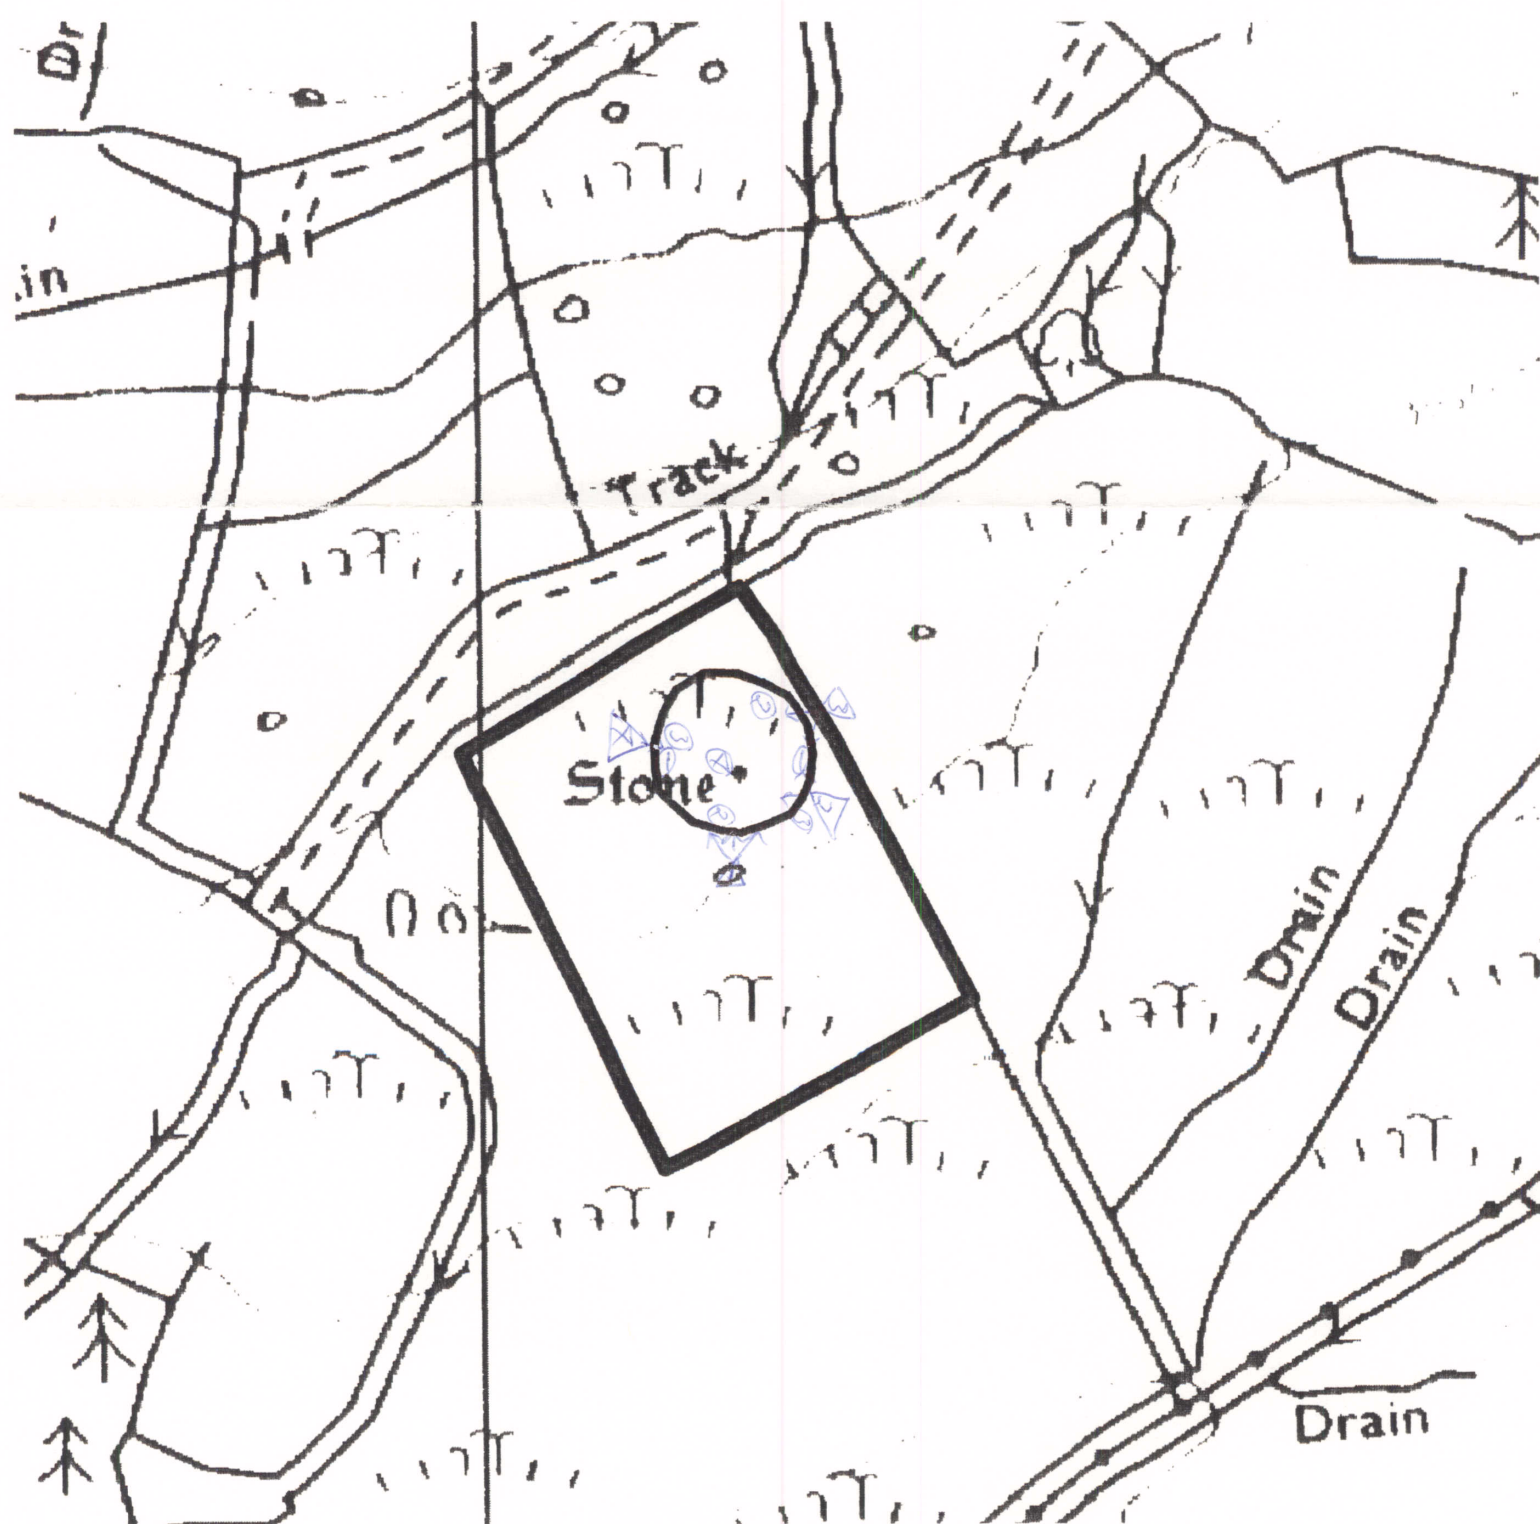
1311

Stone stands about 5' above ground level, stands solid, & appears to be in good condition. A clearly visible texture, extremely easy to locate.
