LLEYN PENINSULA ESA, HISTORIC MONITORING

BASELINE 1994

OS 1:10000 SHEET: SH 43 NW.	GRID REF: SH 4331 3537
PRN: 1332 SITE NAME: Long Hut, S. of Penryn, Morfa Abererch. No other sites present.	
AIR PHOTO No 88101146	LANDSCAPE TYPE: M. Coastal & Valley Flats
No GROUND PHOTOS: 7	
DATE SURVEYED: 28.9.94	SURVEYED BY: Wyn Davies
ACCESS: Park car at Penryn Farm yard. Land owned by Starcoast World, tenants Messrs E.O. Evans, Penryn Farm (two old ladies) also let the land. The land is not in the ESA scheme although Messrs Evans would like to be, but Starcoast World refused. Walk from farm yard to site.

LLEYN PENINSULA ESA HISTORIC MONITORING RESURVEY 1998

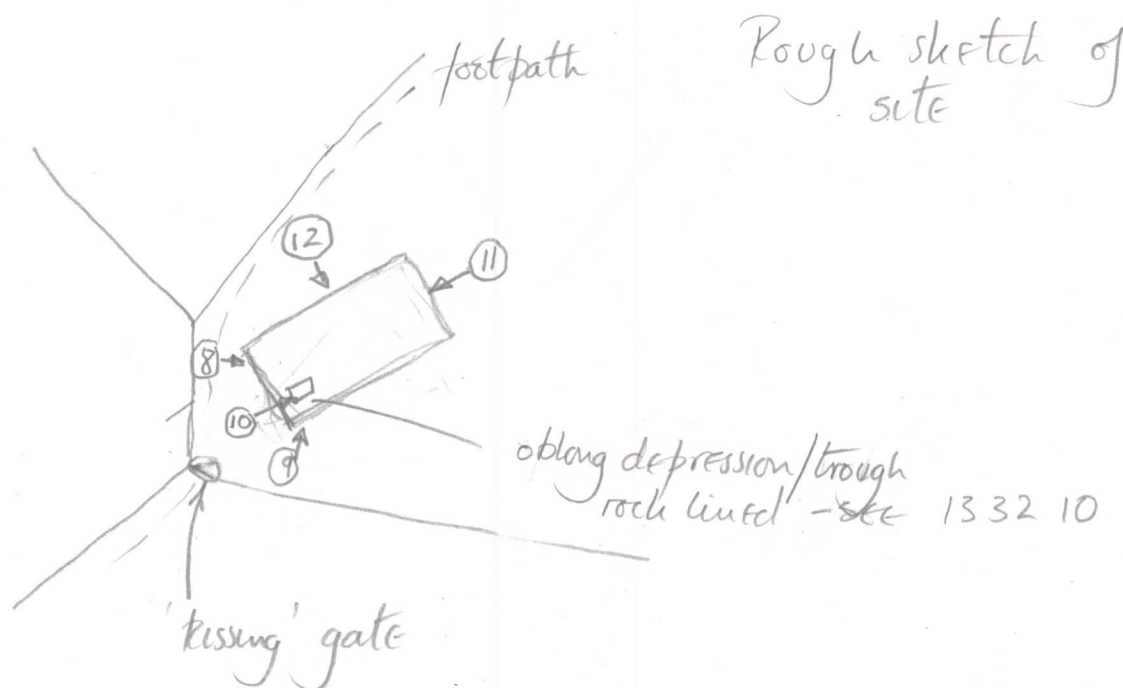
Re-examination/survey of the site suggested that the monument may have been overlooked at base-line survey. An obvious feature was located just outside the marked site. It is a raised platform about 6 x 12 m located a few metres to the left (seaward) side of the path from Penrhyn just before the 'kissing' gate. A sketch of the location is shown in the supplementary notes. None of the base-line photos show the site. Base-photos 13 32 01 to 04 were retained

The site was photographed as above

13 32 08 → 13 32 12.

13 32 10 shows an interesting oblong trough in a corner of the site. The site is flat and grass covered, raised about 0.5 - 1m on the footpath side (- 13 32 12)

Goose is encroaching on most of the boundaries as can be seen in most of the photographs apart from 13 32 10
