# LLEYN PENINSULA ESA, HISTORIC MONITORING

BASELINE 1994

OS 1:10000 SHEET: SH 34 SW	GRID REF: SH 3360 4332
PRN: 2215 SITE NAME: Hut Circle, N.W. of Cilice Uchaf.	
AIR PHOTO No 88/06/23	LANDSCAPE TYPE: D. Hills & Knolls
No GROUND PHOTOS: 4	
DATE SURVEYED: 5:9:94	SURVEYED BY: Wyn Davies
ACCESS: Path @ Cilice Uchaf farm-yard, & walk across one field to site. Location of site pointed out to me by the farmer Mr Jones.

## LLEYN PENINSULA ESA HISTORIC MONITORING RESURVEY 1998

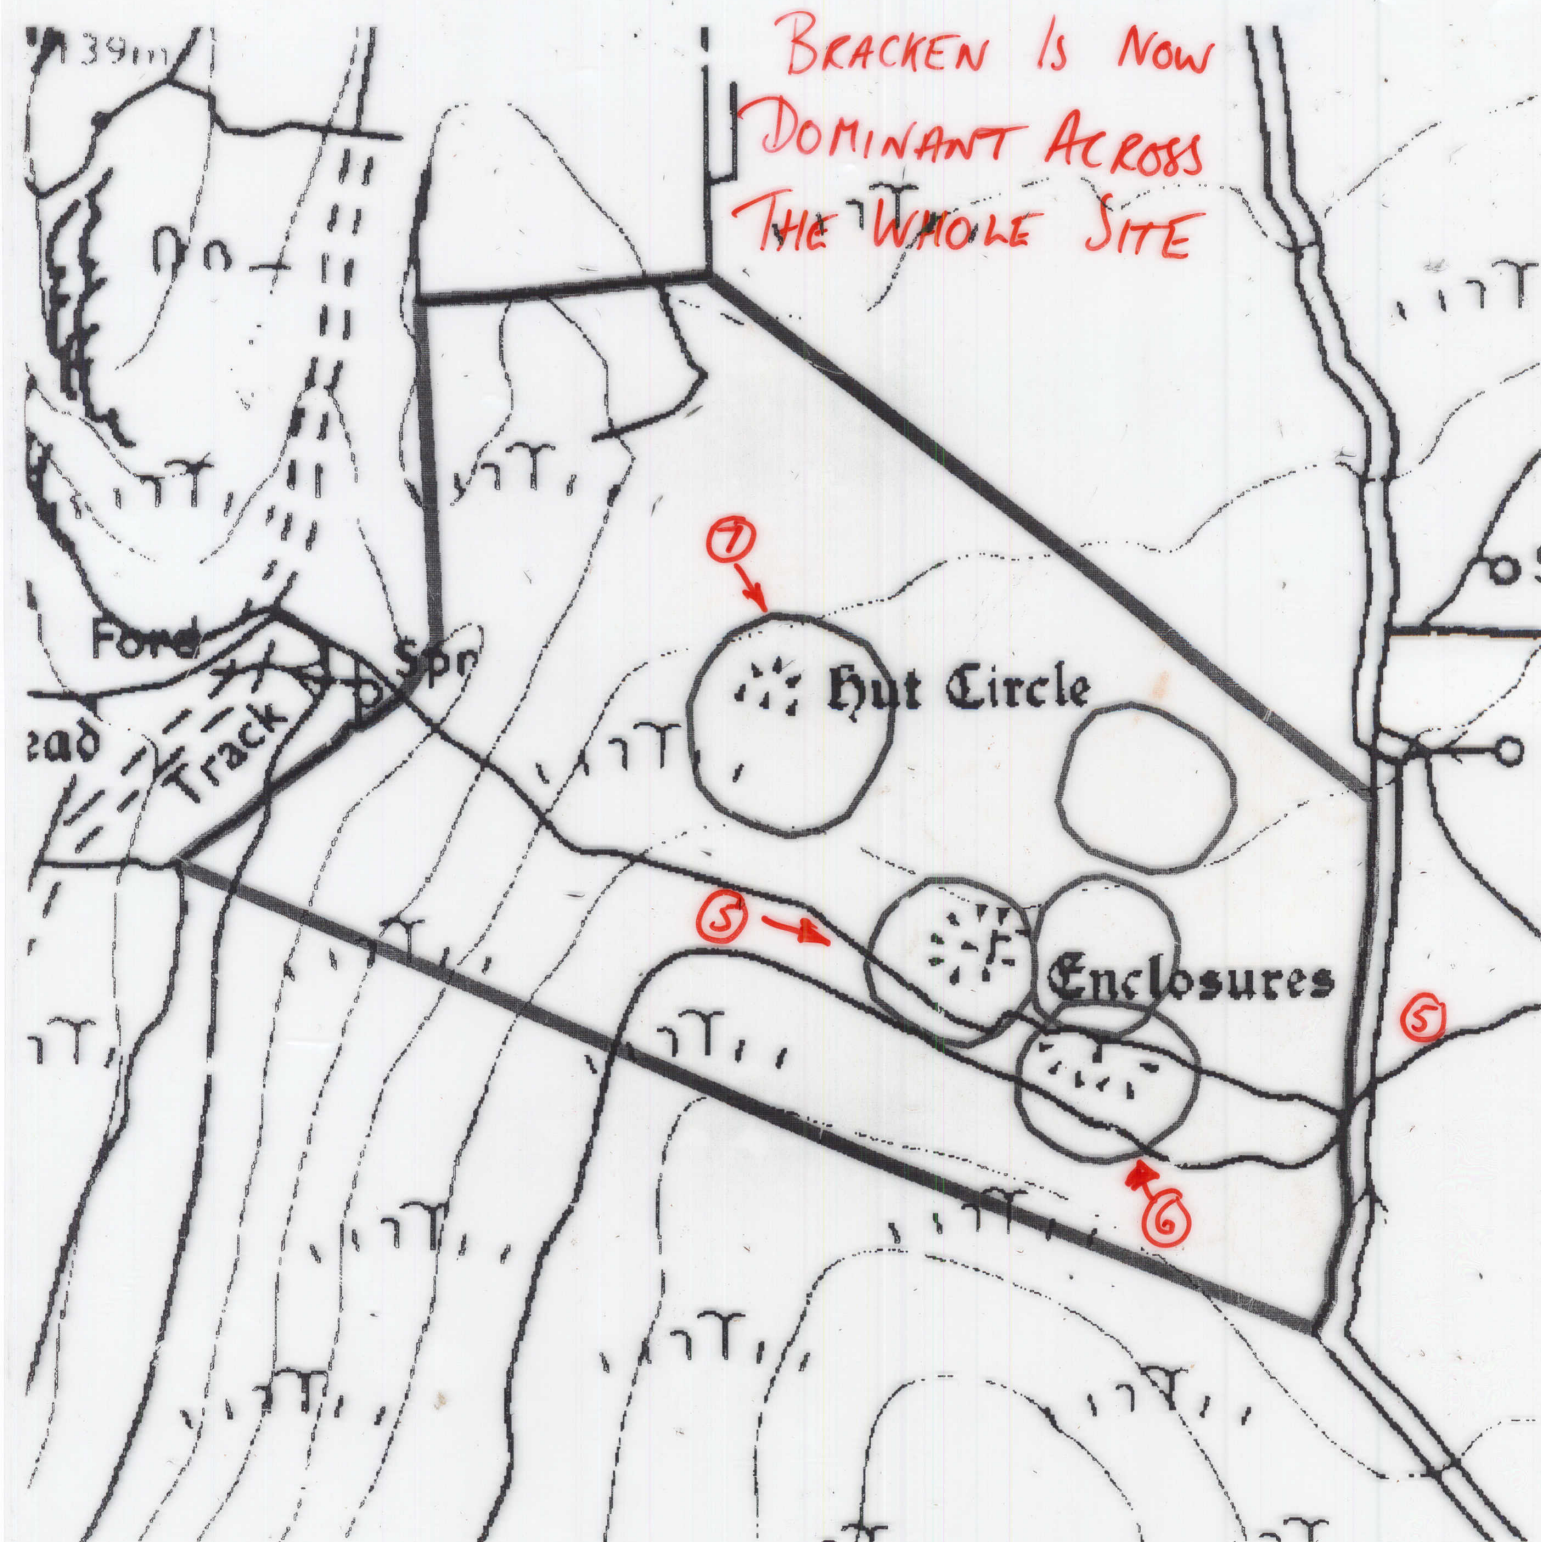
As with the baseline survey, broken cover made re-survey difficult. With careful study all of the features, hut circles and enclosures could be identified. Vista shots 1 and 2 were re-taken (although they show little detail of site) Photo 3 was retaken and should show the raised bank of the obvious enclosure. Photo 4 was not retaken since it shows no detail of the site but new photo 5 was taken instead since it shows location of site along the wall line.
