LLEYN PENINSULA ESA, HISTORIC MONITORING

BASELINE 1994

OS 1:10000 SHEET: SH 33 NE	GRID REF: SH 3846 3708
PRN: 436 SITE NAME: Hut platform, near Llyn Llwyd, no other sites present	
AIR PHOTO No 88104/25	LANDSCAPE TYPE: A. Sheltered parkland
No GROUND PHOTOS: 3	
DATE SURVEYED: 25.8.94	SURVEYED BY: Wyn Davies
ACCESS: One access, Yoke House, Pwllheli. Access not from Yoke House but from Main Road to Llwyn Llyn to Brynallt Farm. Path cut by woodland adjacent to site (on Llwyn Llyn).

LLEYN PENINSULA ESA HISTORIC MONITORING RESURVEY 1998

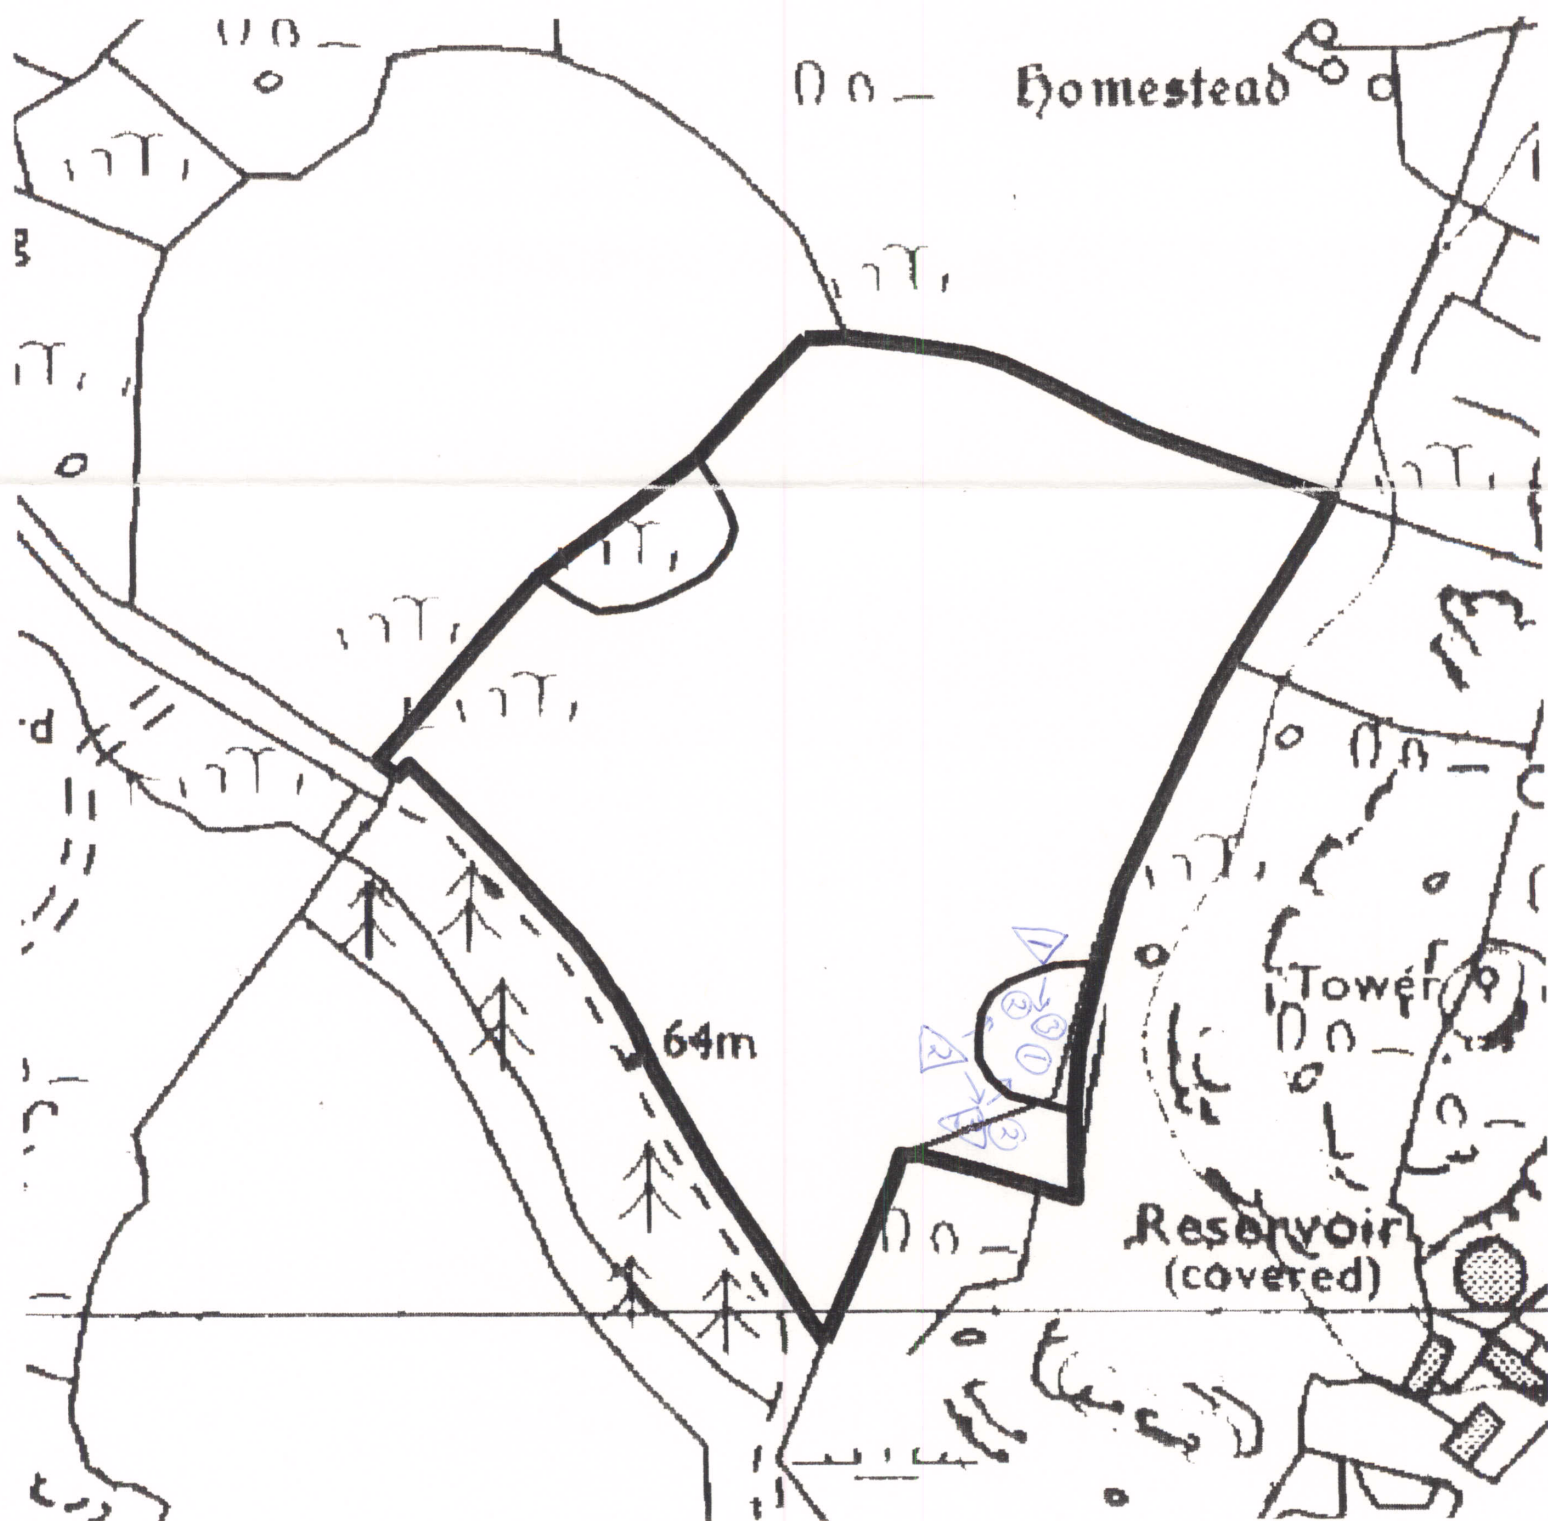
No visible sign of monument above ground level, & even if the grass was cut short nothing would be visible to the naked eye at ground level. Site borders field with rocky outcrops / clumps of European gorse, but this is not perceived as a threat to the monument.

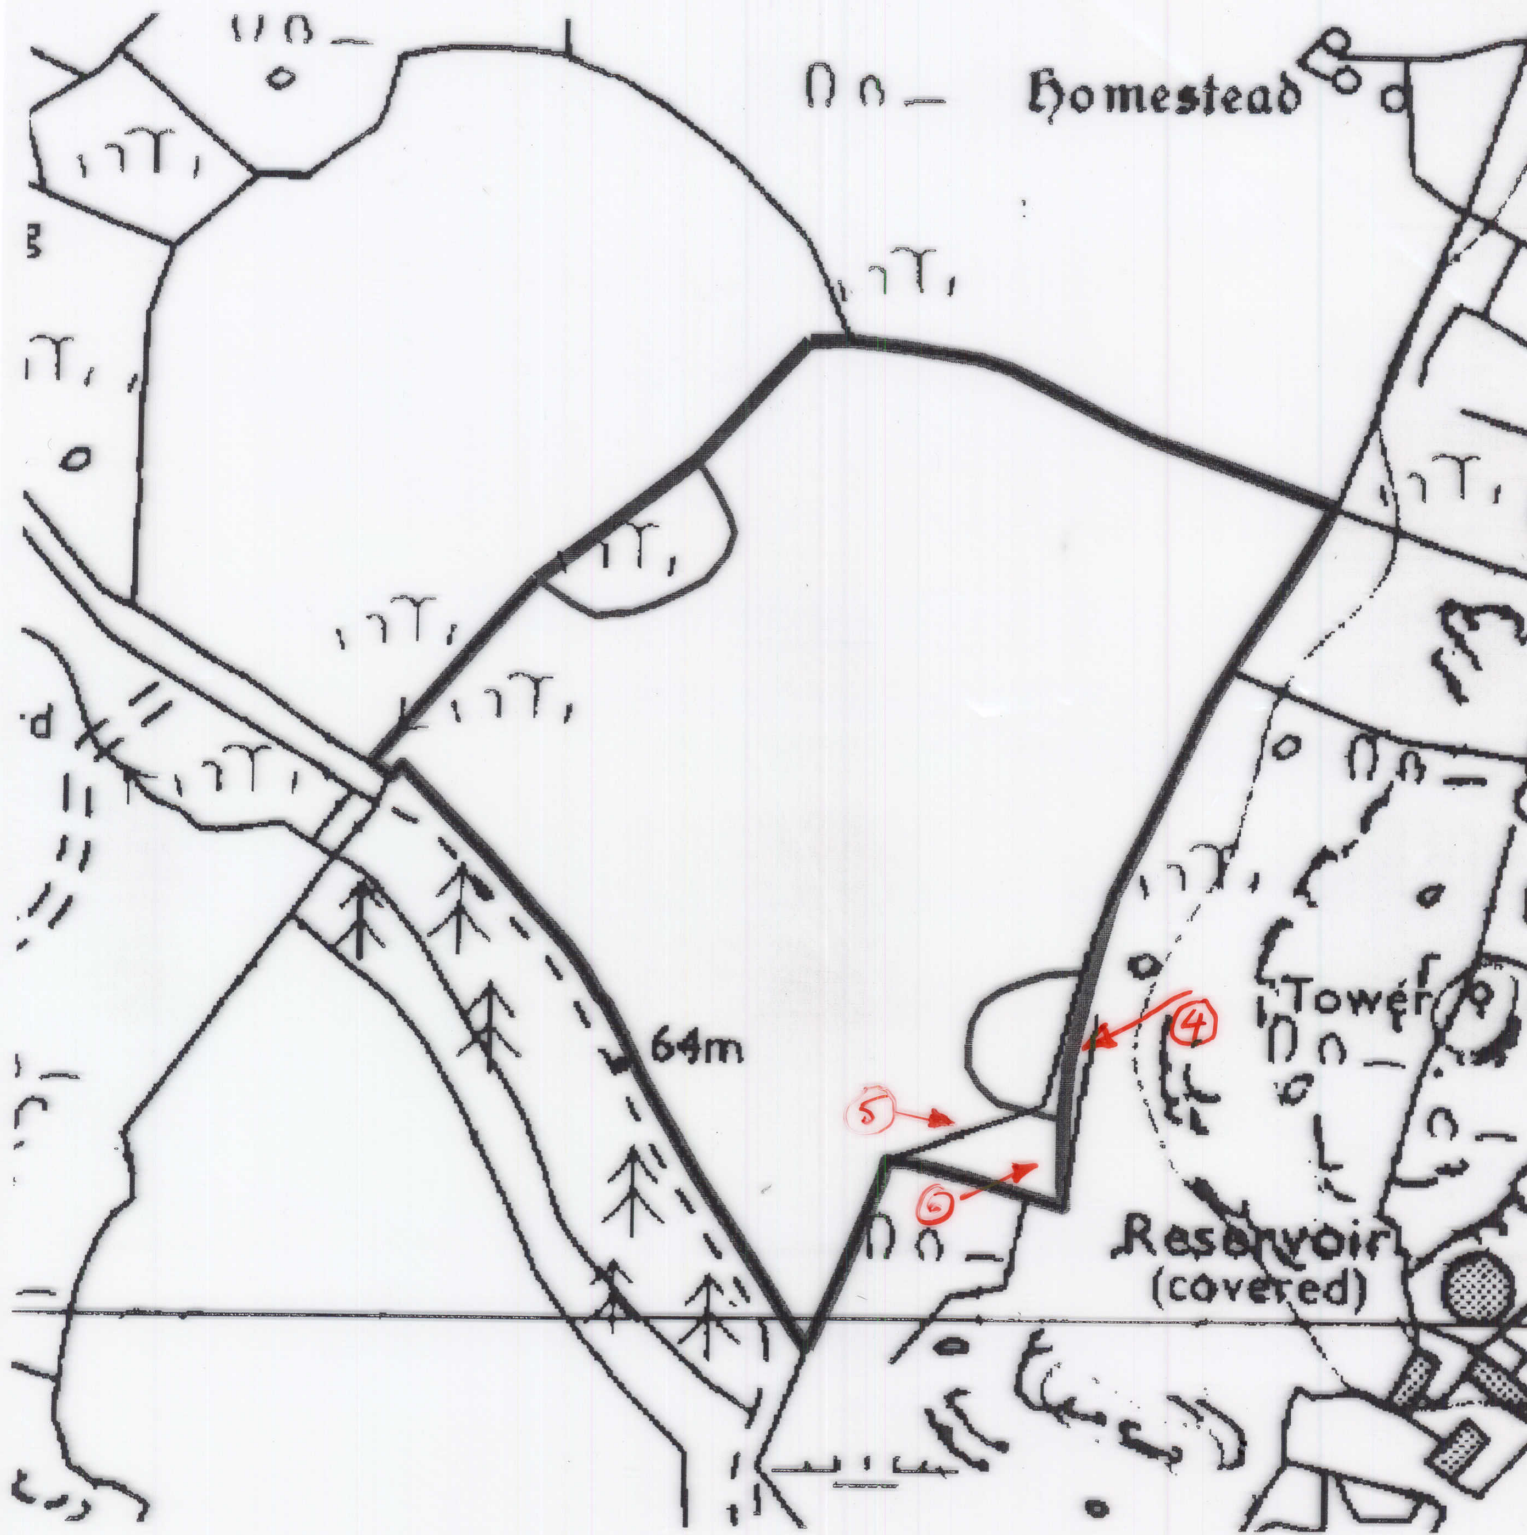
This monument could not be identified.
An opportunity was taken to take an 'aerial'
photo from the steep bank above the site. Photo 4
Base photos 1 and 2 were taken but not photo
3 since it covers the same area as photo 2
and shows nothing new. Photo 5 was taken
of a linear earth mound just S. of the site
- it is probably an old field boundary.
Photo 6 shows a line of large boulders which
may also be related to an old field boundary.
