LLEYN PENINSULA ESA, HISTORIC MONITORING

BASELINE 1994

OS 1:10000 SHEET: SH 34 SE	GRID REF: SH 3590 4479
PRN: 619 SITE NAME: Month s	bye of yor Eigh,
AIR PHOTO No 88 /06/26 No GROUND PHOTOS:	LANDSCAPE TYPE: O. Mills & Knylls
DATE SURVEYED: 5:9:94	SURVEYED BY: Ayra Paries
ACCESS. Drive car up trace for the track. Distance provious track approximenate	in public road to site

LLEYN PENINSULA	A ESA	HISTORIC	MONITORING	RESURVEY 1	998
-----------------	-------	----------	------------	------------	-----

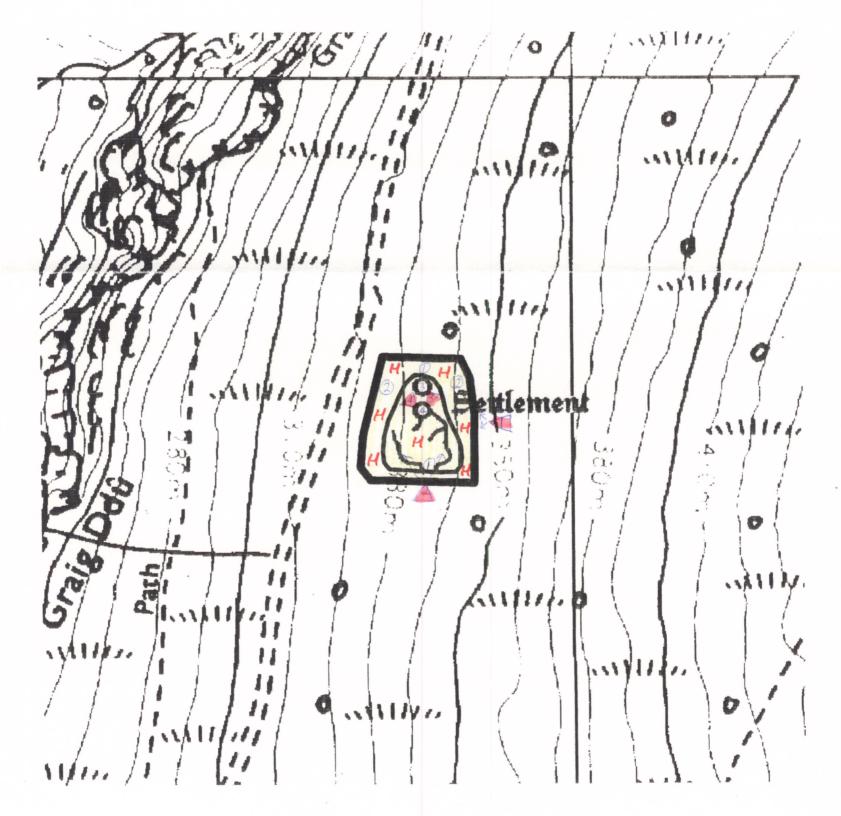
619

E the enclosures are in the background.

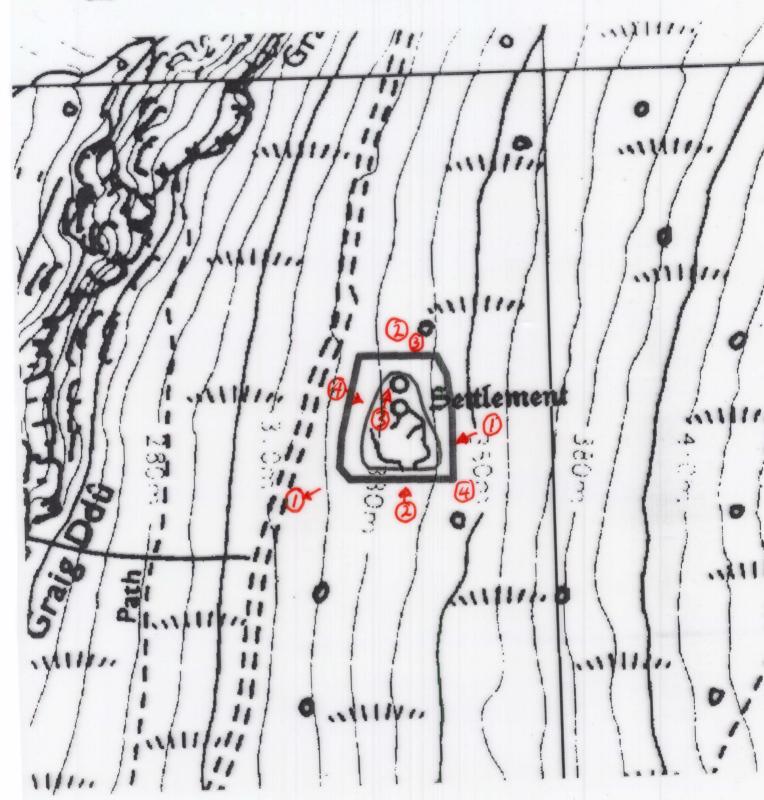
position of baseline photos marked for easier reference.

about 100 metres uphill SE of the site photographed at baseline is the probable site of another but well (not photographed at base line so very) The site is a hollow in the hillsede in which the remnants of a arrular stone wall can be seen. New photos 05,06 e 07 Hillside Depression/ hollow stone wall 4 remains photo 05 across site looking towards Site surreyed at Sast Photo 07 shows remains of wall.
