LLEYN PENINSULA ESA, HISTORIC MONITORING

BASELINE 1994

OS 1:10000 SHEET: SH 12 NE.	GRID REF: SH 1653 2671
PRN: 776 SITE NAME: Hyman Saint-Holy Well, Minsion.	
AIR PHOTO No 88/05/58	LANDSCAPE TYPE: E. Coastal plateau
No GROUND PHOTOS: 5	
DATE SURVEYED: 7.9.94	SURVEYED BY: Wyn Davies
ACCESS: Park car on grass verge opposite Minsion house. Photograph 4 shows access path through vegetation to well. Distance from road to well approximately 8-10 metres.

LLEYN PENINSULA ESA HISTORIC MONITORING RESURVEY 1998

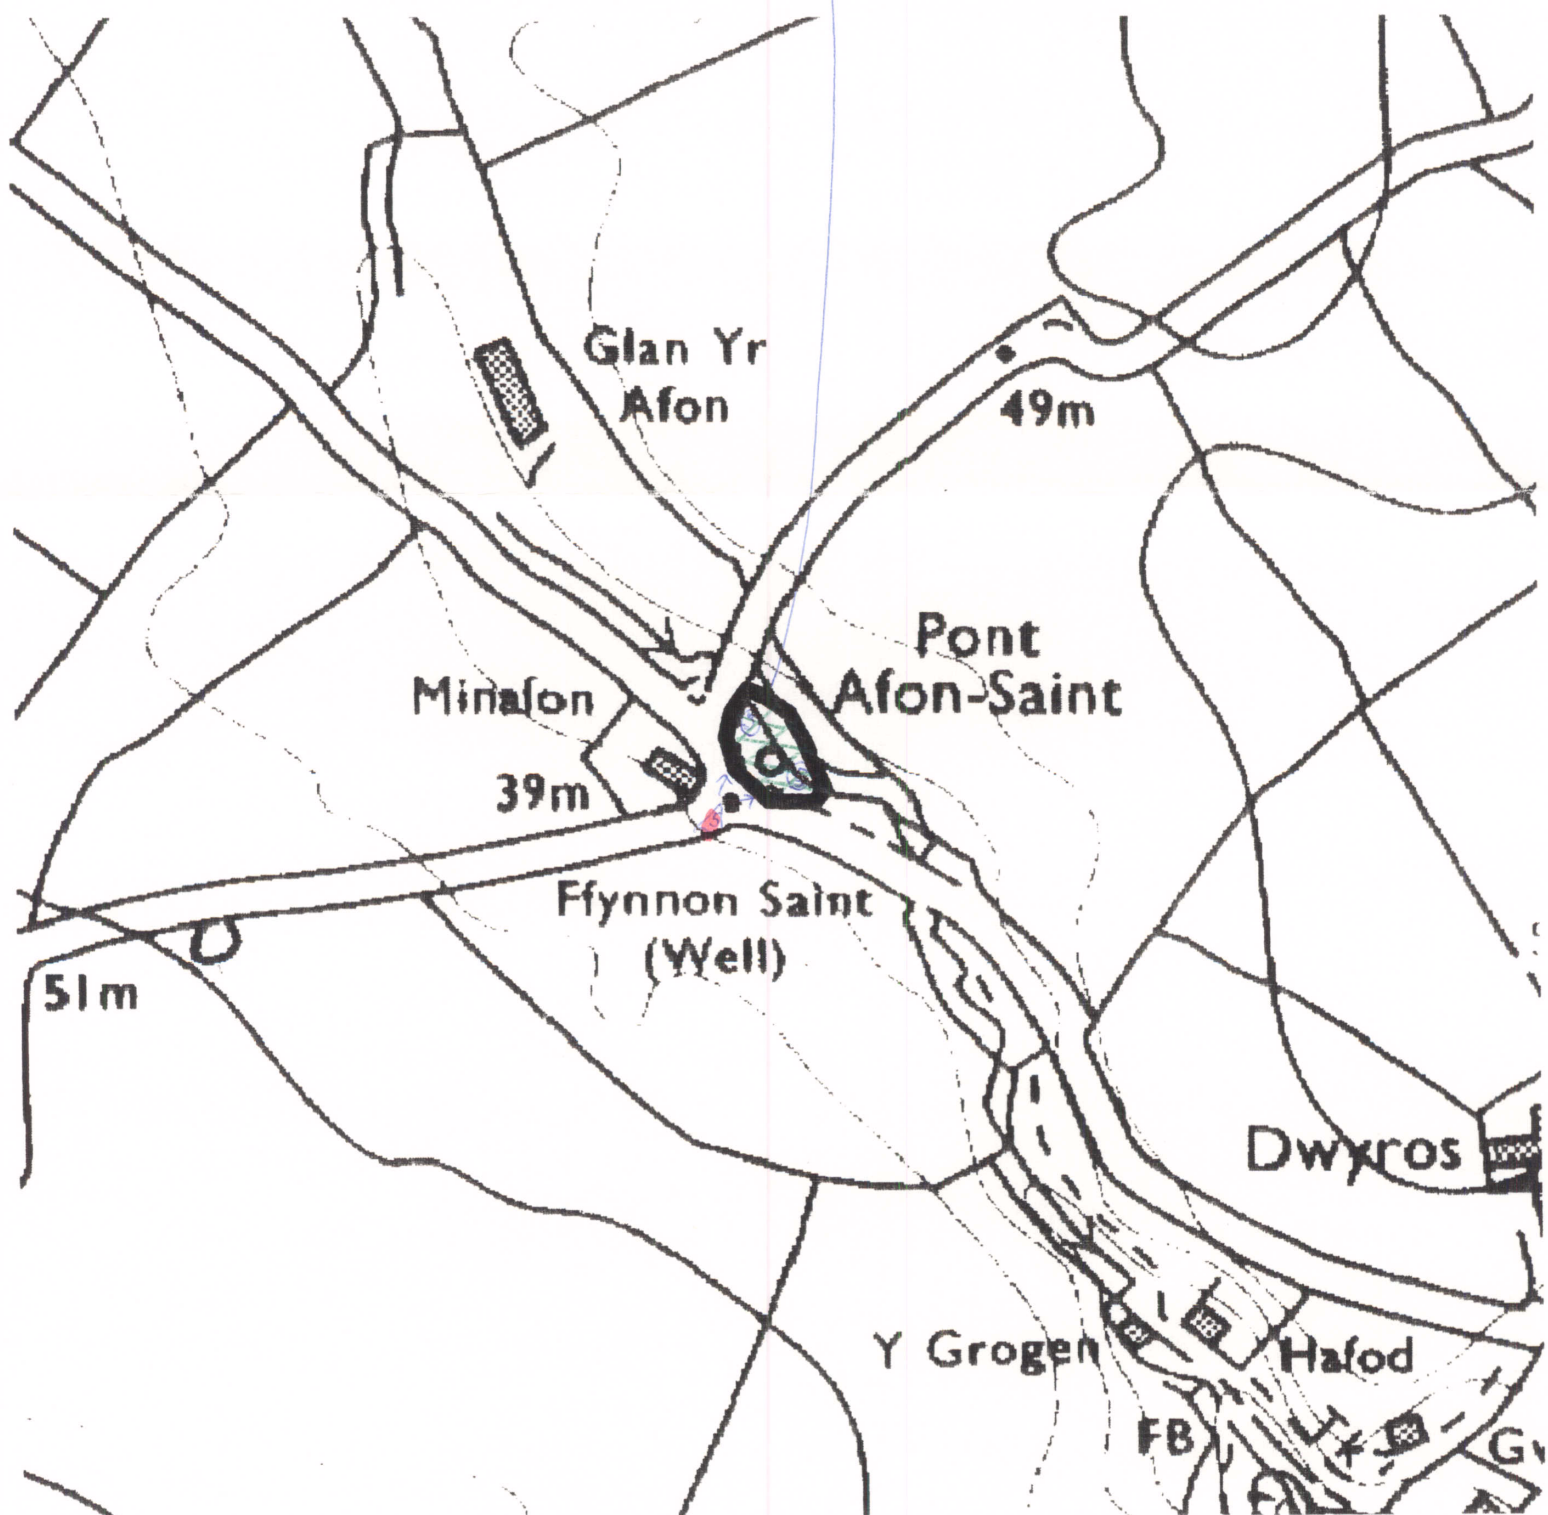
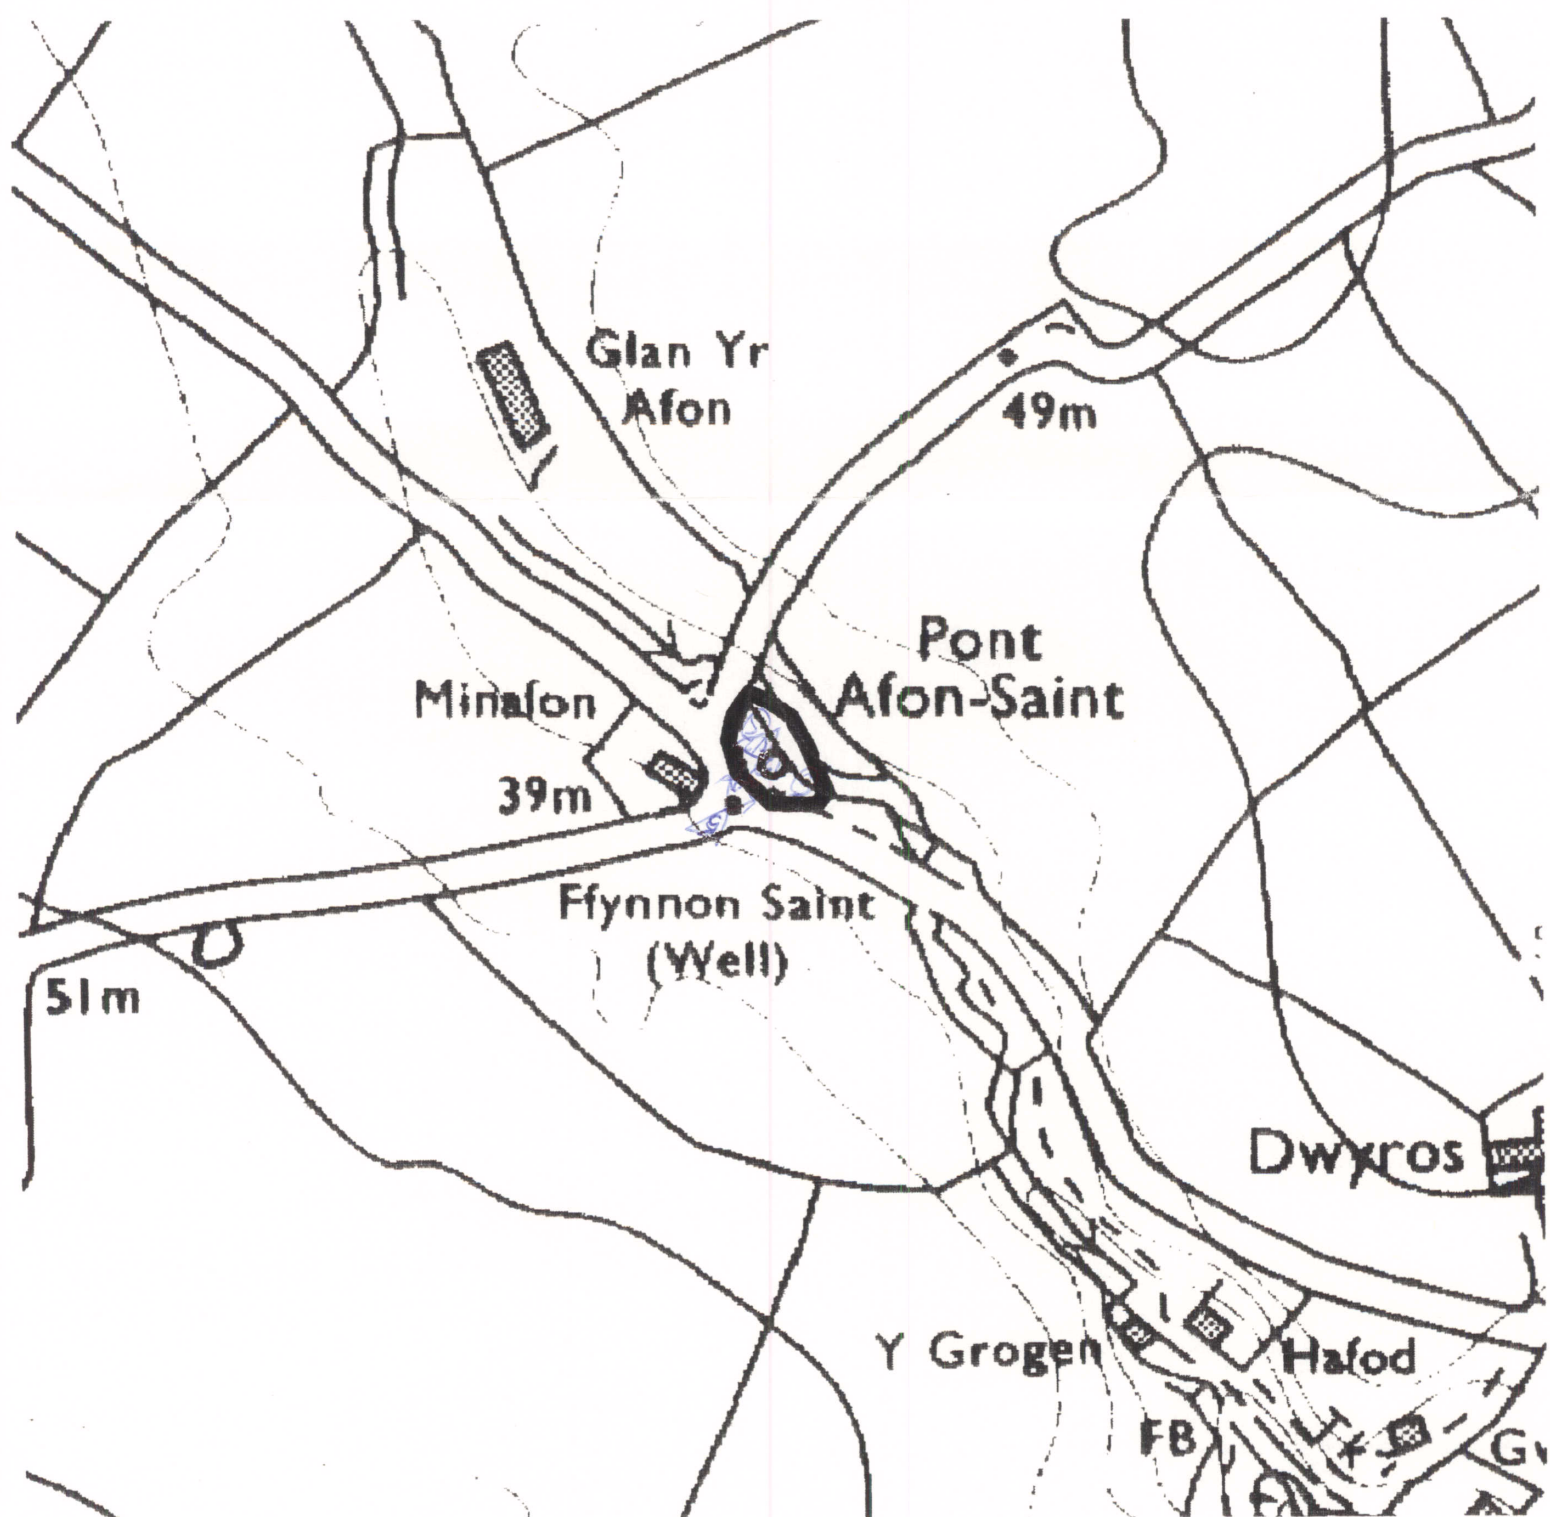
The well is made of cemented stone & has a hinged metal cover covering most (not all) of the well. Unmanaged site - neglected appearance.

In good condition. Stone wall of well is solid, but hinged metal cover is too small for well, & as a result there are a lot of leaves in the water / well. Otherwise, the monument is O.K. - scrub / vegetation biggest threat to monument as it now stands.

1. Root damage by trees.
2. Scrub encroachment - engulfing of well.

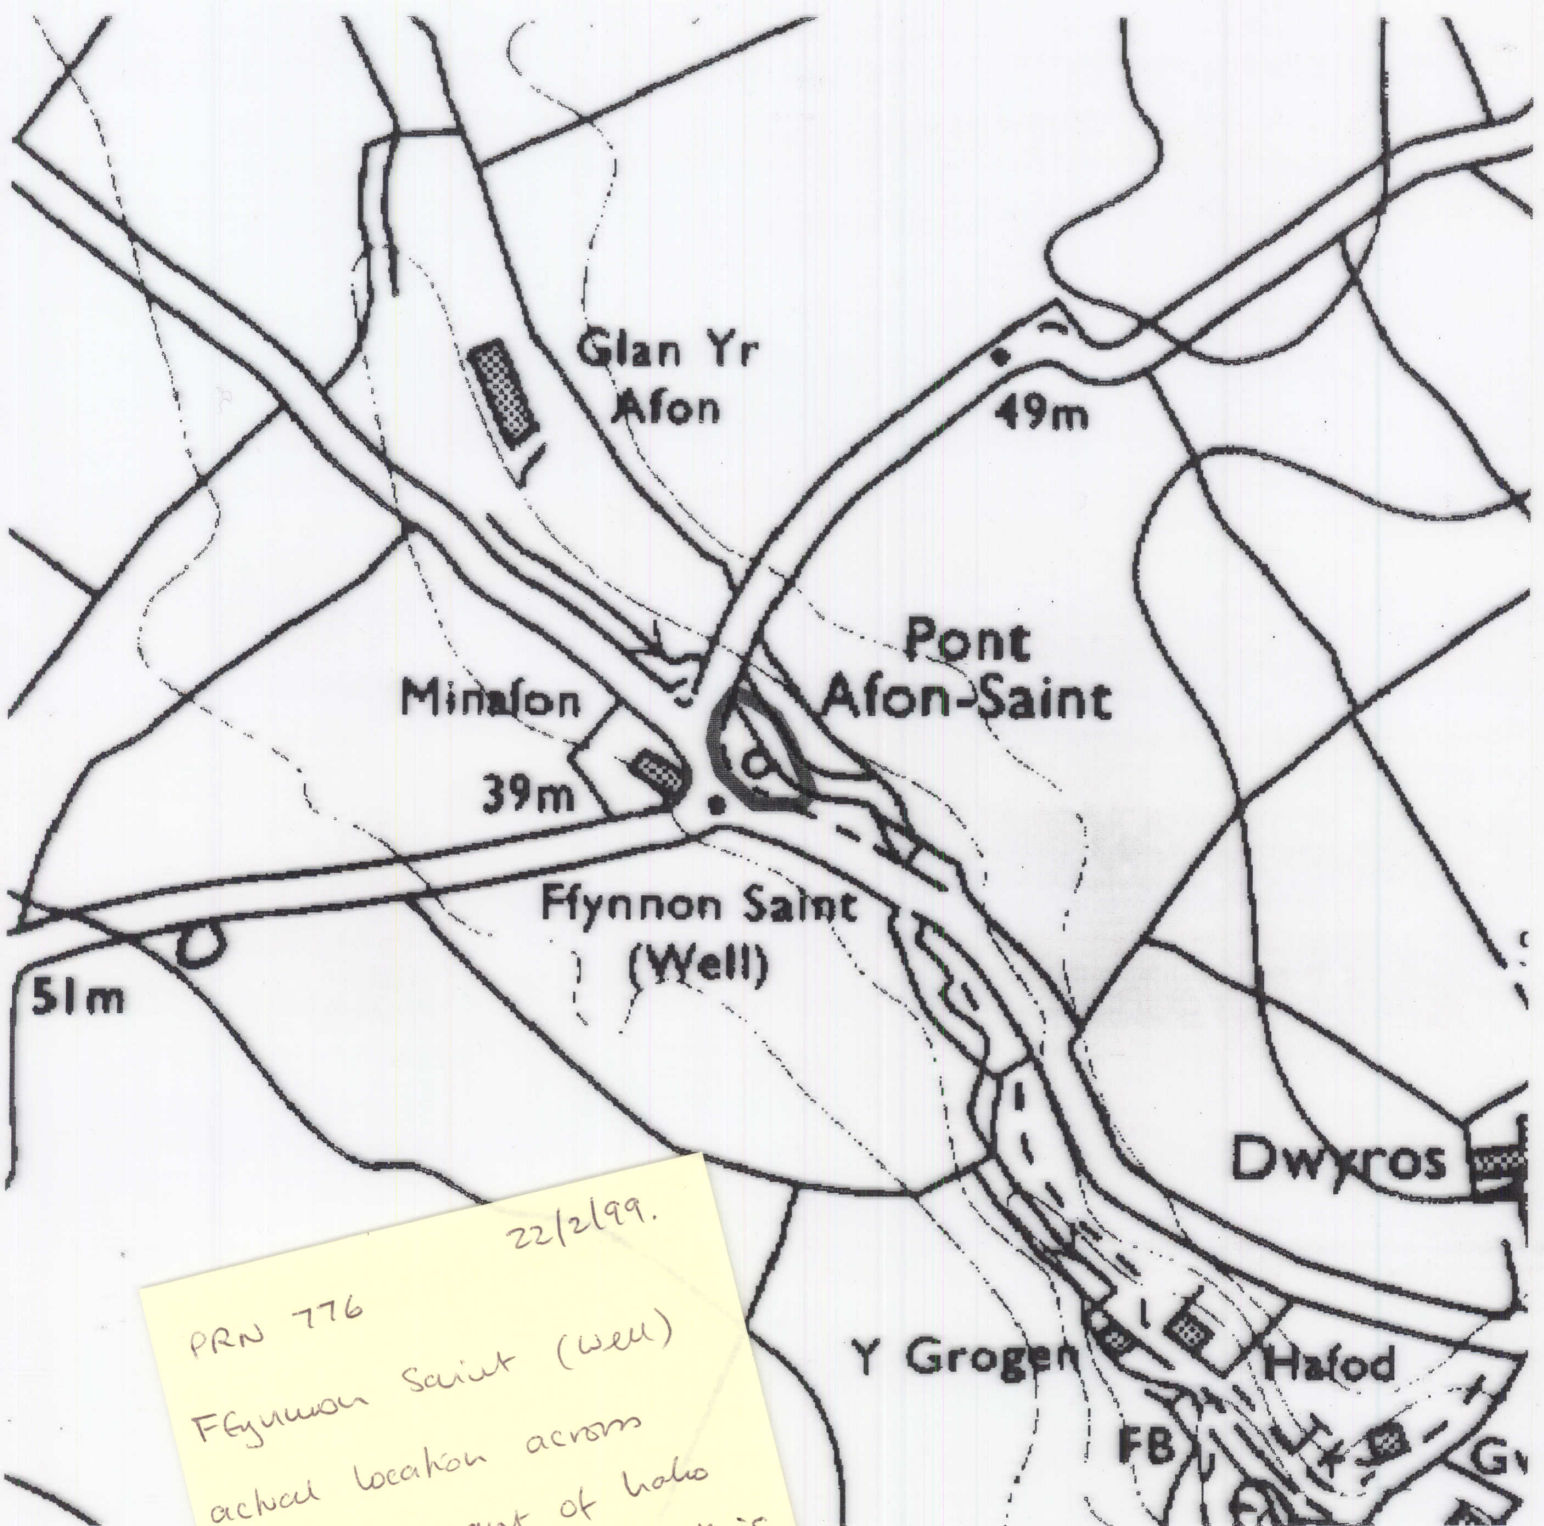
PRN 776

Ffynnon Saint (Well)

actual location across
road but point of hole
on Ag land. Should this
be enclosed as in Ag?

Cover over well does not fit properly and
one of the hinges is rusted through

The site is now very easily located with a good path from the roadside. It is more susceptible to vandalism - damage to the cover and stone work. Once the second hinge on the cover is rusted through there is a risk of leaves and other rubbish falling into the well.
