# PRESELI ESA, HISTORIC MONITORING

BASELINE 1994

| PRN: 17010 SITE NAME: SLEDECH | |

## PRESELI ESA HISTORIC MONITORING RESURVEY 1997/98

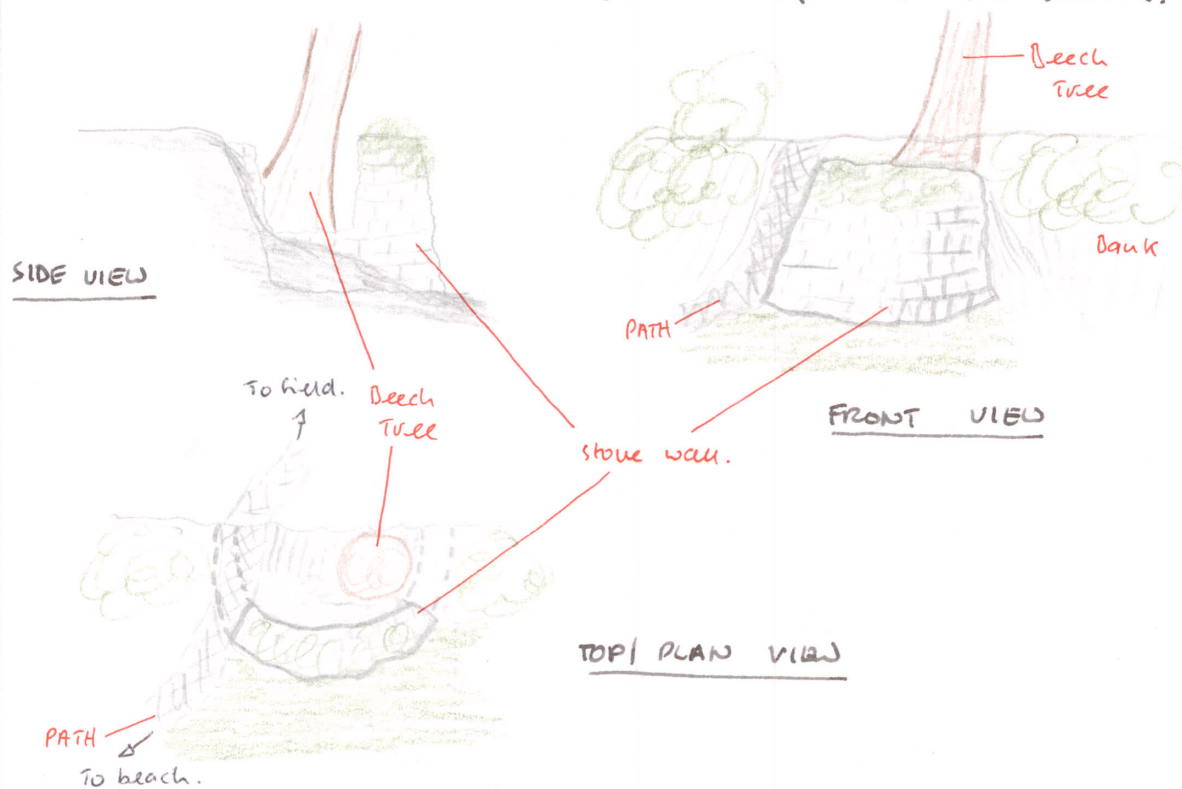
D in the gap between the wall and bank. large tree roots are visible on the structure and this seems to be the main cause of its destruction. The footpath from the beach ascends the bank next to the monument and has certainly contributed to the demolition of the stone wall.

E has caused considerable damage by growing through the monument and pushing it apart. Other vegetation including 2 small holly bushes is growing on the remaining structure and will further contribute to weakening the monument.

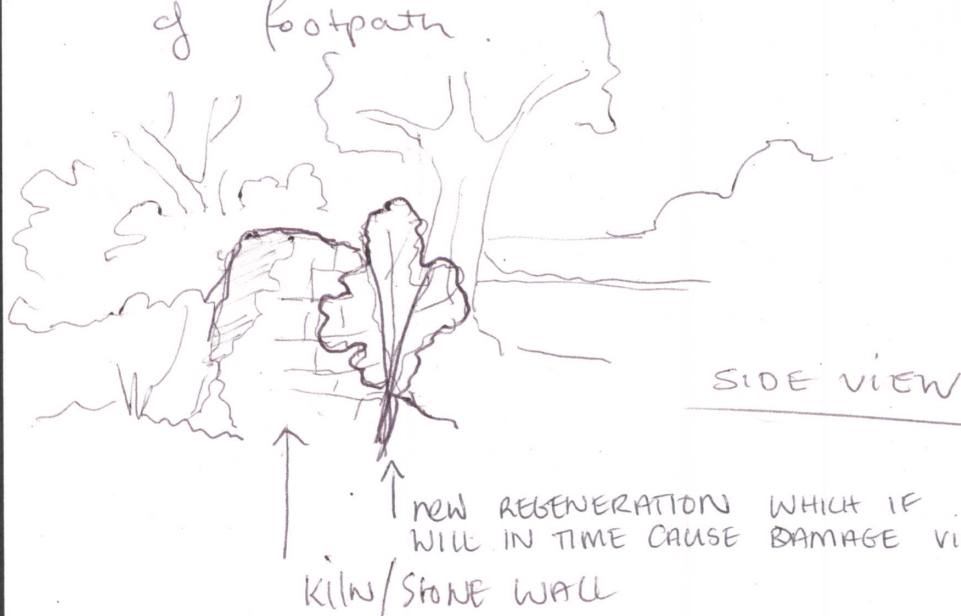
as marked on plan photo  
170105 shows growth of a young  
sapling immediately adjacent  
to kiln - This may cause problems  
in the future as the tree grows  
to maturity + the roots require  
more space.

also v. heavily eroded around site  
from trampling / as consequence  
of footpath.

WHICH IF ALLOWED TO CONTINUE  
WILL IN TIME CAUSE DAMAGE VIA ROOTS AT THE BASE OF THE  
KILN.
