PRESELI ESA, HISTORIC MONITORING

BASELINE 1994

OS 1:10000 SHEET: SM/SN 13 NW	GRID REF: SM/SN 0850 3879
PRN: 18617 SITE NAME: NEVERN	
AIR PHOTO No 59/92/084	LANDSCAPE TYPE: E
No GROUND PHOTOS: 5	
DATE SURVEYED: 30/11/94	SURVEYED BY: SA Hopwood
<p>ACCESS: Site owned by Mr Phillips, Sychpant farm.</p> <p>Tel: Newport (Dyfed) 820488.</p> <p>Grid ref: 084386.</p>

PRESELI ESA HISTORIC MONITORING RESURVEY 1997/98

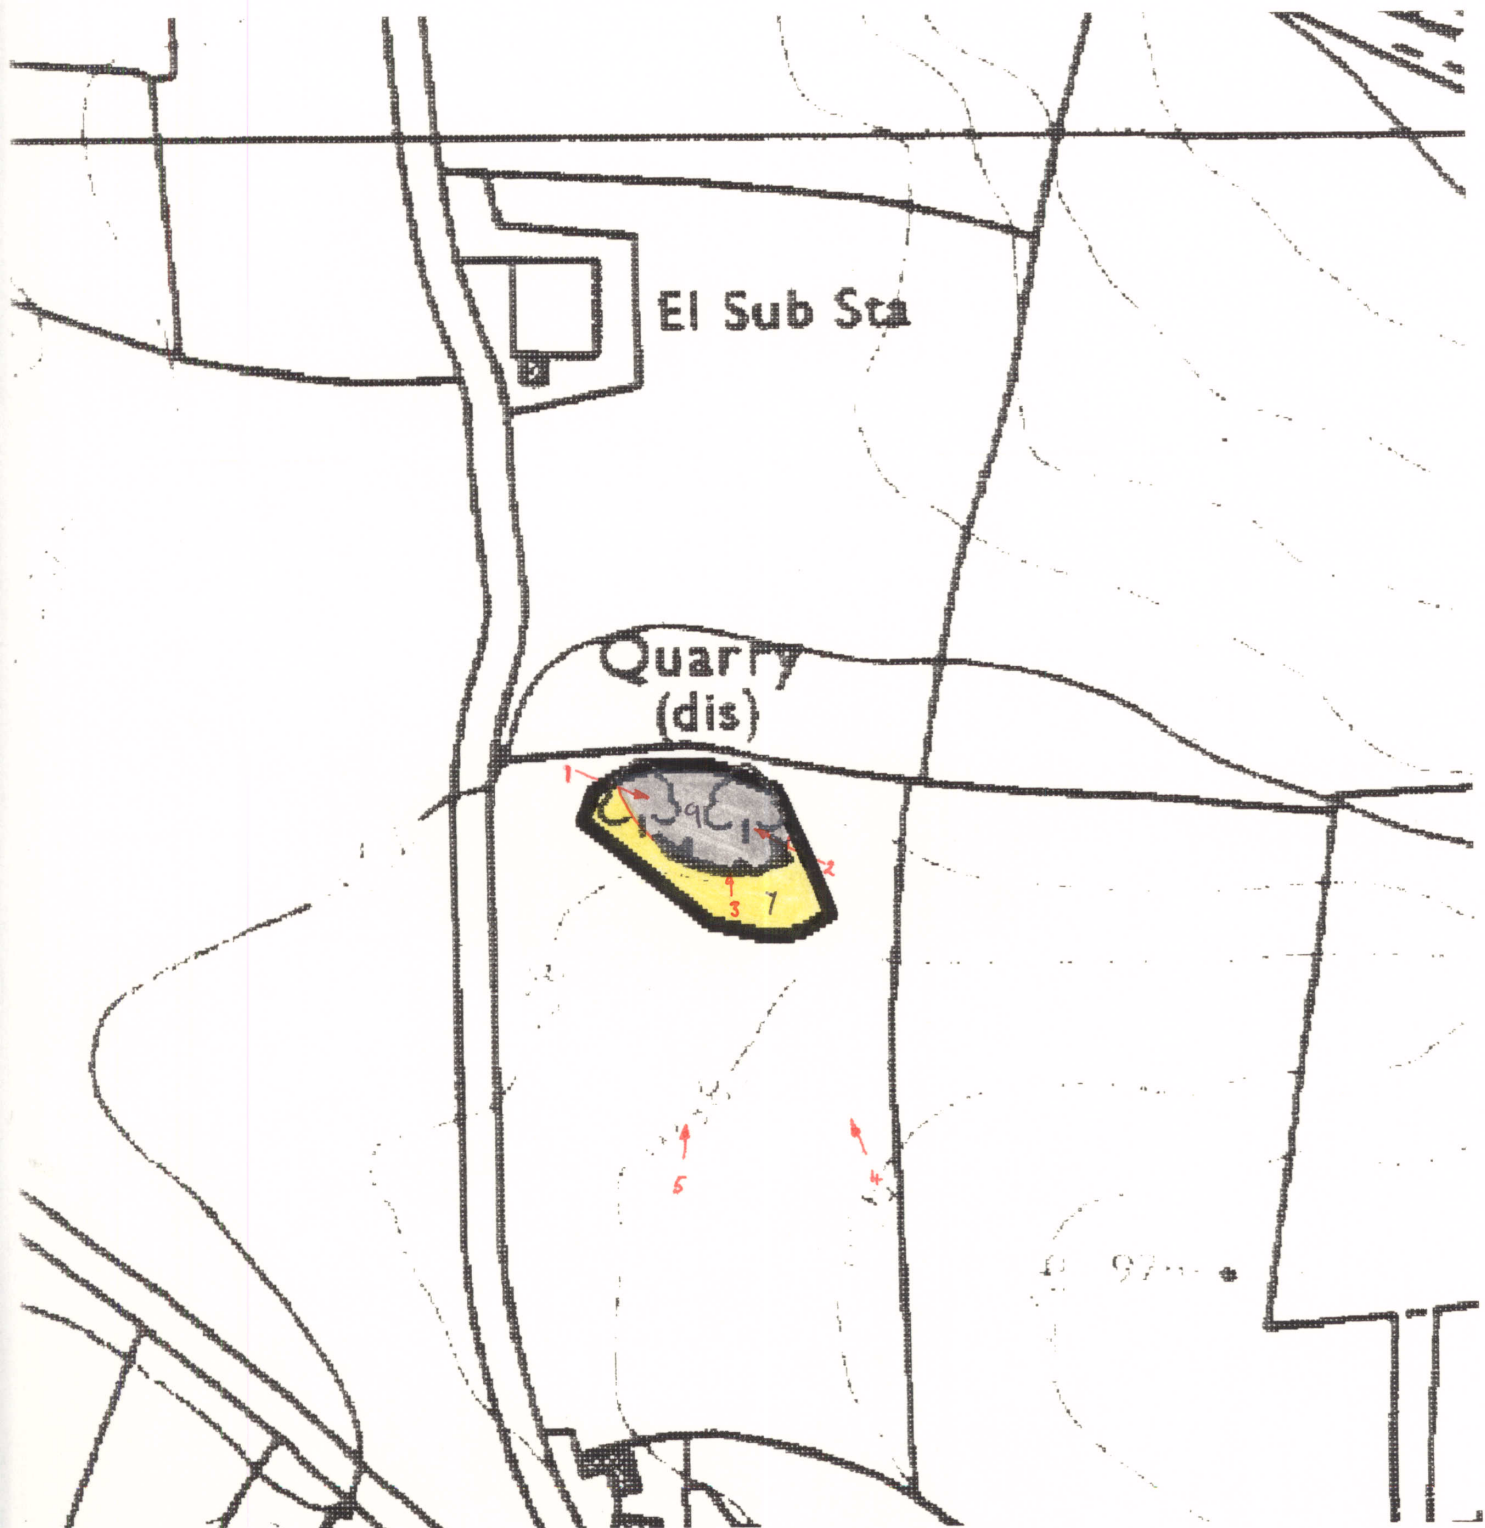
<p>LAND COVER:</p> <p>SITE: A mix of general farm rubbish, topsoil + stone waste. Some scrub and small trees.</p> <p>HALO: Improved grassland.</p>

SITE: Currently used as a dumping area for rubbish and rock/sort waste from a building area in the farmyard.

Difficult to see original quarry because of piles of rubbish and building waste now being dumped. Farmer indicated that the feature would probably be killed in completely at some point. Damage is considerable and the feature is in imminent danger of being totally destroyed. At least one mature tree has been

Most serious threats are rubbish dumping and demolition/removal of monument. The feature will shortly be completely obliterated and probably graded over.

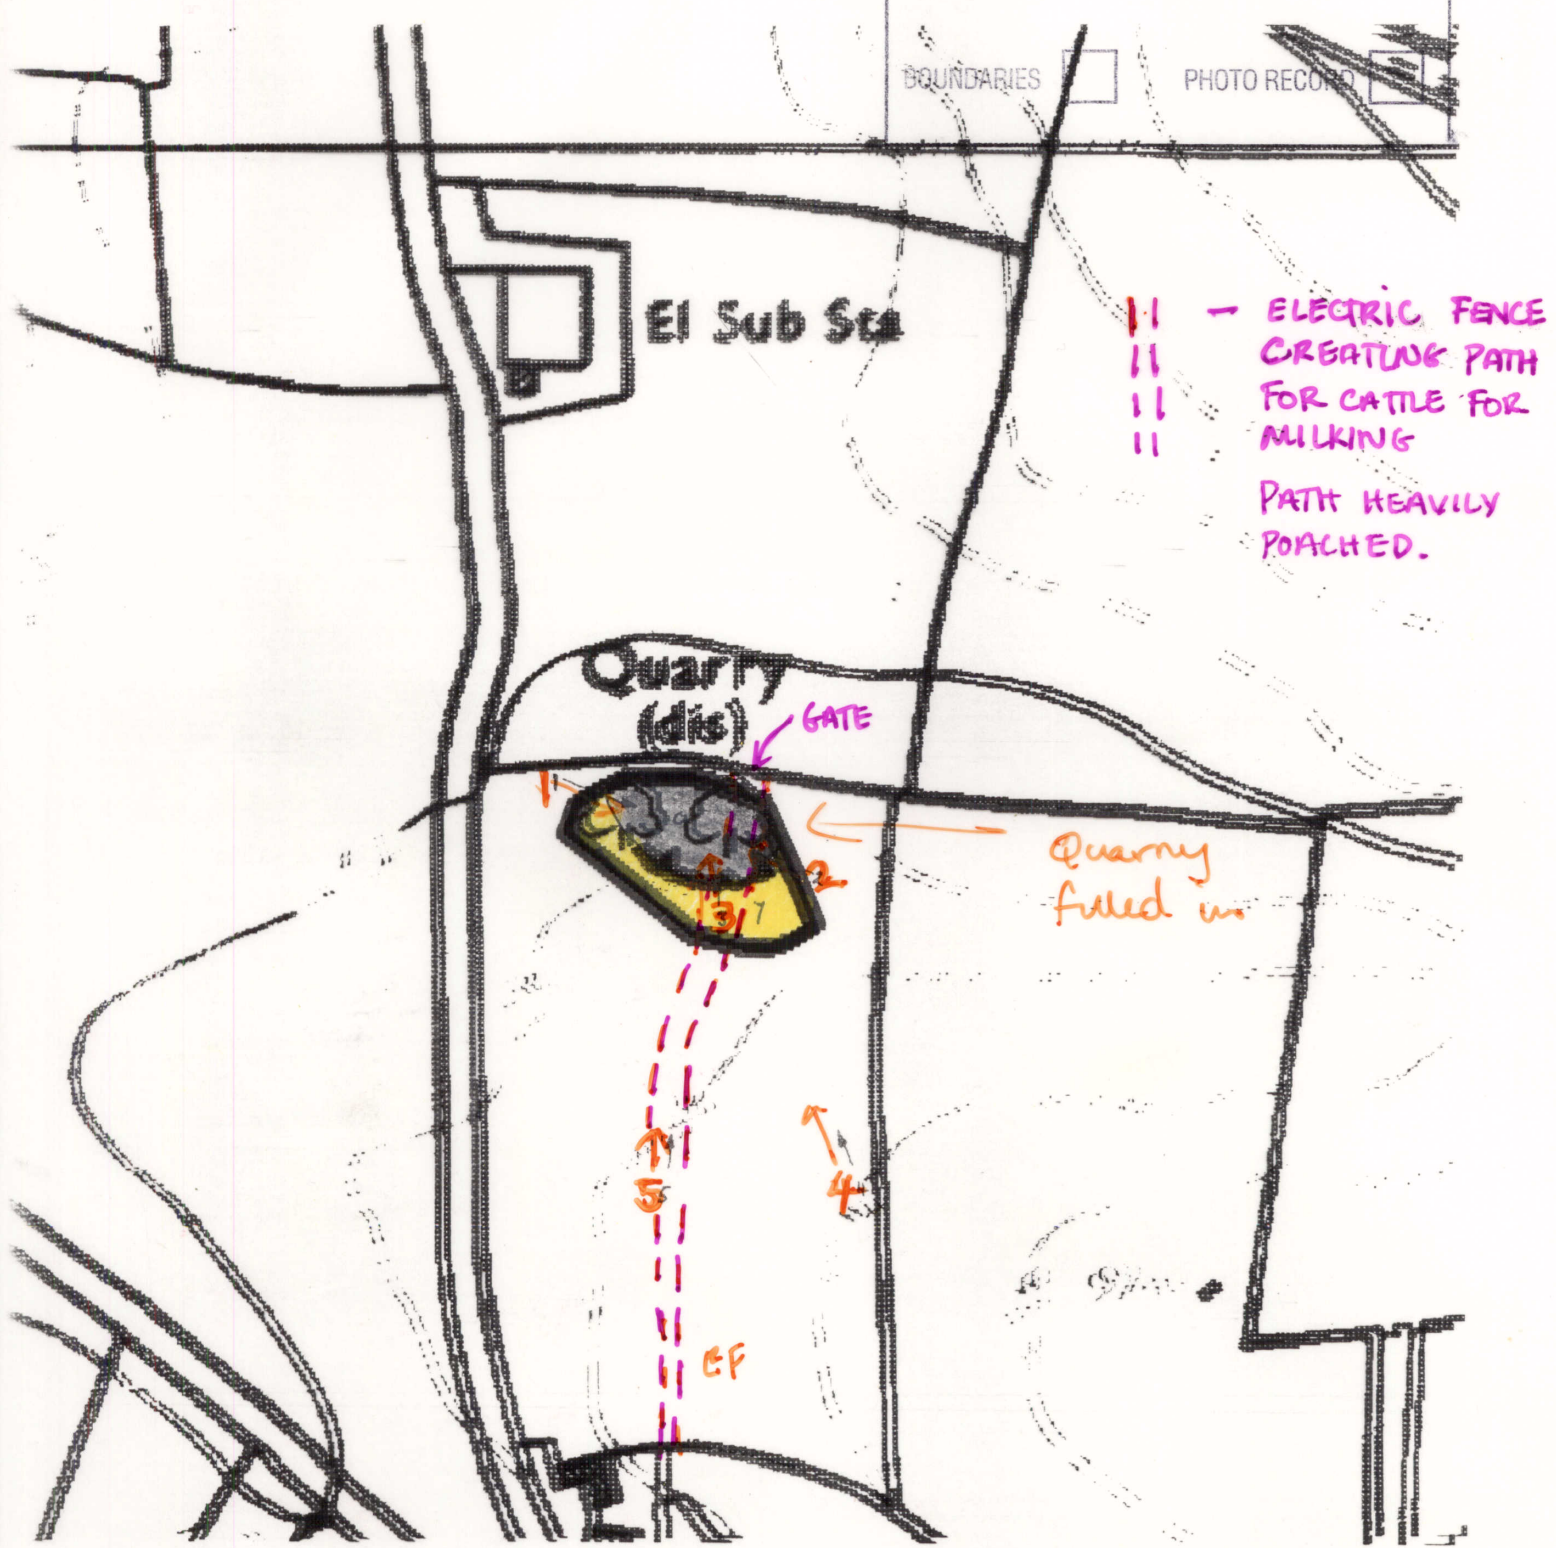
Quarry
filled in

PATH HEAVILY
POACHED.

SITE: The site itself has been infilled
though rubbish, topsoil + stone waste
still exists

HALO: - This area as highlighted in photo
18/61/75 shows the electric fence which
has been erected to create a path probably
for cattle for milking

monument has been completely
in-filled + rubbish still ~~has~~ seems
to be dumped here though it
seems likely this area will be
improved ~~for~~ + the field returned
to agricultural use.

feature no longer exists
