RADNOR ESA. HISTORIC MONITORING

BASELINE 1993

OS 1:10000 SHEET: SN /SO 07 NW	GRID REF: SN /SO 0169 7826
PRN: 959 SITE NAME: <i>Roundbarrow</i>	
AIR PHOTO No <i>03 84 054</i> <i>60mW</i>	LANDSCAPE TYPE: <i>Improved Upland.</i>
No GROUND PHOTOS: <i>6</i>	
DATE SURVEYED: <i>4.3.94</i>	SURVEYED BY: <i>JACF</i>
ACCESS: <i>Mr Hamer</i> <i>Trinnant farm</i>

OS 1:10,000 SHEET: SO/SH/SN 07 NW		GRID REF: SO/SH/SN 0169 7826	
PRN: 959 SITE NAME: Dohen - DDU - (ROUND BARROW)			
AIR PHOTO No: 03-84-054		LANDSCAPE TYPE:	
No GROUND PHOTOS: 6			
DATE RESURVEYED: 10/2/97		RESURVEYED BY: GA Hopwood.

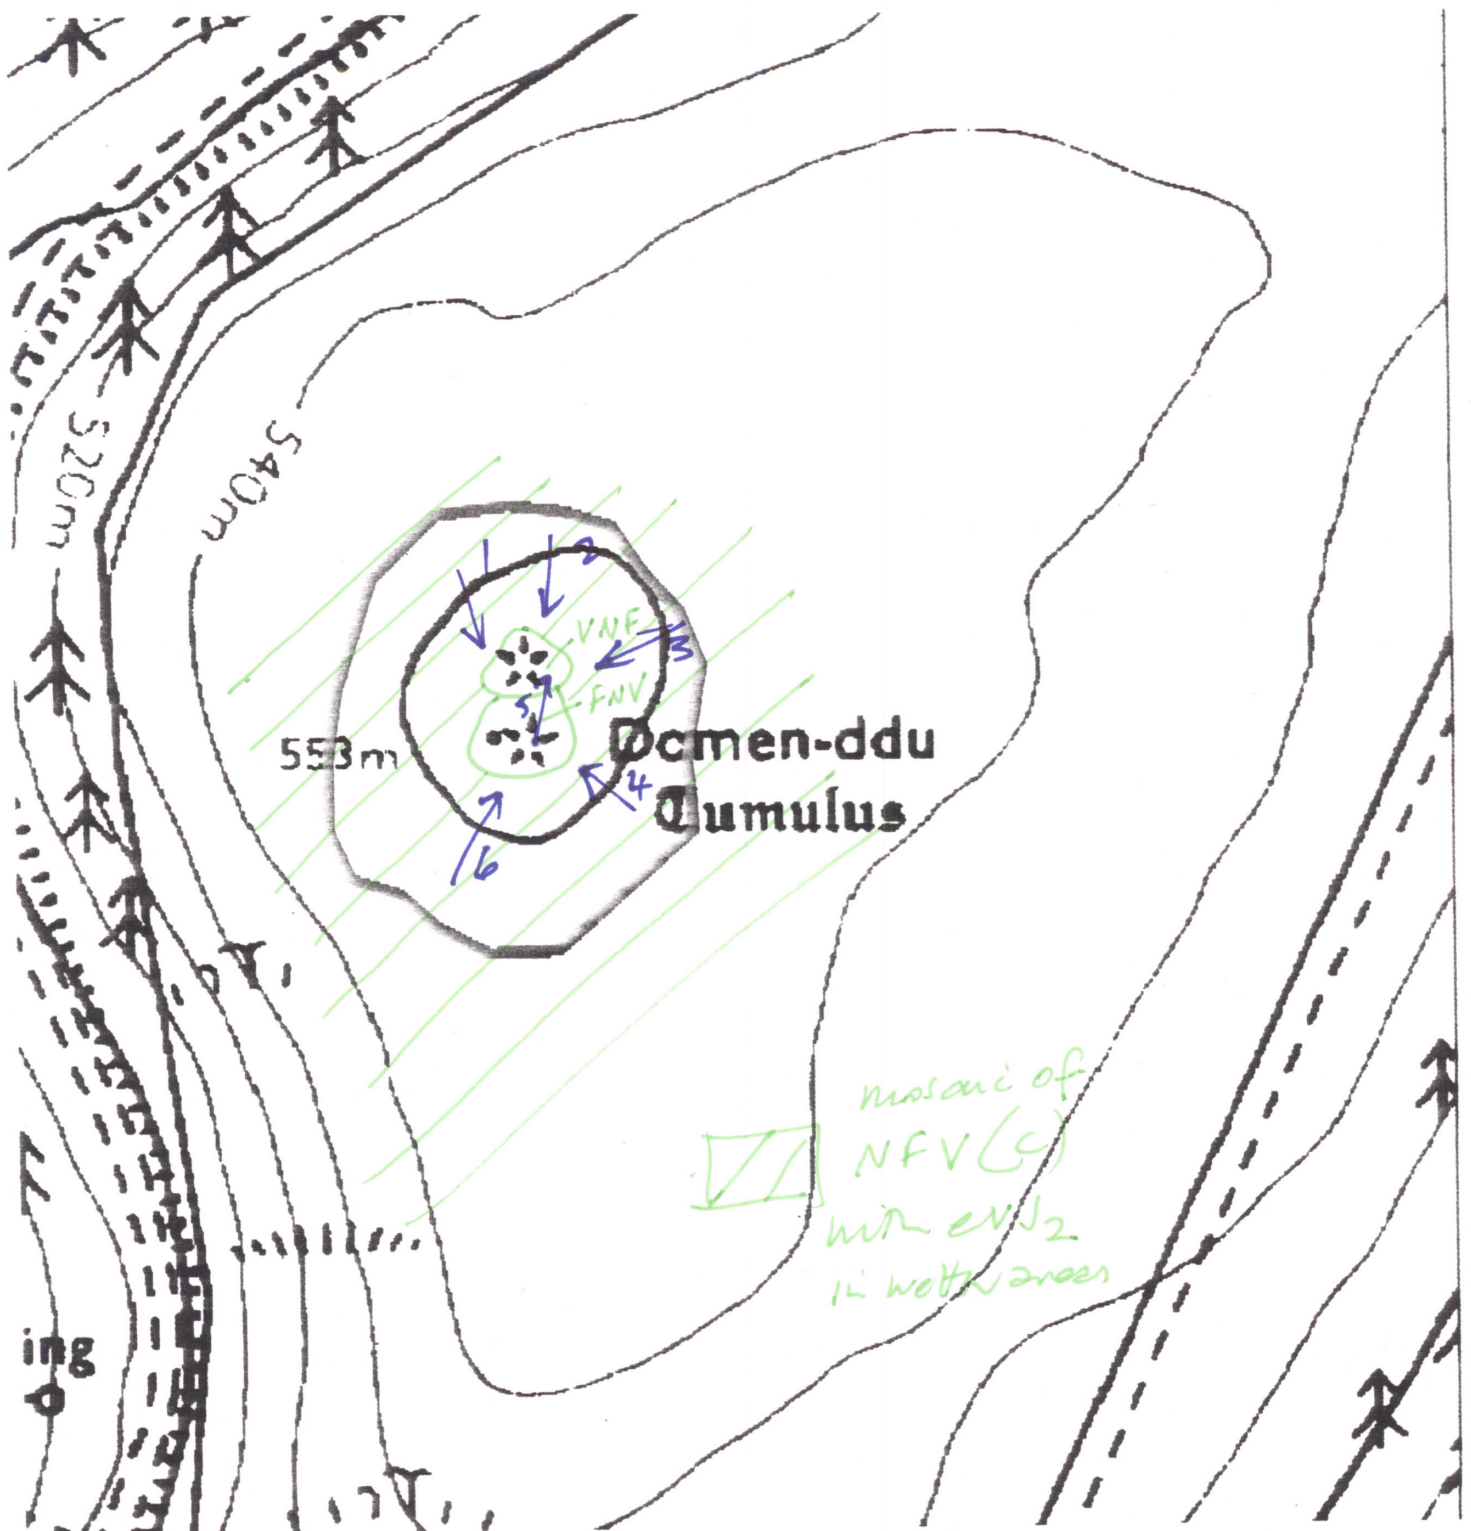
monument forms 2 mound
1 larger with pile of stones on top
1 smaller + lower.
veg. different to most of site
some evidence of sheep damage to larger mound
(ie scrapping) + chafes damage to sand

little threat apart from ~~the~~ grazing.
Site is general is not overgrazed, but
there is sheep damage to larger mound
with stones dislodged by sheep scrapping
to public access.

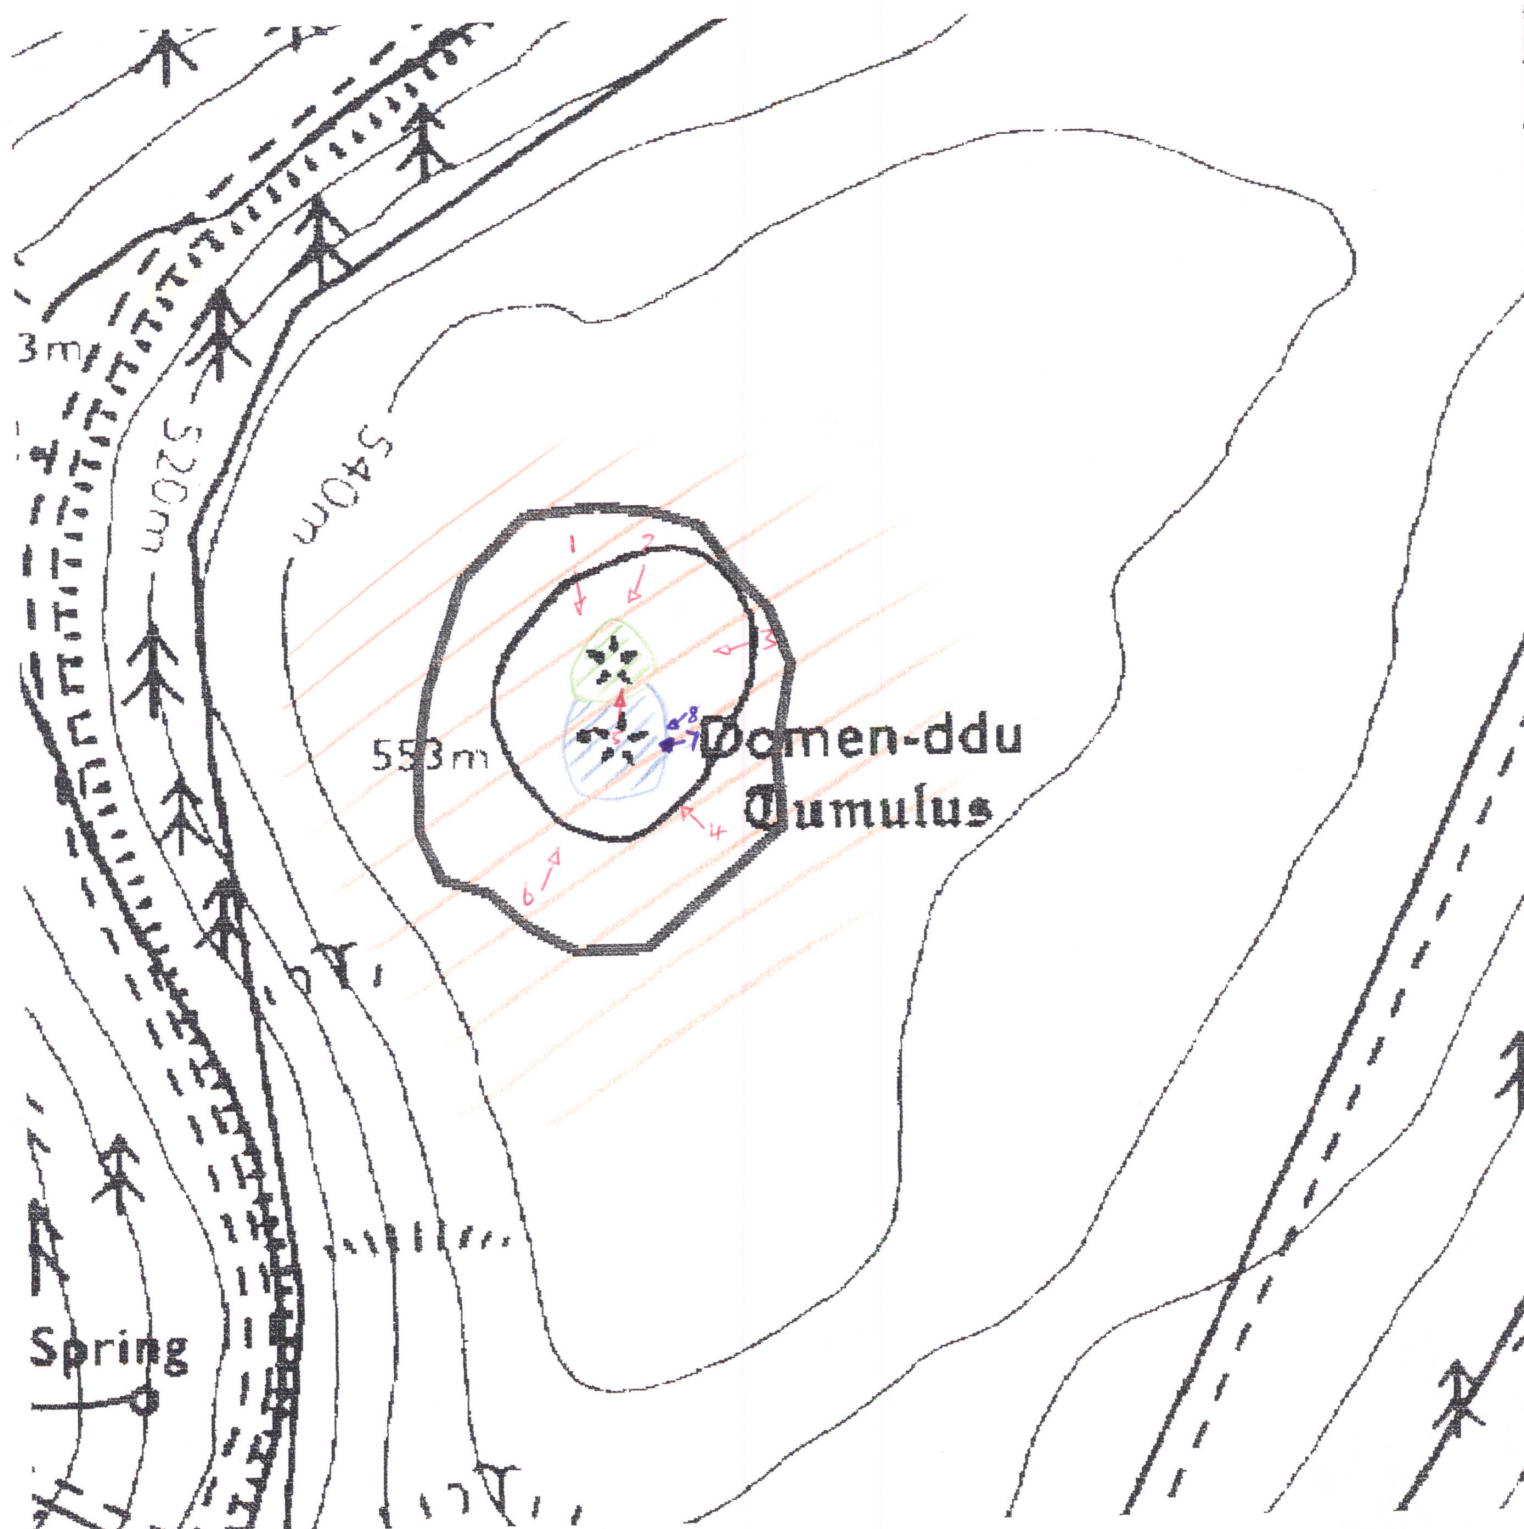
Scrape on side of mound more pronounced. Stone hill visible and has been used to build cairn on top of mound.

Stone cairn now slightly taller than 1996.

Removal of exposed shore to build cañon is allowing further damage by livestock. ~~by~~. Scrape needs to be filled in if possible rather than enlarged!
See photos 7/8.
