RADNOR ESA, HISTORIC MONITORING

BASELINE 1993

OS 1:10000 SHEET: 814/SO26 SW	GRID REF: \$75/SO 2435 6243	
PRN: 678 SITE NAME: Romal Barrow		
AIR PHOTO No 8567 No GROUND PHOTOS: 4	LANDSCAPE TYPE: Radnov Plain	
DATE SURVEYED: 16.02.94	SURVEYED BY: JACF.	
ACCESS: phase not known. field adjusent to noad no accent to land regurned.

RADNOR ESA HISTORIC MONITORING

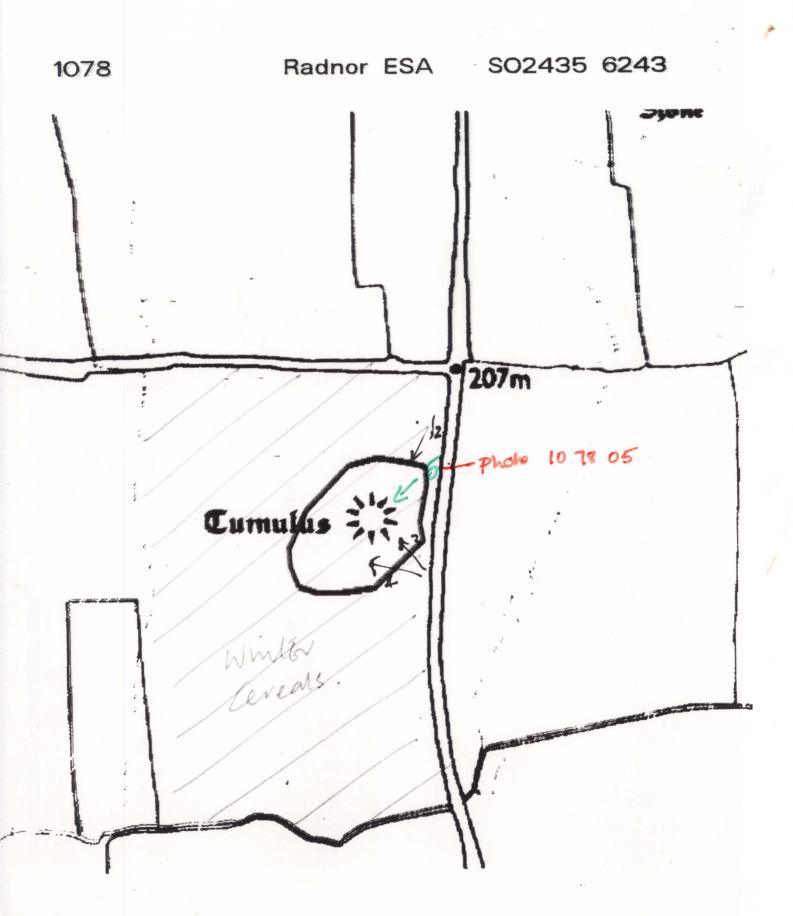
B:LANDCOVER	No real change - land still used as for
	arable cropping - though part of
	field duided for winner grazing.
4	Electricité fence V. close to Round barron.
	chaiding fields from winter certal + grazing

Photo 18 78 g Bud barrow electric fencing	05 - shows close up of with winter cereals + as dividing line.
