Radnor ESA

RADNOR ESA, HISTORIC MONITORING

BASELINE 1993

RADNOR ESA HISTORIC MONITORING RESURVEY 2000

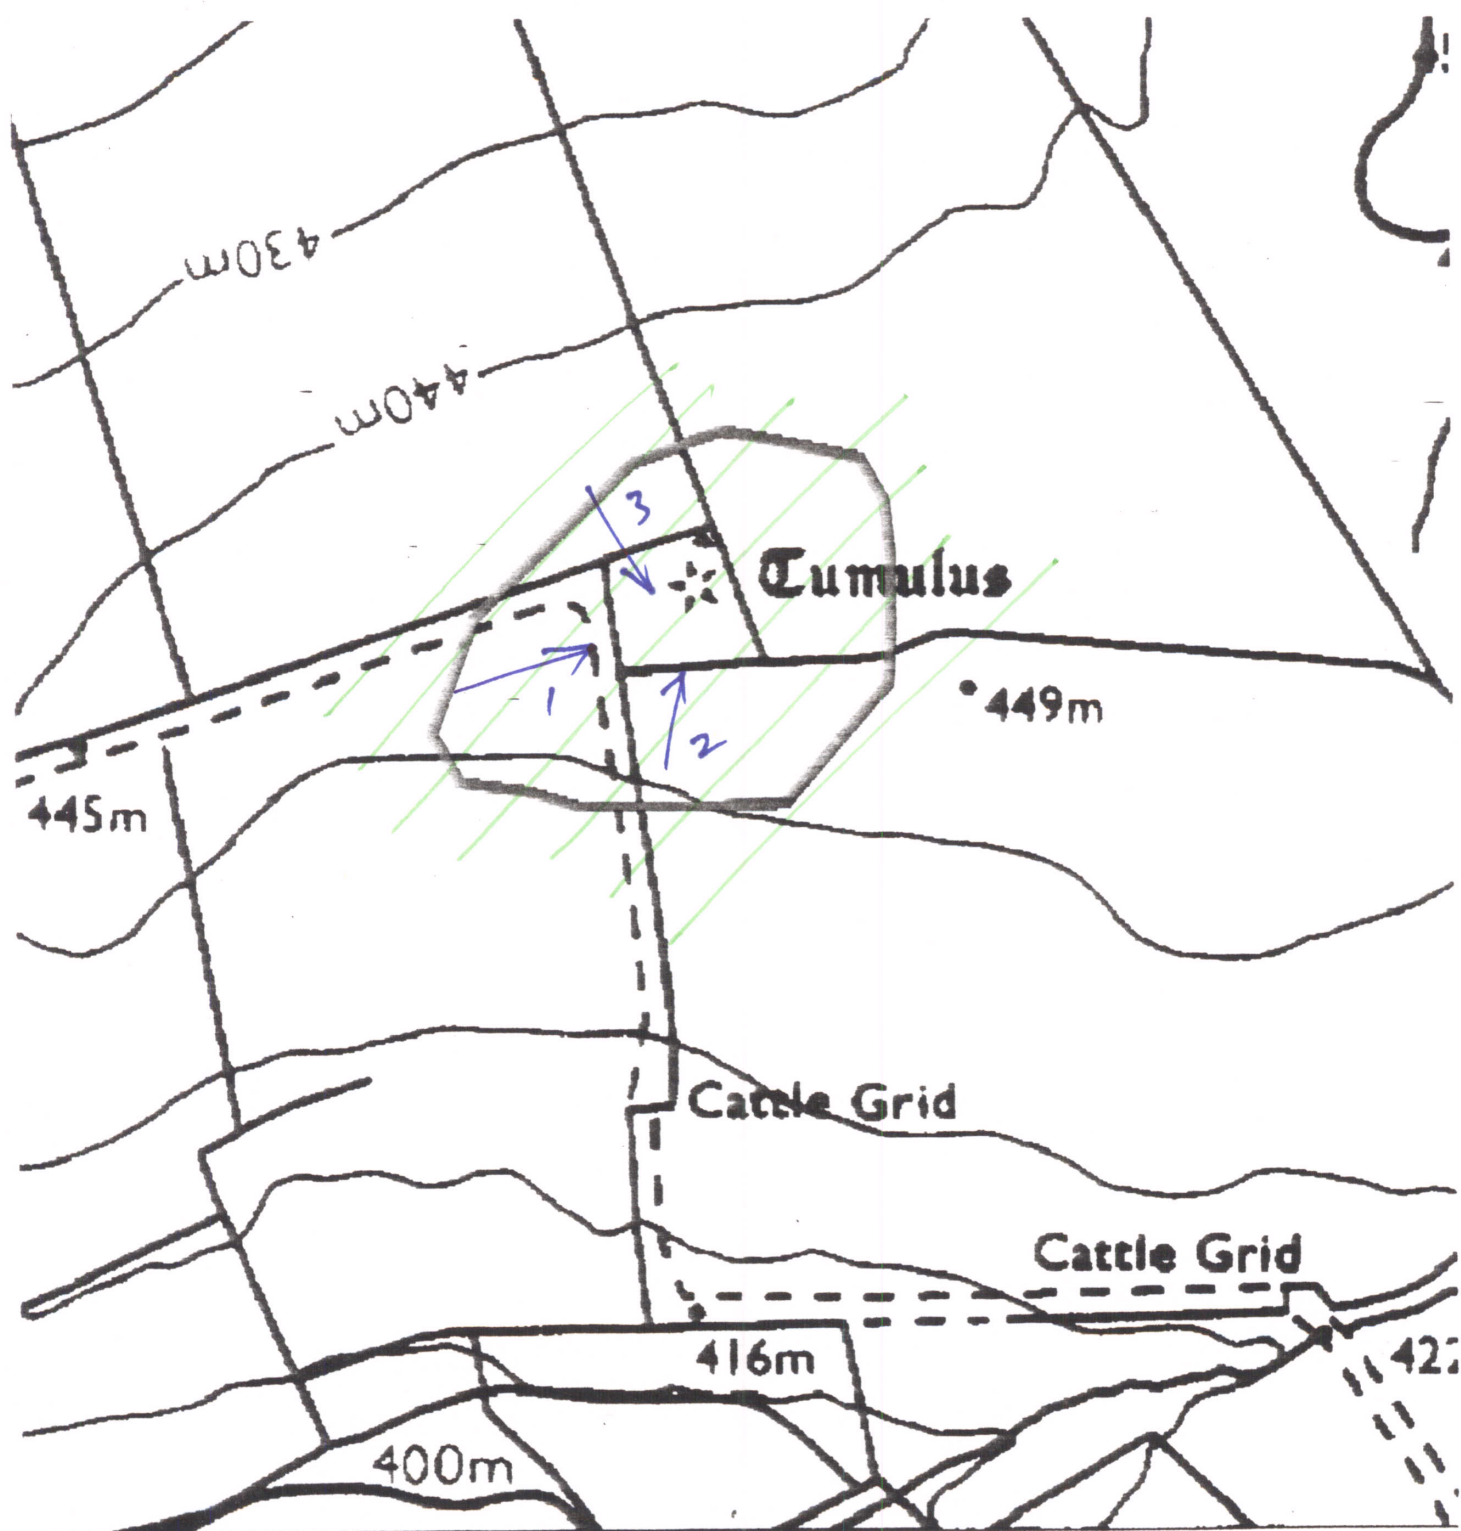
forms mound which has been fenced
off in corner of larger field
opened for grazing on occasion
good condition

little threat.
no public access
little grazing only
fenced from surrounding fields
is an high + exposed site.

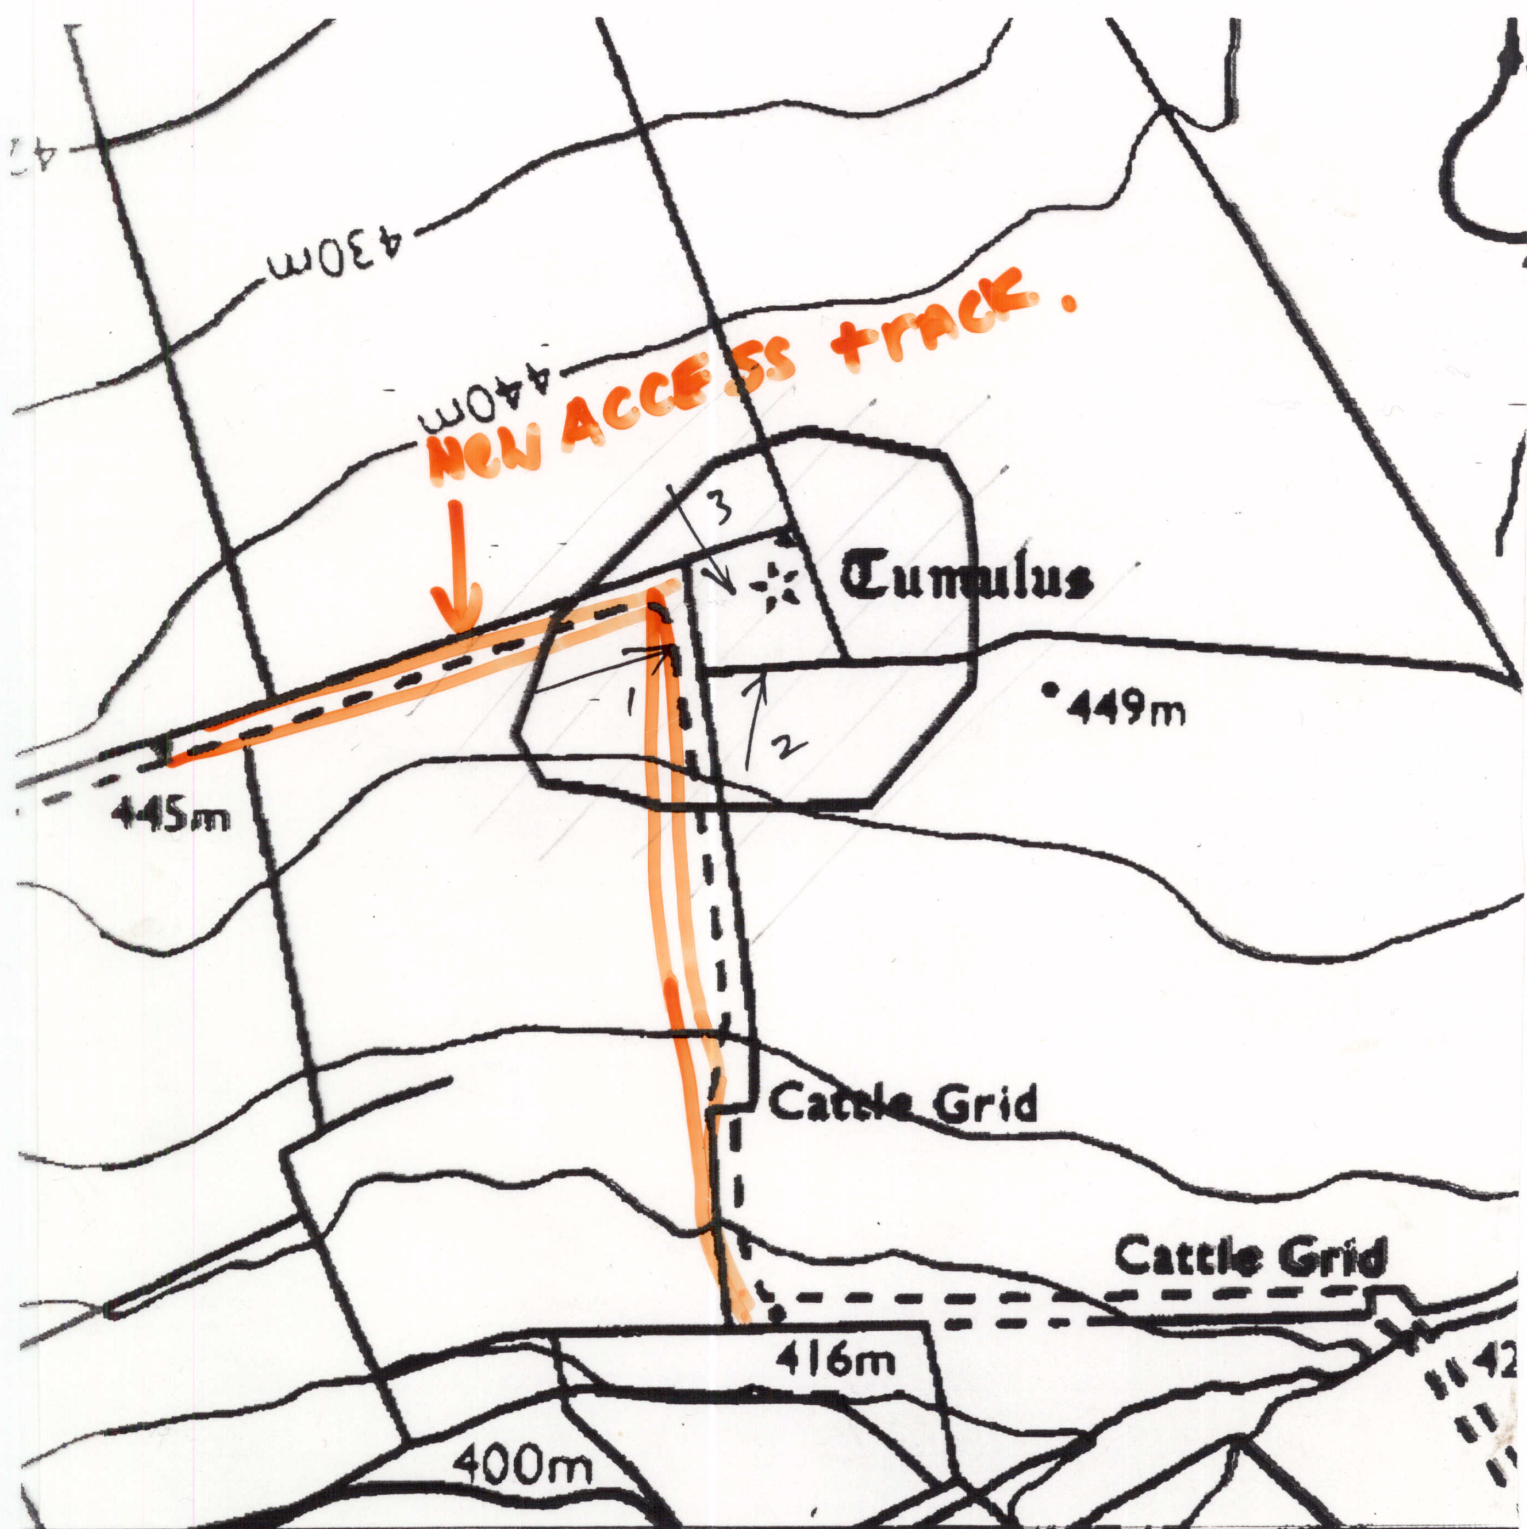
Adjacent new access track - though this does not immediately affect the monument as it has ~~not~~ ~~be~~ been fenced off from any public access - (apparently Cadw are monitoring it).

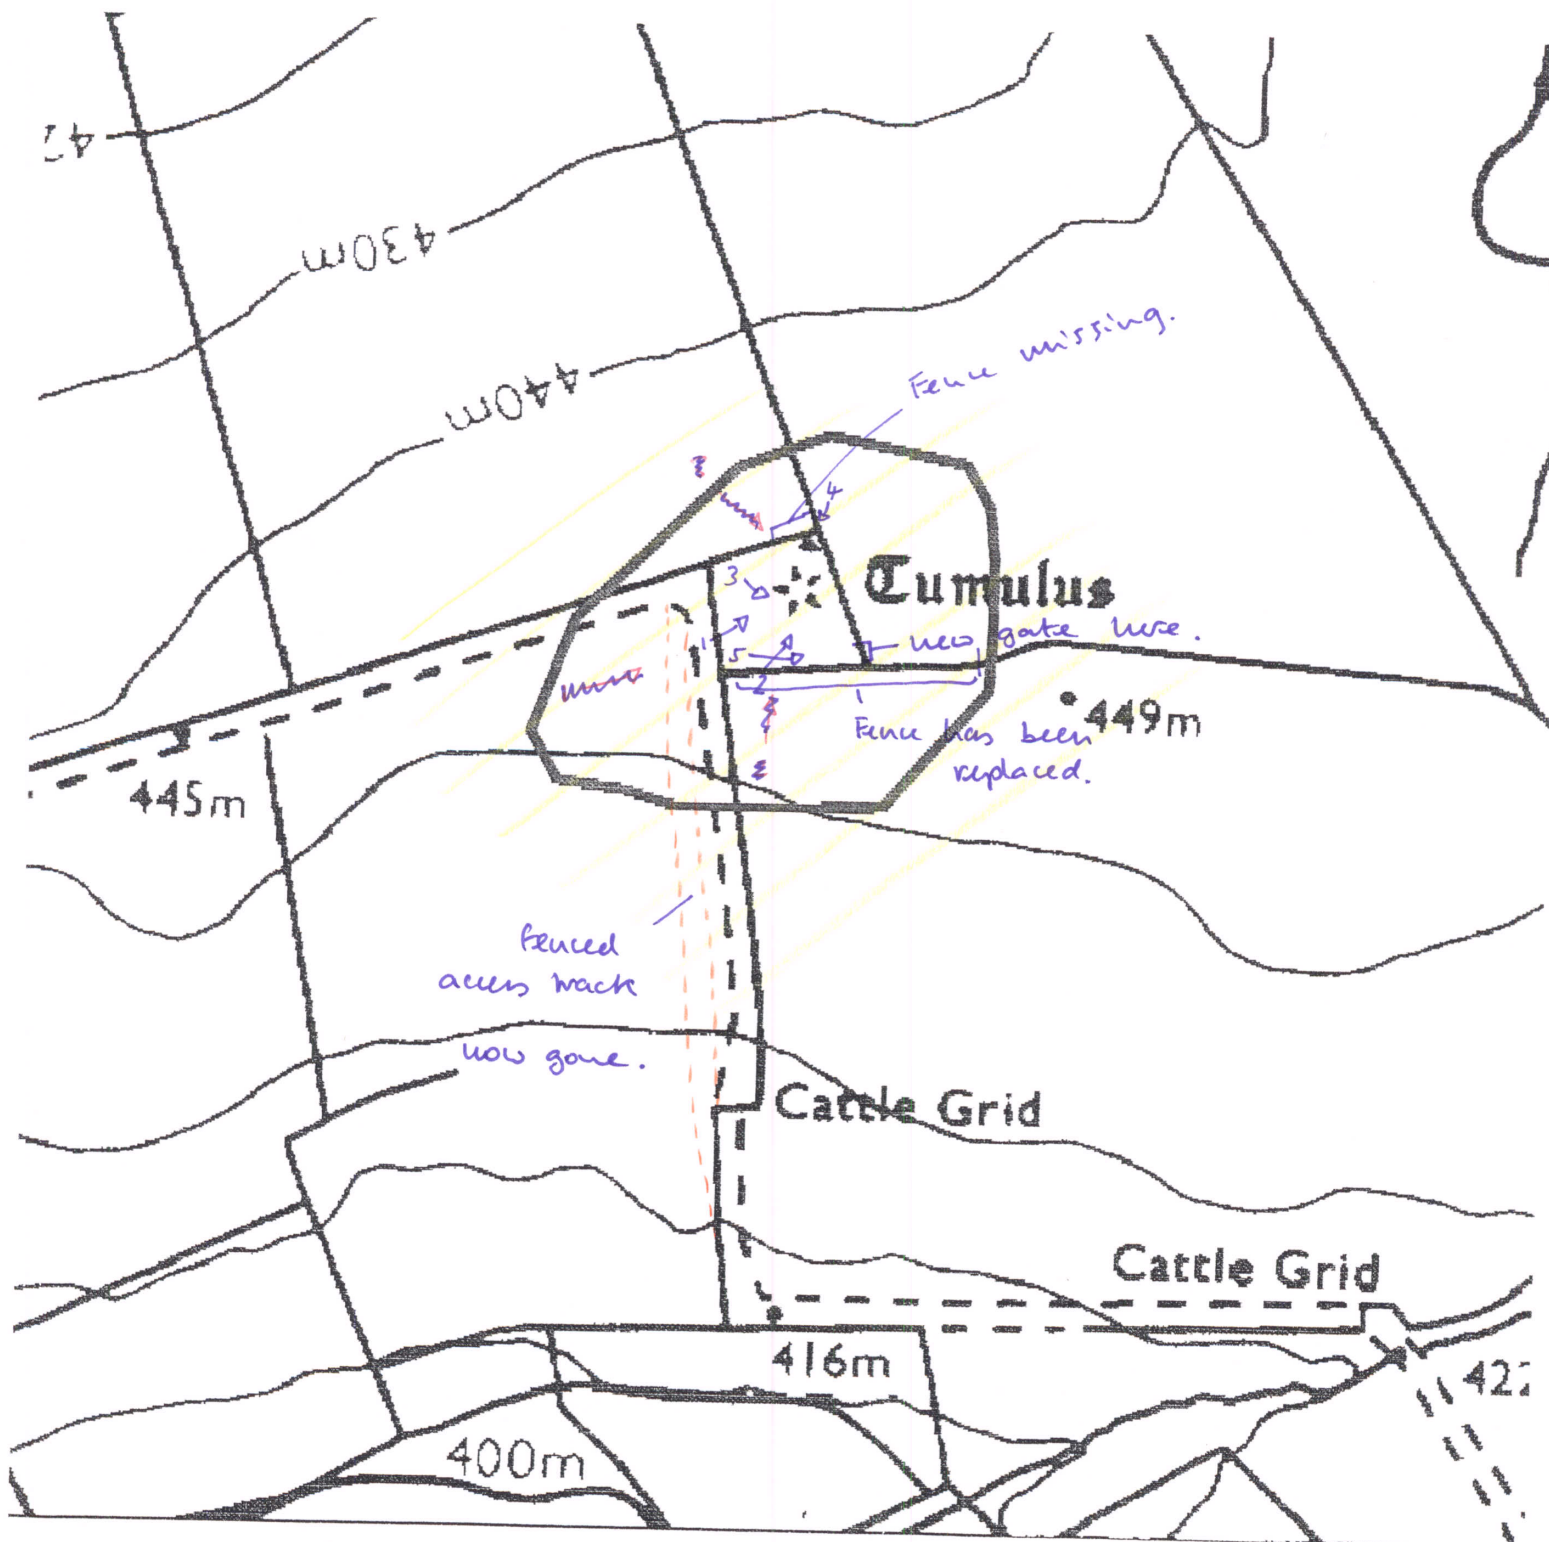
SITE: Fence has been removed allowing sheep/cattle access
Evidence of erosion to low fenced bank (photo 5)
by livestock. No damage to feature.

Access track noted in 1996 survey has now gone.
New fence put up (photo 5).
Now a gap in the fence around the site allowing
sheep/cattle access. No evidence of damage to
feature, but bank around site is being eroded.
Tumulus still has continuous grass cover.

lack of stock control may lead to damage by poaching / hawking.
