Radnor ESA

RADNOR ESA, HISTORIC MONITORING

BASELINE 1993

OS 1:10000 SHEET: SN /SO 26 NW	GRID REF: SN /SO 2445 6770
PRN: 3626 SITE NAME: bunal	
AIR PHOTO No 8573	LANDSCAPE TYPE: Valley floors
No GROUND PHOTOS: 6	
DATE SURVEYED: 23.2.94	SURVEYED BY: JOCF
<p>ACCESS: Mr Thomas Monaghan Farm (tenant) part of Price-Green Estate c/o Worsham & Tyler Burnwell's.</p>

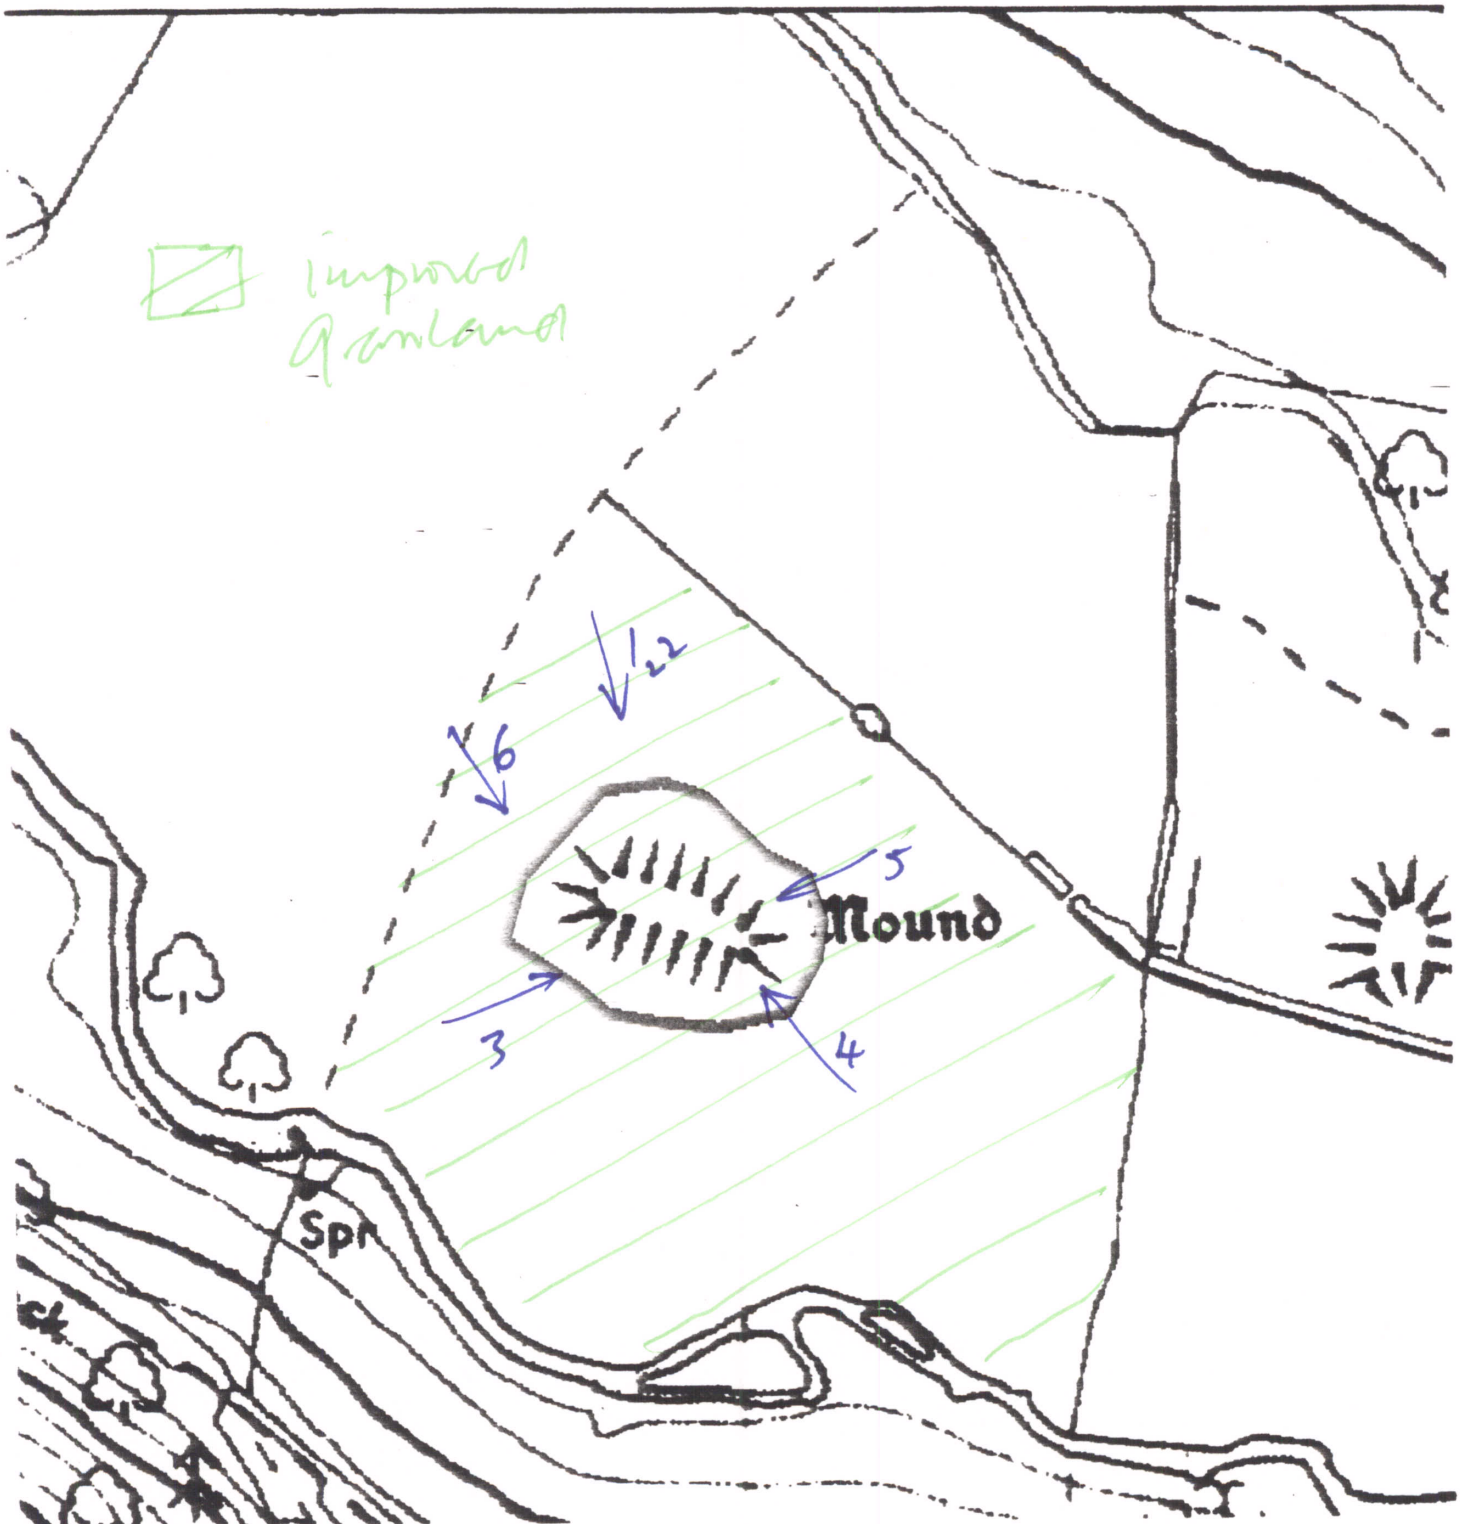
monument forms large mound in middle
of field. (with few hawthorn shrubs on
side)
not plowed or cultivated. (too steep)

Little threat.
too steep to plow or cultivate
no public access.
slight threat from shrubs on side of mound.

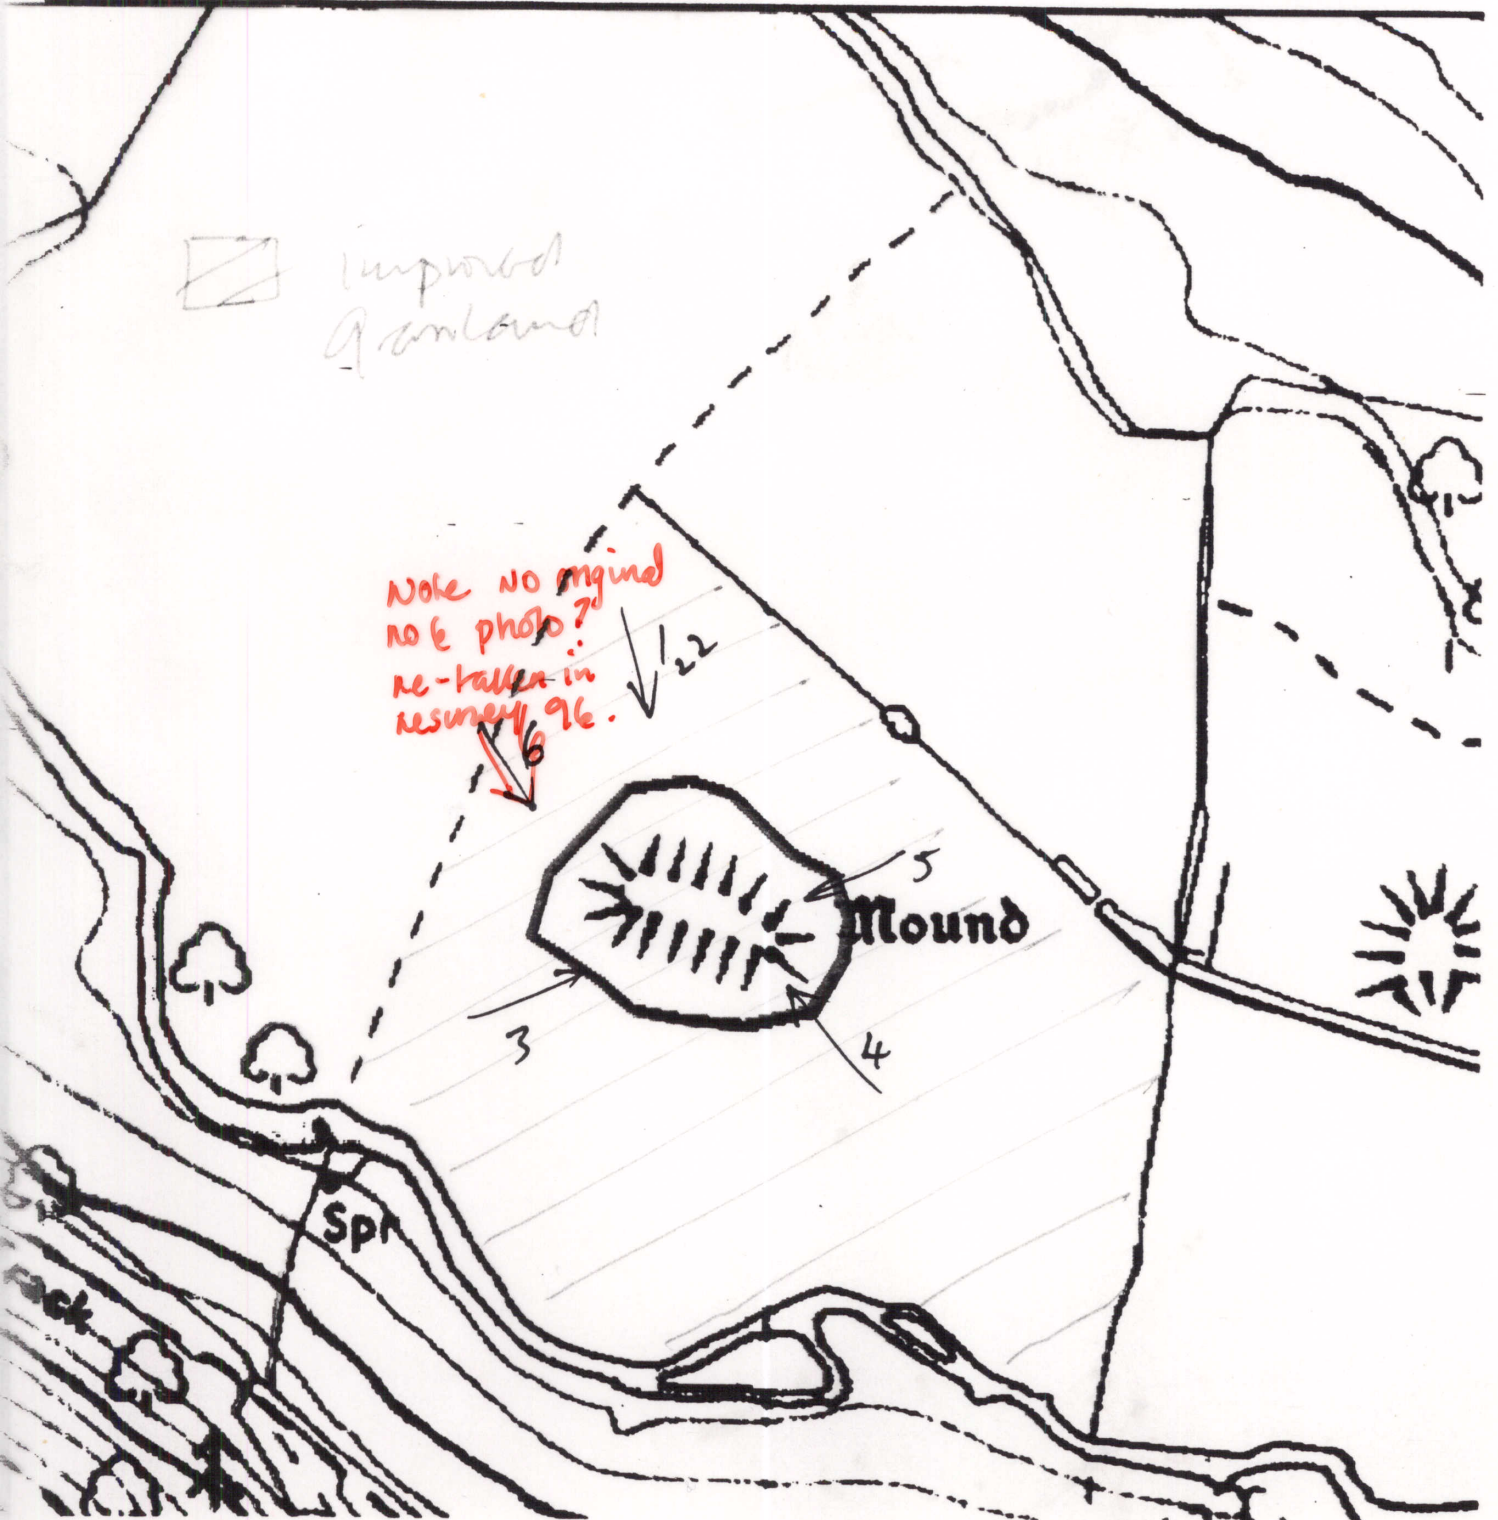
improved grassland but looks as
if weed problem has been controlled
(possibly a trend?)

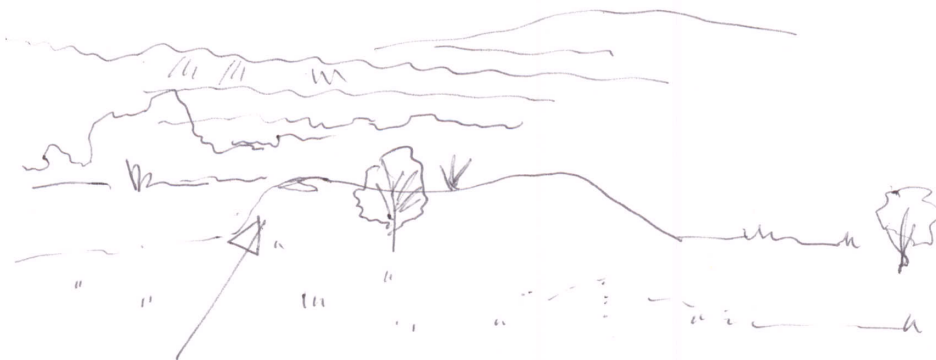
SOME EROSION ON TOP OF BANK + AT BACK
LOOKS LIKE A small rabbit hole.

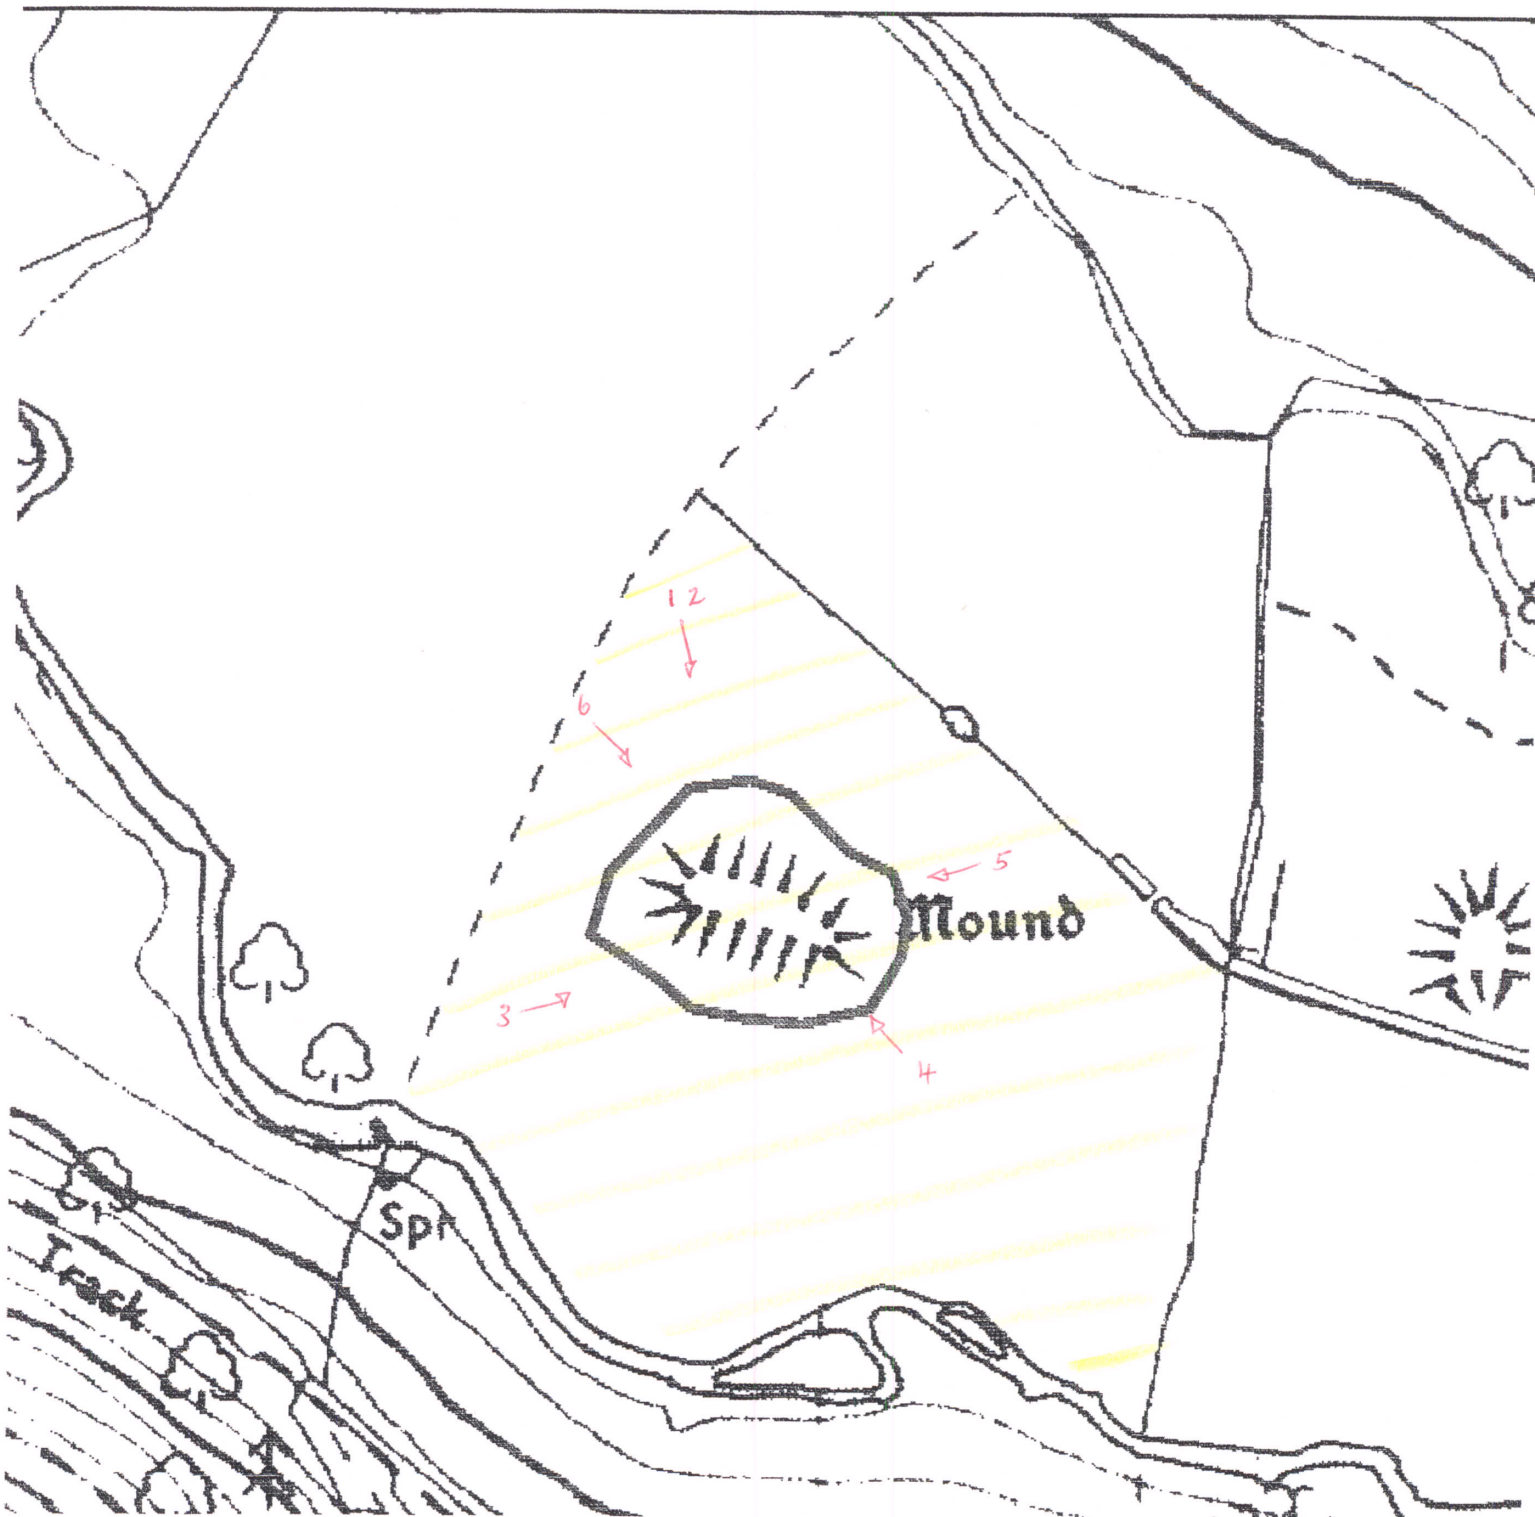
Whole area around mound is covered by ditches + banks. Some substantial ditches ie > 1m deep. Some appear man-made, others natural. According to Mr Thomas (tenant) area was subject to drainage in 17th's - prior to that was wet / marshy.

no real evidence of any damaging activity.
No new trees and no obvious signs of
burrowing activity. In a stable condition -
land not over-grazed.
Existing shrubs are small hawthorn - root
damage small.
