RADNOR ESA, HISTORIC MONITORING

OS 1:10000 SHEET: SN /SO 15 NE	GRID REF: SN /SO 1759 5658
PRN: 4109 SITE NAME: Platform House.	
AIR PHOTO No 8655	LANDSCAPE TYPE: Moorland Hills
No GROUND PHOTOS: 5	
DATE SURVEYED: 17.02.94	SURVEYED BY: J. D. C. F.
ACCESS: Orkney not known. field open to common land

OS 1:10,000 SHEET: SO/SH/5N 15 NE		GRID REF: SO/SH/5N 1759 5628	
PRN: 4109 SITE NAME: PLATFORM HOUSE			
AIR PHOTO No: 8655		LANDSCAPE TYPE: MOORLAND HILLS	
No GROUND PHOTOS: 12 (See sketch map for locations)			
DATE RESURVEYED: 24/1/97		RESURVEYED BY: G. A. Hopwood.

RADNOR ESA HISTORIC MONITORING RESURVEY 2000

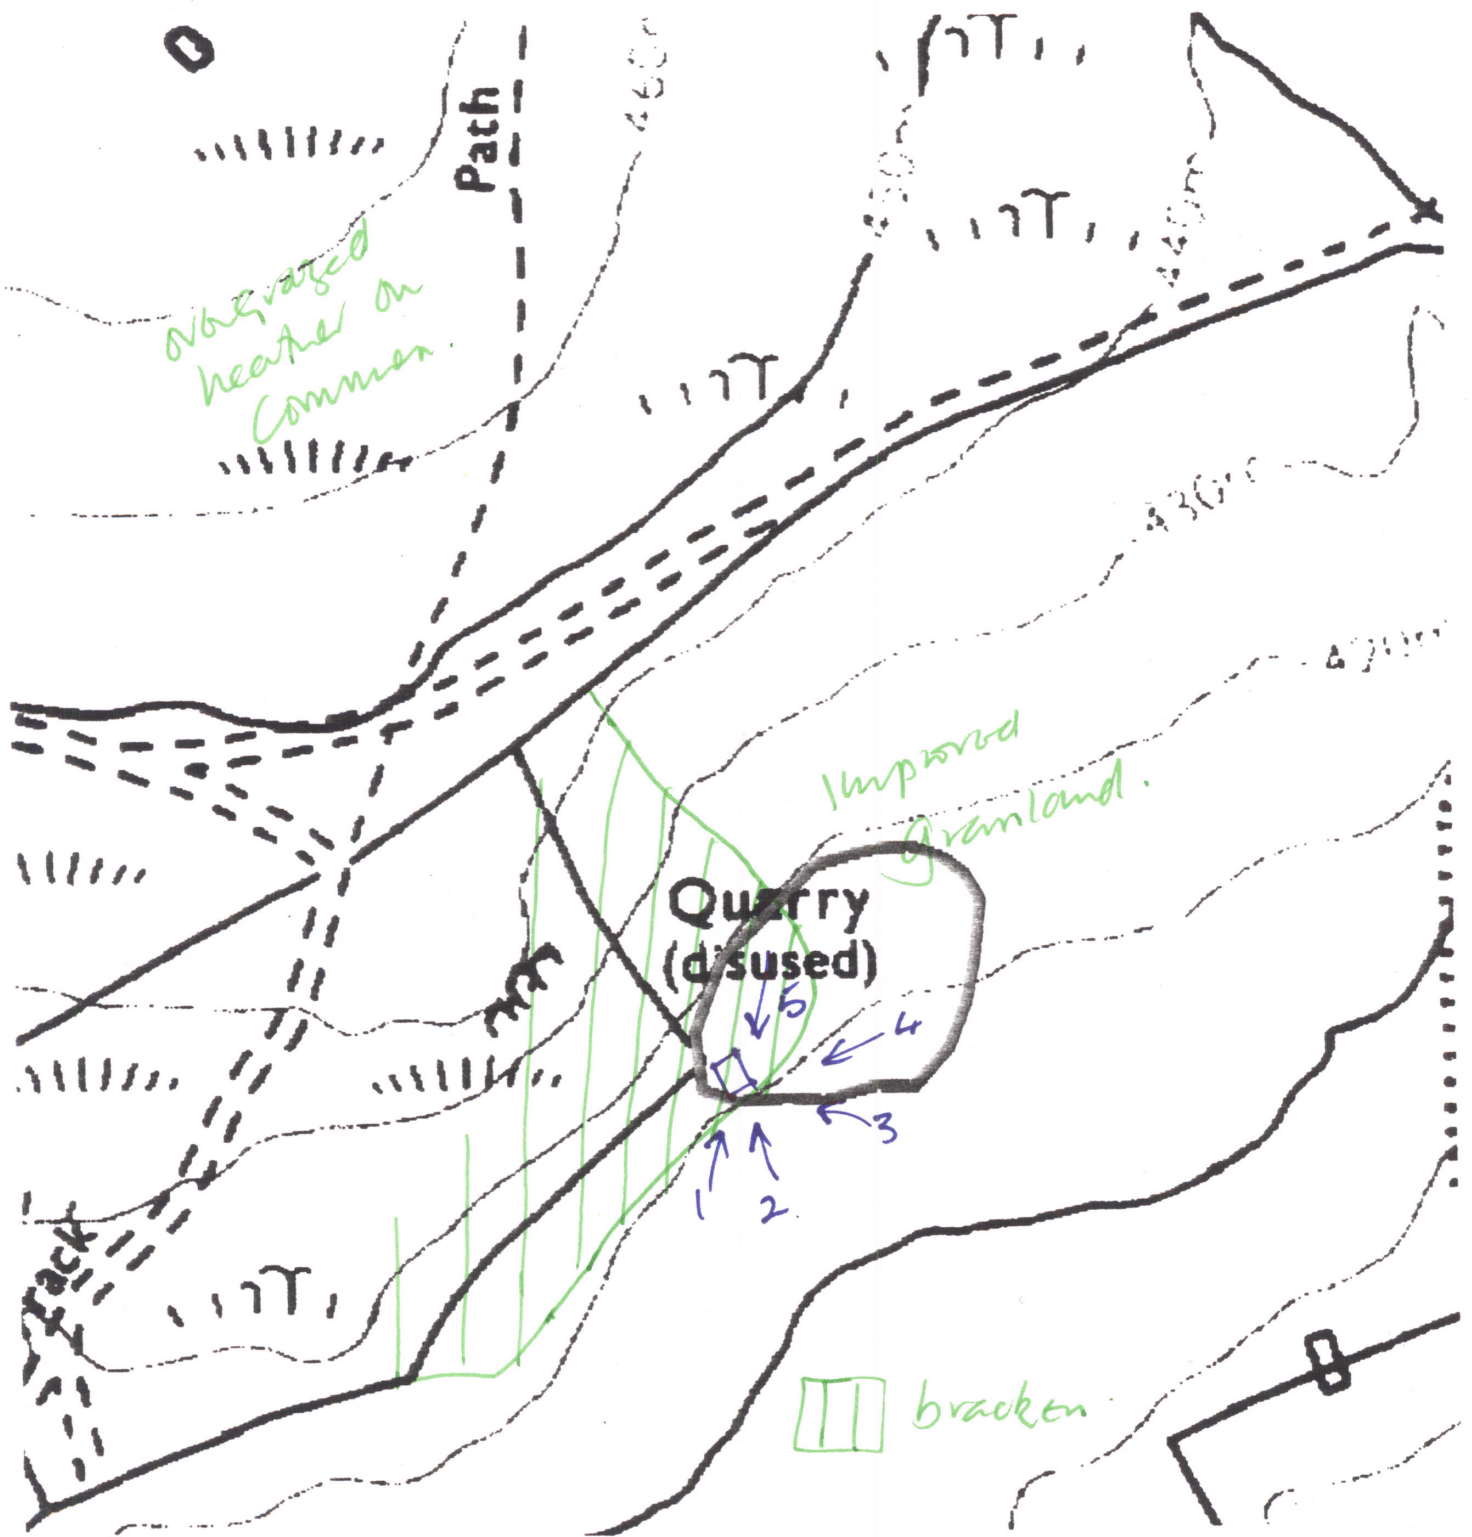
*can be identified on the ground. but
looks eroded
not in particularly good condition but not
due to present management.*

*little threat to present condition
no public access
not likely to be ploughed or reseeded.*

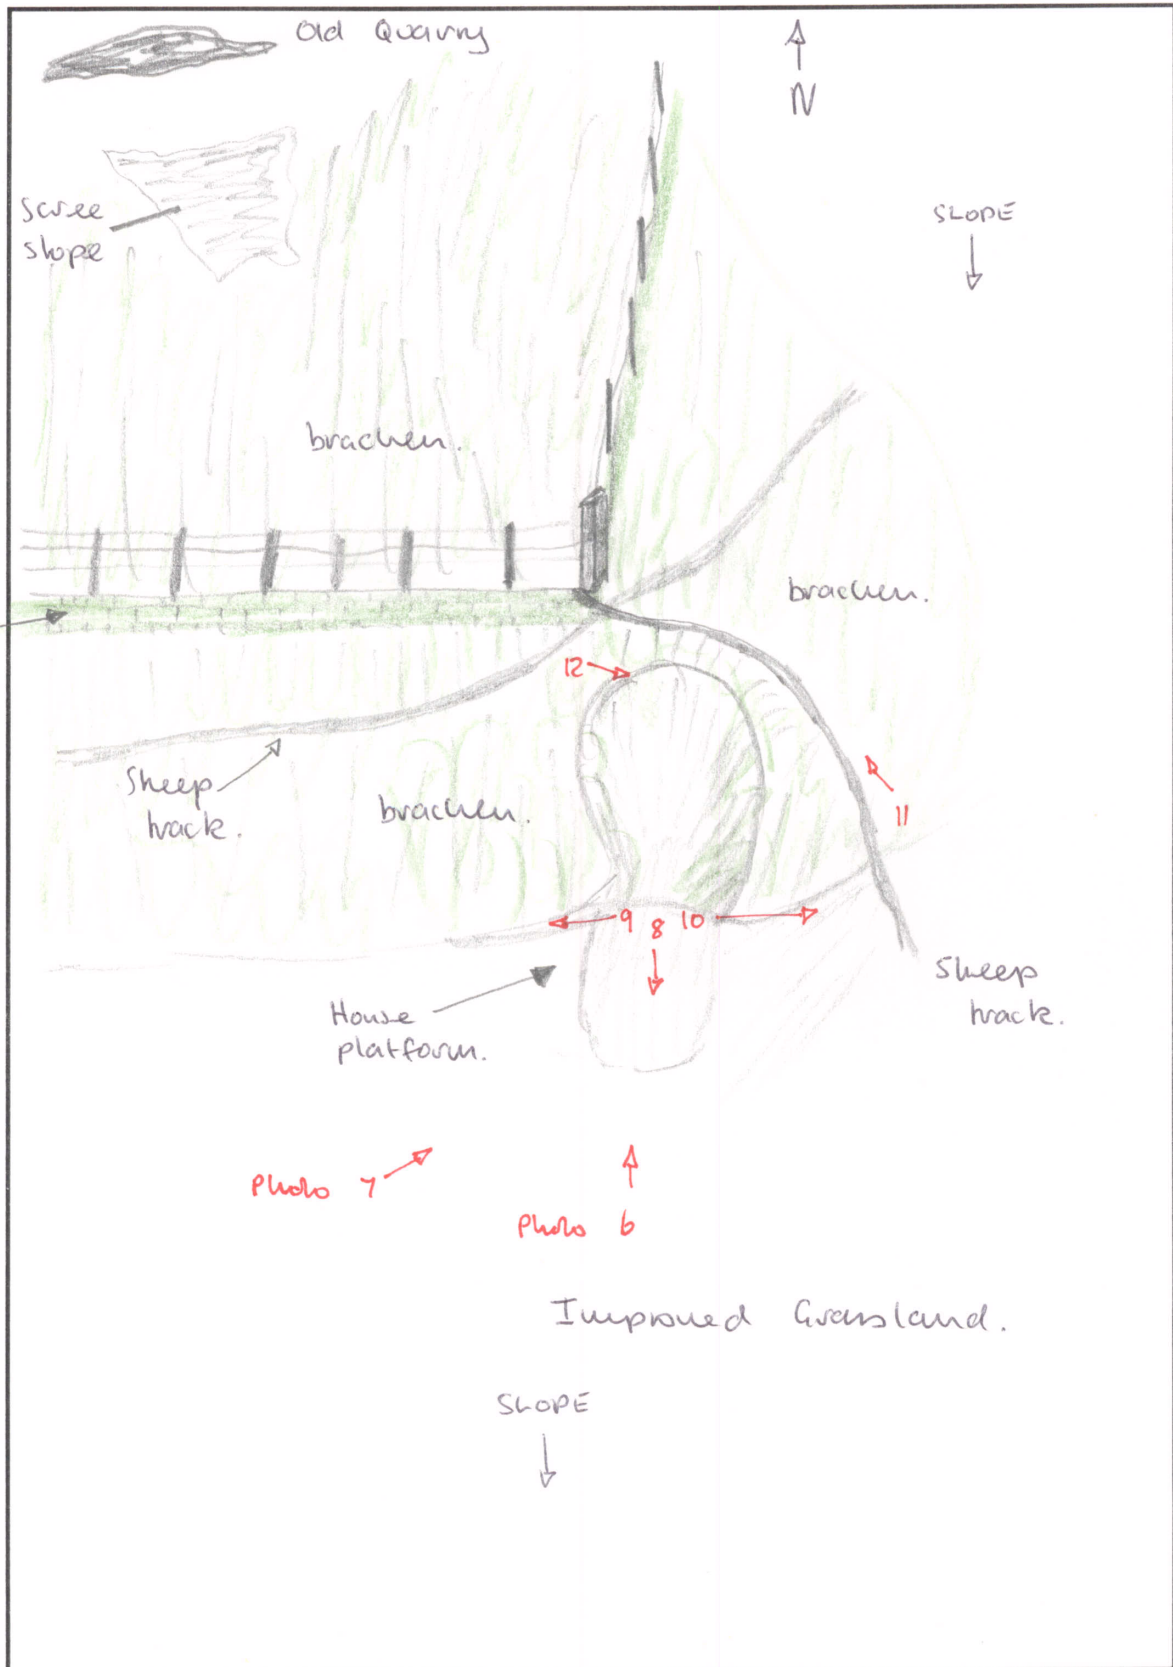
Vague bowl shaped depression cut into a fairly steep bracken covered slope. Facing south, down a gentle slope and overlooking a wide valley. Not particularly well preserved, could almost be a natural feature rather than man-made. Being degraded by sheep damage and rabbit burrows. Part of site has probably been affected by land improvement at some point.

Bracken encroachment.

Sheep trampling - two well defined sheep tracks run next to feature.

Considerable number of rabbit burrows and scrapes on and around feature.

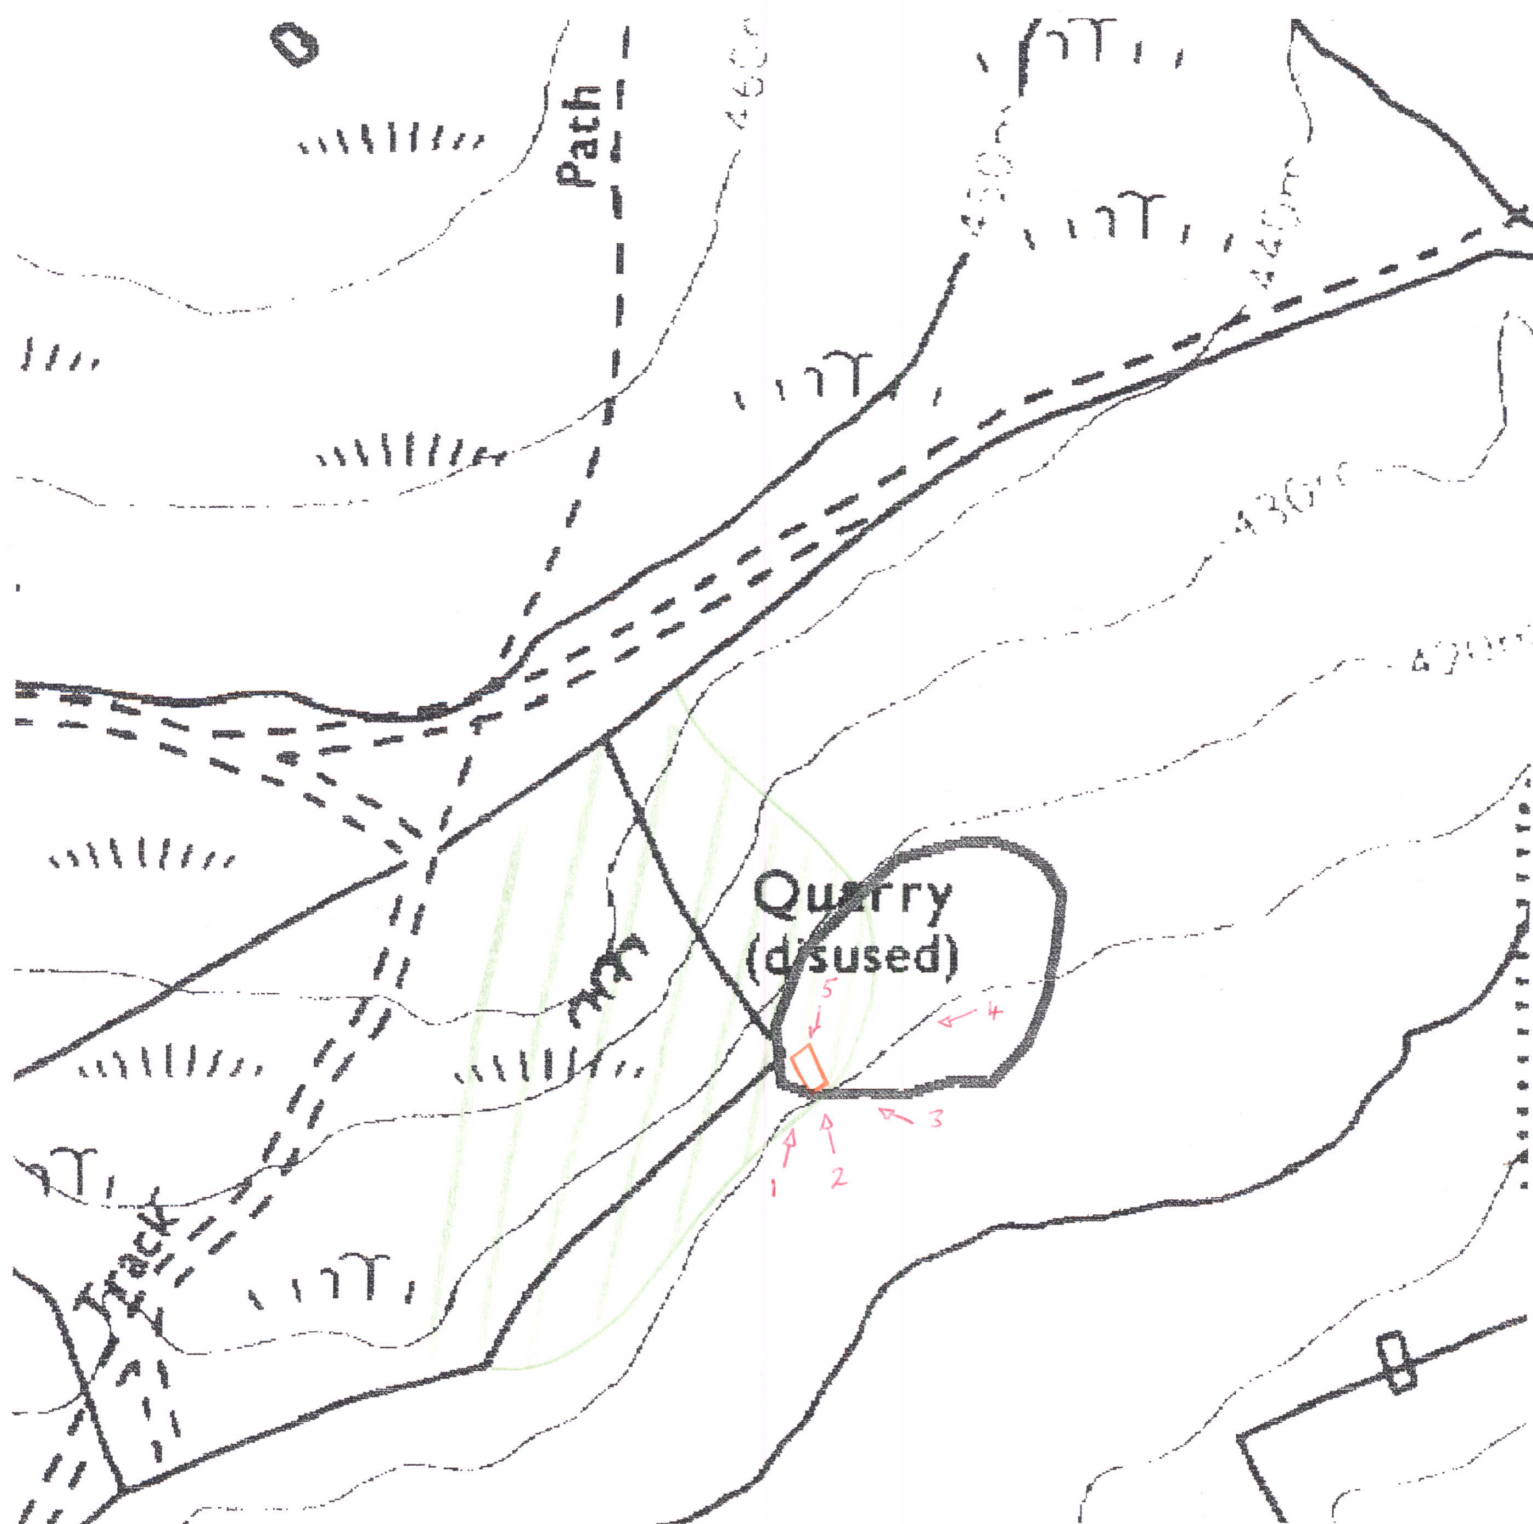
Appears to be more eroded than in 1996, a combination of rabbit and sheep damage. There is now a distinct patch of bare soil which is not visible in the 1996 photographs.

Fence on bank above site has degraded further and no longer forms a stockproof barrier.

Rabbit + sheep erosion much more pronounced.
