Radnor ESA

SO2329 6011

RADNOR ESA, HISTORIC MONITORING

BASELINE 1993

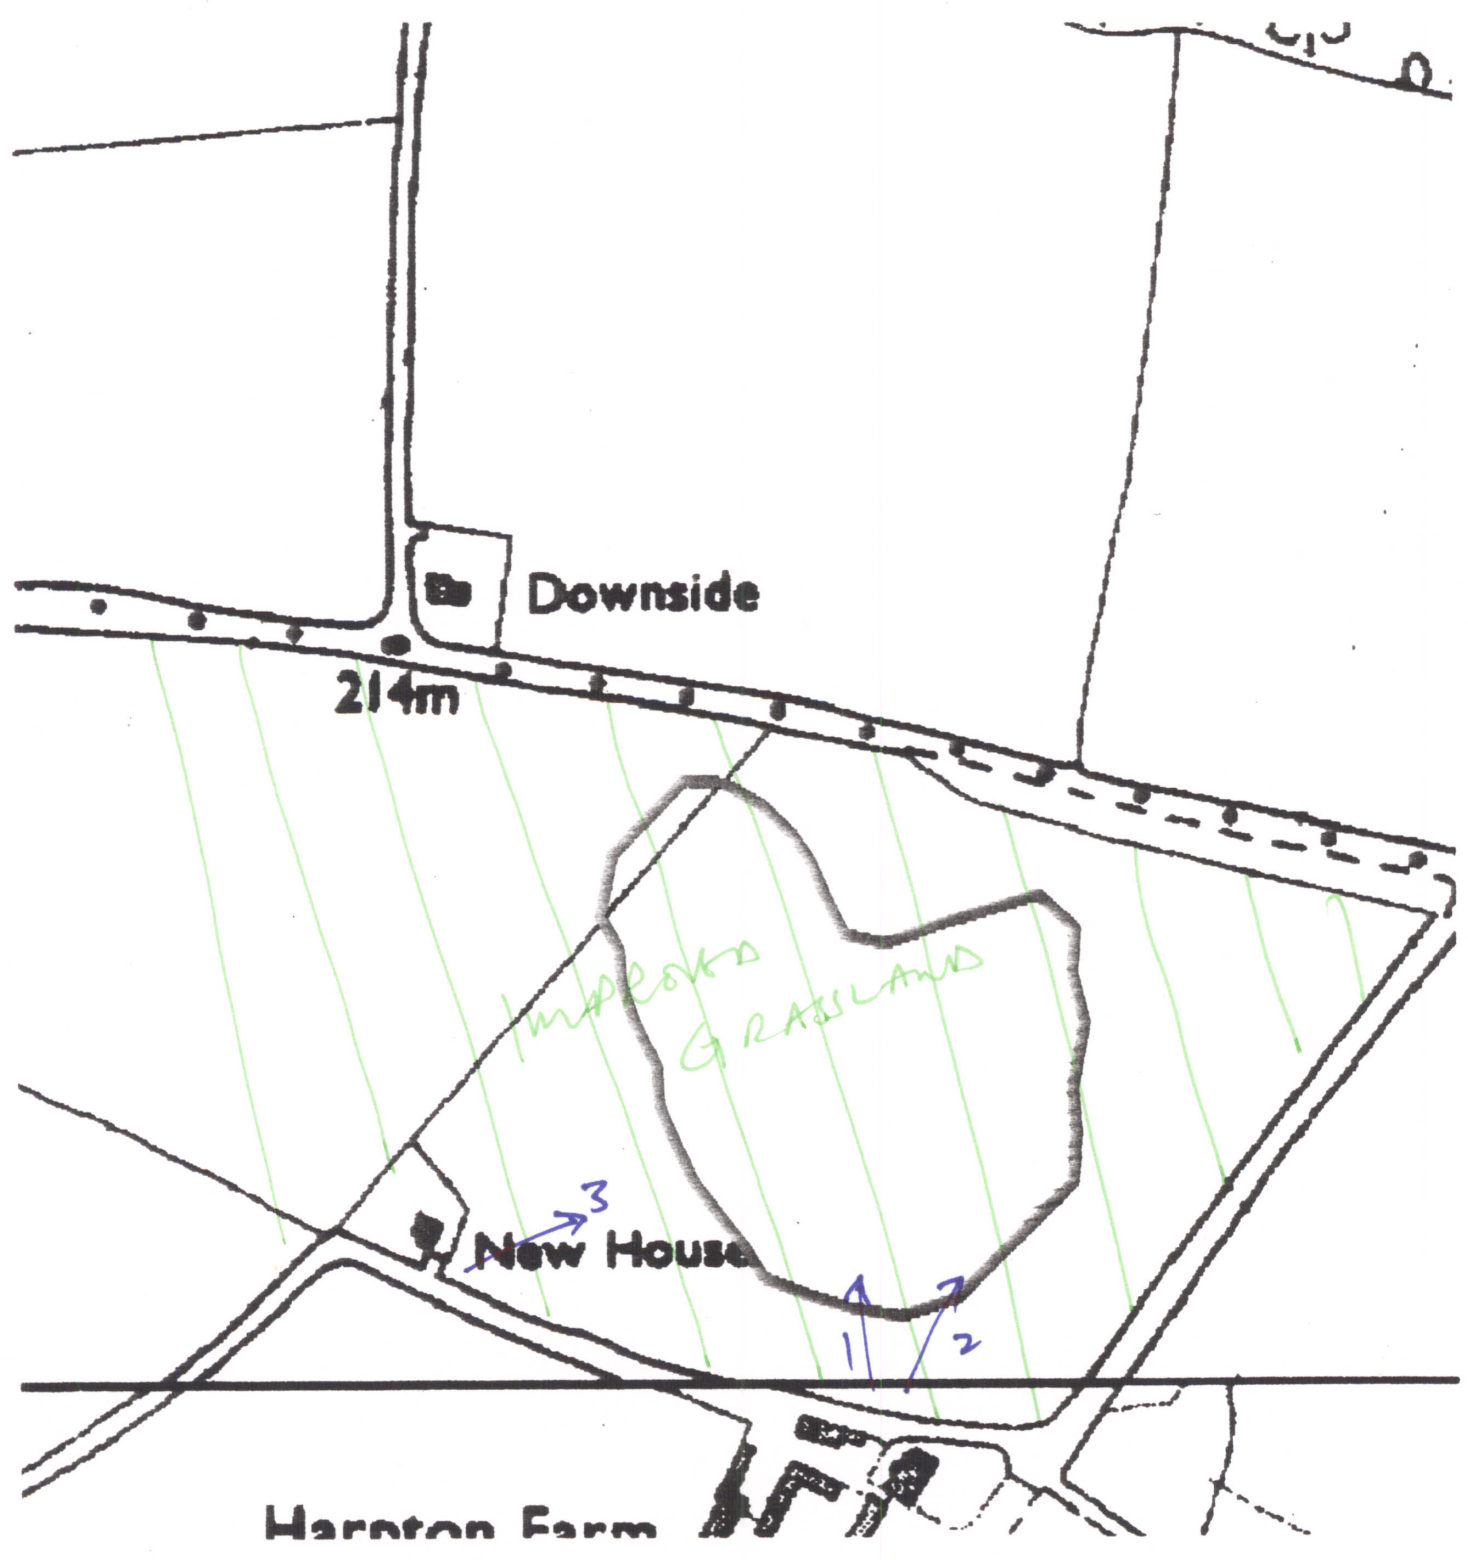
Nothing to be seen on the ground
except perhaps very slight almost imperceptible
embankment in places.

No public access nothing to see.
only real threat ^{normal} agricultural management,
with ploughing and reseedling.
Site is obviously best ag. land in the area.

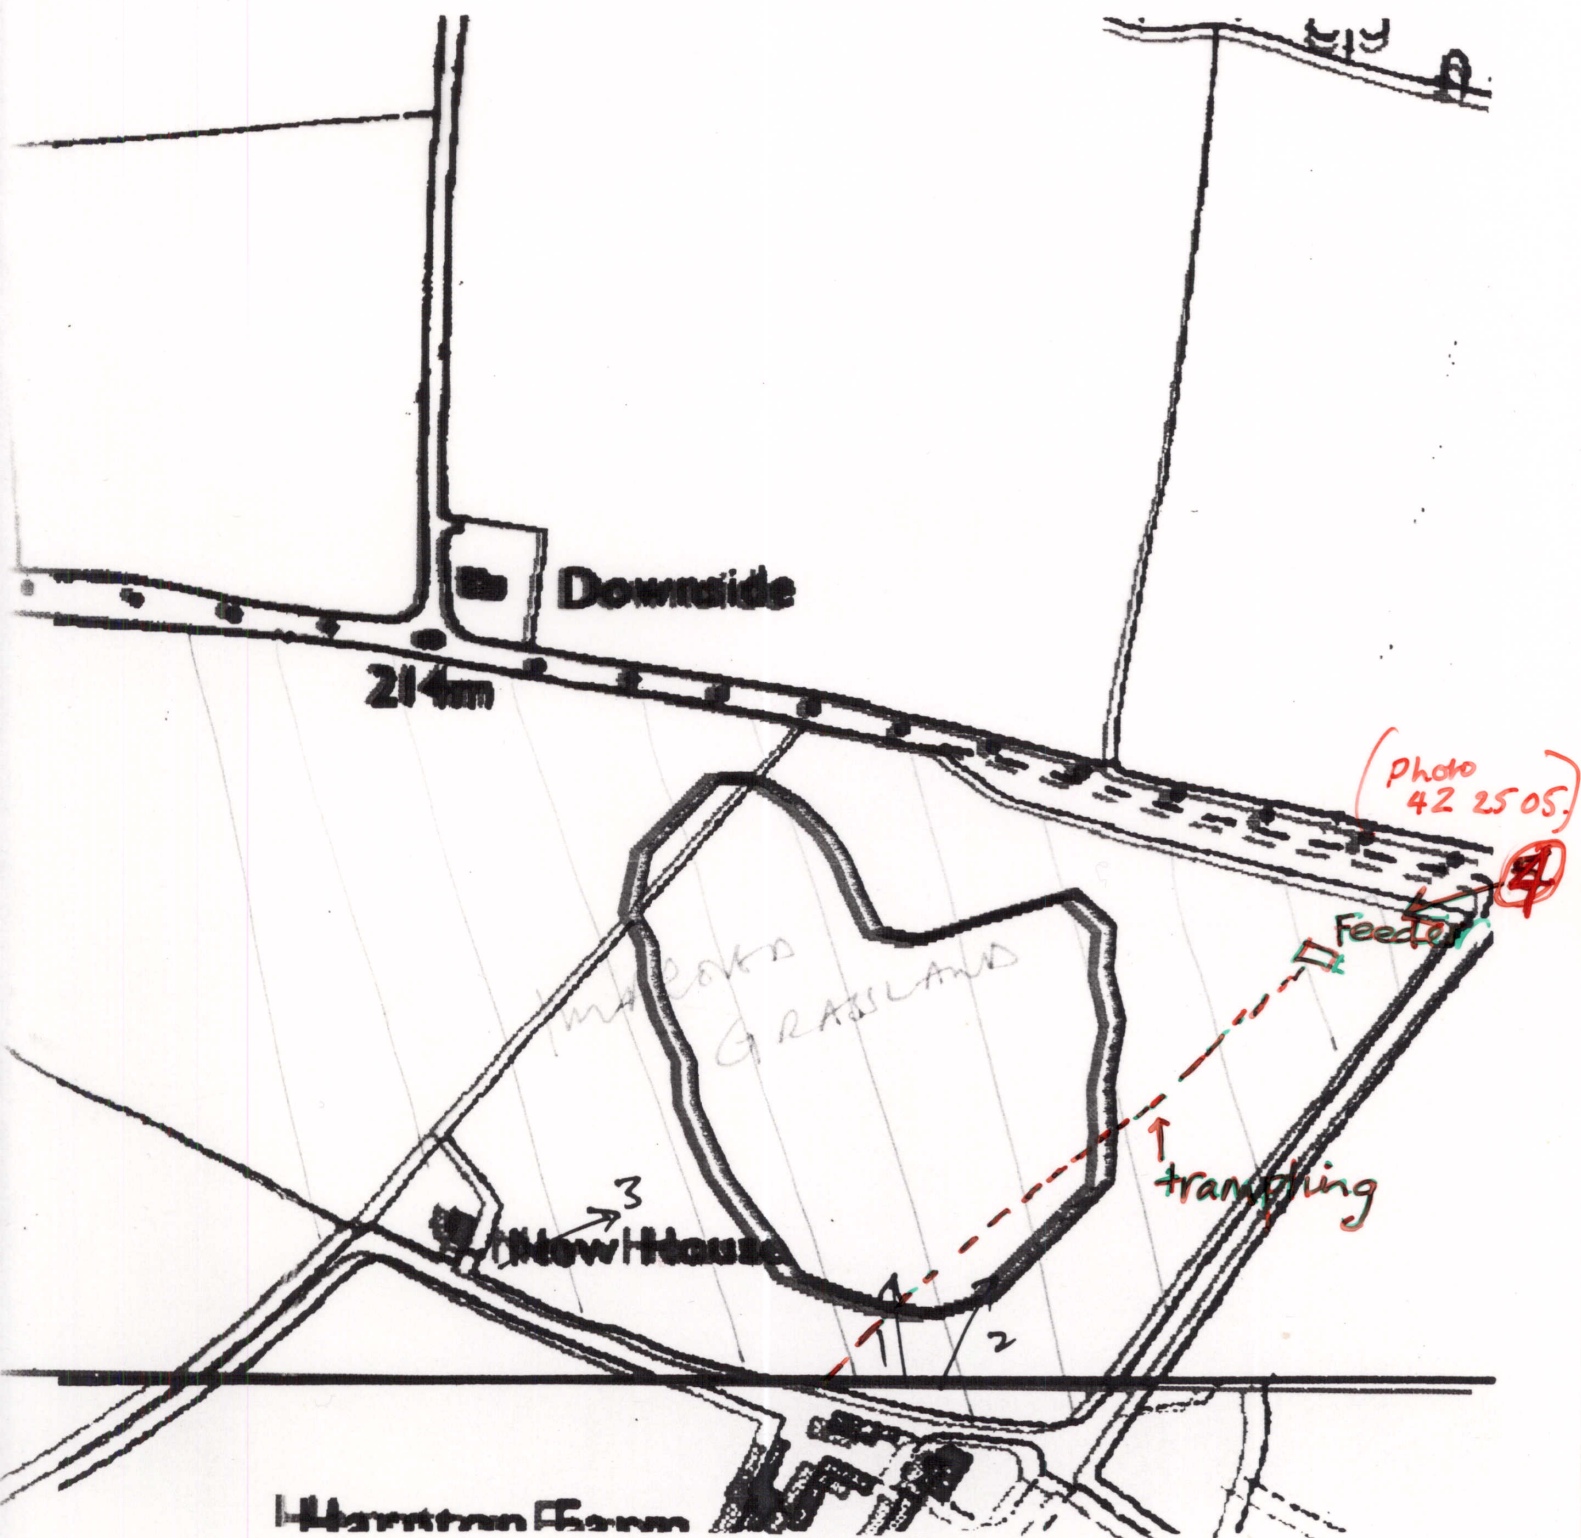
~~for~~ No change
improved + fertilized
though some trampling as a result
of feeder

possibly change to arable land - surrounding
land good quality agricultural land.

Note feeder as located on map was identified in bottom corner of ~~the~~ field. Some trampling + poaching but doesn't occur near ~~water~~ actual feature but on the edge of the halo.
- Possible threat? see photo 42 25 05.

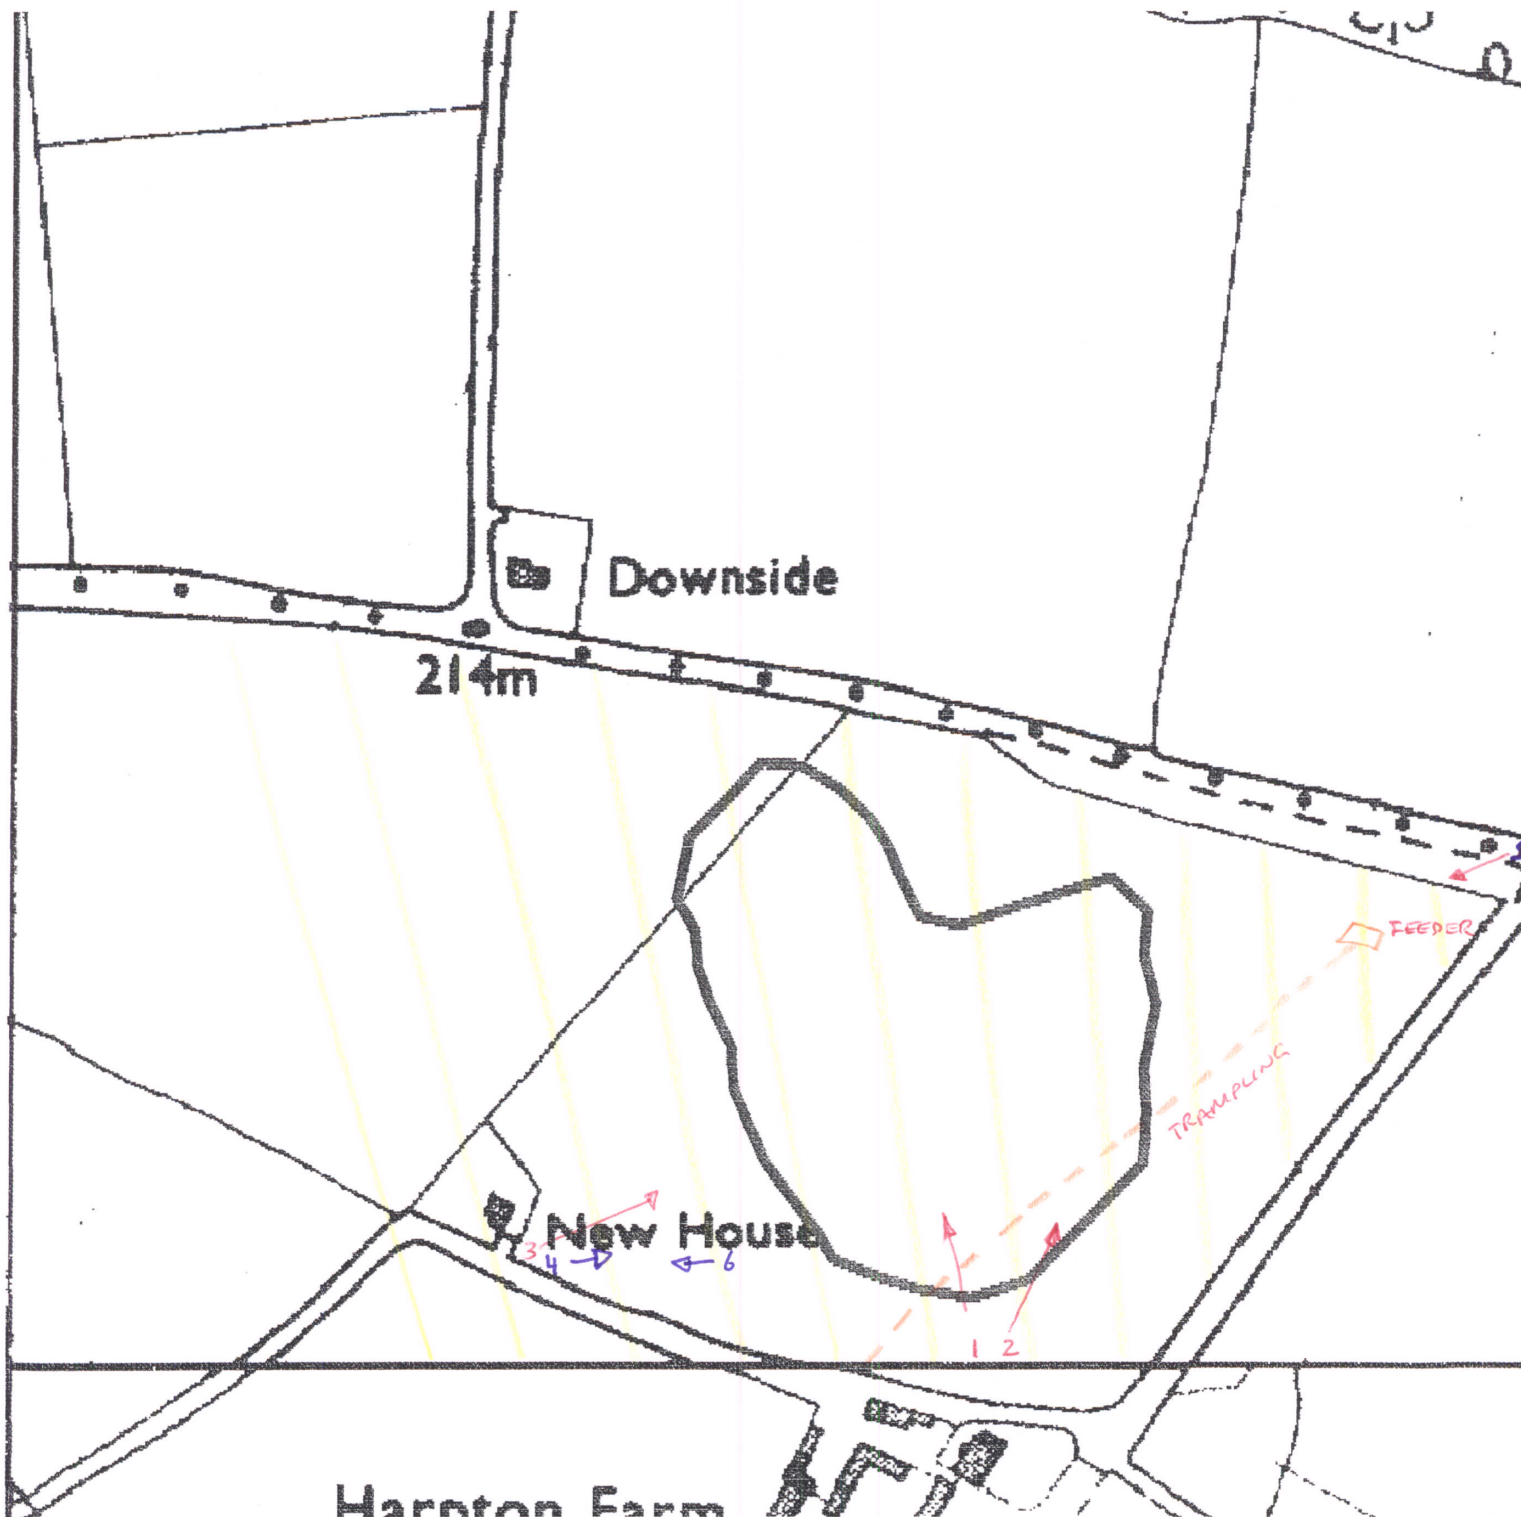
HALO: same bare patches around ring feeder areas
(photo 6).

Nothing obvious on ground, undulations evident but
no clear pattern.

No intention to change to crable. handowner may reseed field. Currently vented out for sheep grazing. Does not appear overgrazed. A bit weedy (thistles).
