# YNYS Môn ESA, HISTORIC MONITORING

## BASELINE 1993

| PRN: 899 SITE NAME: Llys y Rhosyr (Site of) Newborough. | |

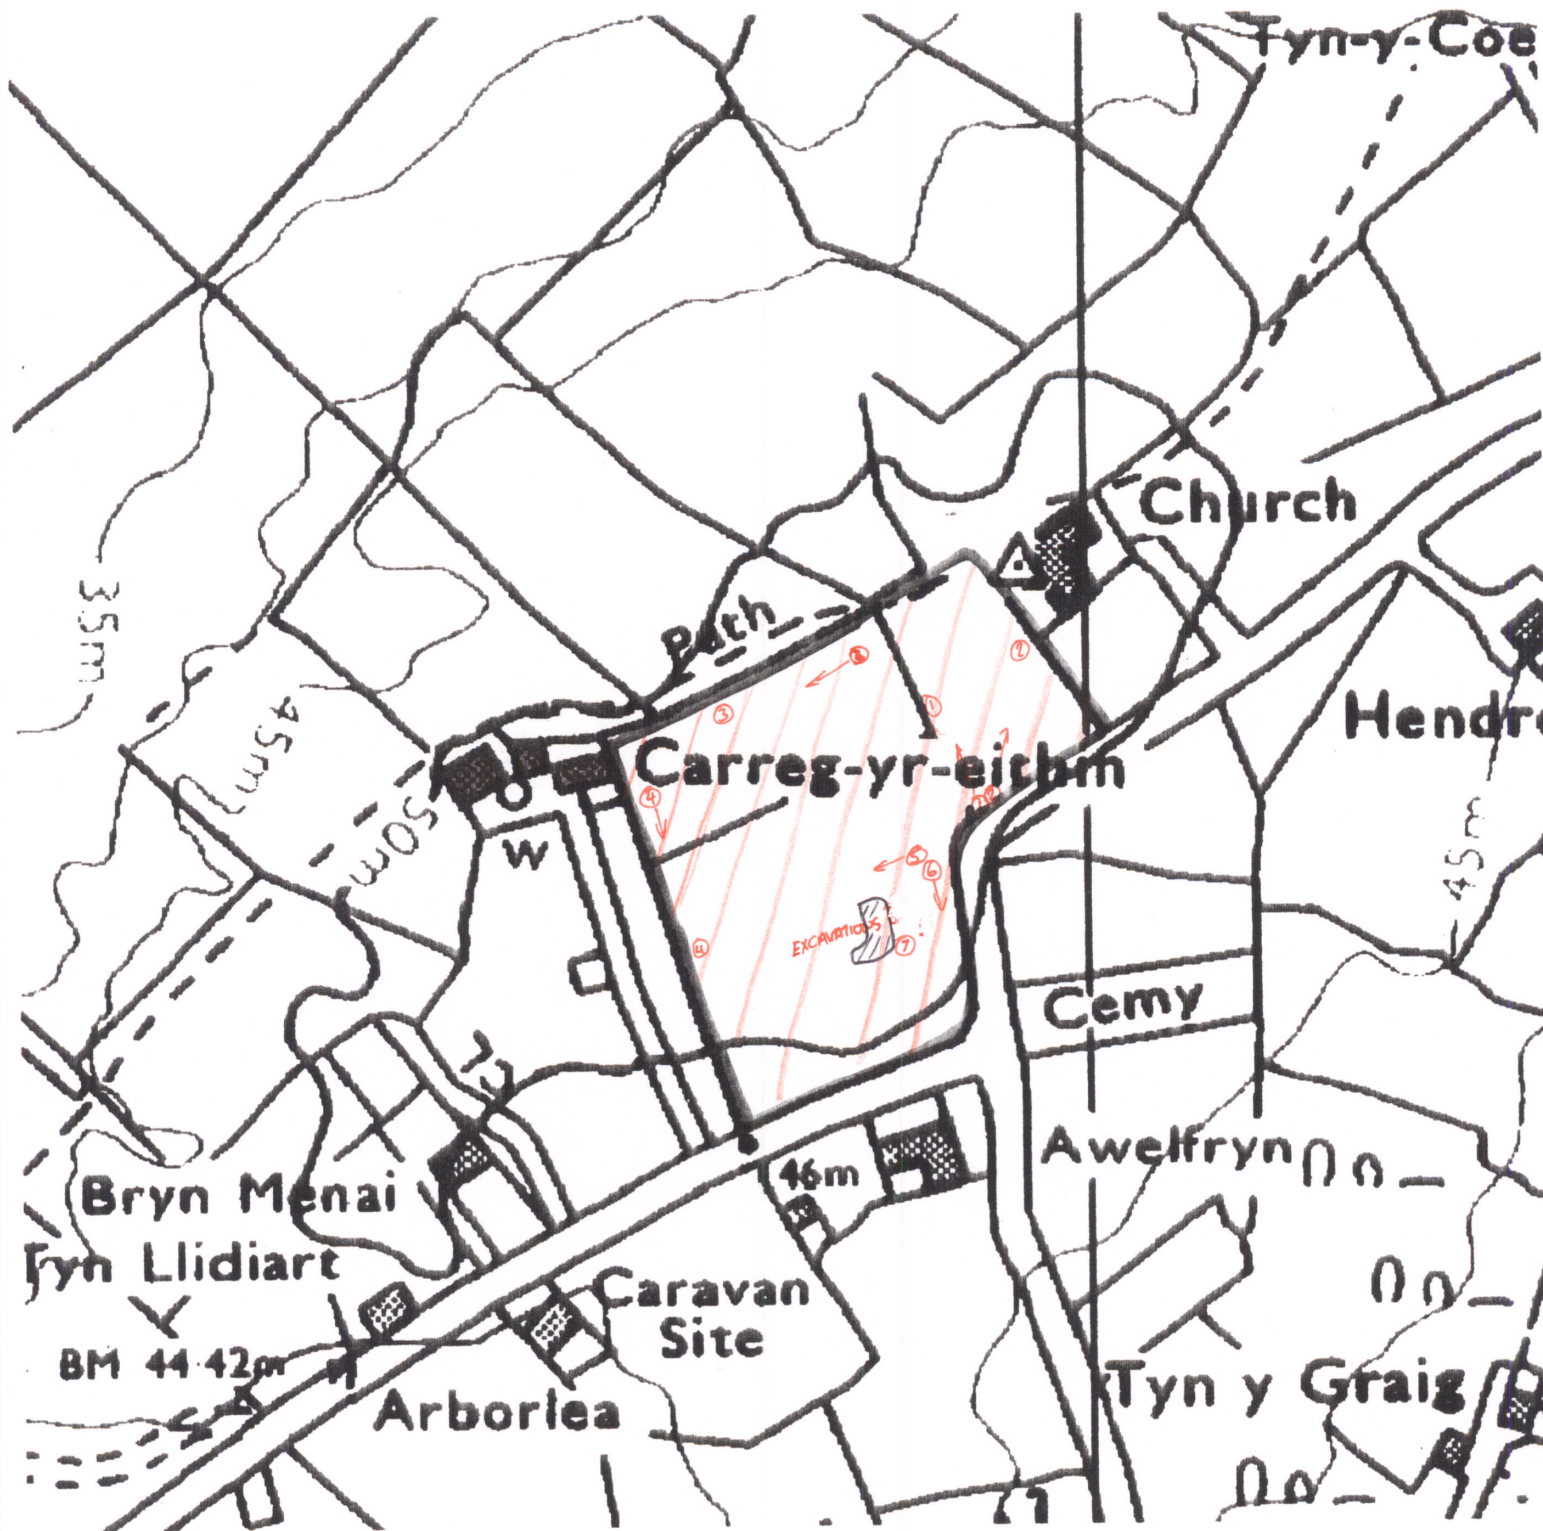
IMPROVED PASTURE.

Little can be seen of the site from visiting it. Only some small scale undulation gave any indication. The area was being excavated while I was there. The remains had been flattened - lying about 2 feet below the sandy soil they consisted of regular shaped stones lying in a disarranged order. The flattened site indicated there were far few visible signs on the surface.

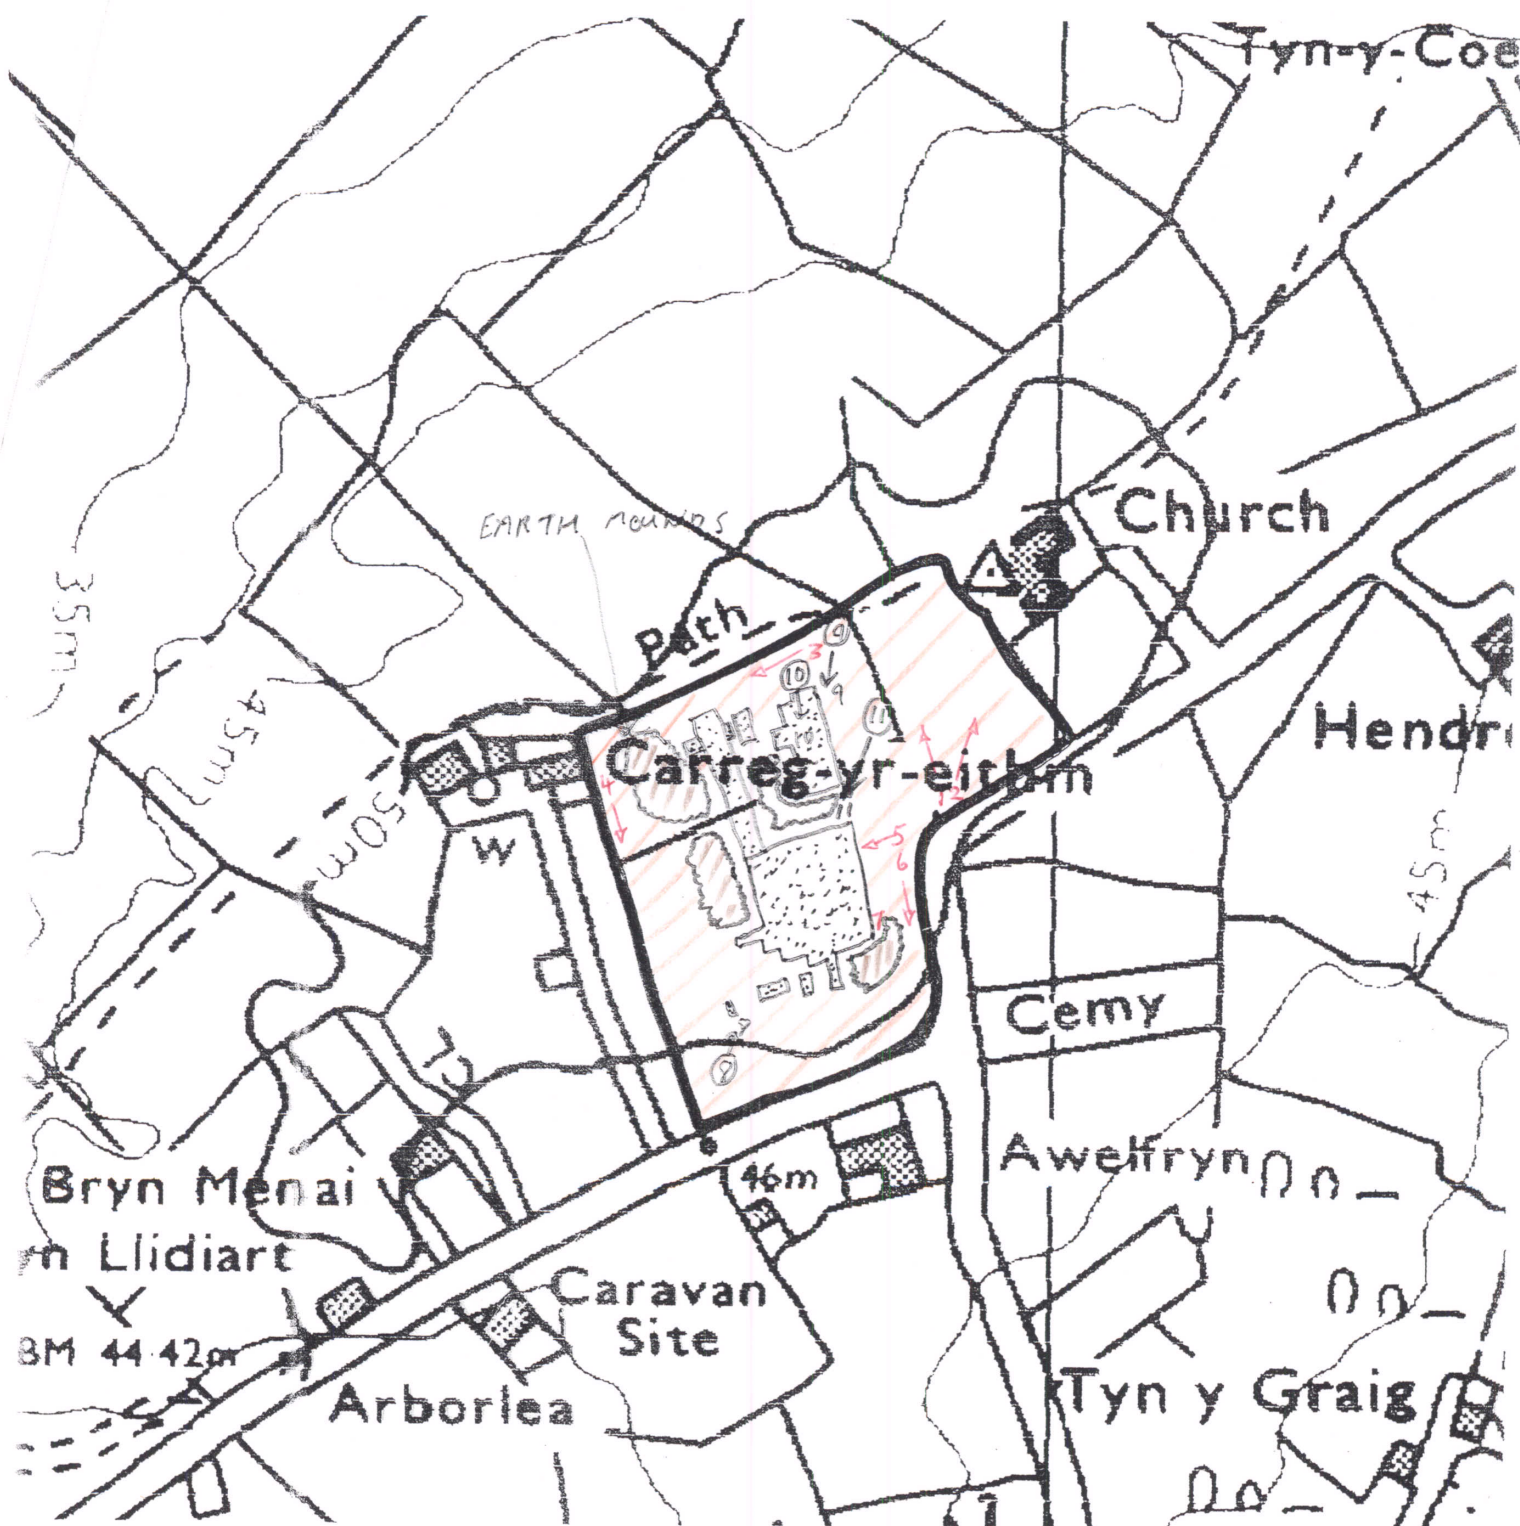
⊘ = EXCAVATIONS (ARCHAEOLOGICAL)

/// Improved pasture.

/// Earth mounds

| <i>Little can be seen of the site from visiting it. Only<br/>some small scale undulation gave any indication.<br/>The area was being excavated while I was there. The<br/>remains had been flattened - lying about 2 feet below<br/>the sandy soil they consisted of regular shaped stones<br/>lying in a disorganised order. The flattened site indicated<br/>the reason for few visible signs on the surface.</i> |
