# YNYS MÔN ESA. HISTORIC MONITORING

BASELINE 1993

| PRN: 1599 SITE NAME: LIME KILNS, SW OF LLEDWIGAN.<br>SITE: A. | |
| DATE SURVEYED: 14 / 12 / 93 | SURVEYED BY: Mark Alexander |

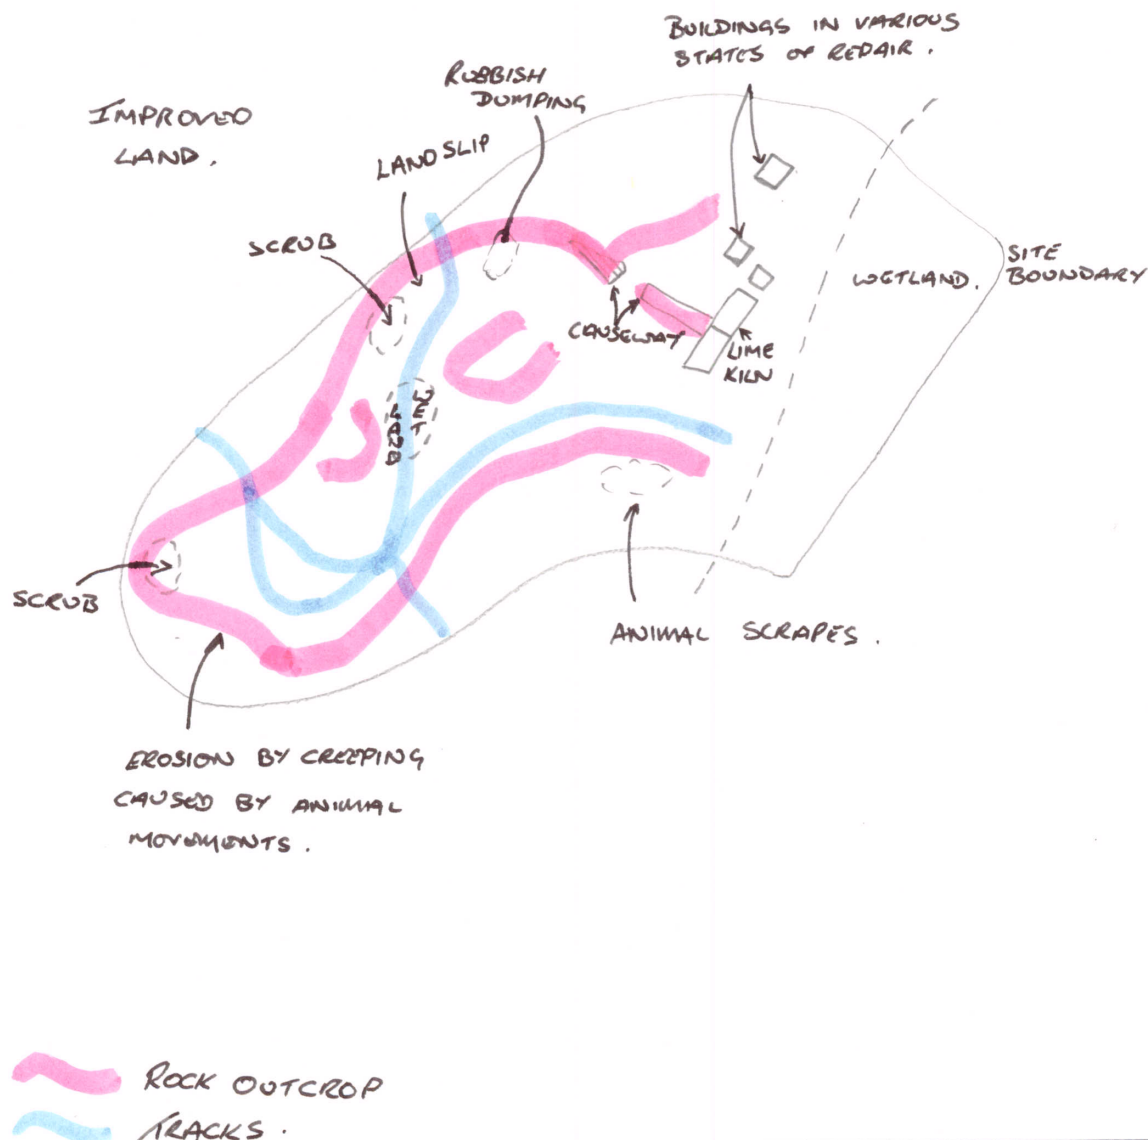
The lime quarry is in a variety of states, some wet areas in the bottom, with scrub, scree and reasonably unstable slopes. See attached diagram.
