# YNYS MÔN ESA, HISTORIC MONITORING

BASELINE 1993

| PRN: 3584 SITE NAME: Circular Earth works.<br>NE of Ynys Fawr | |

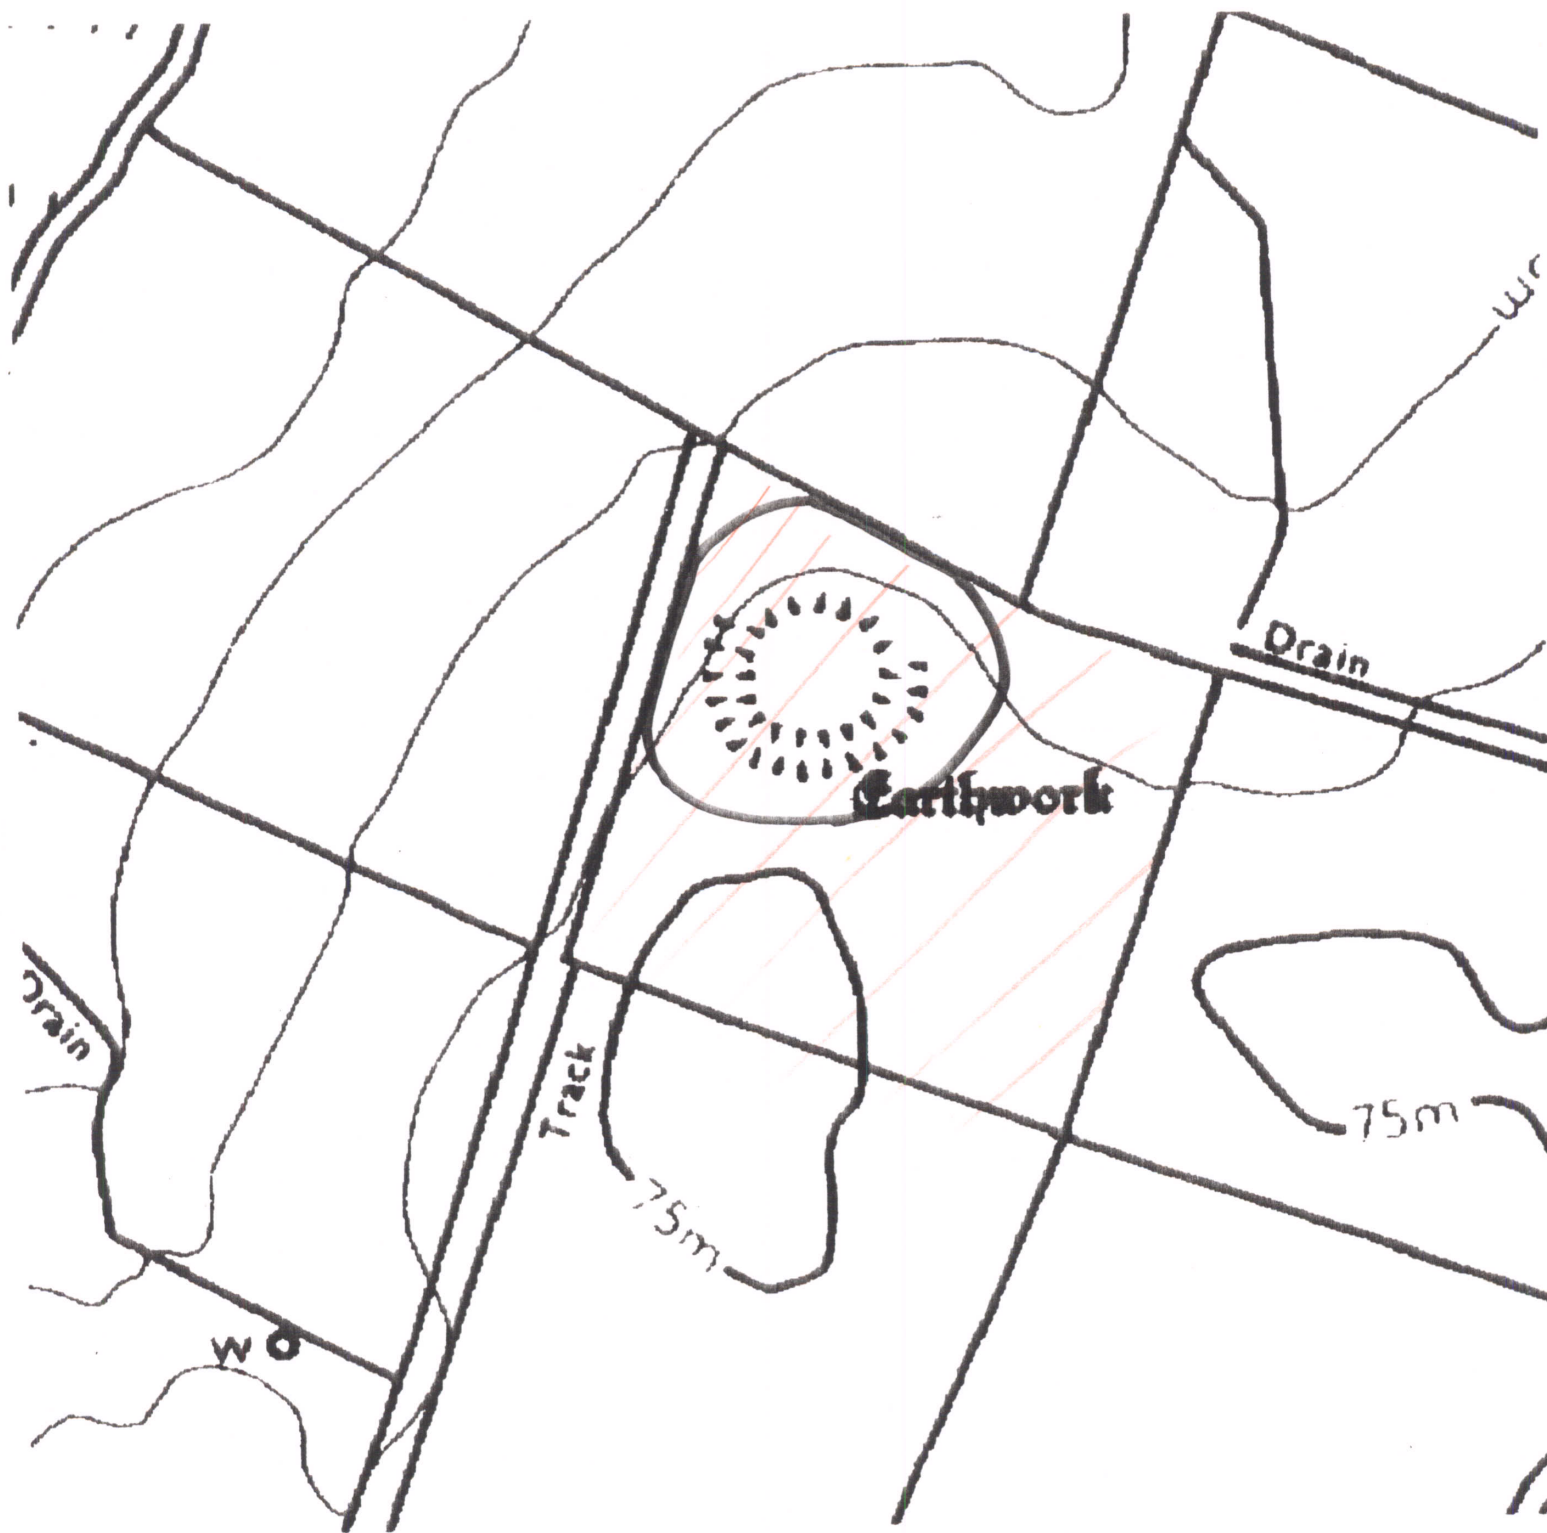
|||| Improved pasture.

*The distinctive shape of the site is clearly visible, yet after years of intensive farming and ploughing the feature is ever decreasing in its distinction from the rest of the field. Set up in an elevated position - the site consists of a raised central area surrounded by a half crescent depression.*

*Continued intensive farming ie ploughing, poaching is the main threat to the site's feature.*

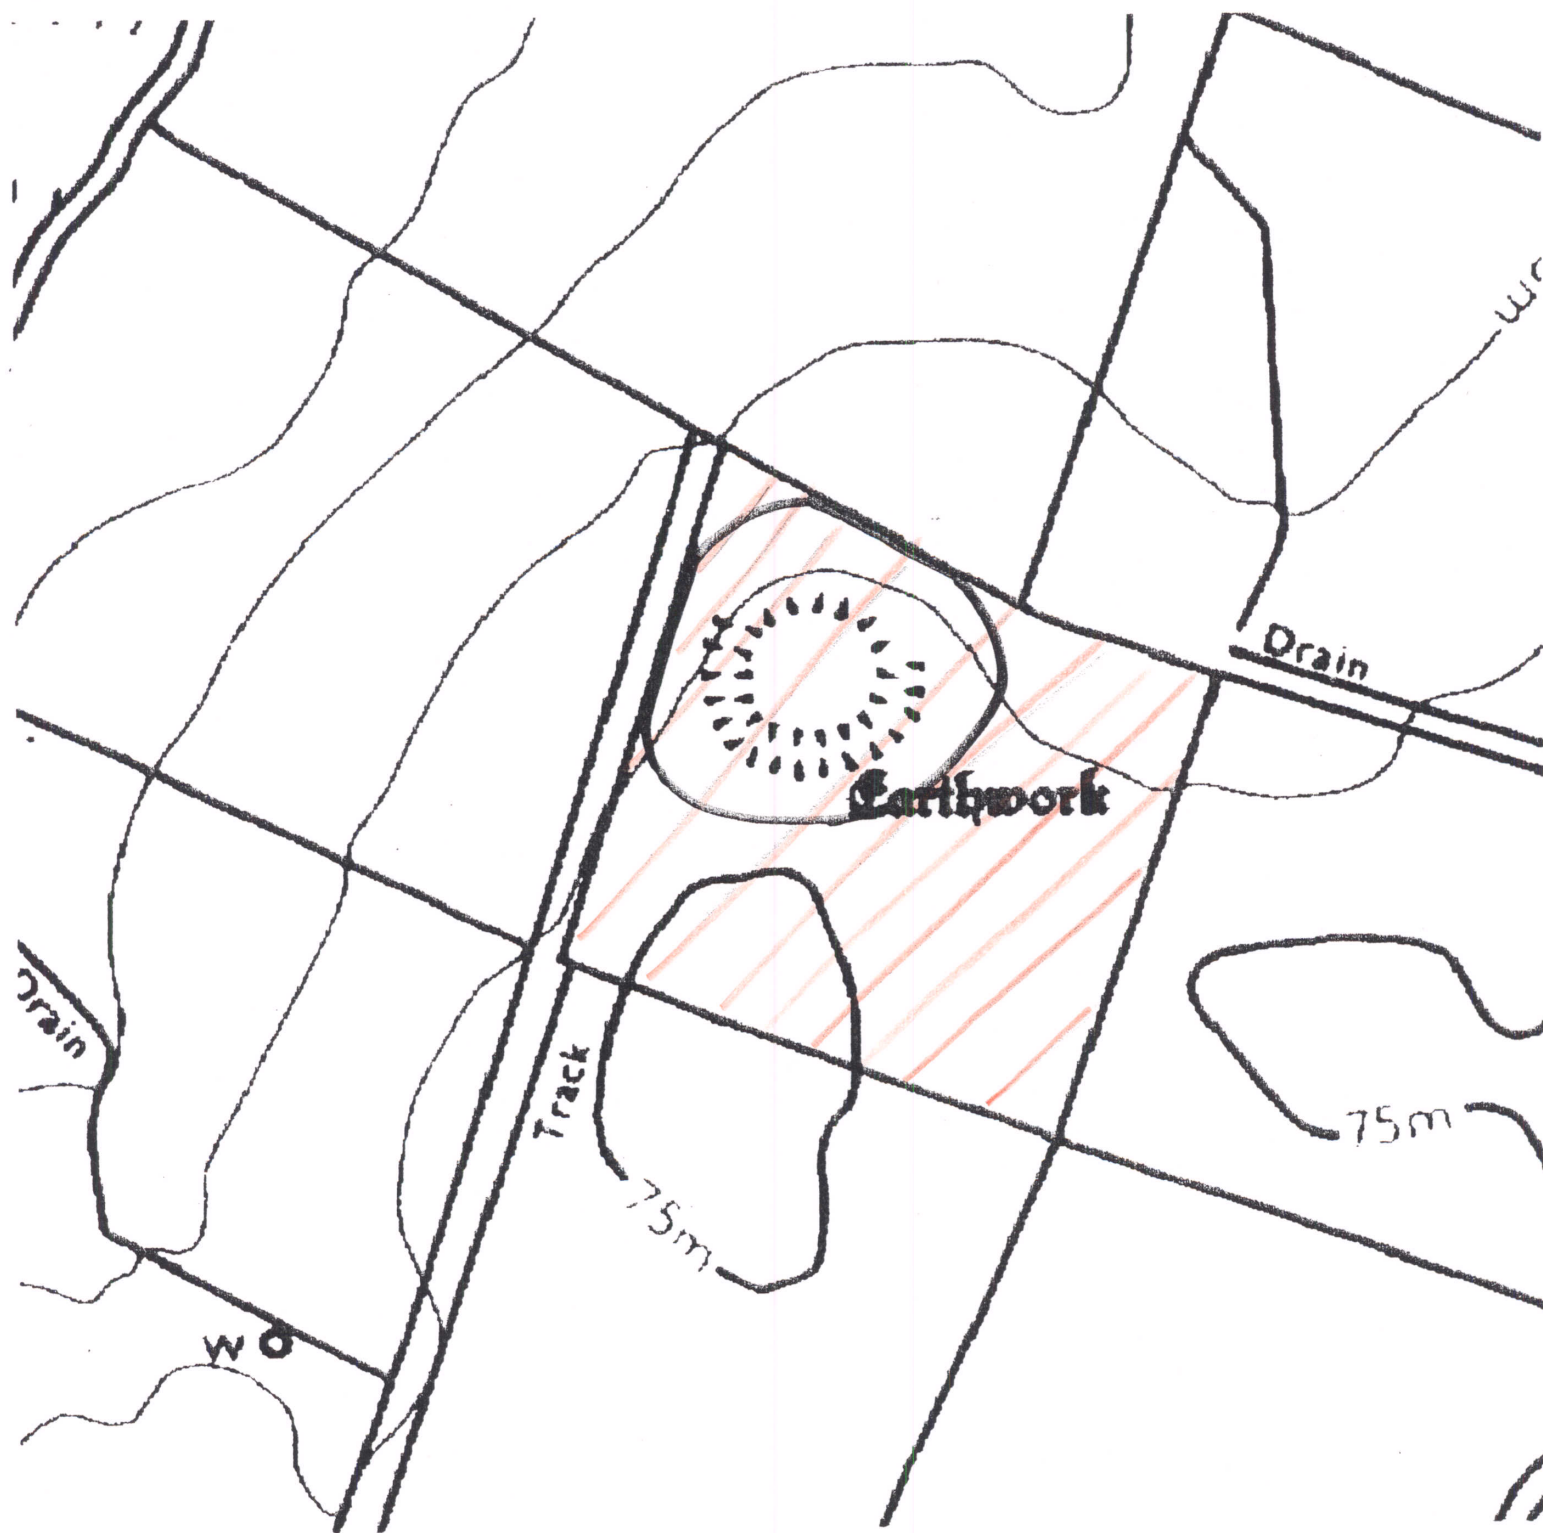
||||| Improved pasture -
