# MEDIEVAL AND EARLY POST-MEDIEVAL CHURCHES AND CHAPELS

A THREAT-RELATED ASSESSMENT 2010-11

Prepared by Dyfed Archaeological Trust  
For Cadw

RHIF YR ADRODDIAD / REPORT NO. 100039  
RHIF Y PROSIECT / PROJECT RECORD NO. 2010/47

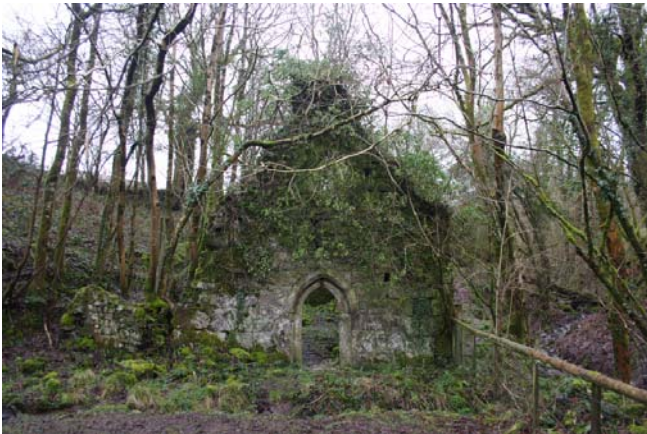
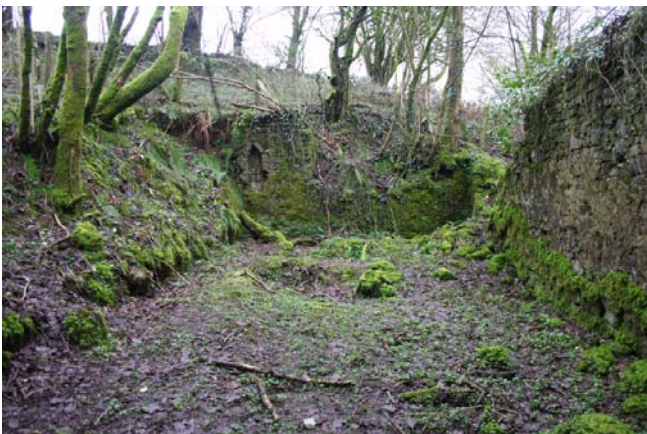
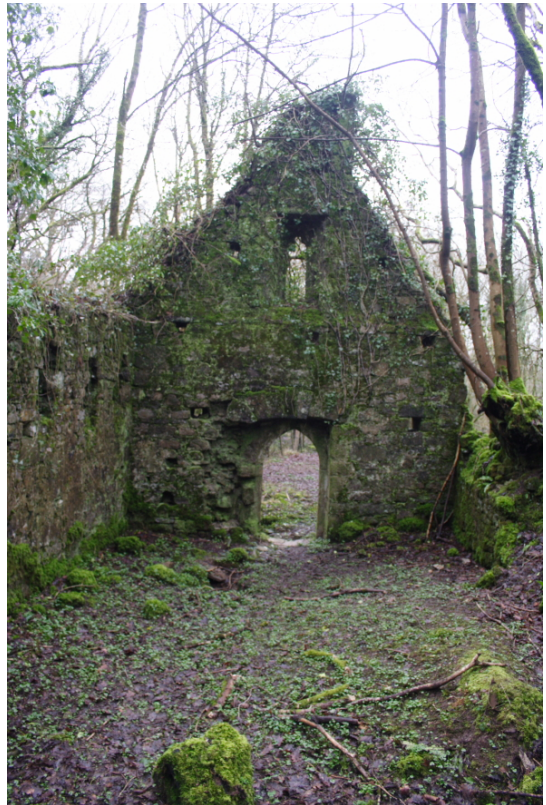
The features of the floor were obscured by a thick layer of fallen leaves, although it was evident that the eastern end is raised. The chapel is recorded as a "well-chapel" and, although no well was evident, an exposed section of a fast-flowing, stone-lined water channel, below floor level, was located just within the entranceway, presumably emanating from a natural spring.

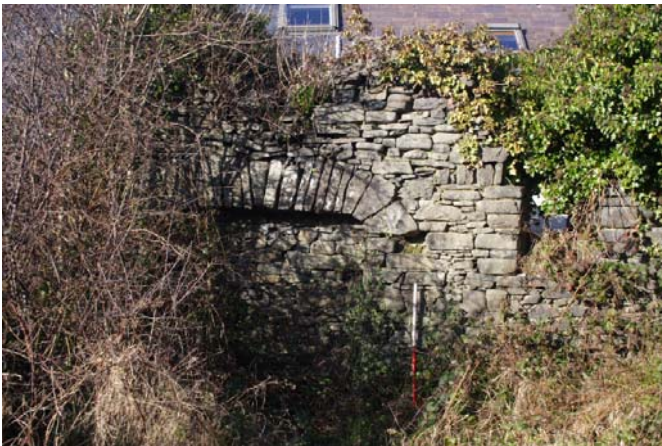
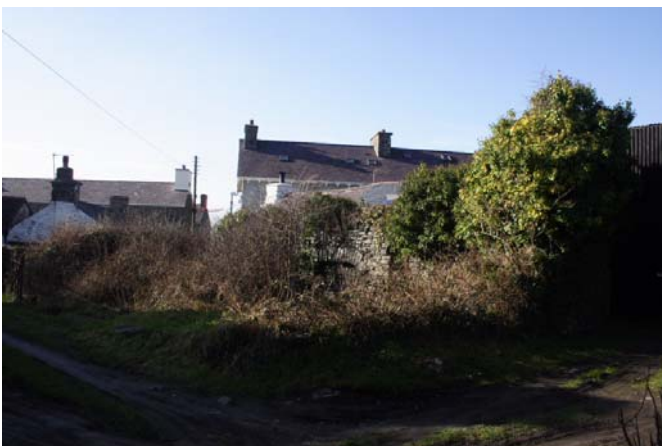
The site, known as Neuadd, was visited during the Churches and Chapels project in 2011. Set within a residential area of old cottages, the site comprises some substantial surviving masonry that forms an east-west rear wall and north-south western end wall of a building. The southern, front wall has almost completely gone - large masonry fragments and the remnant of a possible foundation trench mark its line - and much of the eastern end wall has collapsed. There is a wide fireplace in the rear wall with a pitched stone canopy and evidence of at least two window apertures, one now blocked up. The walls are heavily overgrown with shrubs and trees and the interior of the structure is totally obscured by vegetation.

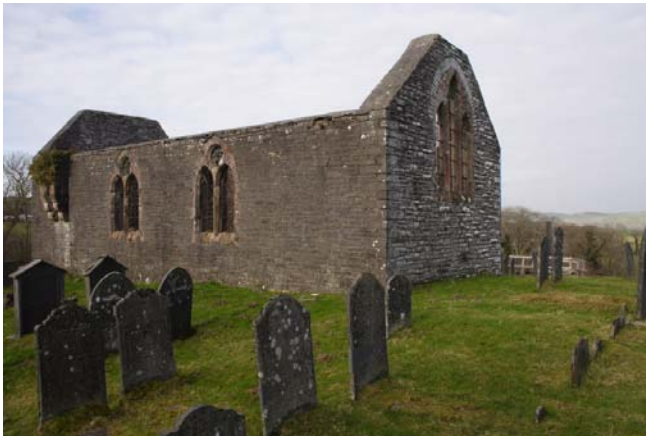
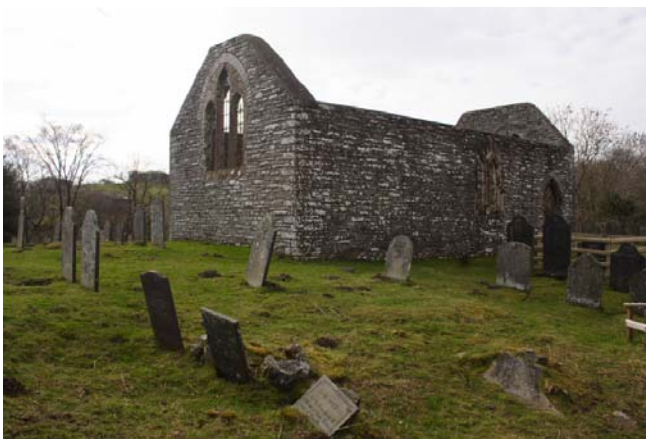
The church is aligned east-west and sits within a sub-rectangular / ovoid churchyard that contains numerous graves. The churchyard is on a built-up platform above a farm track and a stream that runs to the west and south of the church. The church, of slate rubble with dressed quoins, is now roofless but the walls stand to full height, the tops capped with concrete. The gable tops have been removed. The church comprises three rooms; an entrance porchway at the western end that leads to a small vestry, containing a fireplace, and an arched entrance through to the main space of the church. Fragments of red and black floor tiles survive just within the church doorway. Much of the internal plasterwork has deteriorated and fallen from the walls and grass is growing on the window sills. The floor is also covered by a thick layer of grass, obscuring any possible features. Some remnant of stained glass survives in several of the metal-framed windows.

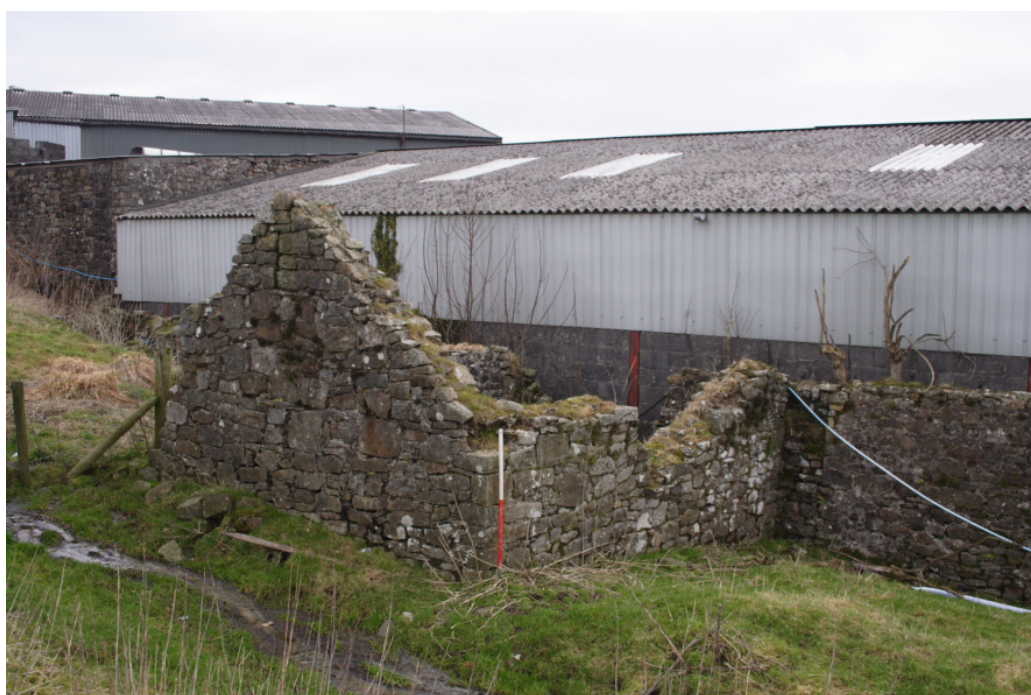
A site visit in 2011 showed that this chapel is a single chambered structure with east, west and south walls still standing. The chapel is orientated SW to NE and is approximately 5m long and 6m wide. The NE gable end has been destroyed, probably by a farm building which itself has been replaced by a modern barn. The entrance was presumably in the NE end as no other entrance is visible. There is a lot of rubble within the interior, and a possible grave.

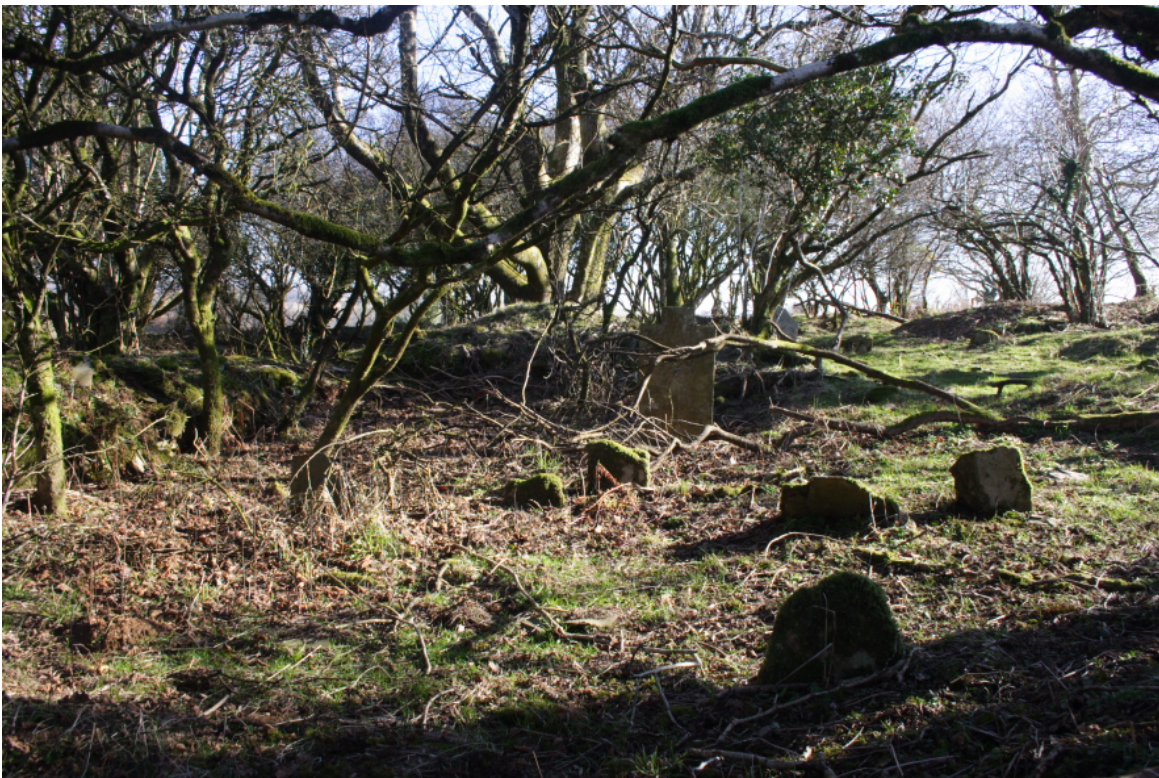
Chapel known as Hendy cwrdd, 'the Old Meeting-house', founded in 1714. The chapel ruins are in a fenced-off area of woodland alongside a trackway that runs along the field boundaries. Depicted on the 19th century Ordnance Survey map as a ruin, the site stands within a graveyard containing 18th-19<sup>th</sup> century graves.

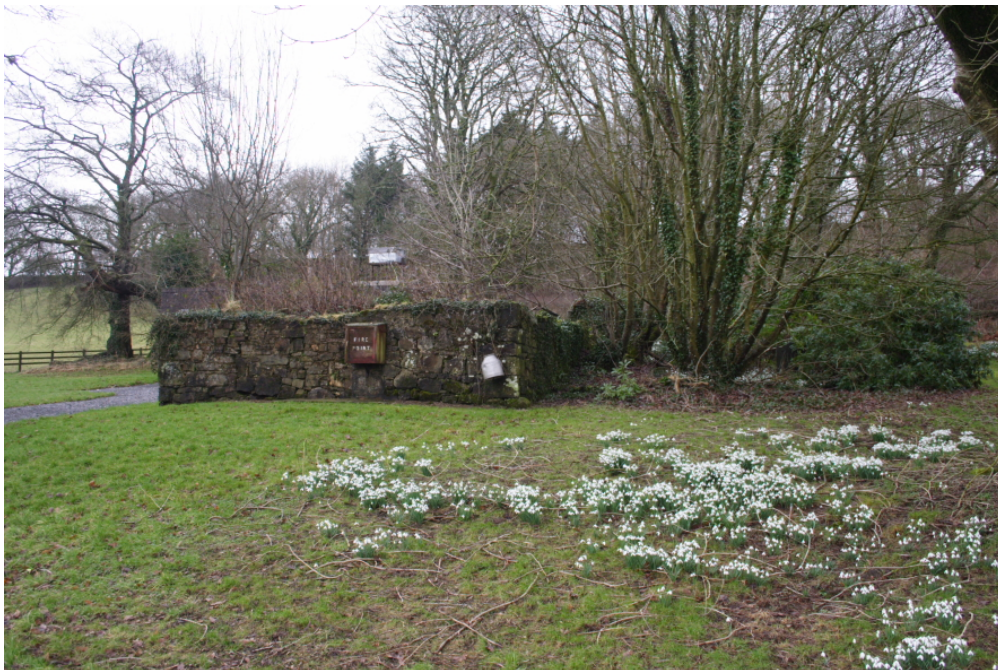
The church is now a roofless shell aligned WNW - ESE. Much of the fabric of the church has been removed since the record made in 1984 and the walls stand just over a metre high. Field observations made by R.E.Kay in 1954 show the entrance doorway and two windows in the western wall and a further two windows in the north wall. His illustrations also depict gravestones standing beyond the northwestern corner of the church, which have now gone. The church is now an overgrown, roofless ruin, and the churchyard is a caravan park. M. Ings 2011

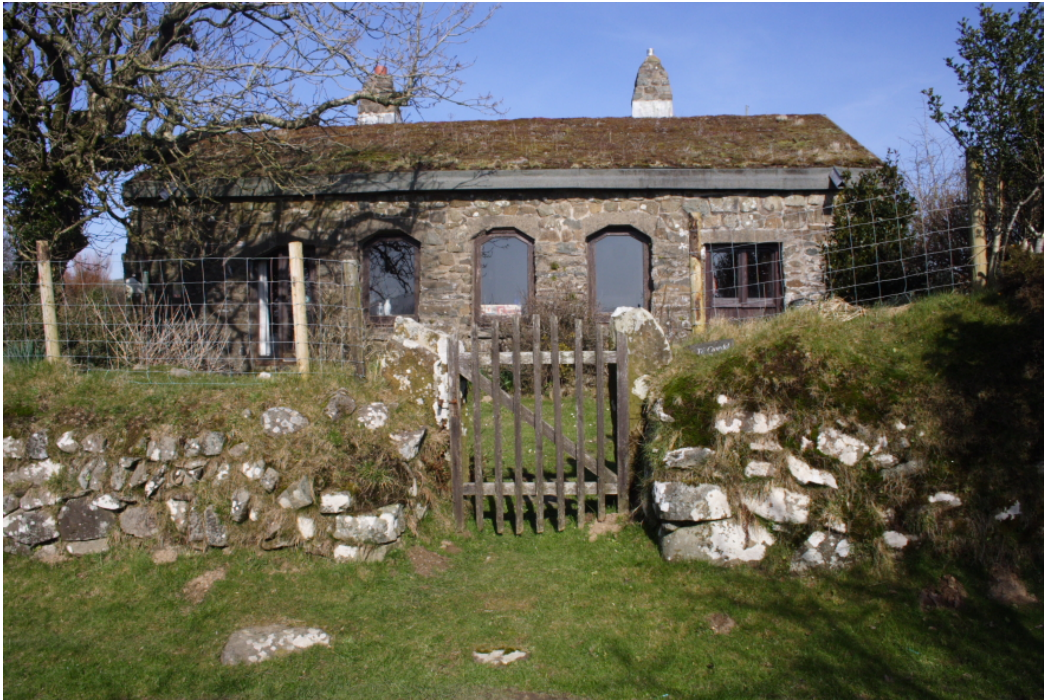
A domestic building is now on the site, on the same footprint as the chapel. It wasn't apparent whether any of the chapel survived within the fabric of the new building and the owners were absent. The substantial stone wall that now comprises the boundary to the front garden may possibly survive from the former churchyard and further remnants of wall were noted to the southwest and northeast of the current building.

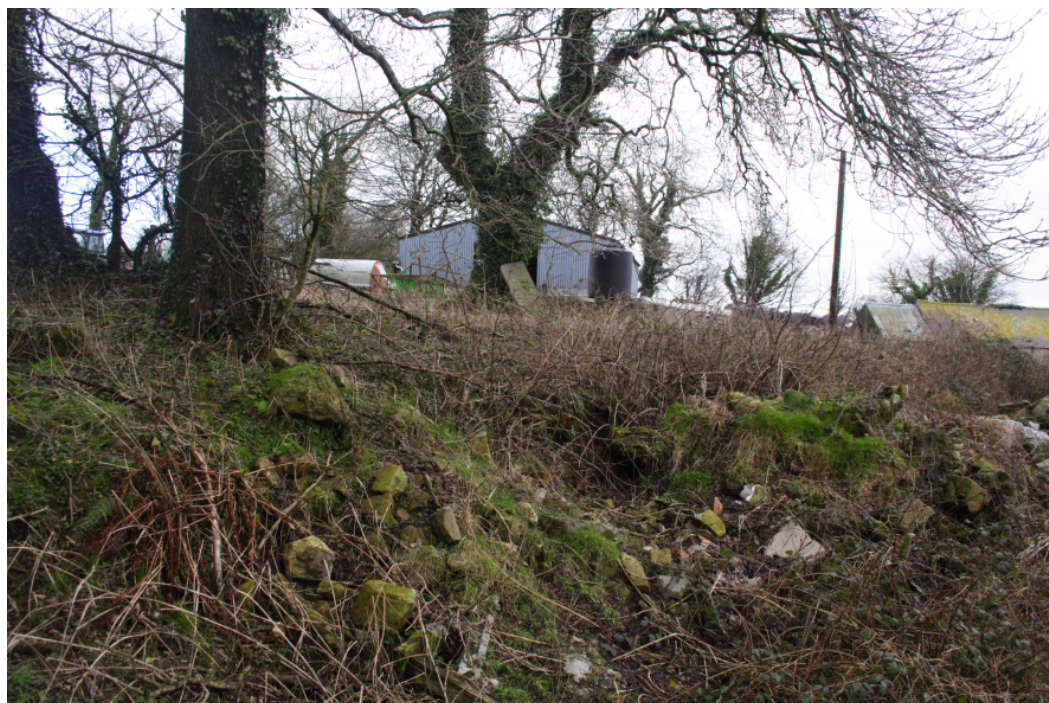
The site comprises a substantial platform within Rinaston Farmstead, built to the side of a farm track. It is marked by steep, stone revetted banks to the west and south and ephemeral earthbanks to the north and west. No standing remains of the former church survive. A gravestone, once recorded to be located within the chancel, now leans against a tree on the platform. This marks the burial of David Morse in 1785 and his wife Martha in 1789  
M. Ings 2011

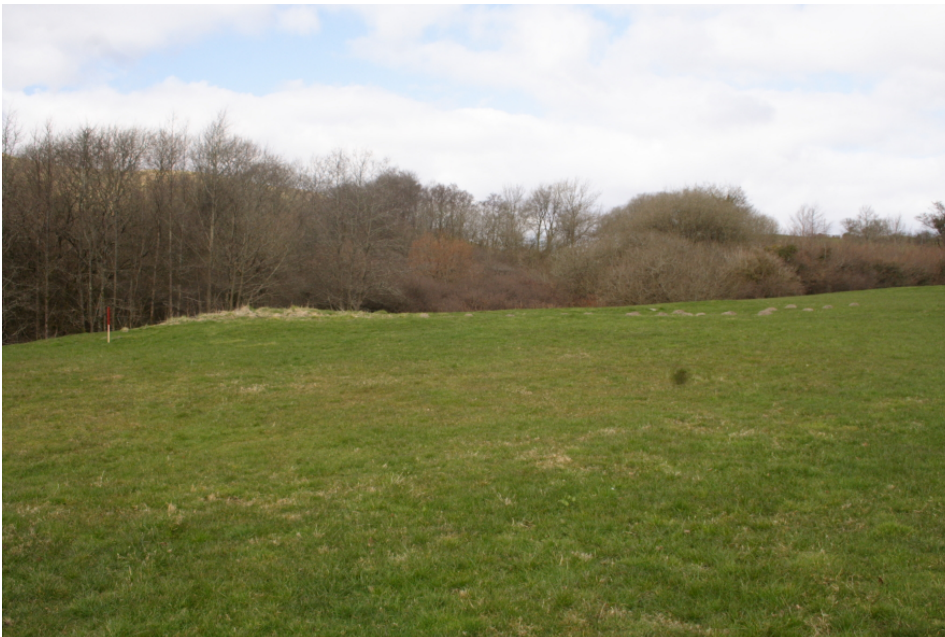
In 2011, the site was still visible as an earthwork occupying a gentle west-facing slope in improved pasture. The chapel was marked by an earthwork 28m E/W and 10m N/S. The earthwork at the west end stood up to 0.3m high internally and 1m externally. Elsewhere the earthwork was less well marked. A large stone was exposed on the north side. Approximately 30m to the south and the east of the chapel were linear undulations, 0.3m high, and numerous depressions, which may mark the limit of the chapel enclosure/cemetery. The farmer had no knowledge of a holy well, but a farm well had been in use up to 15 years ago in the field to the north on the other side woodland. R Ramsey and K Murphy 2011, compiled from several sources.

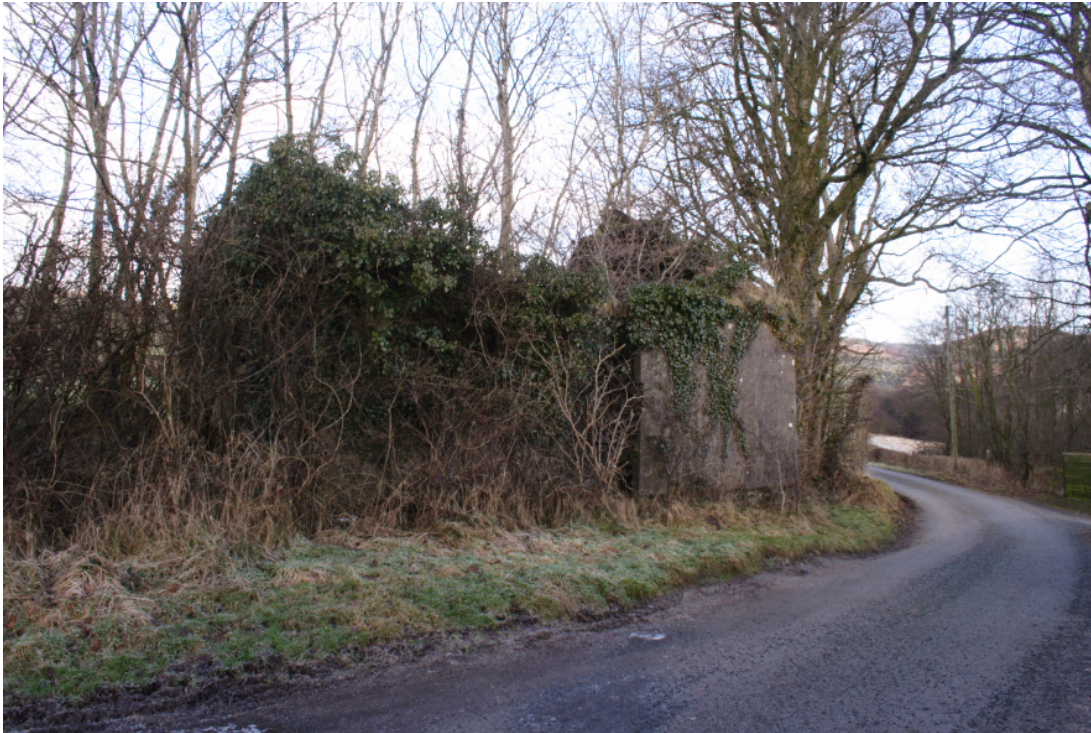
Methodist chapel shown on OS 1st and 2nd ed maps. It is a single chambered structure orientated E to W. It is around 5x7m in size with a small rectangular structure added on at its E gable end. It is constructed of mortared stone and rendered in concrete. The owner remembers it having a slate roof, although it is now roofless, and a pulpit. There are two large windows at either end. The doorway is in the centre of the south wall. The walls are partially collapsed on the north side and there is considerable scrub growth around and within the structure. OD 2011
