GELLIWERNEN FARM LLANNON CARMARTHENSHIRE (SN 5340 0595)

HISTORIC BUILDING RECORDING

DYFED ARCHAEOLOGICAL TRUST
RHIF YR ADRODDIAD / REPORT NO. 2011/12
RHIF Y PROSIECT / PROJECT RECORD NO. 100490
Ionawr 2011
January 2011

GELLIWERNEN FARM LLANNON
CARMARTHENSHIRE
HISTORIC BUILDINGS RECORDING

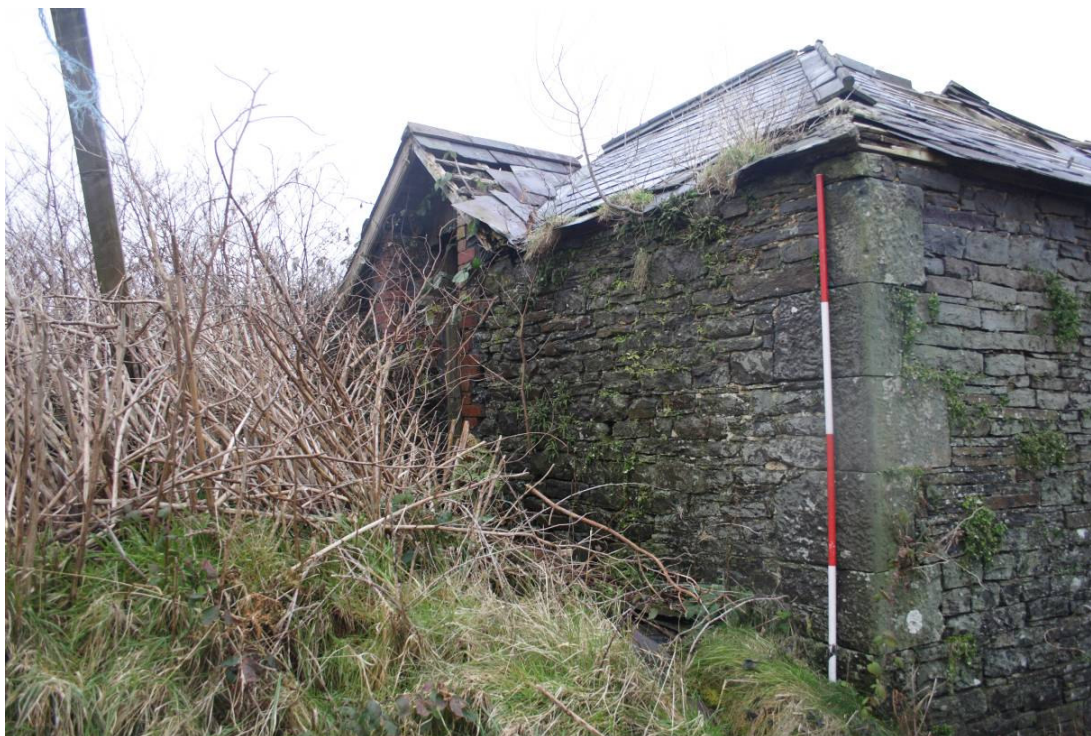
- 4.1.2 The NW gable end of the building is pierced by a single doorway with red brick surrounds set at first floor level. At the rear of the building a series of three first floor windows each with dressed stone surrounds and sills pierce the wall. Towards the NW corner of the building, and set at ground level, a further opening pierces the wall and may represent a further window.

Photo 1: Doorway in NW gable end of Building 1

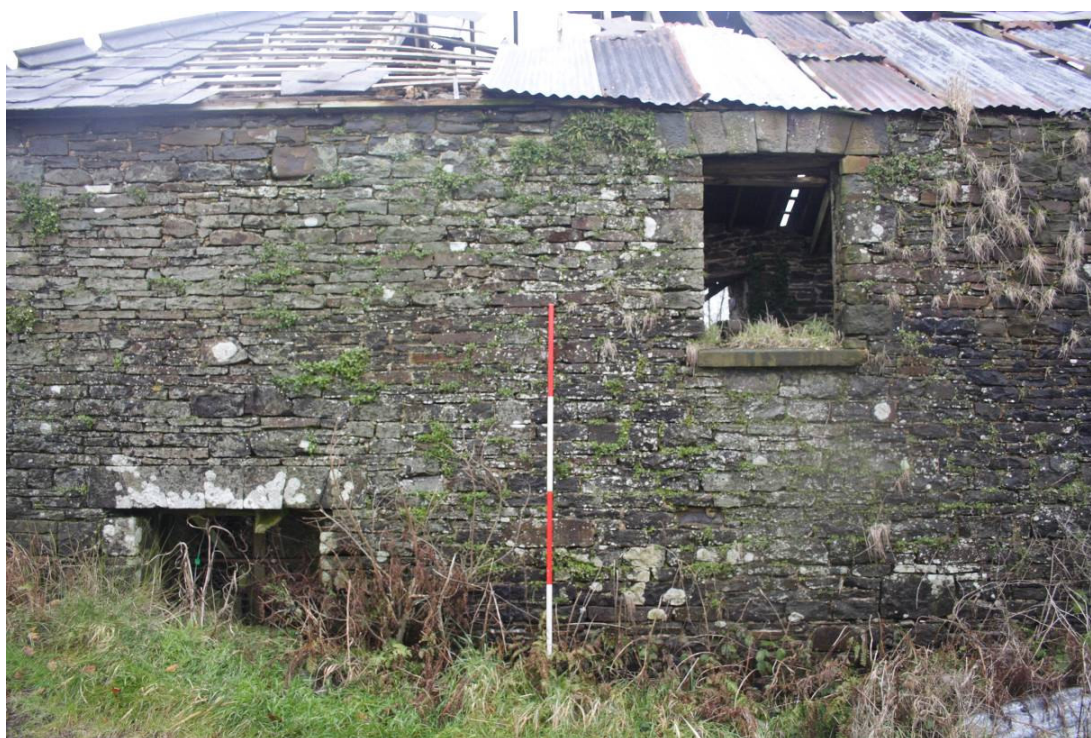
Photo 2: Windows piercing SE wall of Building 1

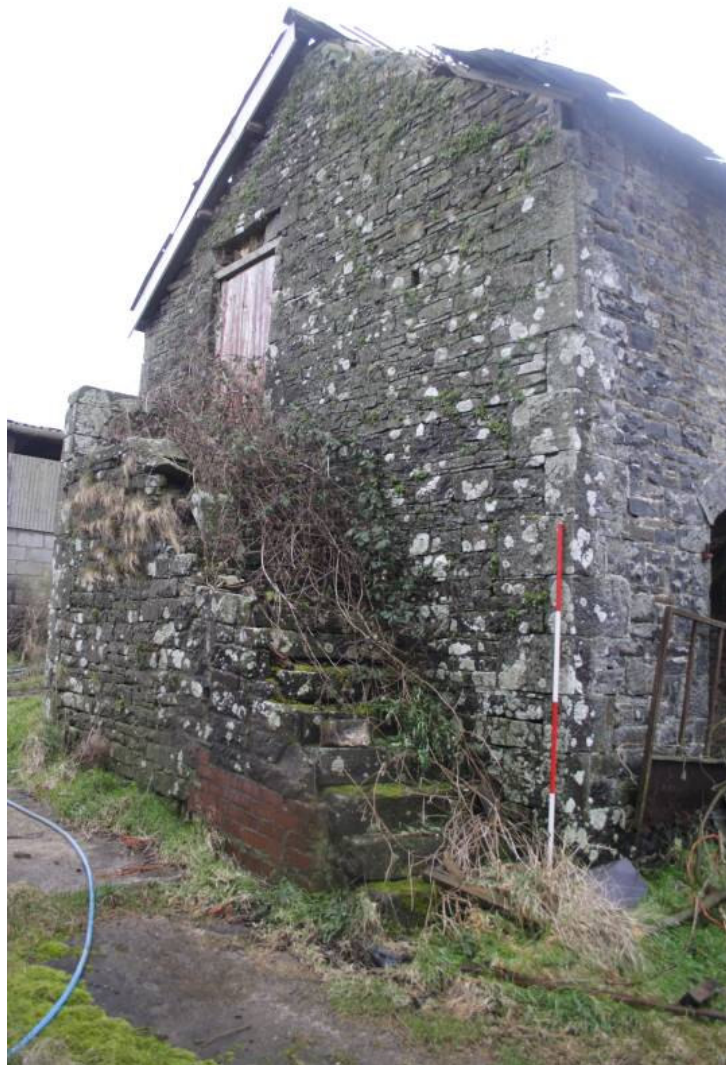
- 4.1.3 At first floor level a centrally placed single doorway with dressed stone surround and retaining a boarded timber door is present in the SE gable end of the building. A flight of external stone stairs provided access to the doorway and had been repaired with red brick.

Photo 3: Steps and doorway at SE gable end of Building 1

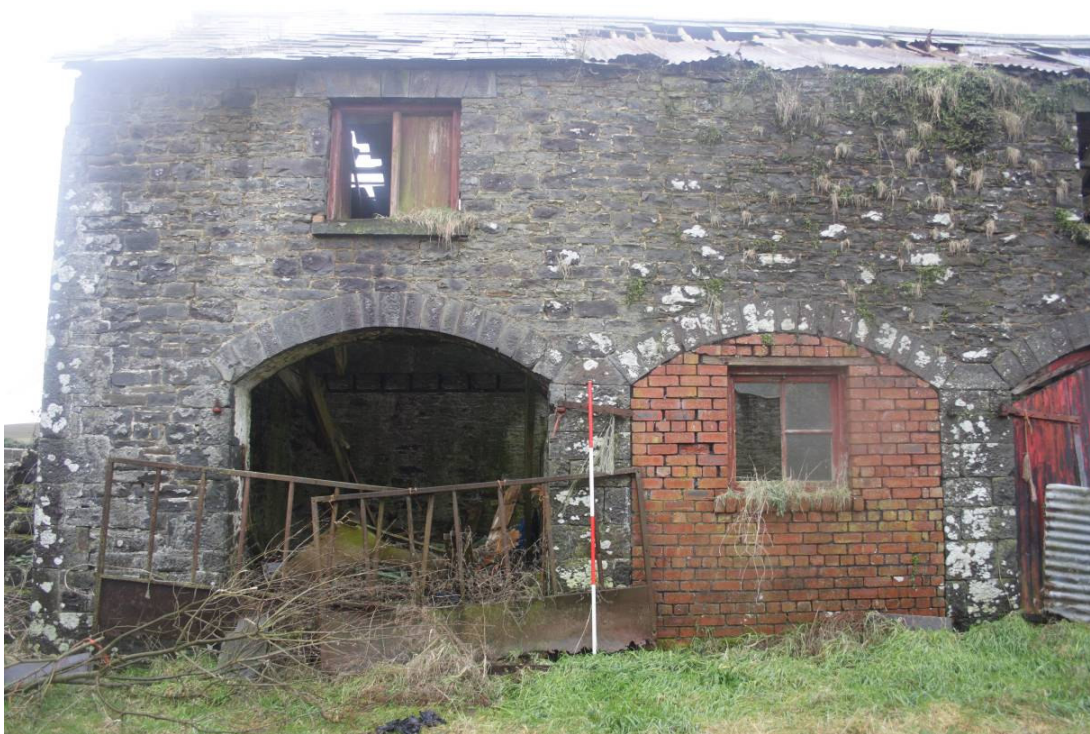
- 4.1.4 Five substantial dressed stone arched openings, each with wrought iron hinges set within the stone work, access the ground floor level of the NE wall of the building. Of the five openings, only the SE arch remains fully open, with the remaining four in-filled with red brick and concrete block and windows and doors inserted. At first floor level three square window openings are present each with dressed stone surrounds and sills. The example towards the SE of the building retained its original timber shutters.

Photo 4: Detail of arches and upper window within NE wall of Building 1

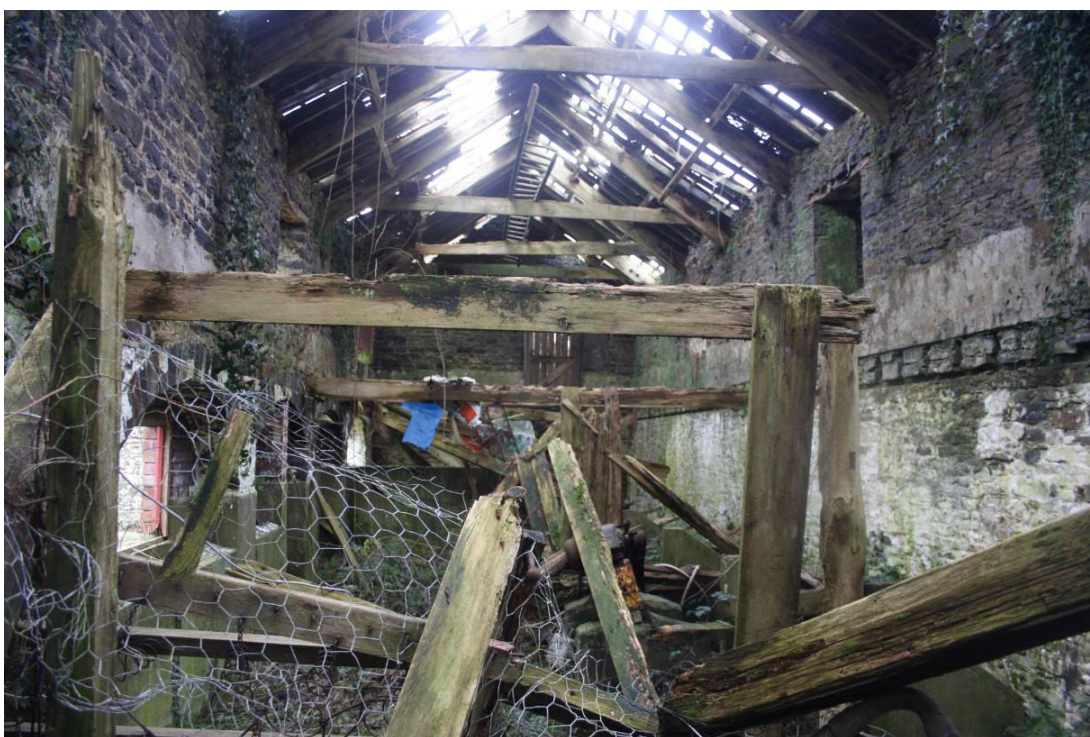
- 4.1.5 It was not possible to fully access the interior of Building 1 as it was full of debris and the roof was in a very poor state of repair, however, it was possible to view that the ground floor of the building was subdivided with timber framework some of which remained in situ. It was also possible to view the former floor line of the first floor level, evident as a series of small openings to accommodate former floor joists. No flooring remained in situ at first floor level in Building 1, although this allowed a view of the collar roof trusses, that are considered to be constructed of hand sawn timber.

Photo 5: Interior of Building 1 facing SE

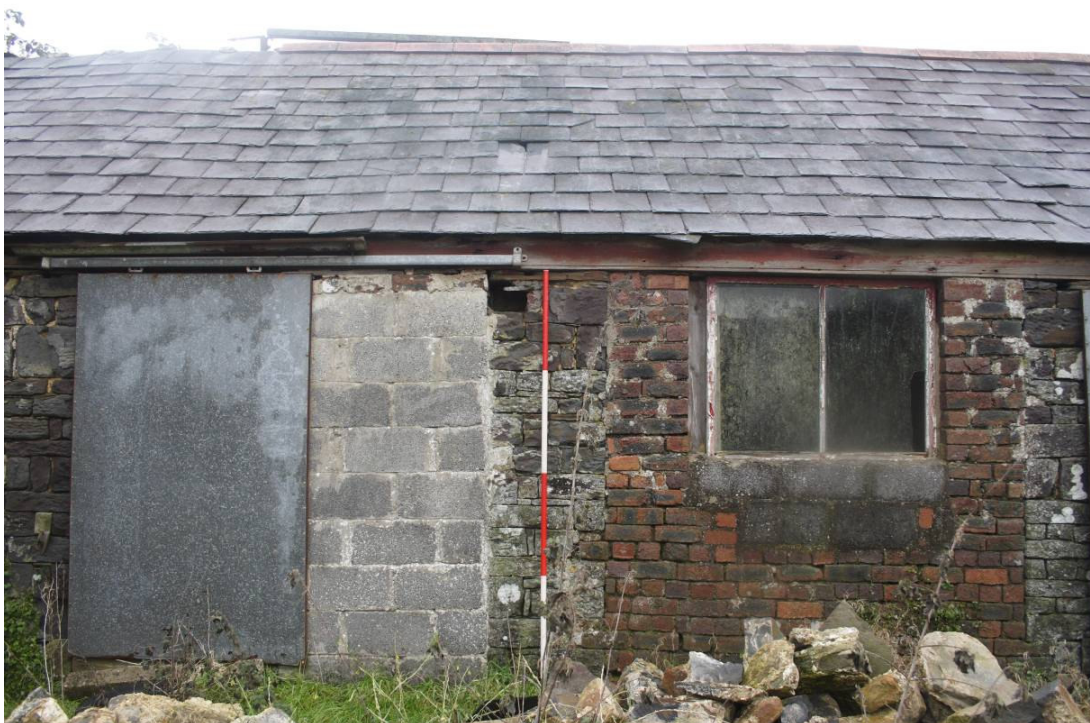
- 4.2.2 The SE wall of Building 2 was originally pierced by a series of five openings that extend to wall plate height. The openings have been partially blocked with red brick and concrete block, and run in an alternating door window arrangement. It is considered that the five openings were originally doorways providing access to the interior of the building. Towards the NE end was a further small window, with dressed stone surrounds and sill, along with a doorway with red brick head at the junction with Building 3. This doorway provided access into a small self contained room which retained a brick and concrete trough like structure in its NW corner with a hay feeder hanging on the wall to the side.

Photo 7: Detail of openings within SE wall of Building 2

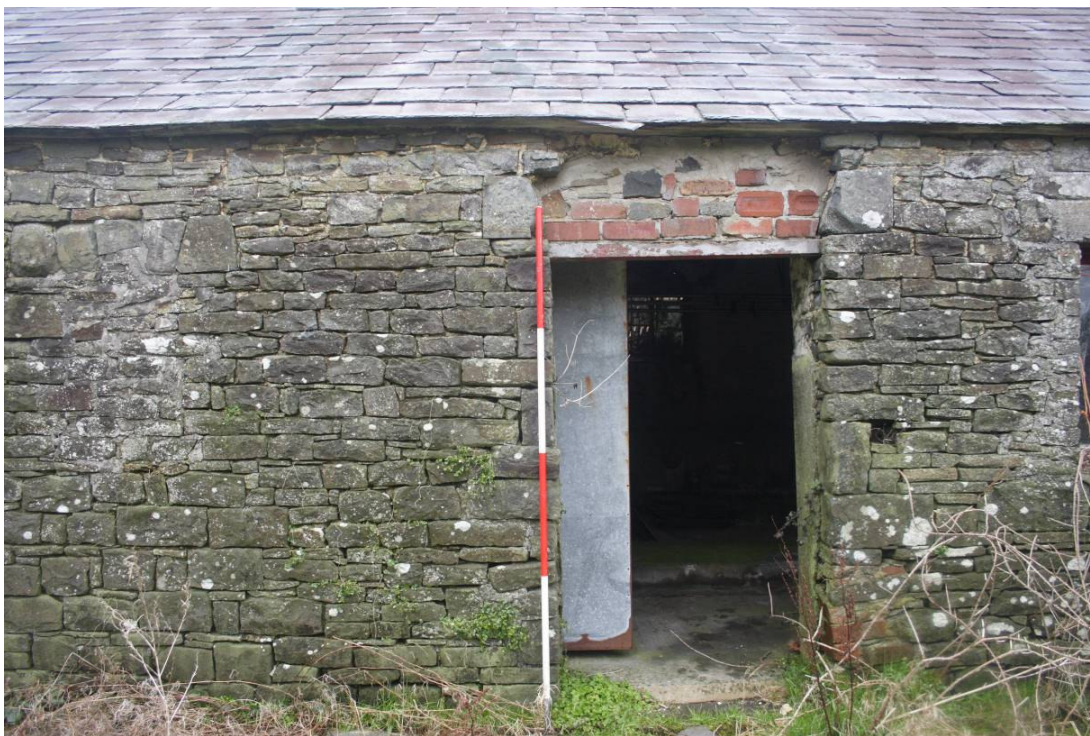
- 4.3.3 The SW wall of the building has a series of four doorways and three windows. Three of the doorways retain their dressed stone surrounds whilst the fourth, which is located towards the NW end of the building, has lost its dressed stone head, which has been replaced with red brick. A further doorway, now blocked with stone work, was visible in the central portion of the wall. The doorways are considered to be contemporary with the construction of the building, however, the windows are considered to be later insertions given the presence of concrete supporting lintels and red brick surrounds.

Photo 14: Detail of opening with brick replacement head, SW wall Building 3

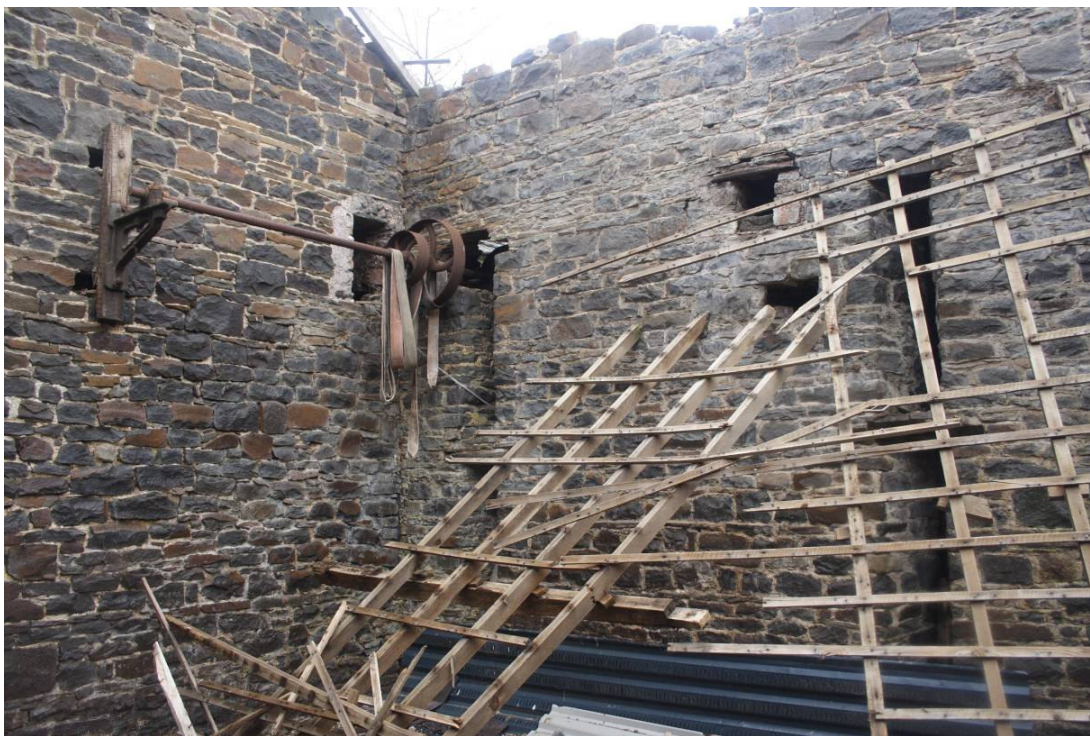
Photo 19: Remains of belt driven machinery within Building 4. Access opening connecting belts to possible wheelhouse visible behind drive wheels

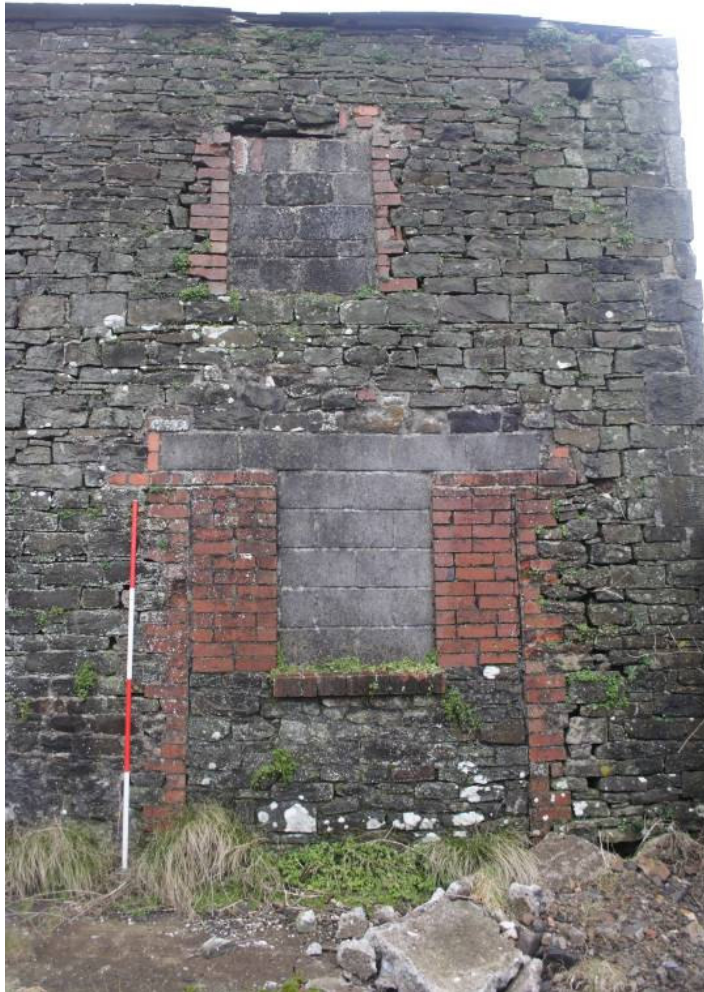
Photo 22: Blocked window and doorway,
SW wall Building 5

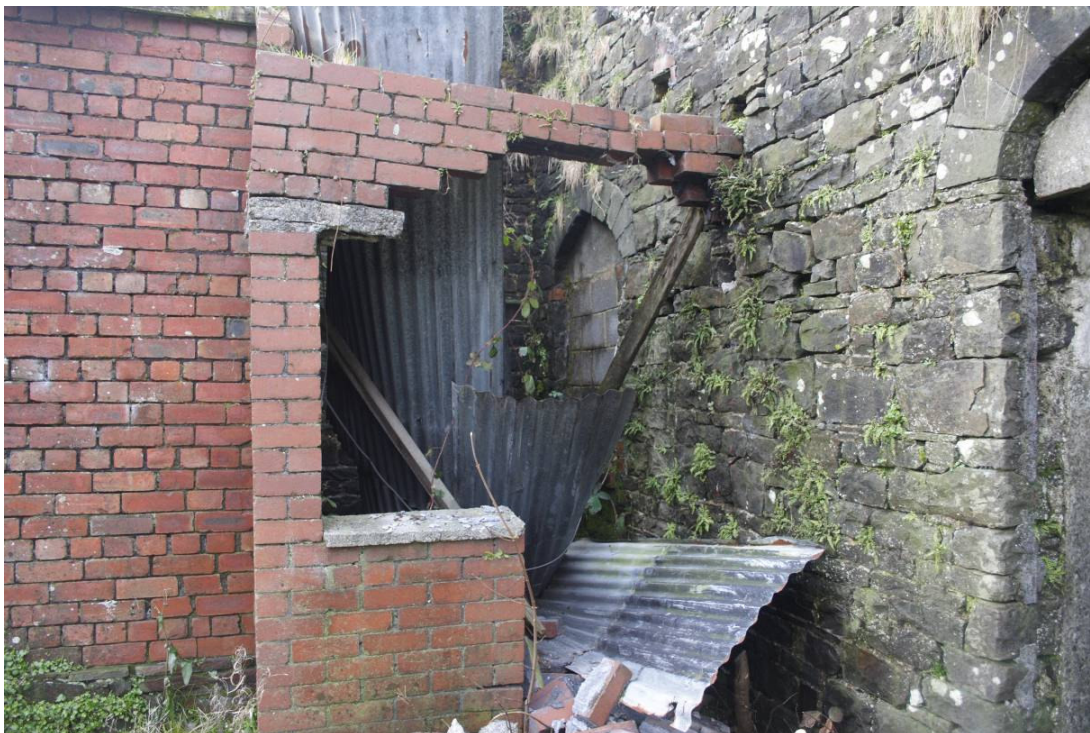
Photo 29: Partially destroyed opening at NE end Building 7

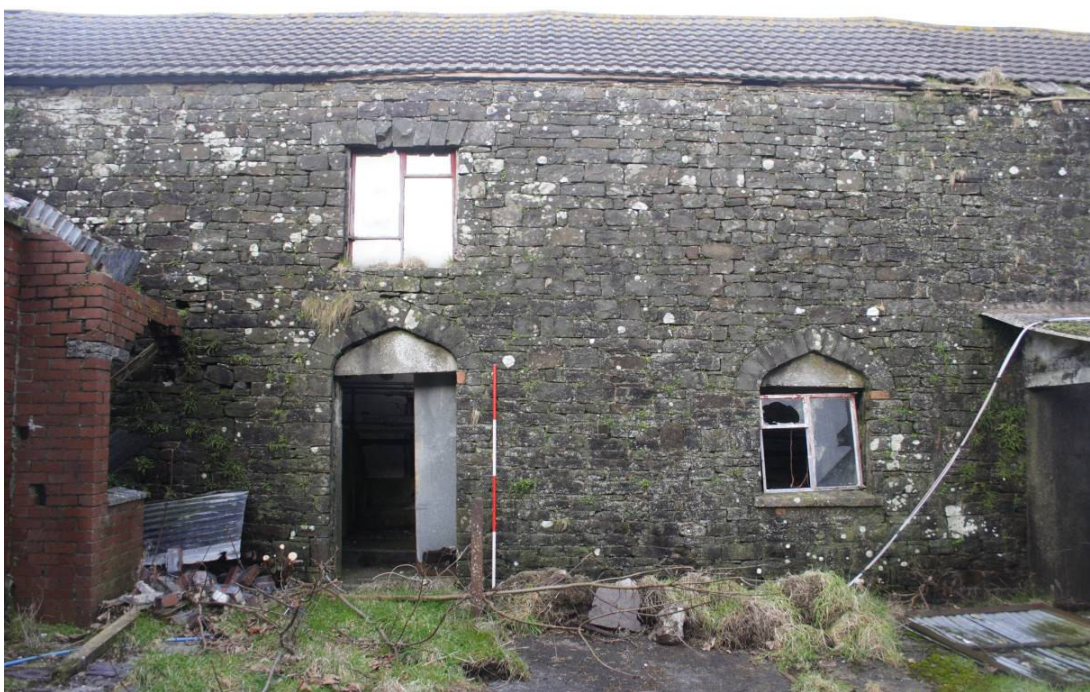
- 4.7.3 At first floor level the SW wall of Building 8 contains two dressed stone window openings, the northwestern window retaining its 'Tudor' style four centred arched head, whilst the other example has had its head replaced in red brick. The ground floor level of the wall has a series of five openings, each with a 'Tudor' style four centred, stone arched head and dressed stone surrounds. These openings run in an alternating window - door arrangement from NW – SE. The central window of the series, however, appears to occupy the position of a former doorway now partially blocked with stone. A relatively recent concrete block structure with corrugated asbestos sheet roof, housing stainless steel milk storage tanks, obscured a large section of the SE end of the wall.

Photo 36: Openings in SW wall of Building 8

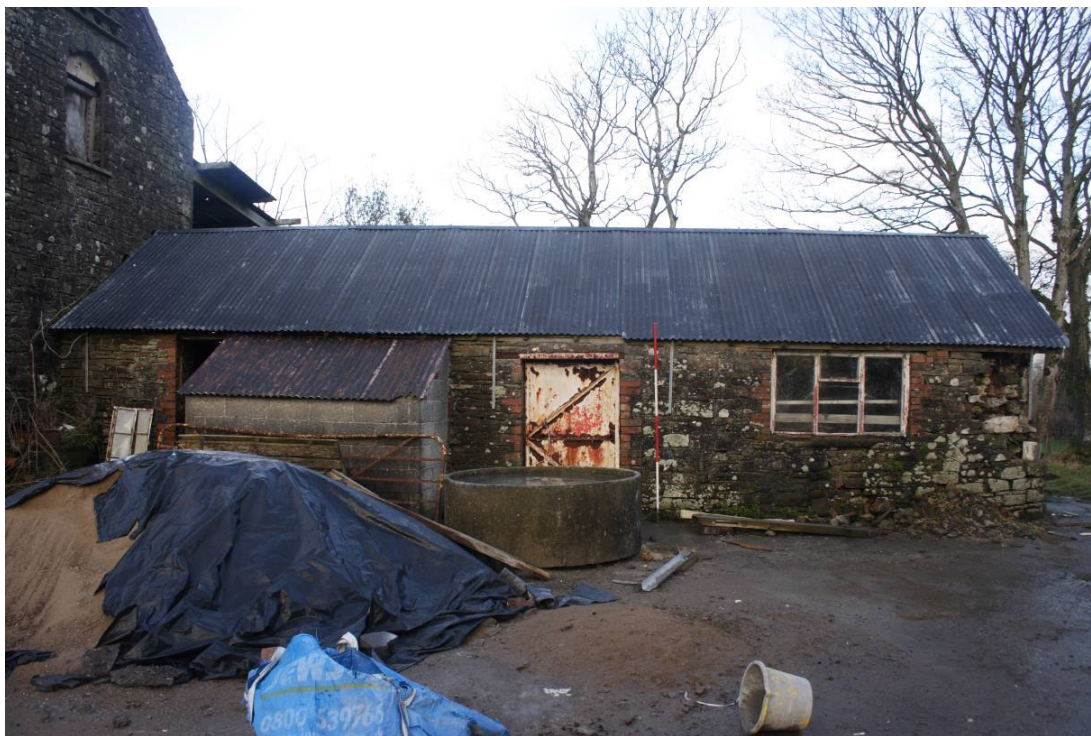
- 4.9.1 Building 9 is a stone built, single storied structure with corrugated iron roof and built on a NW – SE alignment. The SE gable end and NE wall were devoid of any architectural details or features, although there had been substantial damage to the NE corner of the building.

Photo 37: Overall view of Building 9 facing NE
