# COEDWEDDUS FARMHOUSE LLANGADOG CARMARTHENSHIRE

## HISTORIC BUILDING RECORDING

**DYFED ARCHAEOLOGICAL TRUST**  
**RHIF YR ADRODDIAD / REPORT NO. 2011/07**  
**RHIF Y PROSIECT / PROJECT RECORD NO. 100548**

**COEDWEDDUS FARMHOUSE, LLANGADOG,**  
**CARMARTHENSHIRE**  
**HISTORIC BUILDINGS RECORDING**

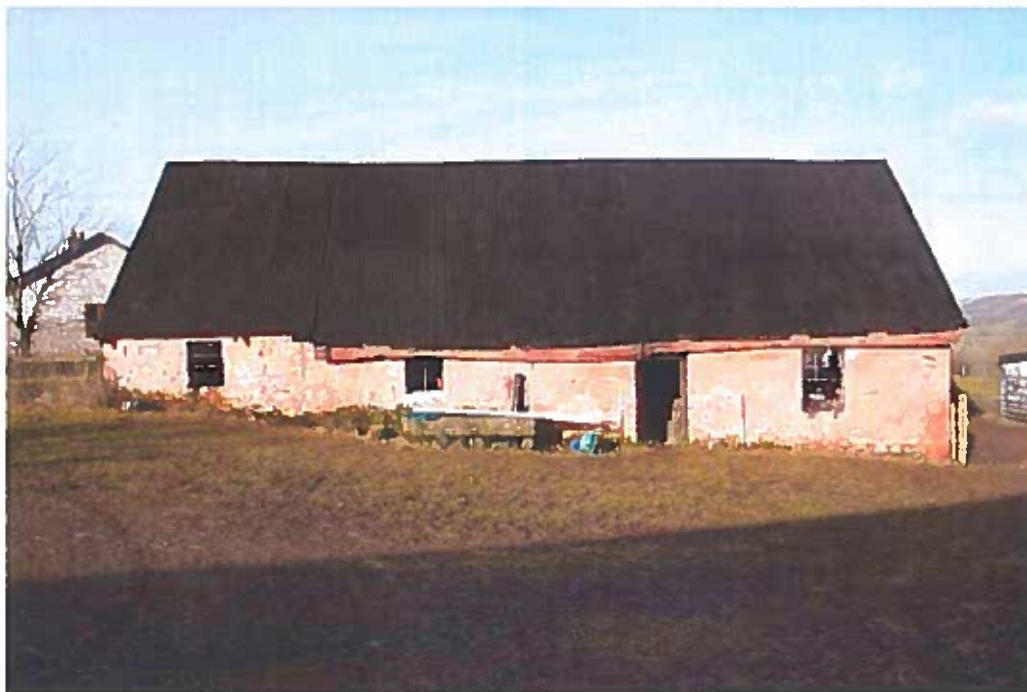
- 4.2.2 The SE front wall (photo 1) of the house contains three windows and a single doorway (photo 2). The simple boarded timber door has the initials H. W. carved as graffiti. The window openings in the SW end of the building appear to be contemporary with the original structure and retain their simple single barred timber window frames with timber supporting lintels (photo 3 & 4). There is no visible evidence that they are later insertions. A possible blocked doorway, visible as a pair of vertical straight joints in the masonry, was identified between the two SW windows (photo 4). The window at the NE end of the front wall contains a twelve pane sash window of probable 19<sup>th</sup> century date, with timber supporting lintel, and is contemporary with the construction of this part of the building (photo 5). Below this window are a series of five sawn off timbers within the wall fabric that may have once supported a small structure, the purpose of which is unclear (photo 5). At the SW end of the wall concrete blockwork has been added at roof plate height, presumably when the corrugated iron roof was added.

**Photo 1:** Overall view of SE elevation

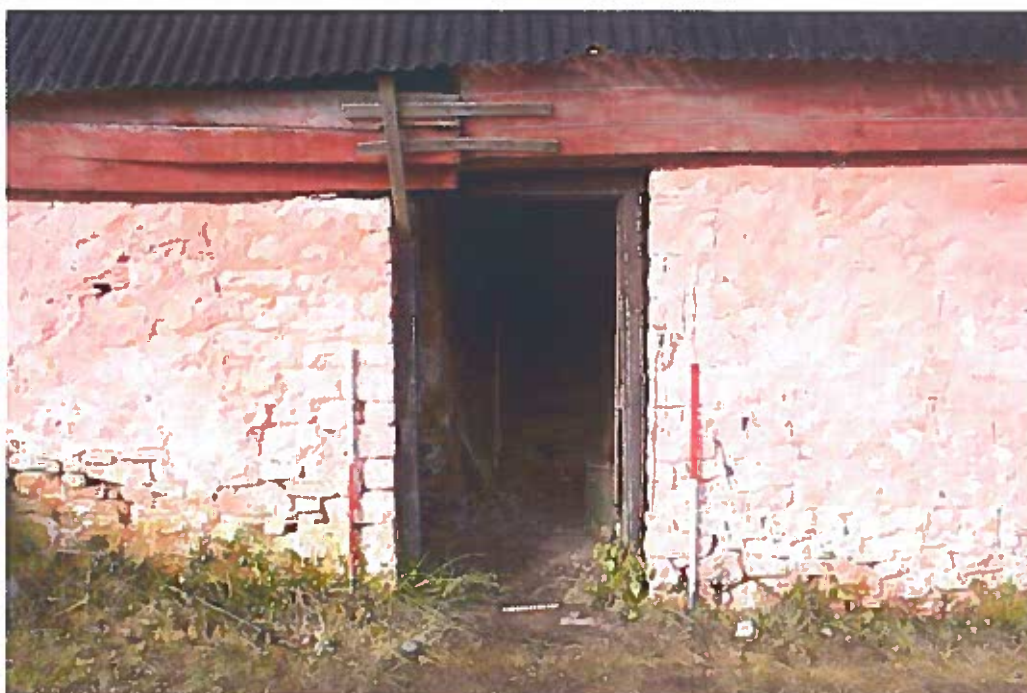
**Photo 2:** Detail of doorway in SE wall.

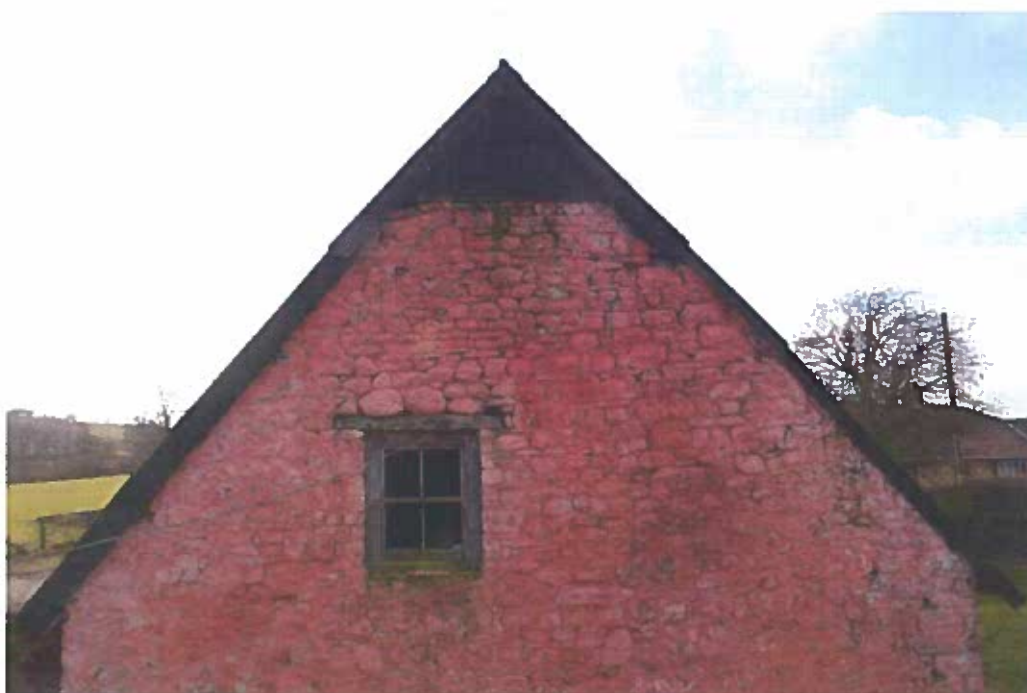
- 4.2.3 A first floor window opening is present within the NE gable end of the structure and retains a timber four paned sash window with timber supporting lintel and sill (photo 6). At ground floor level, a small rectangular, centrally placed opening of uncertain purpose is present, but may represent a drain (photo 7).

**Photo 6:** Window within upper NE gable end.

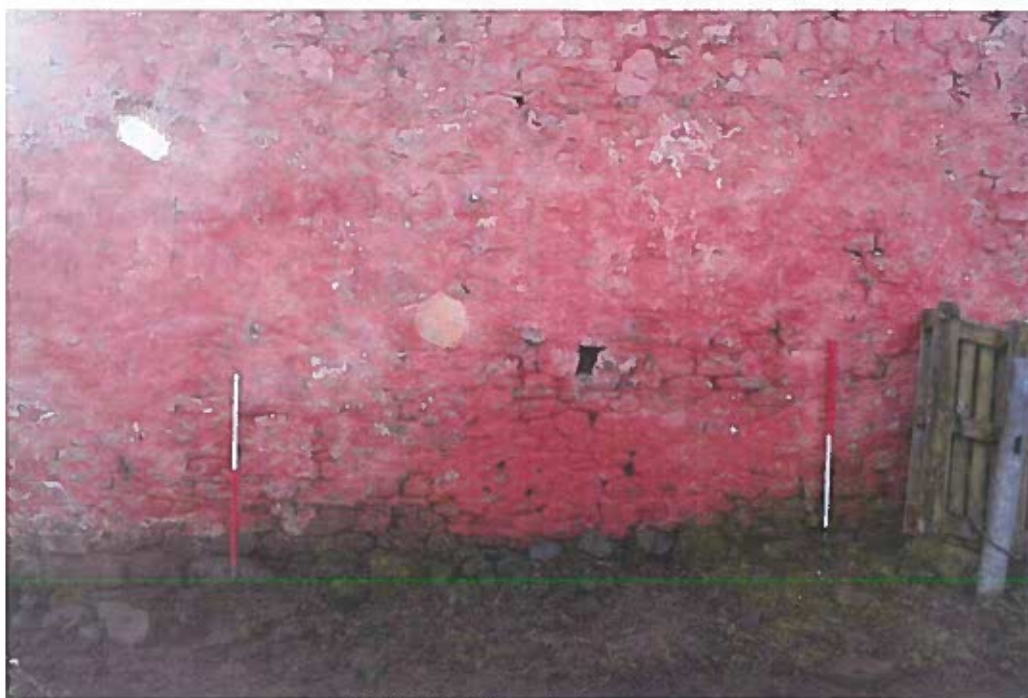
**Photo 7:** Possible former drain, NE gable end.

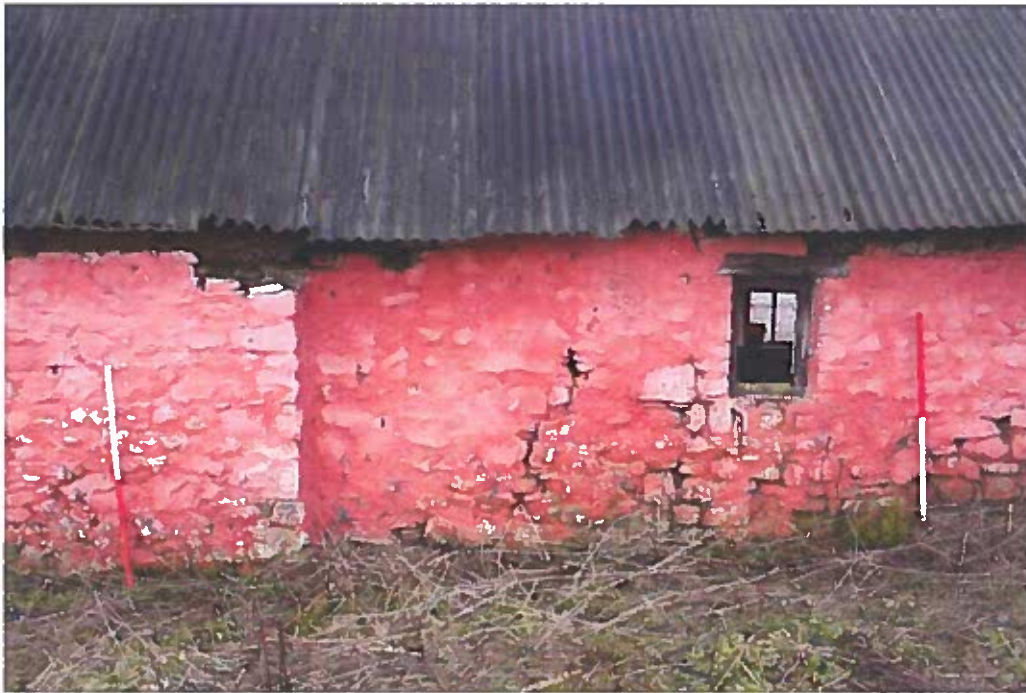
- 4.2.4 The NW (rear) wall of the structure contains a single small rectangular window with partial timber frame remaining in situ, with timber supporting lintel above (photo 8 & 9). This window is described as having mortice holes for an original diamond mullioned pane window by the RCAHMW.

- 4.2.5 Towards the SW end of this wall a possible change in wall thickness was visible as the wall steps inwards indicating a possible repair or rebuild (photo 9). Also in this area at wall plate height there is a change in the material used to bind the thatched roof to the wall top, from possible turf to earth. To the SW of this change in binding material, the end of a substantial timber beam was visible within the wall construction (photo 10). Towards the SW end of the wall two timber crucks protruded from the wall (photo 11 & 12). It has been suggested (RCAHMW) that the fact that the cruck frames are exposed on the exterior of the building may suggest that there was an earlier phase of the building in which the walls were clom built and the crucks would have been fully encased within the walls.

**Photo 9:** Detail of window and wall step, NW wall.

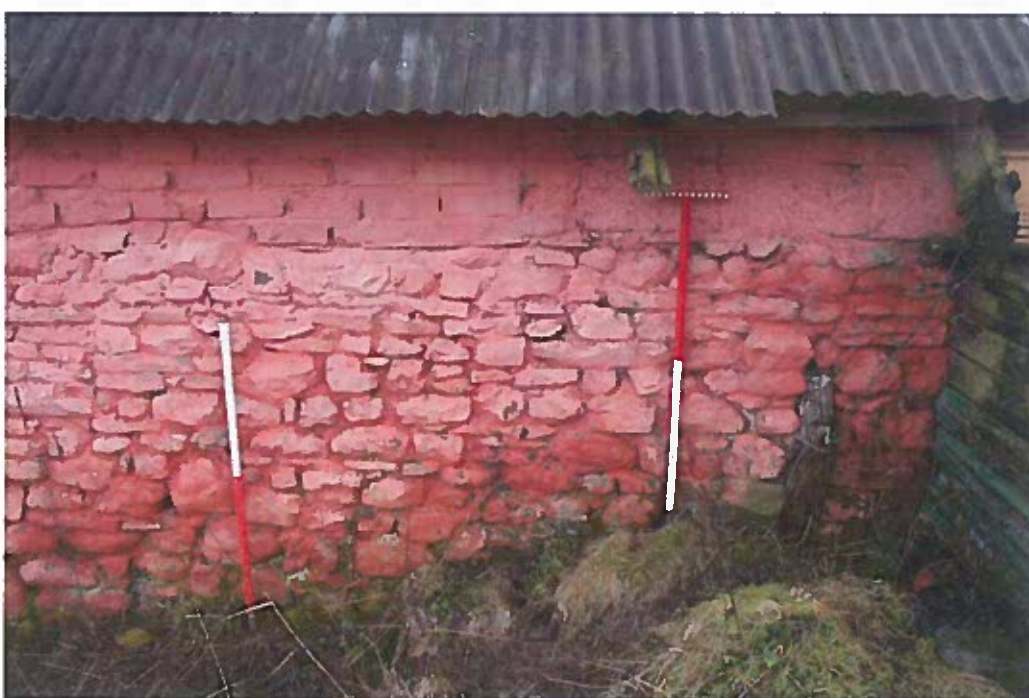
**Photo 12:** Protruding cruck, with inserted concrete blockwork above, NW wall.

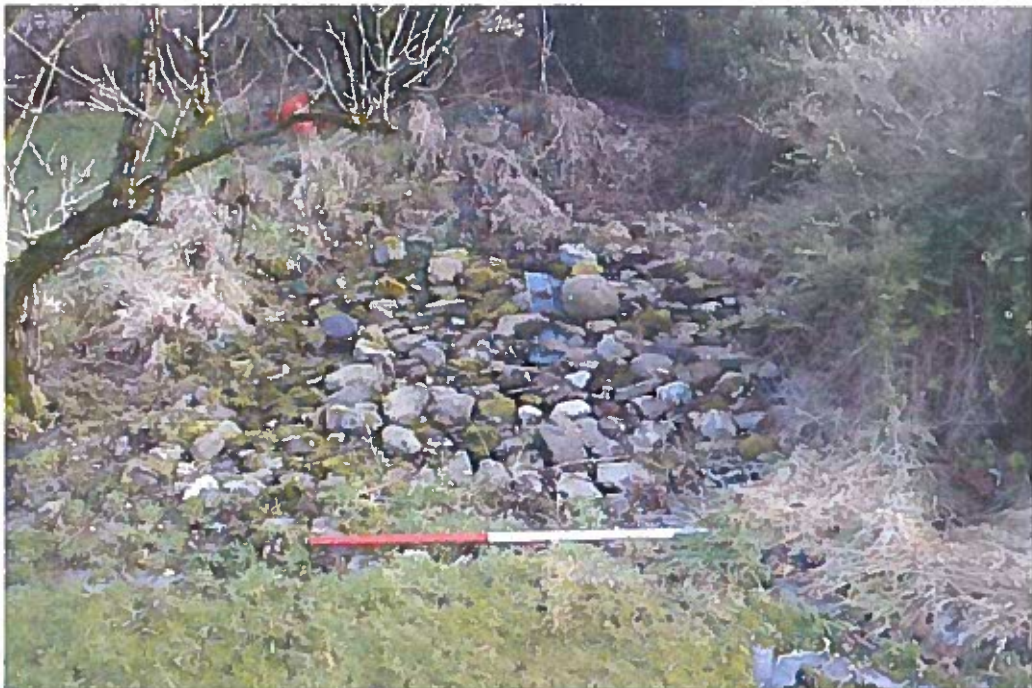
- 4.2.7 A short distance, c.10m, to the SW of the gable end, an area of stone was noted which on closer inspection was found to cover a series of large metal grills (photo 14). Beneath the grills was a c. 1m diameter vertical shaft that contained water at a level c. 2m below the present ground surface and it is unclear how far the shaft continues below the water-line. It is possible that this shaft may be a well that supplied water to the farm.

**Photo 14:** SW view of probable well.

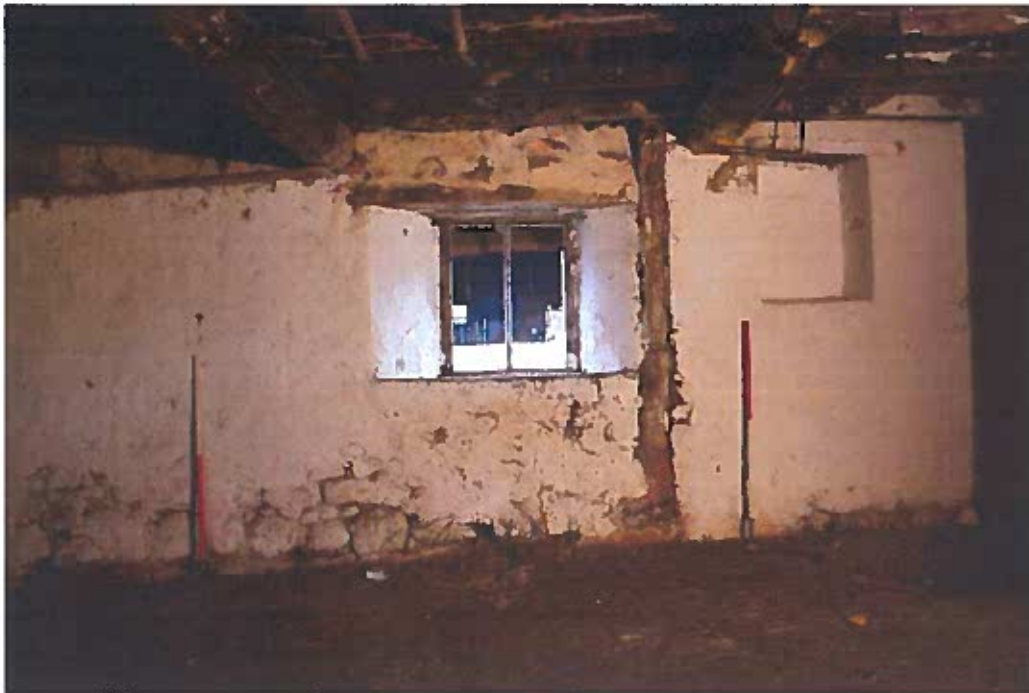
- 4.5.1 The SE wall contains a single splayed window (photo 17). To the side of the window a timber cruck is visible for the full height of the wall (photo 17). Towards the SW corner is a former recessed cupboard with a timber lintel (photo 17). The position of the cupboard corresponds with the possible evidence for a blocked doorway identified on the exterior, but lime wash obscured any evidence of a blocked doorway on the interior. Towards the NE end of the wall a timber shelf is set at ceiling height.

**Photo 17:** Window, cruck and cupboard within NW wall Room 2.

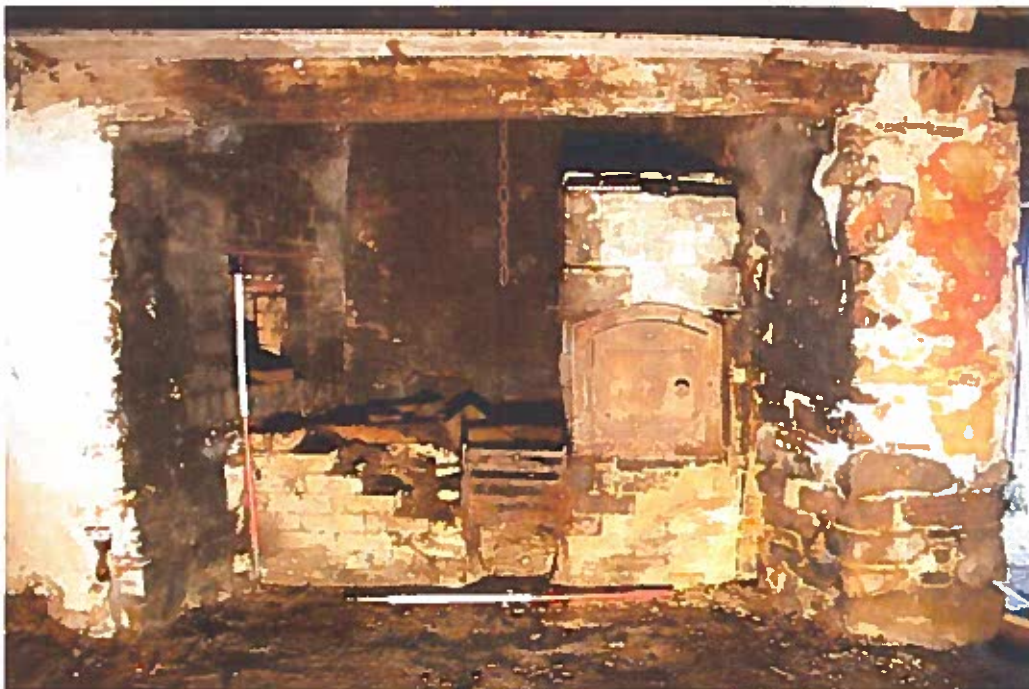
- 4.5.2 A substantial fireplace with chamfered timber bressemer forms almost the entire NE wall of the room, with doorway to the east (photo 18). The NE wall would have formed the original gable end of the cottage. Above this bressemer was a single timber shelf. The fireplace shows evidence of having been modified at various times. It contains brick infill with a cast iron grate and two ovens which probably date from the 19<sup>th</sup> century. The oven on the SE side of the fireplace bears the manufacturers, or more likely, the retailers name of 'Walter Lewis Ironmonger Llangadock' (photo 19). The oven on the NW of the fireplace is brick lined with a tiled floor, much of which had been destroyed. The substantial chimney stack contains a timber frame with a hand made chain that formerly supported cooking vessels above the fire. The interior of the fireplace was heavily smoke-blackened. On the SE side of the fireplace are portions of surviving painted plaster wall decoration consisting of a cross hatched design in red set on a yellow background (photo 18 & 19).

**Photo 18:** Overall view of fireplace surviving wall decoration to right.

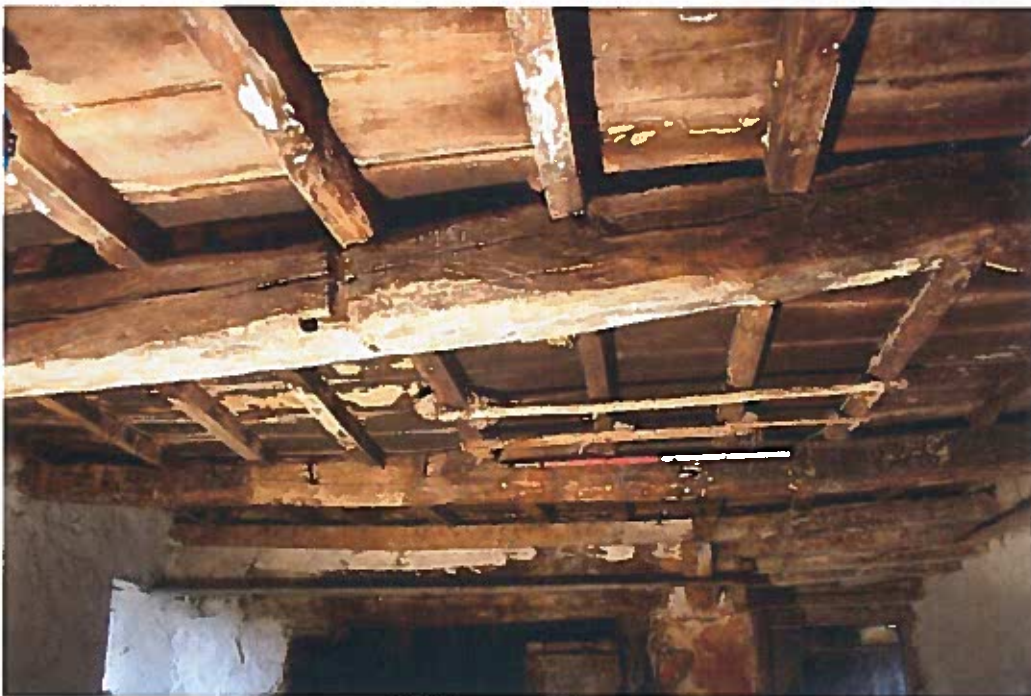
- 4.5.4 The ceiling of Room 2 was supported on two substantial rough timber beams set into the NW and SW walls of the building (photo 20). The beam at the NW side of the room was connected to the cruck by timber pegging. This beam also has soffit peg holes and two further rectangular recesses cut into it suggesting that the room was once partitioned. The floor of the room was made of pitched stone cobbles set into earth (photo 21). No evidence for any former stairway that may have provided access to the attic before the later modifications to the building were apparent within Room 2.

**Photo 20:** Ceiling timbers Room 2.

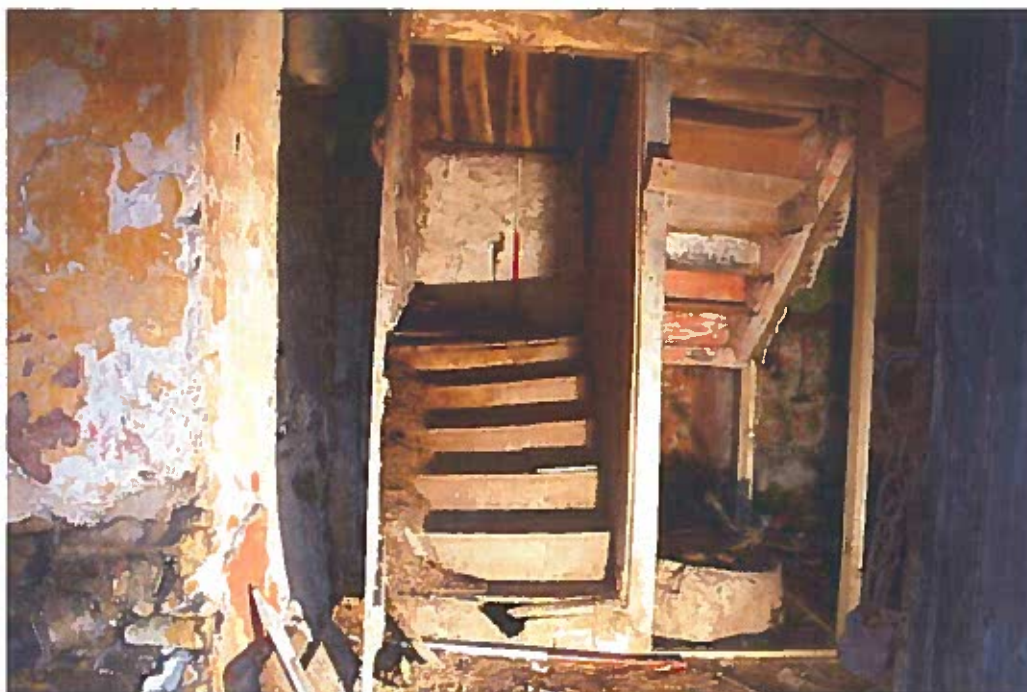
4.6.1 Room 3 is located within a later addition to the building and contains a timber staircase providing access to the upper floor (photo 22). The wall adjacent to the main entrance to the house was curved. The NE wall was of wattle construction and rendered with lime plaster but this had been partially removed towards the NW and replaced with modern timber (photo 26). The NE wall also contained a doorway but this had been partially destroyed by the insertion of the modern timber work. A battened timber doorway provides access to the staircase (photo 23). On the NE side of the staircase doorway was the location of a further doorway, which provided access to the area beneath the stairs, although the door is no longer present (photo 23). The staircase door had a notch cut into the top that corresponded with a timber peg hanging from one of the ceiling joists (photo 24). When the door was opened the timber peg would enter the notch and would hold the door open. It was also noted that the rear of the door had been covered in old newspapers and advertisements of late 19<sup>th</sup> and early 20<sup>th</sup> century date (photo 25).

**Photo 22:** Dog leg stair, Room 3.

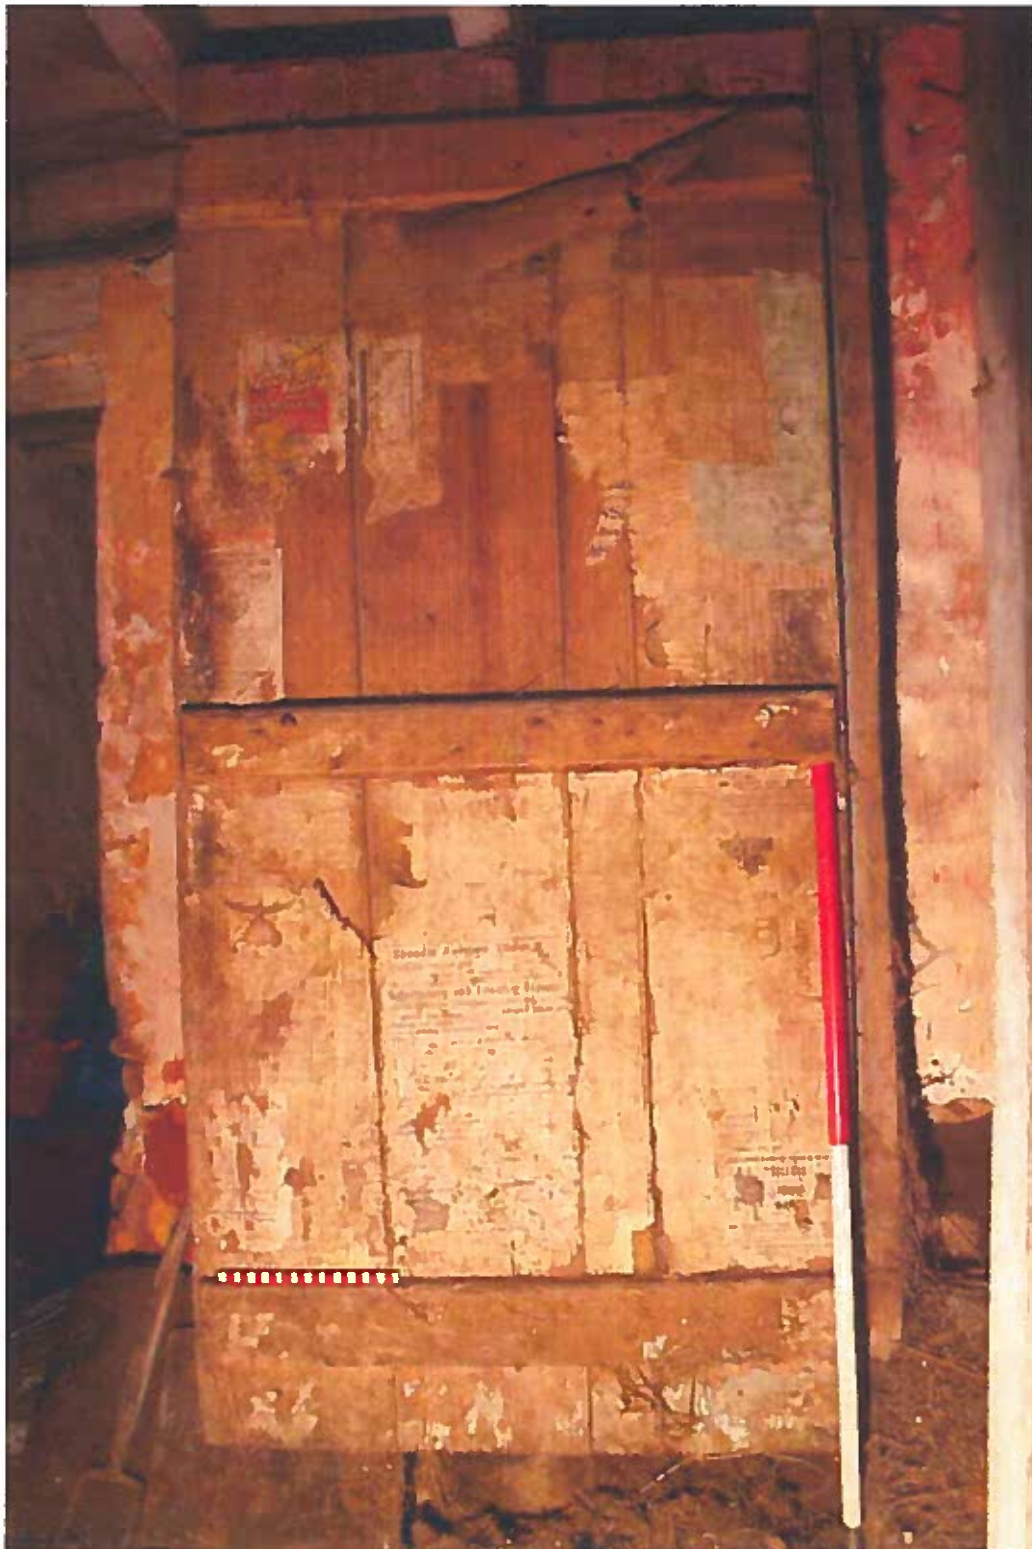
**Photo 25:** Rear of staircase door showing newspaper covering.

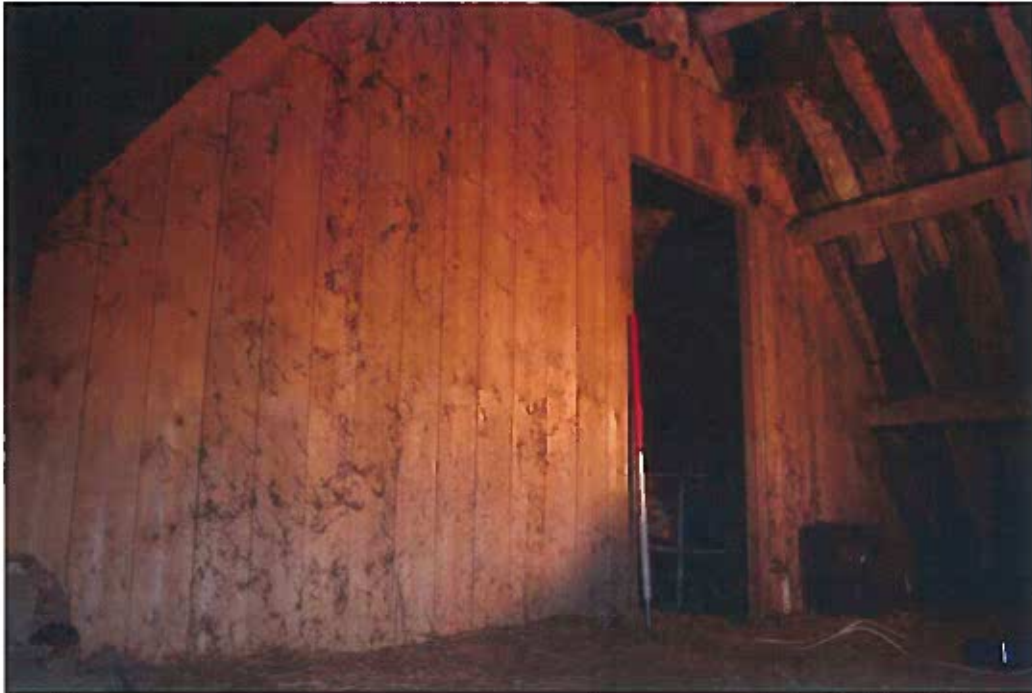
- 4.9.1 Room 6 is a cabin-like roofed structure built within the roof-space, and constructed of pine timber tongue and groove panels fixed to a timber framework supported by the roof truss (photos 34 & 35). The roof truss had been covered with newspaper and other printed matter including part of a sale catalogue map showing the lands of Neuadd Fawr. In addition it was possible to view scorch marks on the interior face of the timber partition wall between Room 5 and 6 which are may have been caused by candles.
- 4.9.2 A single window with four paned sash window frame is located in the gable end wall (photo 35). Further details of the roof construction and surviving thatch are obscured by the tongue and groove cladding.

**Photo 34:** Timber partition wall of Room 6 from staircase.

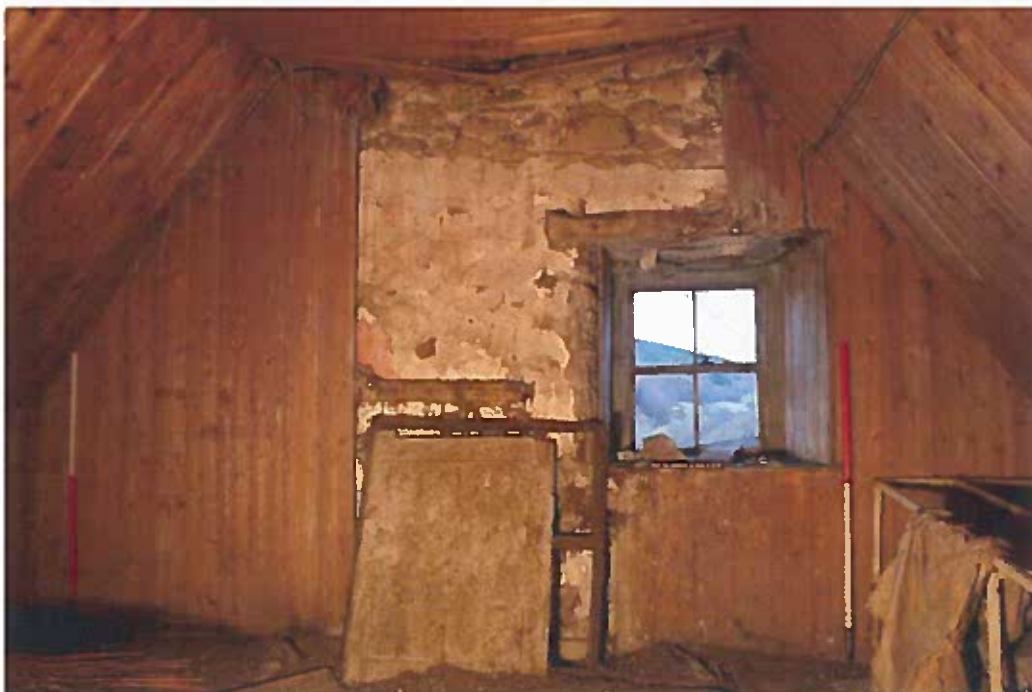
**Photo 35:** Interior of Room 6 showing sash window.
