## BLAEN MYHERIN FARM, NORTH CEREDIGION (SN 5340 0595)

### HISTORIC BUILDING RECORDING

RHIF YR ADRODDIAD / REPORT NO. 2011/11
RHIF Y PROSIECT / PROJECT RECORD NO. 100554
Mawrth 2011
March 2011

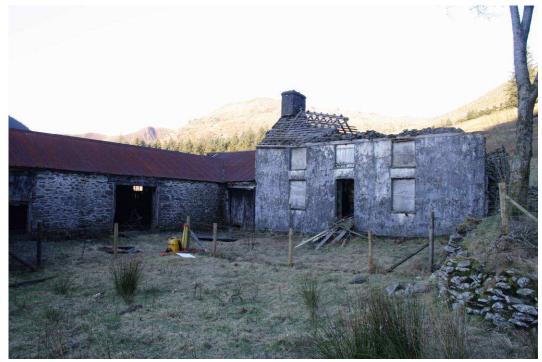
Photo 1: Blaen Myherin Farm

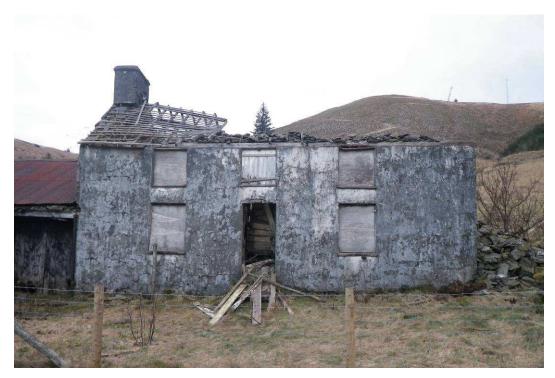
- 4.1.2 The SW wall of the house contained a series of five boarded up windows, each with stone sills and a single door (Photo 2; Figure 4). These were arranged with three square windows at first floor level with two rectangular windows flanking the doorway at ground floor level. It is considered that the window openings would have housed timber sash frames, but these no longer survive. A small white ceramic fixing with metal core was noted set into the wall on the right hand side of the SE ground floor level window. This fixing may indicate the position of the entry point for an electricity or telephone cable to the house.

- 4.1.3 Concrete render covered the SW wall obscuring any evidence for modifications or alterations within the wall fabric. A timber wall plate was visible running along the top of the wall forming the tops of the upper floor windows. A series of steps, now partially buried in debris provided access to the central doorway.

Photo 2: Blaen Myherin Farmhouse, main SW elevation

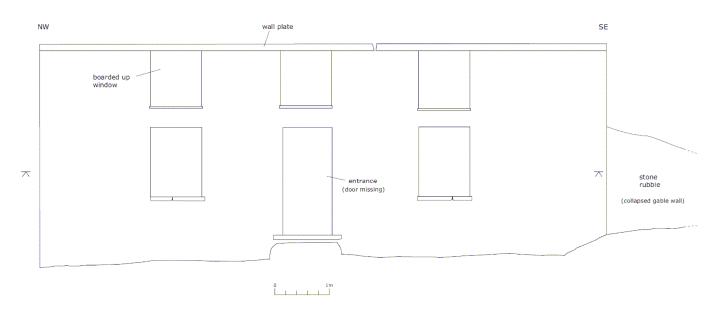
Figure 4: SW elevation of Blaen Myherin Farmhouse

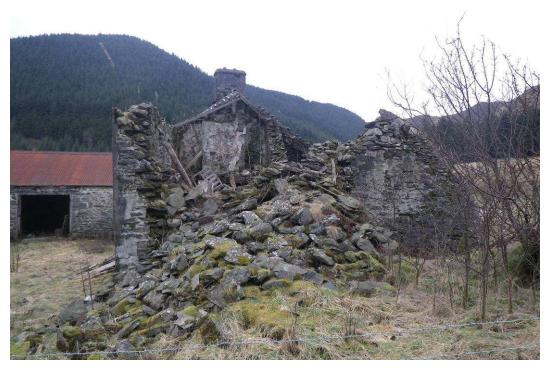
- 4.1.4 The SE wall of the house had almost entirely collapsed, although at its NE end a small part survived to full height (Photo 3). No architectural detailing was visible within the wall.

Photo 3: Collapsed SE elevation of farmhouse

- 5.11 ideally a scheme of consolidation of the remains of Blaen Myherin farm should be undertaken. The poor state of preservation of the main farmhouse is such that the remaining roof structure could not be saved. It would be possible to stabilize the walls by cement capping of the wall tops to prevent further water ingress and leaching of lime mortar. Repointing of the walls should also be undertaken.

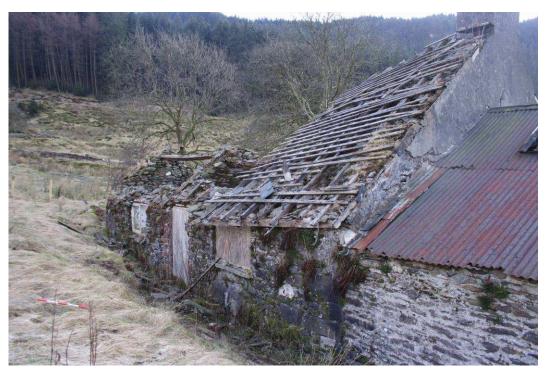
Photo 4: NE elevation of Blaen Myherin farm

- 4.1.5 The NE elevation of the building was of single storey height, comprising a central doorway and two flanking rectangular windows (Photo 4). It is possible that this side of the building had a single storey extension added at some point with a cat slide roof present at the NW end of the building continuing the roof line down to the upper part of the new wall at the same pitch. Inside the building a stone wall was visible which may have been the original exterior NE wall of the farm (Photo 5). At the SE end of the farmhouse on this elevation, the area of the extension would seem to have been built with a separate pitched roof as evidenced by a surviving ridge beam and partial gable wall (Photo 6)

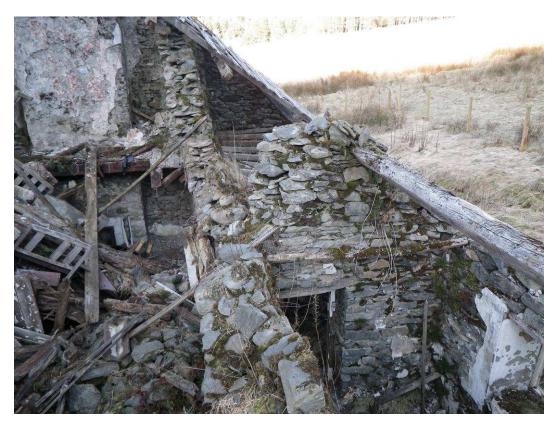
Photo 5: Interior view of Blaen Myherin farmhouse showing line of interior stone wall

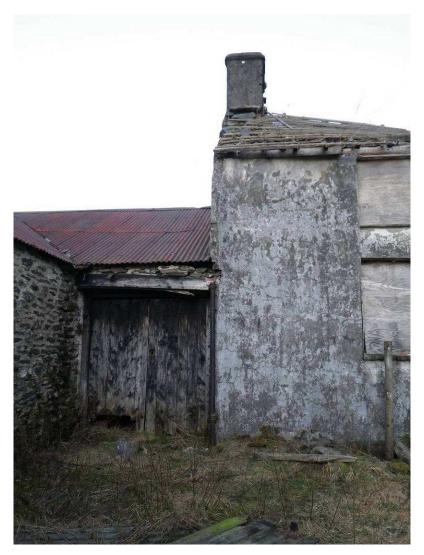
Photo 7: Doorway into barn extension on NW facade, with the main farmhouse to the right, clearly showing the difference in wall heights

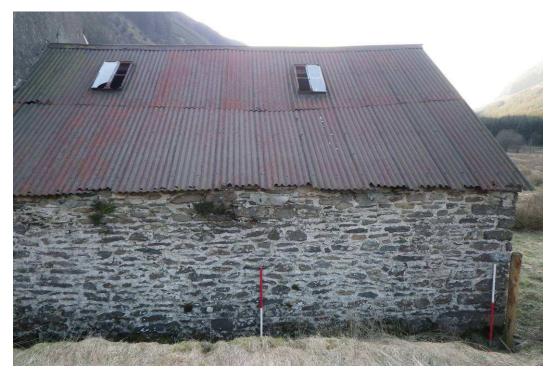
Photo 8: NE facade of barn structure

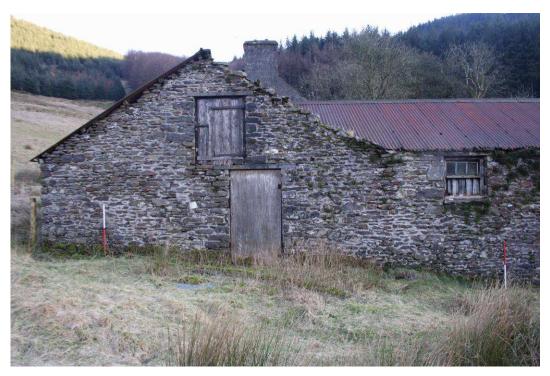
Photo 9: NW facade of barn structure

- 4.2.3 The NW facade of the building comprised the exposed gable end of the structure, with two openings, a doorway at ground level and an upper hay-loft door (Photo 9). It was noted that the upper hay loft door had remnants of a purple paint around the doorframe, something noted on all other internal timber work surrounding windows and doors, other than the doorway at ground floor level below (Photo 10). It is likely that the purple paintwork may have been a colour used for various estate buildings in the area. The lack of paint on the lower doorway suggests it may be later insertion into the wall. No remains of an upper floor survived within the structure. Both doorways were timber framed with wooden lintels. The door survived in the hayloft, but the lower doorway was boarded up.

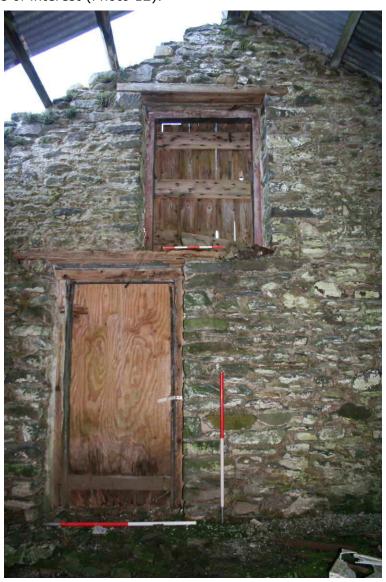
Photo 10: Internal view of doorways on NW wall of barn structure

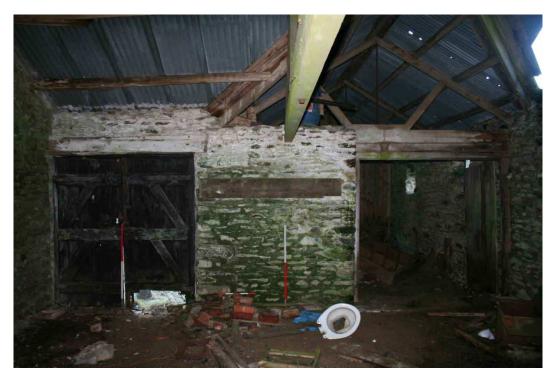
- 4.2.4 Little other internal detail was present within the barn, except the entrance to the yard and animal shed to the SW (Photo 11), both with timber door frames and intact doors. The wall between the barn and the farmhouse showed no features of interest (Photo 12).

Photo 11: Internal view of doorway to yard (left) and access into the animal shed to the SW (right)

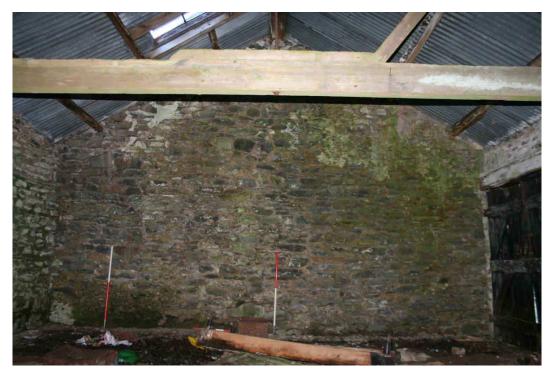
Photo 12: Internal view of wall between barn and adjacent farmhouse

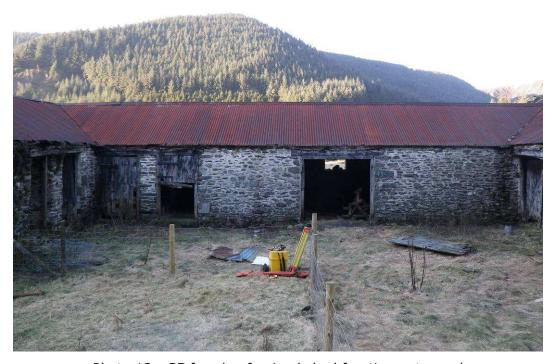
Photo 13: SE facade of animal shed fronting onto yard

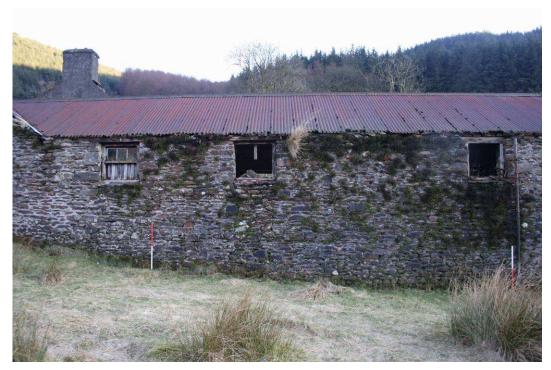
4.3.3 The NW facade had three small window openings with timber framed surrounds and wooden lintels (Photos 14 & 15). The windows may have been larger, as indicated by straight joints in the masonry projecting below the existing base of the frames. Only one window survived intact, that to the north, with a three pane glazed upper half and louvered lower half, presumably providing ventilation for animal housing (Photo 16). The middle window retained a central timber mullion for the glazed upper half (implying it had two panes), but the southern window was completely missing.

Photo 14: NW facade of animal sheds showing windows and raised level of structure

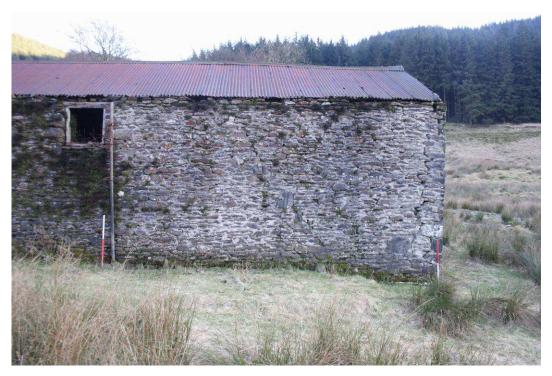
Photo 15: SW end of Animal shed

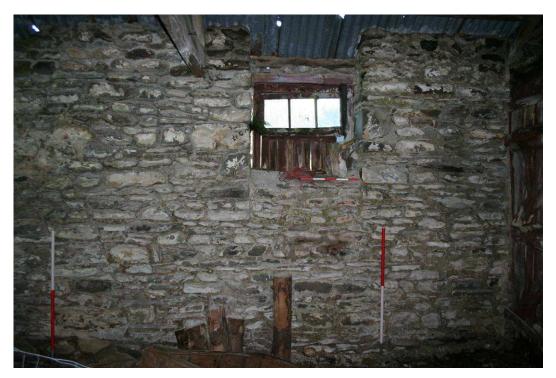
Photo 16: Internal view of surviving louvered window, and showing partially blocked opening below

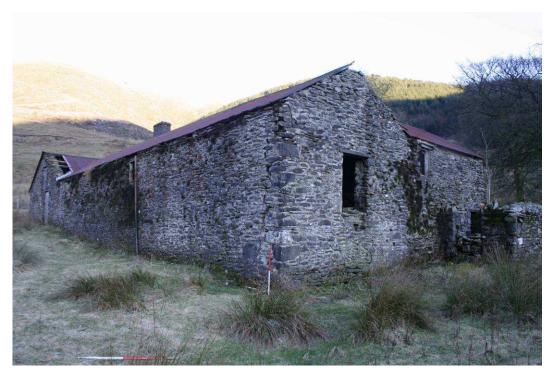
Photo 17: SW corner of animal shed, showing gable end wall

- 4.3.4 The SW elevation of the animal shed had a single doorway opening, with a drop from the threshold of the door of 1.82m down to the exterior ground surface (Photo 17). The doorway had a partial timber frame surviving, but no door. It was clear that the structure had been built on quite undulating ground, with a significant drop on the western side, although the interior floors were level with the yard to the east, indicating that they had been raised. The exterior walls of the structure were far taller at the southern end also indicating this change in ground level. No evidence was visible for the material used in the levelling.

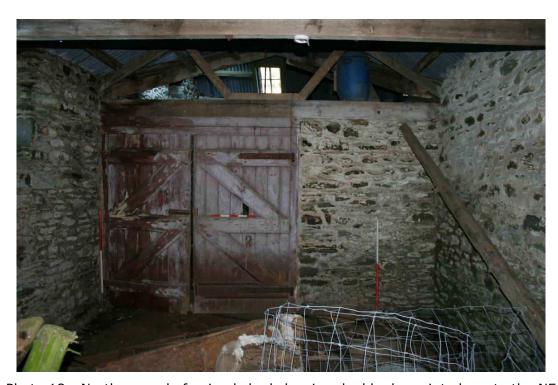
Photo 18: Northern end of animal shed showing double doors into barn to the NE

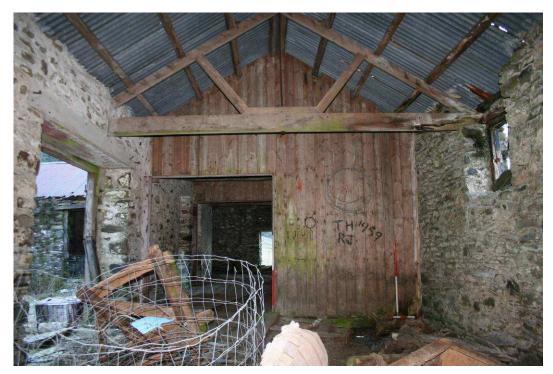
- 4.3.6 A timber partition wall separated the northern part of the animal shed from that to the south (Photo 19). The partition wall was built over and below one of the timber roof trusses which formed the roof structure of the shed. Graffiti on this wall dated from the latter half of the  $20^{th}$  century (such as that dated 1959 on Photo 17).
- 4.3.7 A second timber partition wall divided an area in roughly the central part of the building, again rising to roof. An animal pen was formed between the two by a further low partition wall (Photos 20 & 21) which had graffiti upon it dating from 1901 (Photo 22). The third window provided light for this animal pen.

Photo 19: Timber partition wall in middle of animal shed, showing exposed roof truss

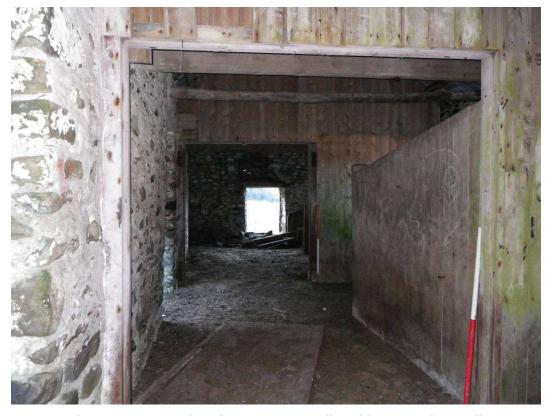
Photo 20: Second timber partition wall and lower timber wall forming an animal pen in the central part of the animal shed

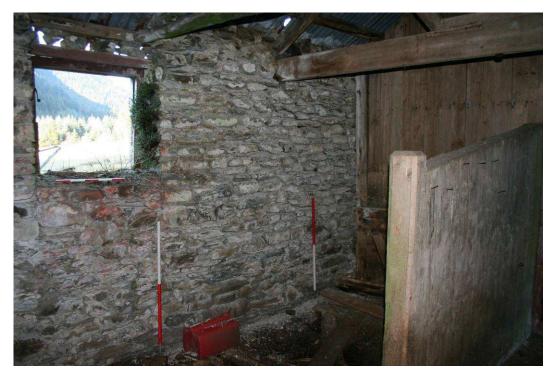
Photo 21: Inside of animal pen showing window and partition walls

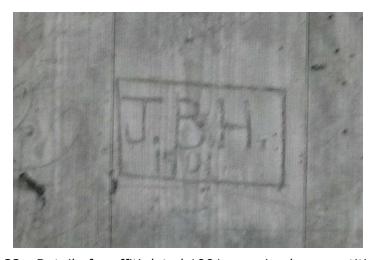
Photo 22: Detail of graffiti dated 1901 on animal pen partition wall

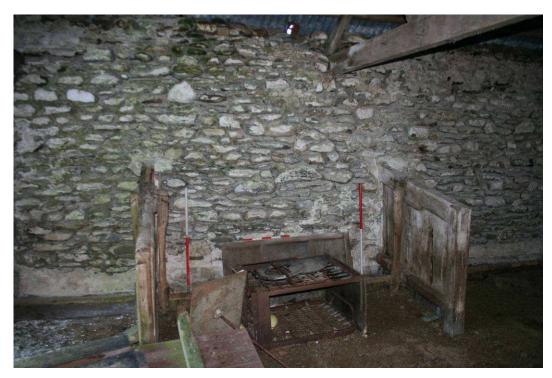
Photo 23: Animal stalls in southern part of building

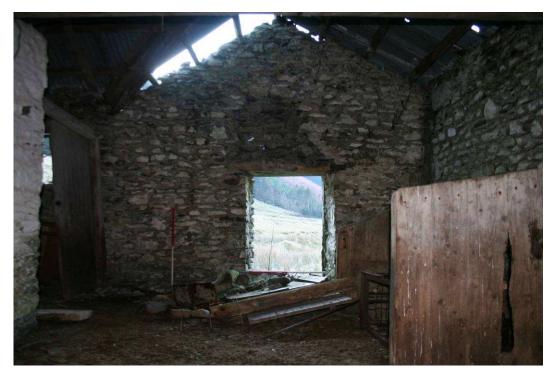
Photo 24: SW end of animal shed showing doorway and animal stalls

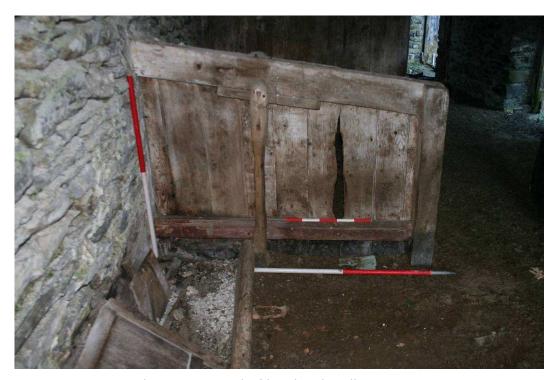
4.3.8 The southern part of the animal shed housed three animal stalls divided by two low level timber partitions between the SW end stone wall and the full height timber partition wall (Photos 23 & 24). The stalls retained tethering posts on either side of the stalls and a feeding trough along the NW wall (Photo 25).

Photo 25: Detail of low level stall partition, tethering post and remains of timber trough

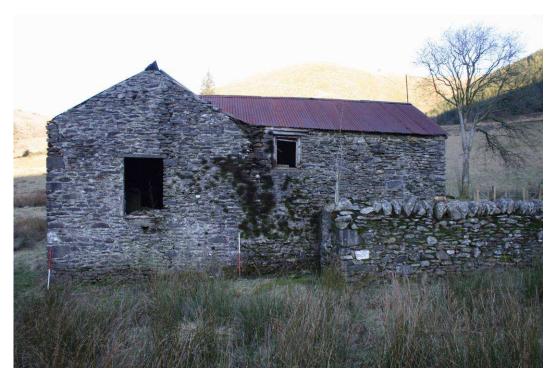
- 4.3.1 Attached to the SE of the gable end wall of the animal shed was a further small structure. This was almost square in size, with a roof ridge line aligned NW to SE, and thus perpendicular to that of the animal shed. This building was also roofed with timber trusses and corrugated metal sheet roof (Photo 26).

Photo 26: SW elevation of stores and pigsty building

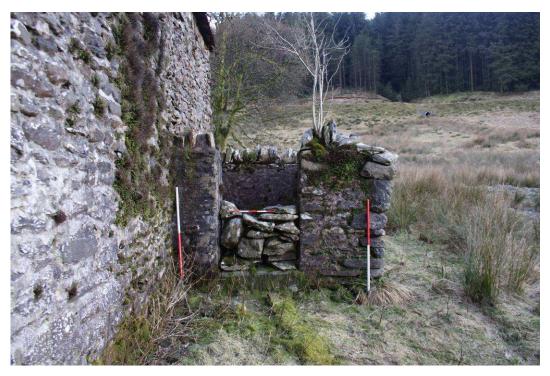
Photo 27: Entrance to walled pen for pigsty on SW side of building

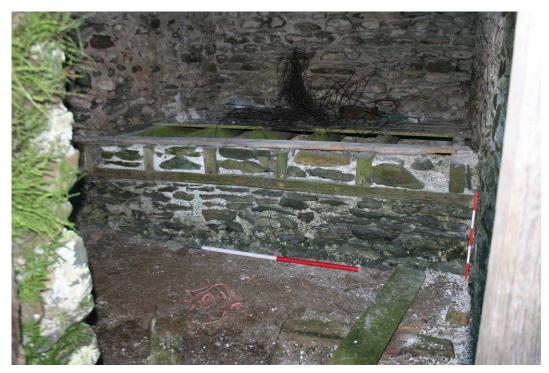
Photo 28: Raised area within store shed, providing access to pigsty below

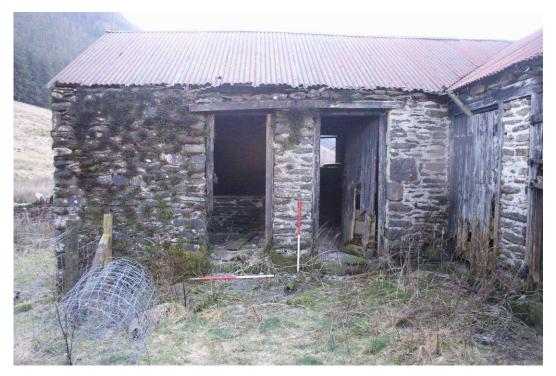
Photo 29: NE elevation of stores and pigsty building showing doorways

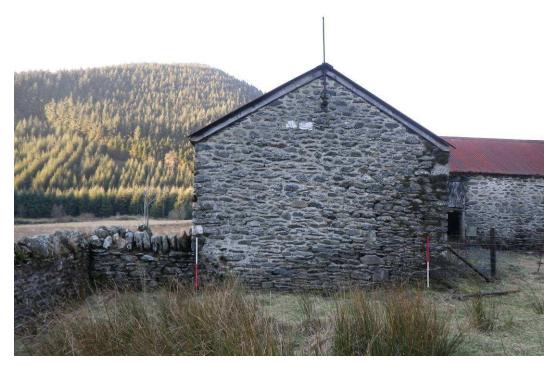
- 4.3.3 The SW gable end of this structure had no architectural detail (Photo 30). The NE corner of this part of the structure was in a poor state of repair. A further stone wall projected to the SE of the exterior pigsty pen wall, forming a partial enclosure around the farm yard, although its full extent was unclear.

Photo 30: SE gable end of stores and pigsty building
