**ROCH CASTLE,
PEMBROKESHIRE
(SM 8803 2121)**

**HISTORIC BUILDING
RECORDING AND
ARCHAEOLOGICAL
INVESTIGATIONS**

RHIF YR ADRODDIAD / REPORT NO. 2011/26
RHIF Y PROSIECT / PROJECT RECORD NO. 100723

March 2012

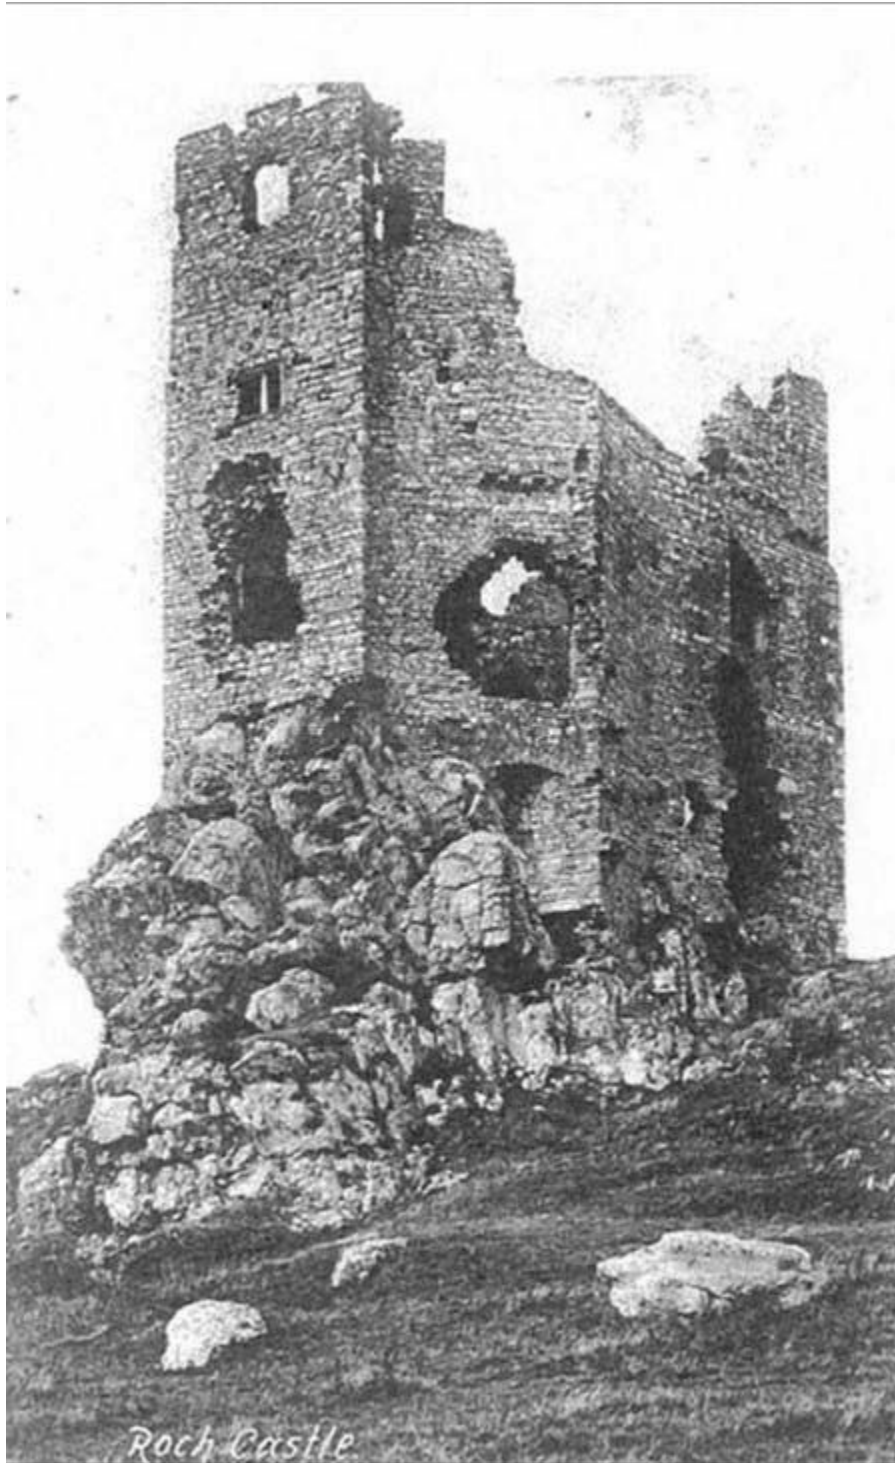
Photo 1: View of Roch Castle from Southeast Pre-1900
(reproduced from Acanthus Holden Design and Conservation Statement 2008)

Photo 1 above was taken at some point prior to the 1900s renovations by Viscount St Davids. It corresponds with the information shown on the 1857 and 1864 illustrations, showing the well preserved facade of the Square Tower, including crenellations at the parapet. The lower window in the Square Tower is clearly shown as arched within the illustrations, but in this photograph only a hint of the arched opening is visible back from the damaged façade. The void in the wall on the eastern façade is clearly shown, which corresponds with the present entrance. A large void is also shown in the southeastern facade of the Stair Extension, which corresponds with the top of the rock outcrop at first floor level.

The relieving arch is shown below this opening which is still extant today, which presumably provided support for the exterior wall where it crossed a fissure in the underlying outcrop. The photograph confirms the survival of much of the fabric of the eastern turret.

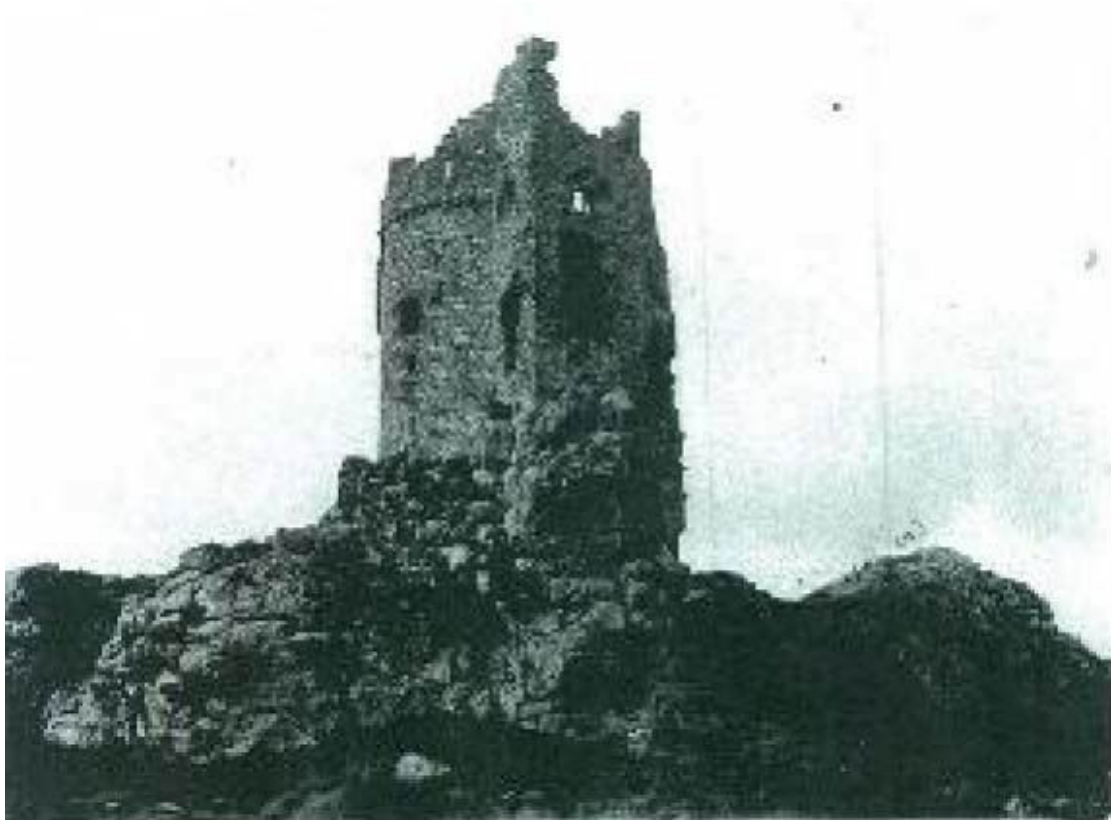
Photo 2: Southwestern view of Roch Castle taken pre-1900
(reproduced from Acanthus Holden Design and Conservation Statement 2008)

Photo 2 also dates from pre-1900, showing a view of the southern façade. The photo clearly shows that the upper part of the Square Tower, from the third storey window to the top of the crenellated parapet is missing. The fact that it is shown as surviving on the other photograph and illustrations from 1854 and 1867, and the fact that internally there seems to be no evidence for a large scale rebuild of this part of the wall, it is considered possible that the photograph has been altered to create a more 'ruinous' look.

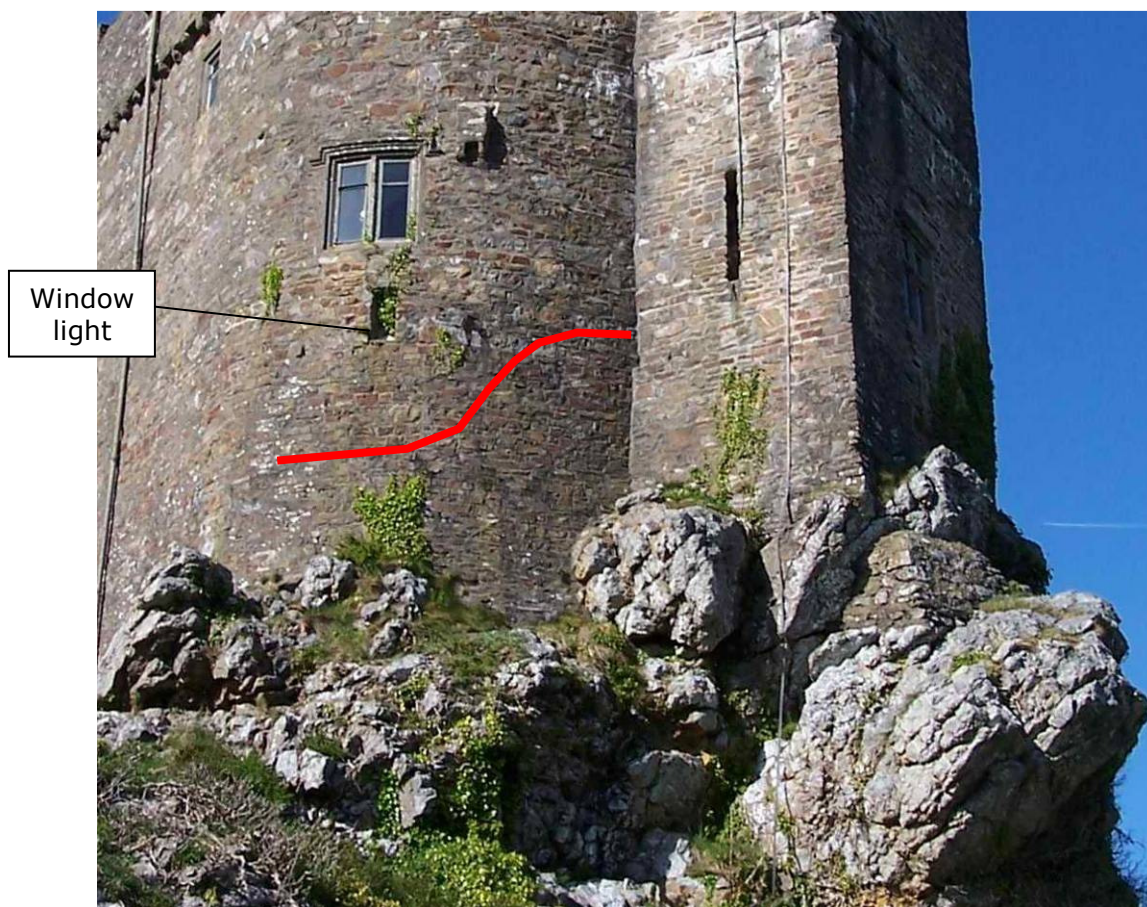
Photo 15: Approximate height of basement floor and rock outcrop (red line) in relation to the exterior southwestern wall of the castle

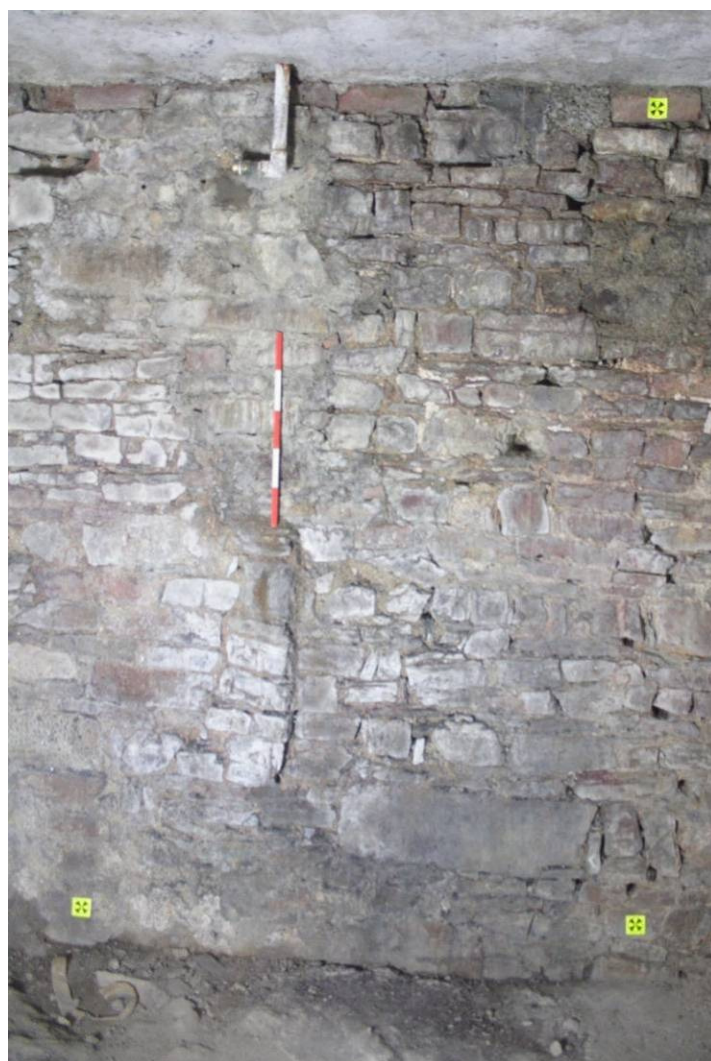
Photo 16: Small area of projecting stonework on eastern internal wall
(located directly below 0.5m ranging rod)

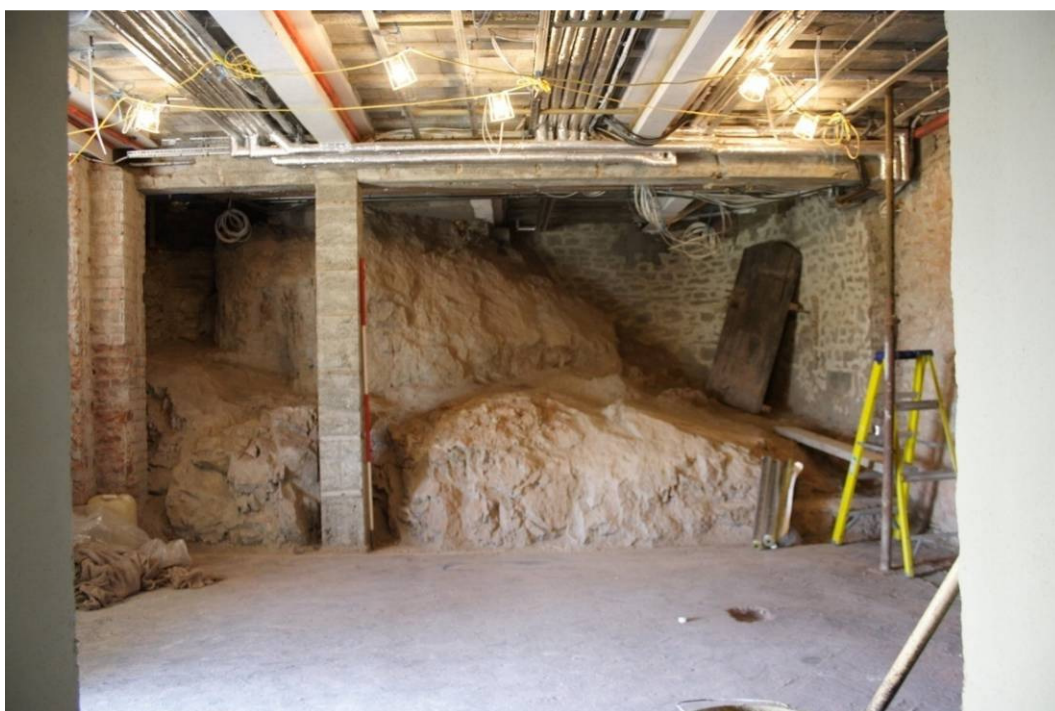
Photograph 17 shows that the Basement / Ground Floor of the castle is generally D-shaped, with only a slight projection to the east for the Stair Extension. There is no indication of the Square Tower's presence at this level.

Photo 17: Rock outcrop in southern part of Basement / Ground floor following removal of dividing walls (2m ranging rod against retained concrete pillar support)

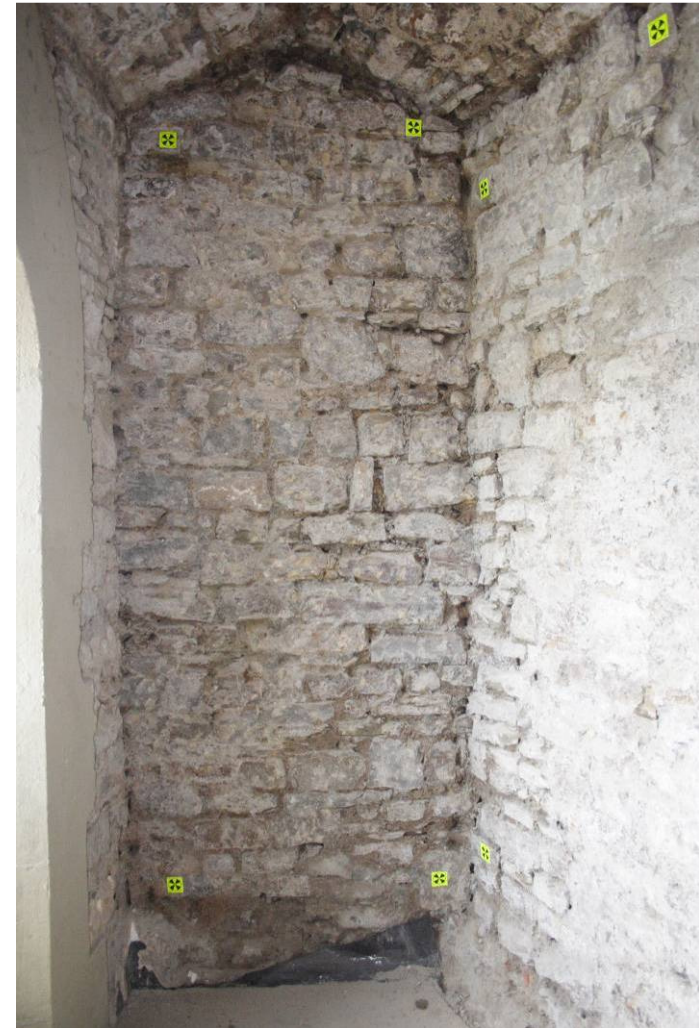
Photo 41: Possible blocked passageway, which may have led to the First Floor of Square Tower

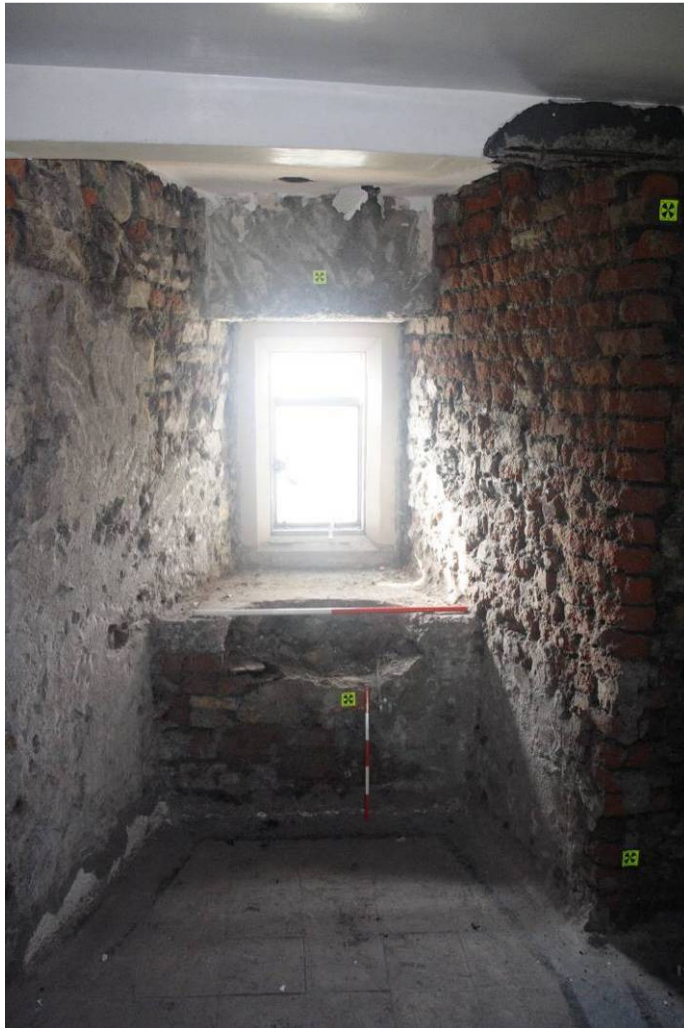
Photo 49: Window in western wall of southern room of Second Floor showing brick infill and repairs

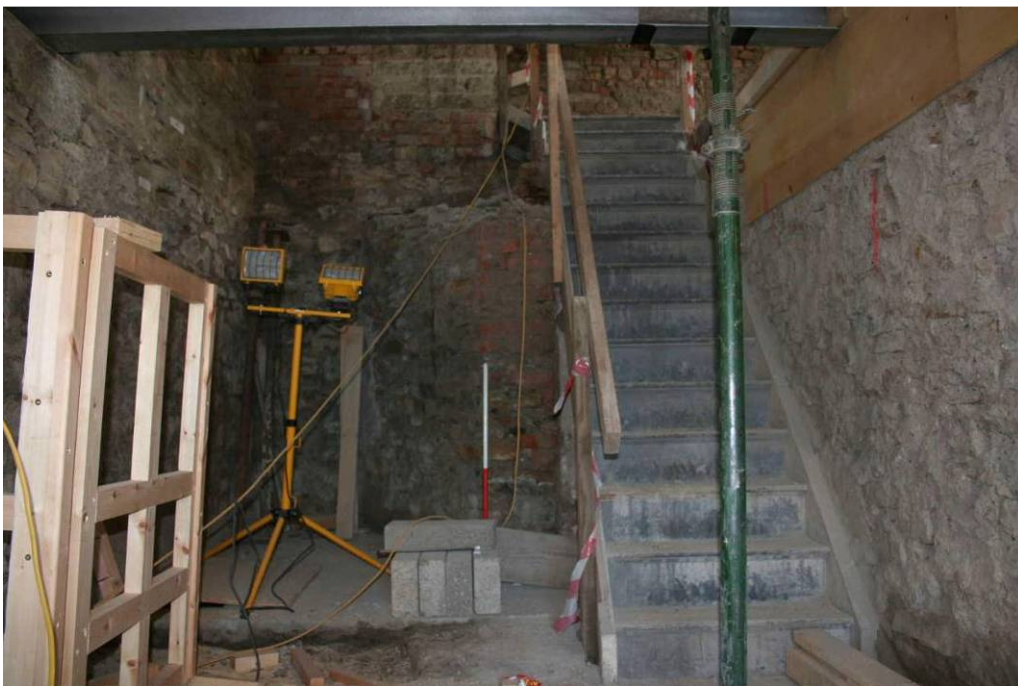
Photo 80: Possible indications of continuation of curved feature on northeastern side of basement below stairs adjacent to scale

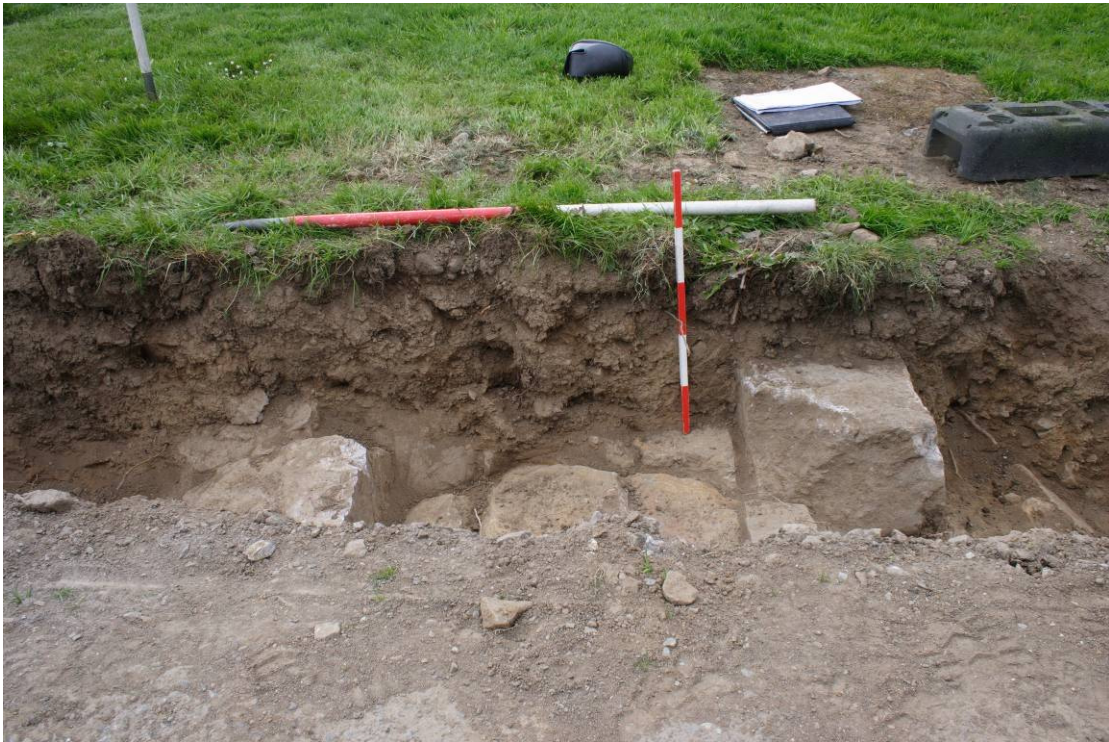
Photo 98: Probable wall within eastern kerb trench at southern end of driveway showing depth within section (facing east)

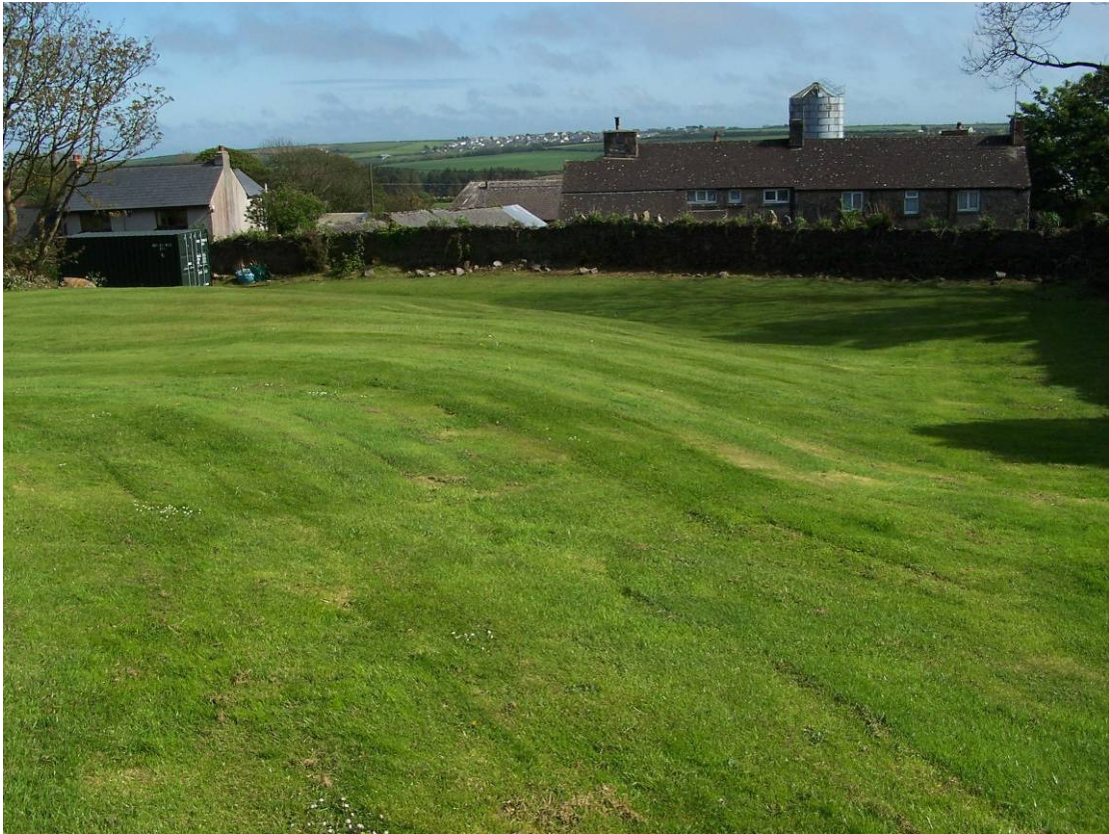
Photo 109: Lawned area to southeast of castle showing possible depression of former moat (view southeast)

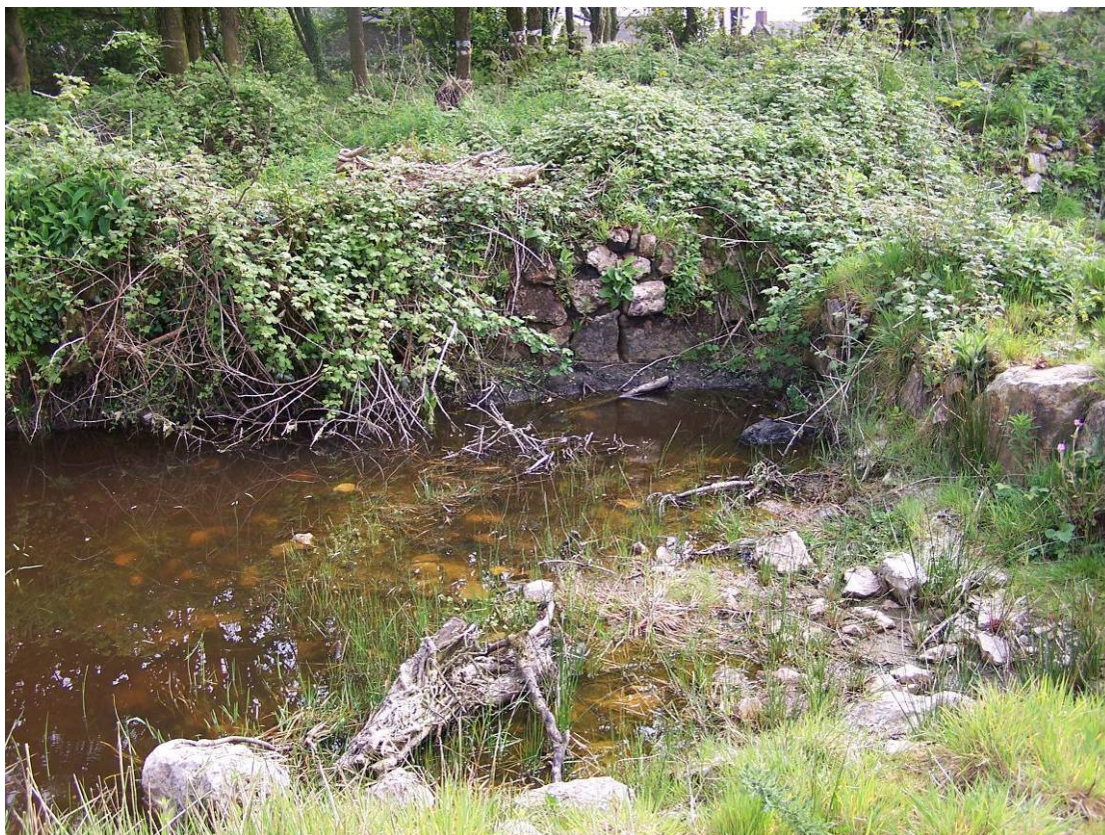
Photo 115: Stone walls of former building on northeastern side of castle enclosure, of uncertain date and function (view south)

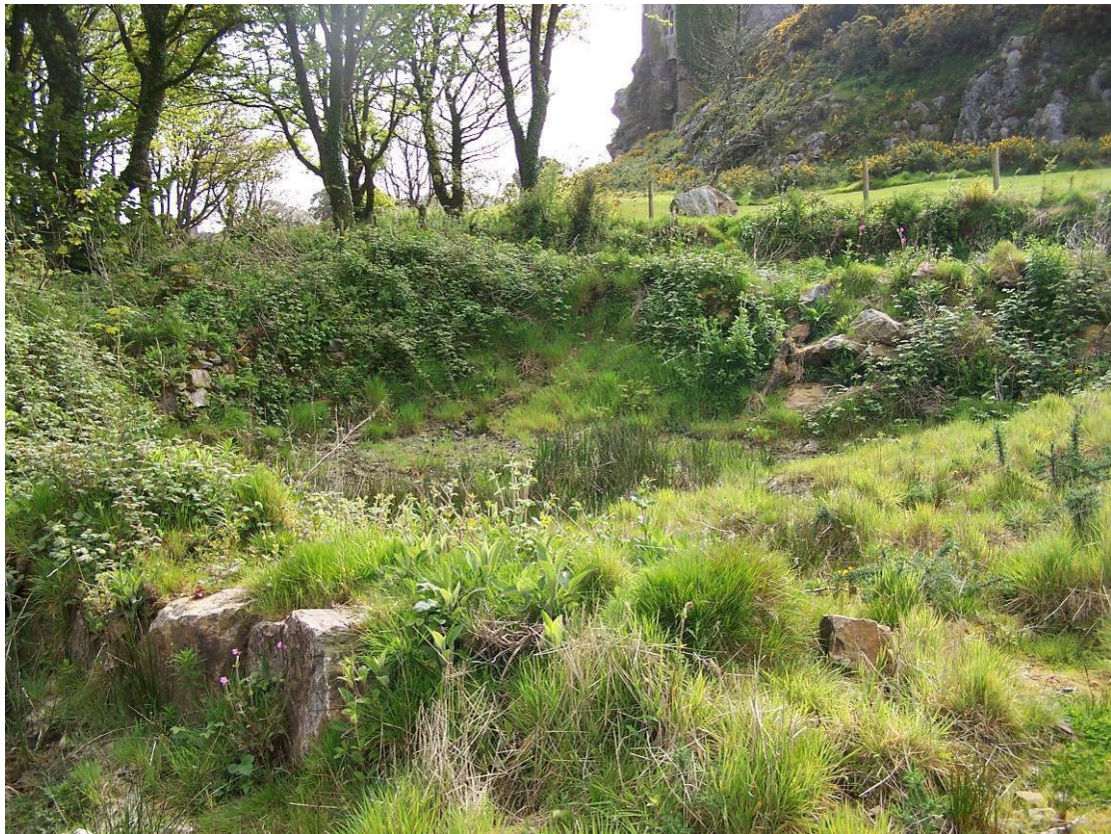
Photo 116: Stone walls of former building on northeastern side of castle enclosure, of uncertain date and function (view west)
