LLANSTADWELL SEA WALL, PEMBROKESHIRE: ARCHAEOLOGICAL WATCHING BRIEF 2011

RHIF YR ADRODDIAD / REPORT NO. 2011/34
RHIF Y PROSIECT / PROJECT RECORD NO. 102239

LLANSTADWELL SEA WALL, PEMBROKESHIRE: ARCHAEOLOGICAL WATCHING BRIEF

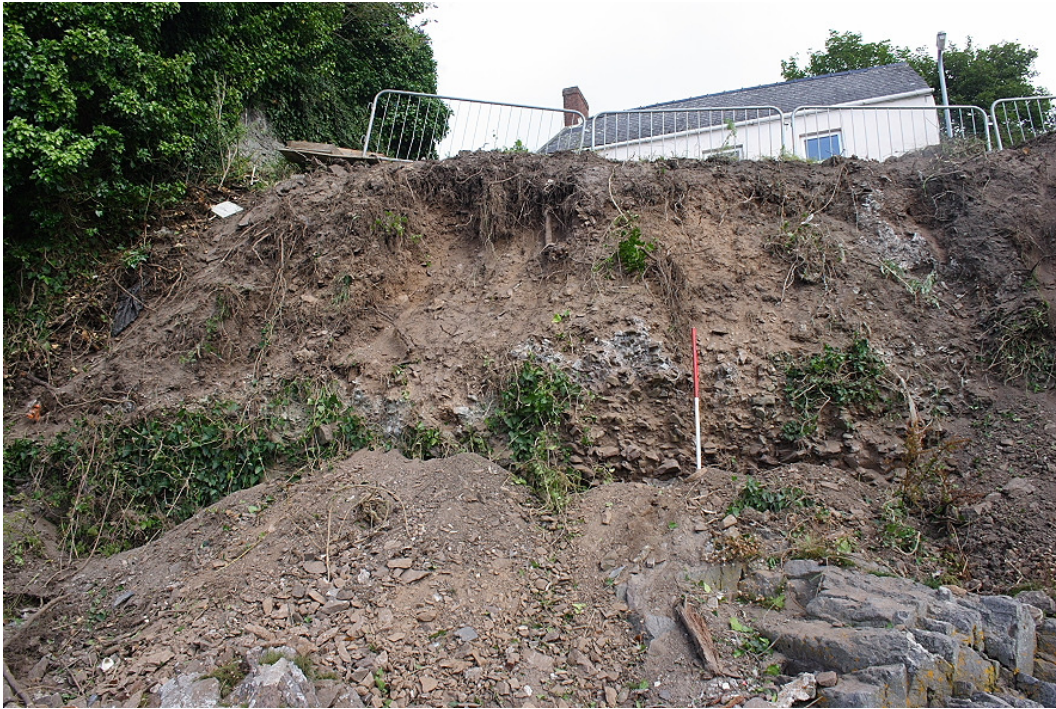
- 3.2.1 The excavations of the westernmost section (photos 3 – 5) revealed a sequence of naturally occurring deposits that consisted of a base of Old Red Sandstone bedrock (layer 100), running in ridges aligned roughly southeast – northwest, and rising to the northwest. The exposed face of this bedrock was fracturing and was topped by a compact layer of shattered and folded bedrock embedded in a mid orange-brown clay, c.0.3m thick (layer 101). On top of this lay a thicker deposit of broken up, medium to large, sub-angular fragments of bedrock (c.50%) mixed in a light brown sandy-clay, up to 1m thick on the exposed face, but rising to the north becoming c.1.8m thick at the rear of the excavated area (layer 102). This was in turn topped by c.0.2m of finer friable sandy clay, mid orange-brown, with fewer stone inclusions (layer 103). These deposits appeared to represent a series of naturally occurring fluvio-glacial deposits, containing no archaeological material. All deposits were remarkably dry, and no palaeo-environmental material was noted.

Photo 3: The exposed face of the western section, after vegetation removal but prior to excavation, 1m scale

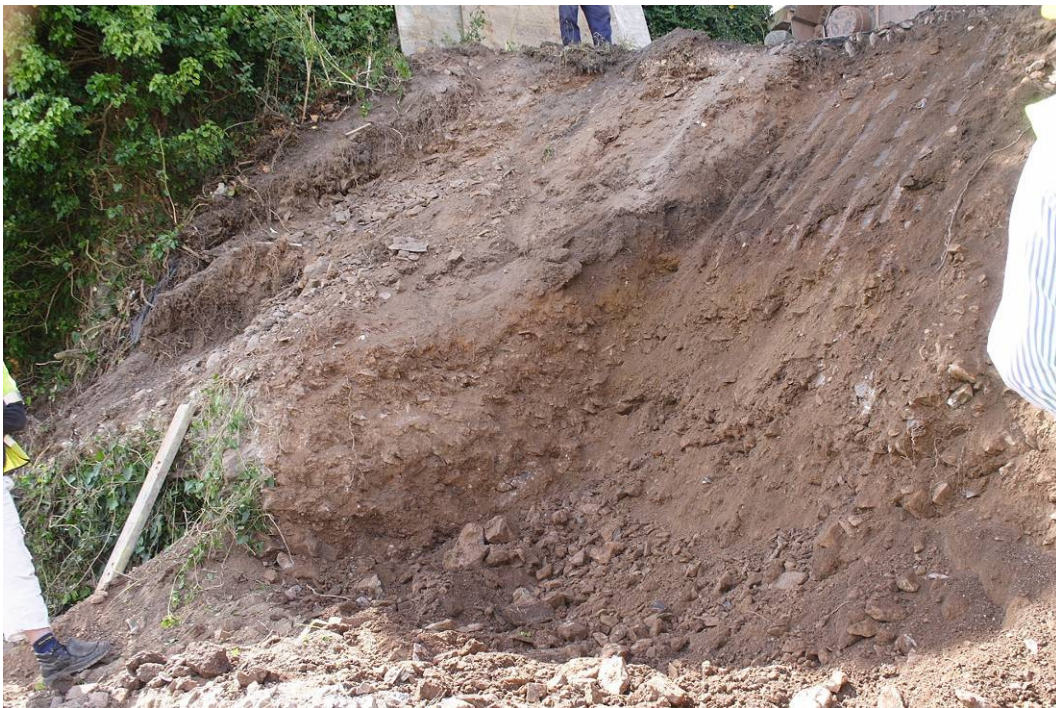
Photo 4: Excavated face of the western section, looking WNW

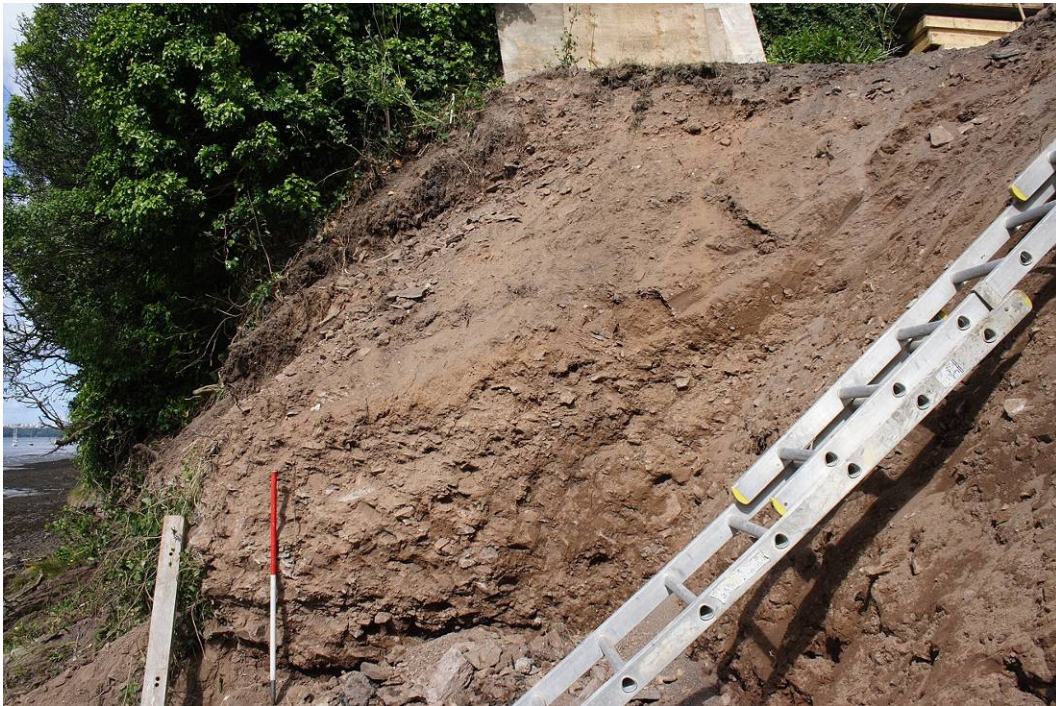
Photo 5: Excavated face of the western section, looking west, 1m scale

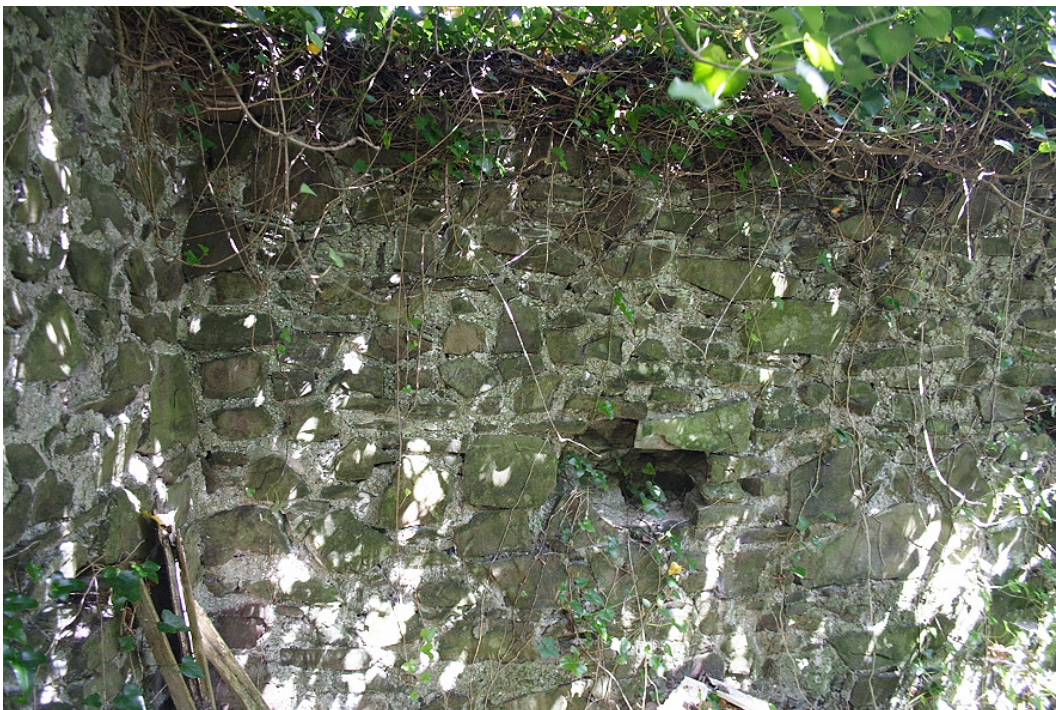
- 3.2.4 The excavation also revealed the construction of the walls of the adjacent ruined stable building (photos 6 & 7). A retaining wall of lime-mortared uncoursed, random rubble had been built on top of the deposit of compact shattered and folded bedrock mixed with clay. This wall was 0.35m wide, and roughly 1.5m high before becoming lost in vegetation. The wall of the building itself, built in the same style, stood 0.4m behind this, but the base of the wall being a metre higher having been cut into the overlying deposit of broken bedrock in sandy-clay. The remaining dimensions of the building were not recorded as part of the archaeological works. Enough of the building was visible amongst the vegetation to determine it was a rectangular structure, aligned roughly north-south, with featureless northern and eastern walls. A collapsed section of the southern gable wall, off-centre to the east, appears to have been a former window high in the wall. A doorway opening is visible midway along the western wall, flanked by two low window openings with slate sills. Material within the building suggests it may have been roofed with corrugated iron in its latter stages.

Photo 6: Internal upstanding face of building wall, the former stables, that forms the boundary to the development area

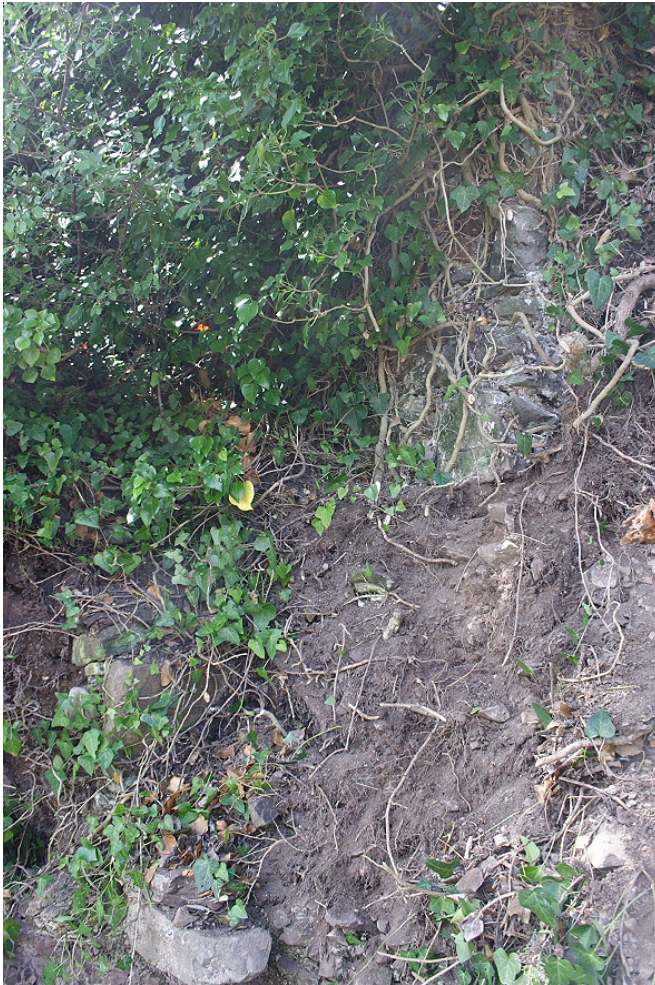
Photo 7: Exterior face of former stable wall forming western boundary to the development area. The stable wall foundation is visible to the top right, fronted by a retaining wall visible at the bottom left

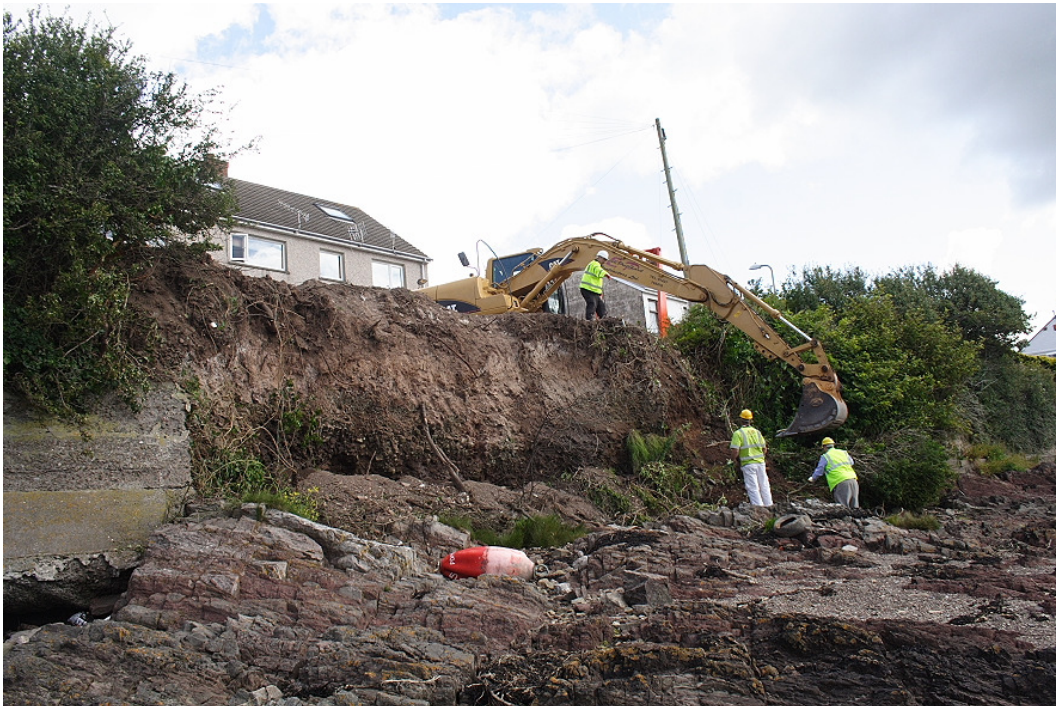
- 3.2.6 The excavations along the eastern section (photos 8 – 12) revealed a very similar series of naturally occurring fluvio-glacial deposits overlying the Old Red Sandstone bedrock. The lowest levels directly overlying the bedrock were not revealed during the watching brief, but a thick deposit consistent with the layer of broken-up bedrock in a light brown sandy-clay (layer 102) was recorded, up to 1.8m thick on the exposed face and rising as it was excavated inland. The existing concrete seawall that ran between the western and eastern section was built of shuttered concrete on top of solid bedrock, and fronted this deposit. As with the western section, this was also topped by a deposit of mid orange-brown sandy-clay, with the occasional medium to large sub-angular stone, up to 1m thick and rising as it heads inland (layer 103). As the face was exposed during the works a deposit was recorded lying between these two layers, consisting of a mix of broken sub-angular bedrock (c.30%) within a orangey-yellow clayey-sand (layer 109). A similar deposit to the underlying layer, but clearly with a greater sand content. This deposit was 0.5m thick and increased in thickness to the east.

Photo 8: Exposed face of the eastern section during vegetation removal

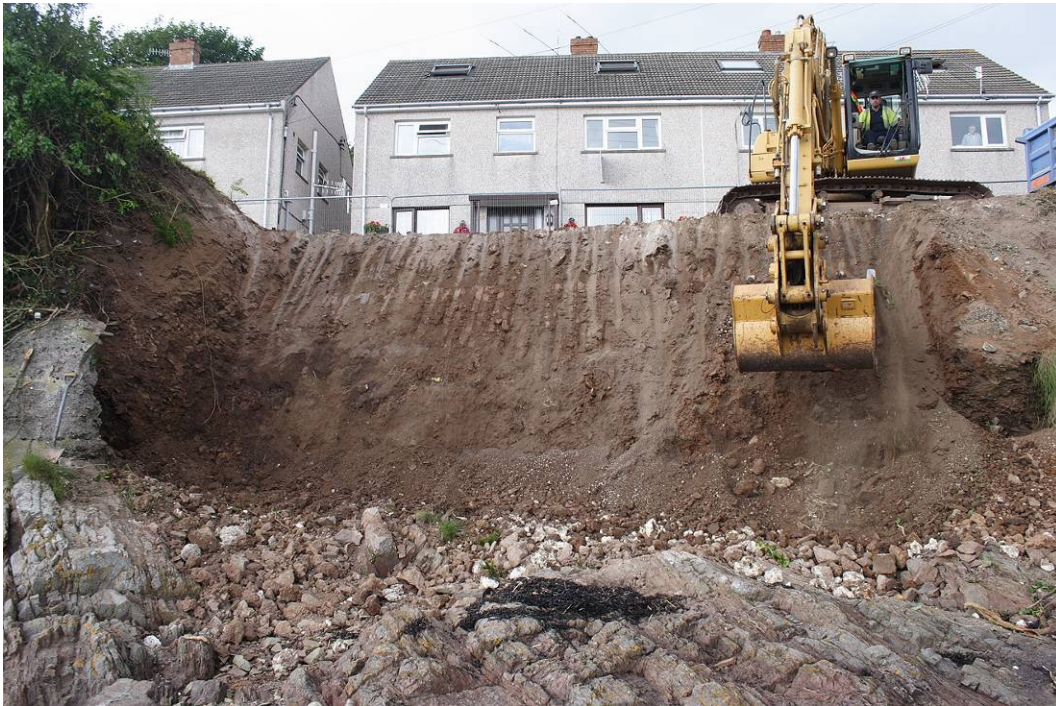
Photo 9: Eastern section under excavation

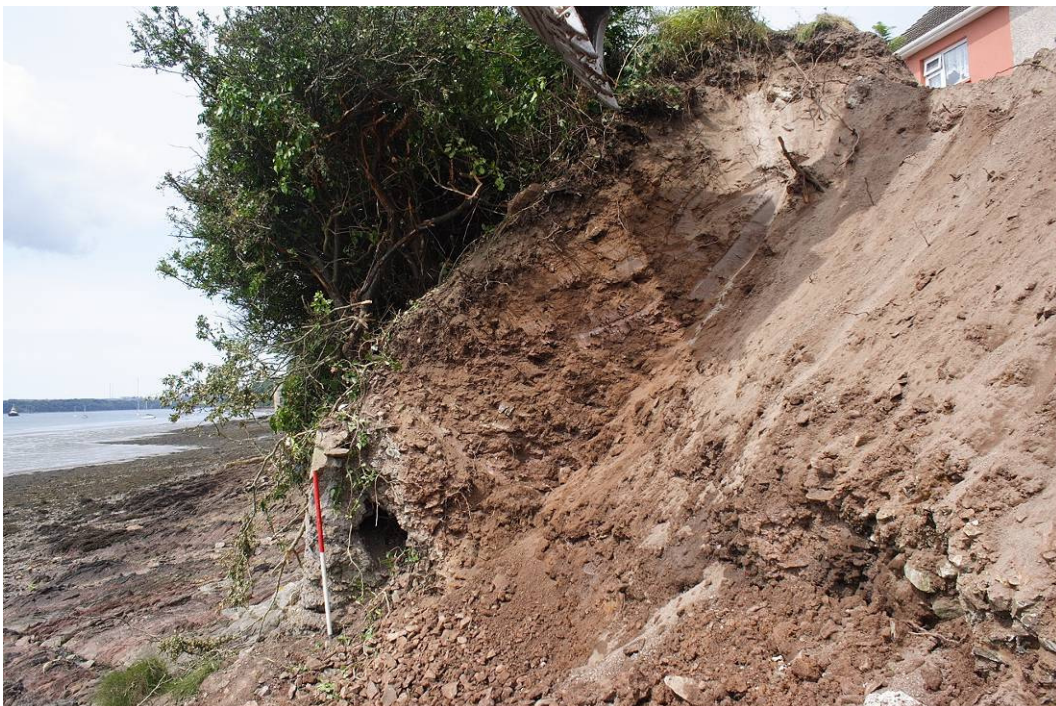
Photo 10: Excavated face of the eastern section, taken facing west, 1m scale

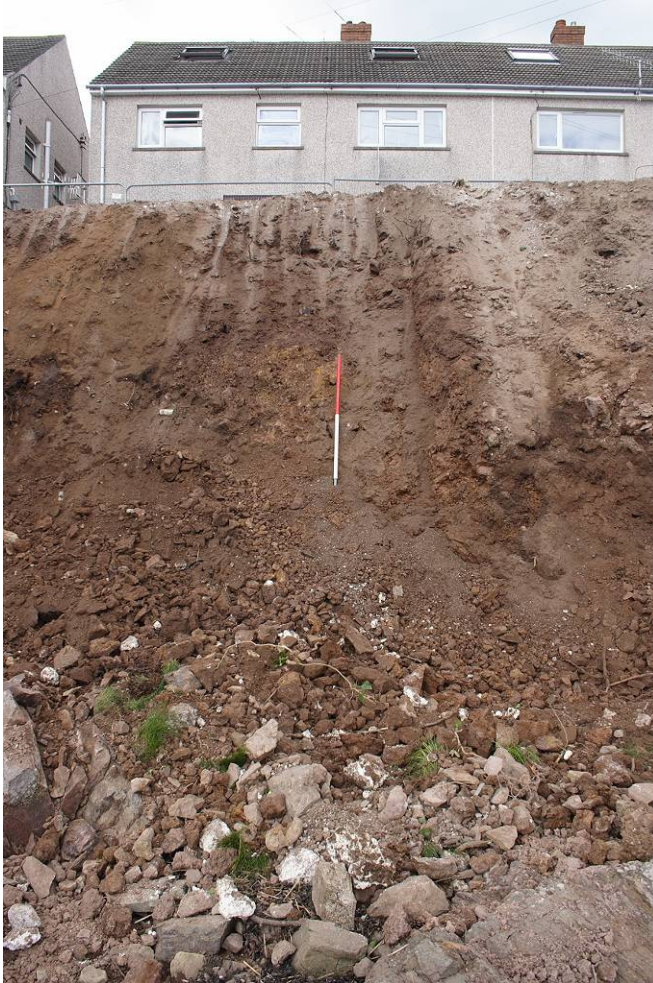
Photo 11: Excavated face of the eastern section, showing sandier deposit adjacent to the 1m scale

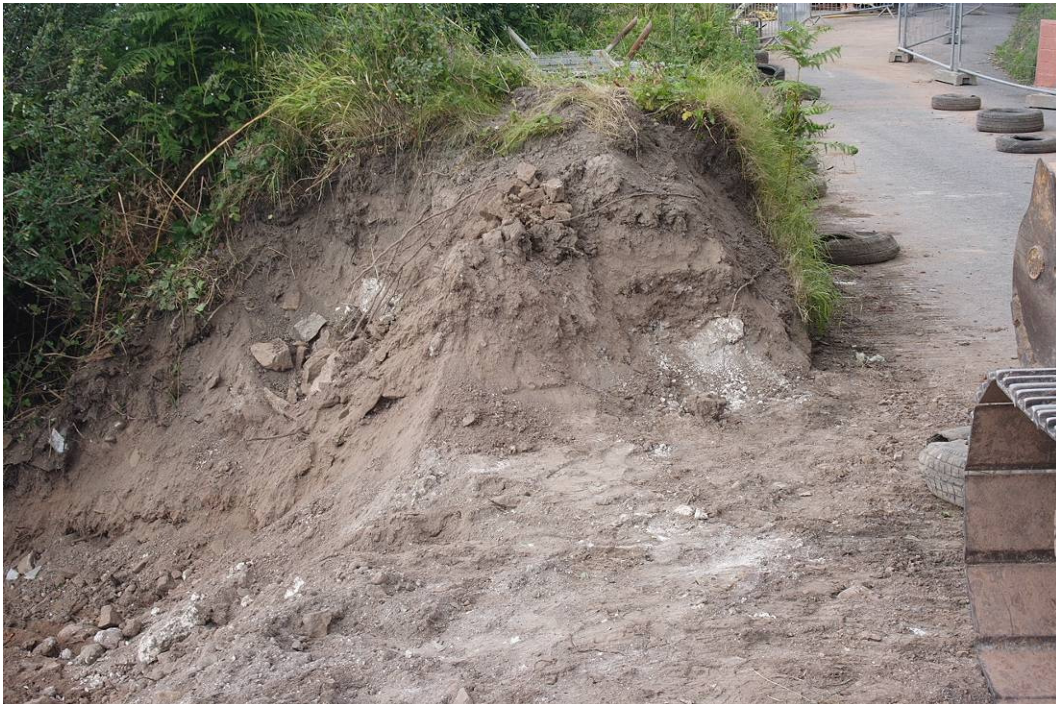
Photo 12: Remnants of the layer of lime mortar fragments recorded in the eastern section, lying above the level of the road.
