**ST MICHAEL'S CHURCH, CILIAU AERON,  
CEREDIGION (SN 50244 58139)  
ARCHAEOLOGICAL WATCHING BRIEF**

Prepared by: Dyfed Archaeological  
Trust Ltd.  
For: Ken Filkins Ltd

RHIF YR ADRODDIAD / REPORT NO. 2011/39  
RHIF Y PROSIECT / PROJECT RECORD NO.102245

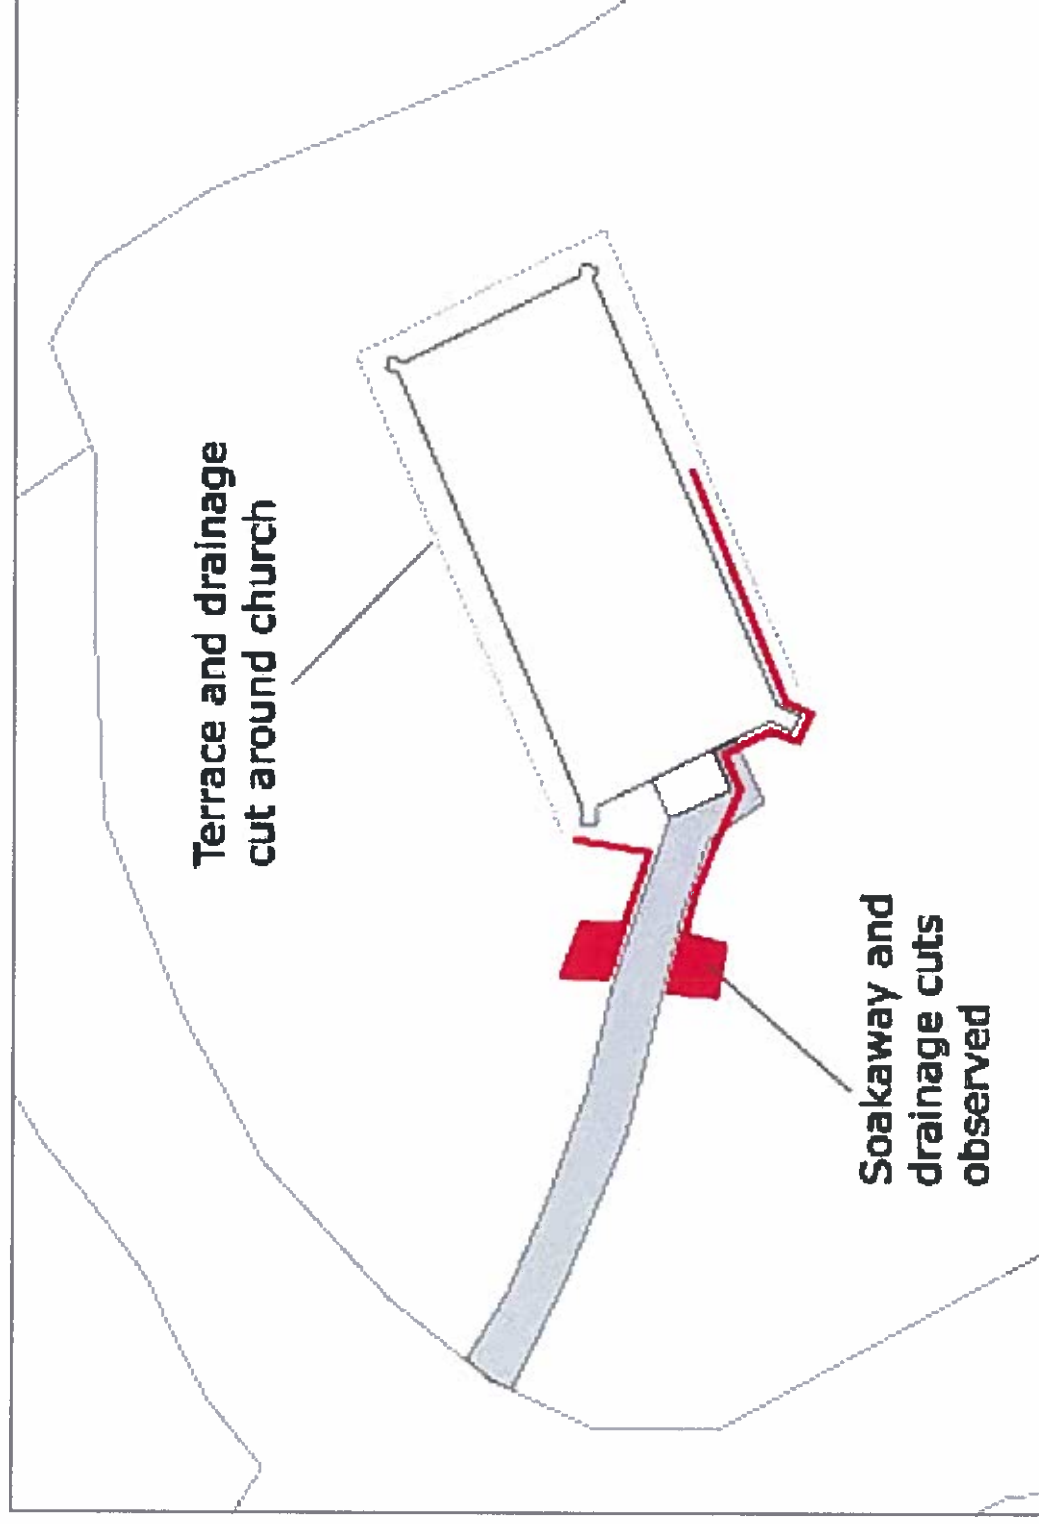
**Figure 5:** Plan showing approximate locations of drainage and soakaways observed during the watching brief (not to scale)

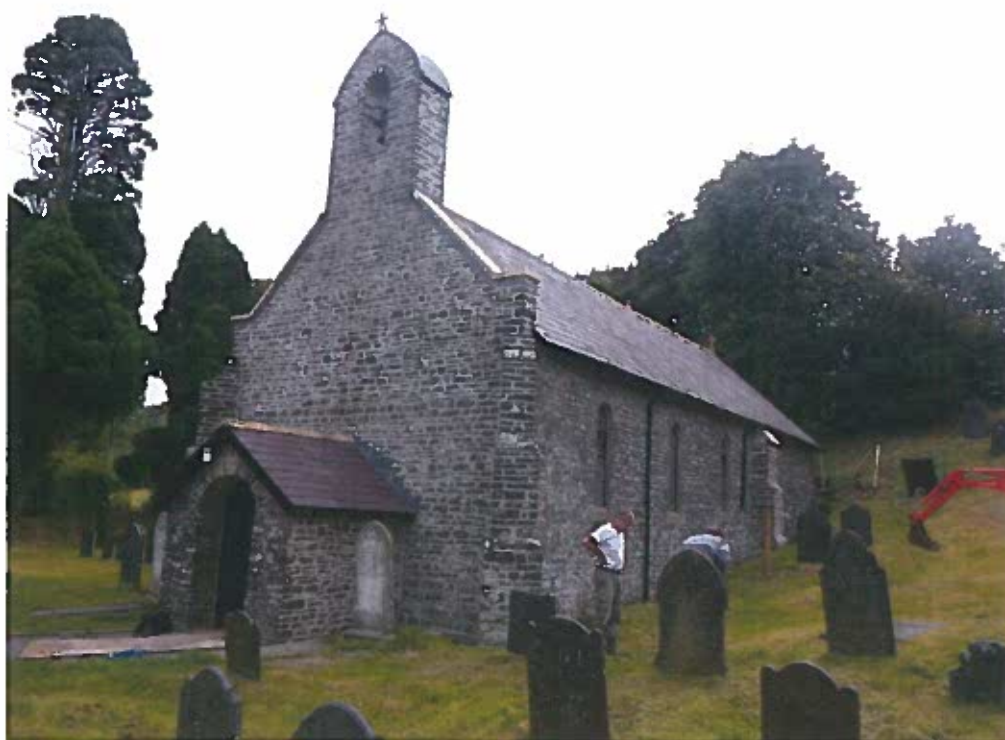
- 5.5 No evidence of earlier (pre 18<sup>th</sup> century) stonework was visible in the exterior walls of the church. This supports the theory that the medieval church was completely rebuilt during the 18<sup>th</sup> century, although is not conclusive.

**Photo 1:** Exterior of church

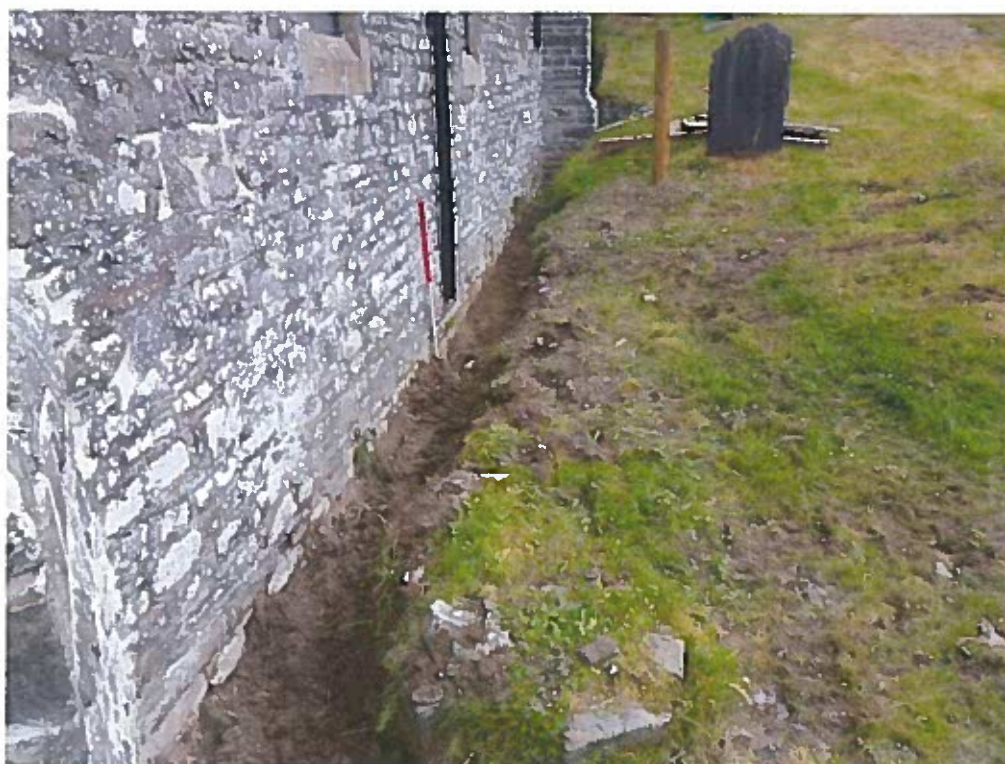
- 4.1 The soil around the base of the south wall had been previously disturbed both in the past and more recently during the re-pointing of the exterior of the church. No previously undisturbed material, burials or other features were exposed. Drainage trenches were cut deep enough to ensure a sufficient drop to allow drainage, to a maximum depth of approximately 0.40m.

**Photo 2:** Drainage trench along base of south wall

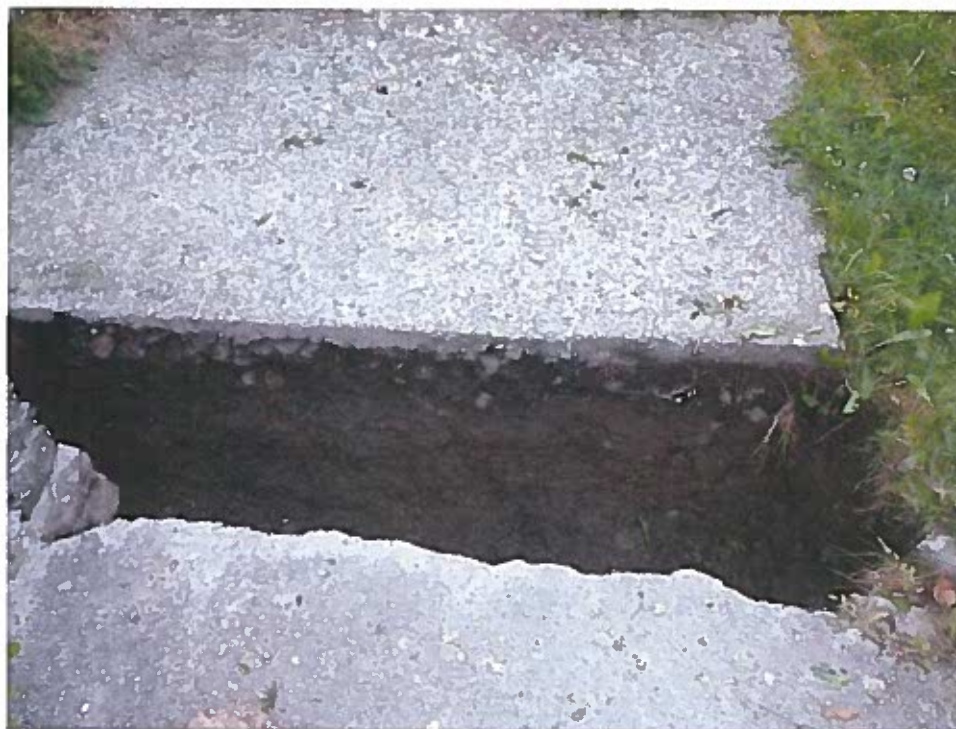
**Photo 3:** Drainage trench at southwest corner of the church

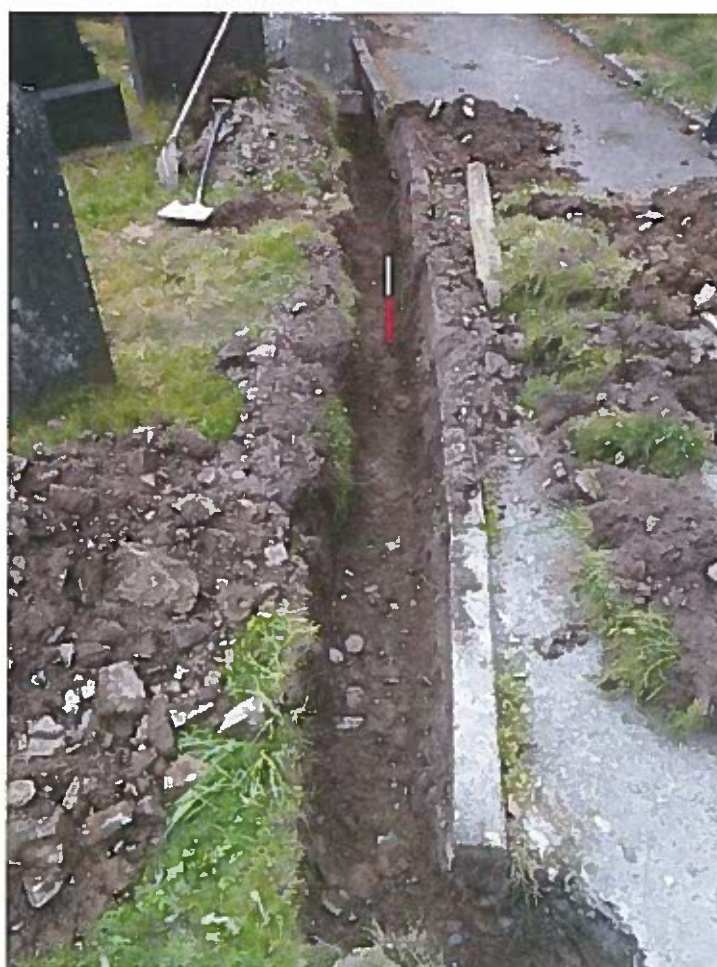
- 4.3 The drain runs excavated on both sides of the pathway leading from the church avoided burial monuments, and no *in-situ* human remains were exposed. Occasional fragments of disarticulated human bone were encountered. These were backfilled in the drainage trenches in the approximate locations from where they were found.

**Photo 4:** Drainage trench along south edge of path

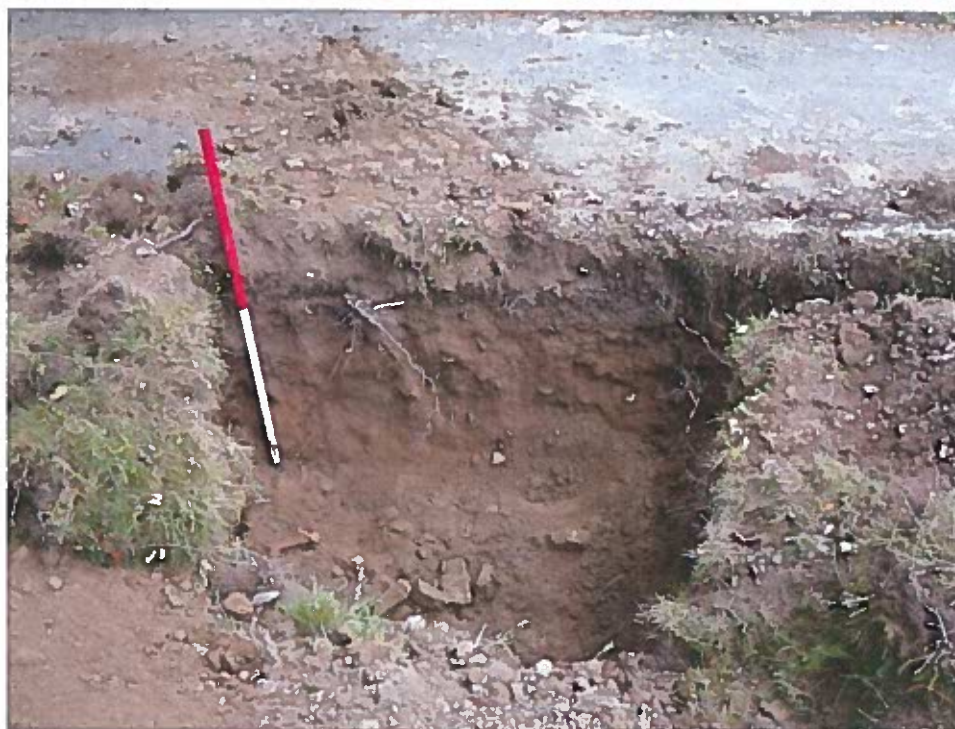
- 4.4 The two soakaways were located in areas in which no burials were apparent, to depths of approximately 1.0m. No *in-situ* human remains were encountered.

**Photo 5:** Soakaway on south side of path

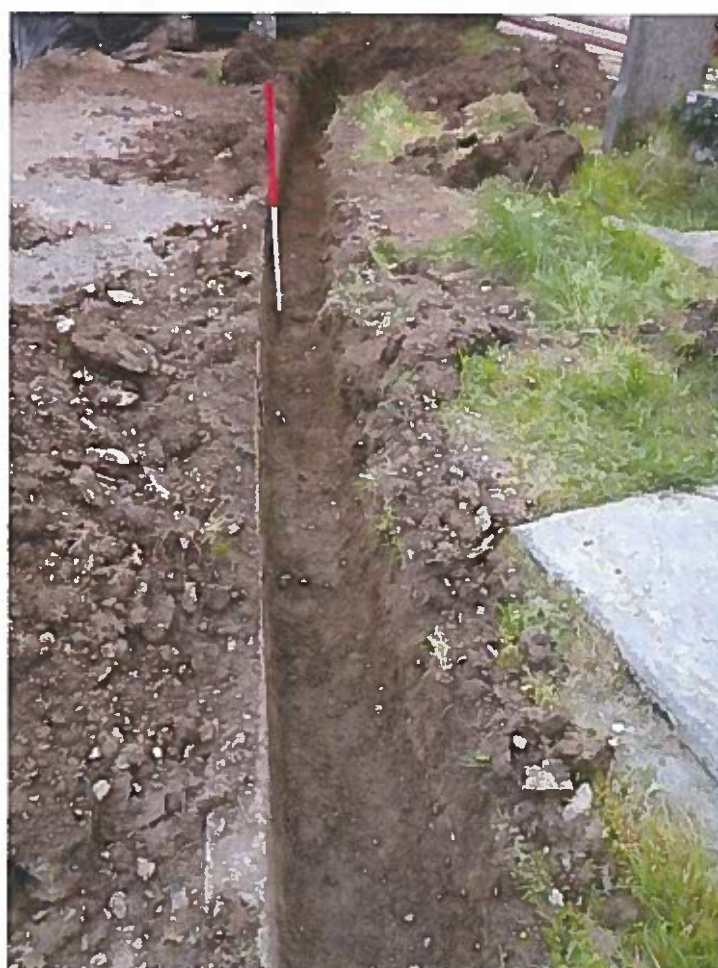
**Photo 6:** Drainage trench on north side of path

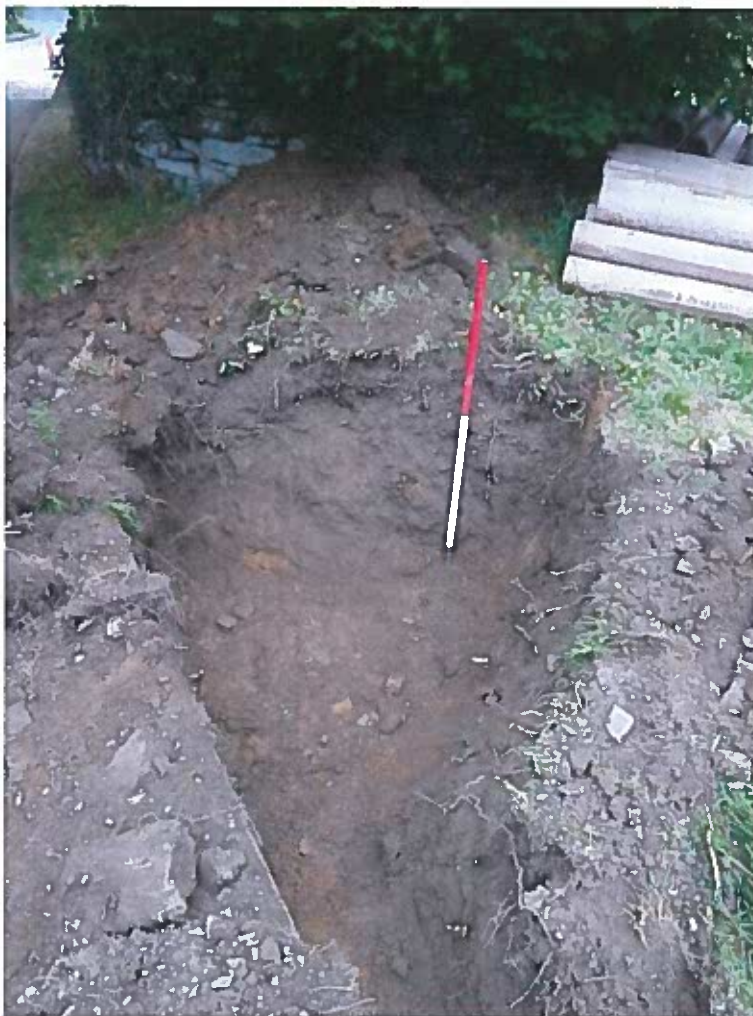
**Photo 7:** Soakaway on north side of path
