# CARDIGAN CASTLE, CEREDIGION ARCHAEOLOGICAL WATCHING BRIEF, PHOTOGRAPHIC SURVEY, & EVALUATION

Prepared by Dyfed Archaeological Trust  
For: Ceredigion County Council,  
Cadwgan Trust / Purcell, Miller, Tritton

RHIF YR ADRODDIAD / REPORT NO. 2011-50  
PHOTOGRAPHIC SURVEY - RHIF Y PROSIECT / PROJECT RECORD NO. 102421  
WATCHING BRIEF - RHIF Y PROSIECT / PROJECT RECORD NO. 102422  
NORTHEAST TOWER INVESTIGATION -  
RHIF Y PROSIECT / PROJECT RECORD NO. 102423  
FERNERY INVESTIGATION - RHIF Y PROSIECT / PROJECT RECORD NO. 102424

**Rhagfyr 2011  
December 2011**

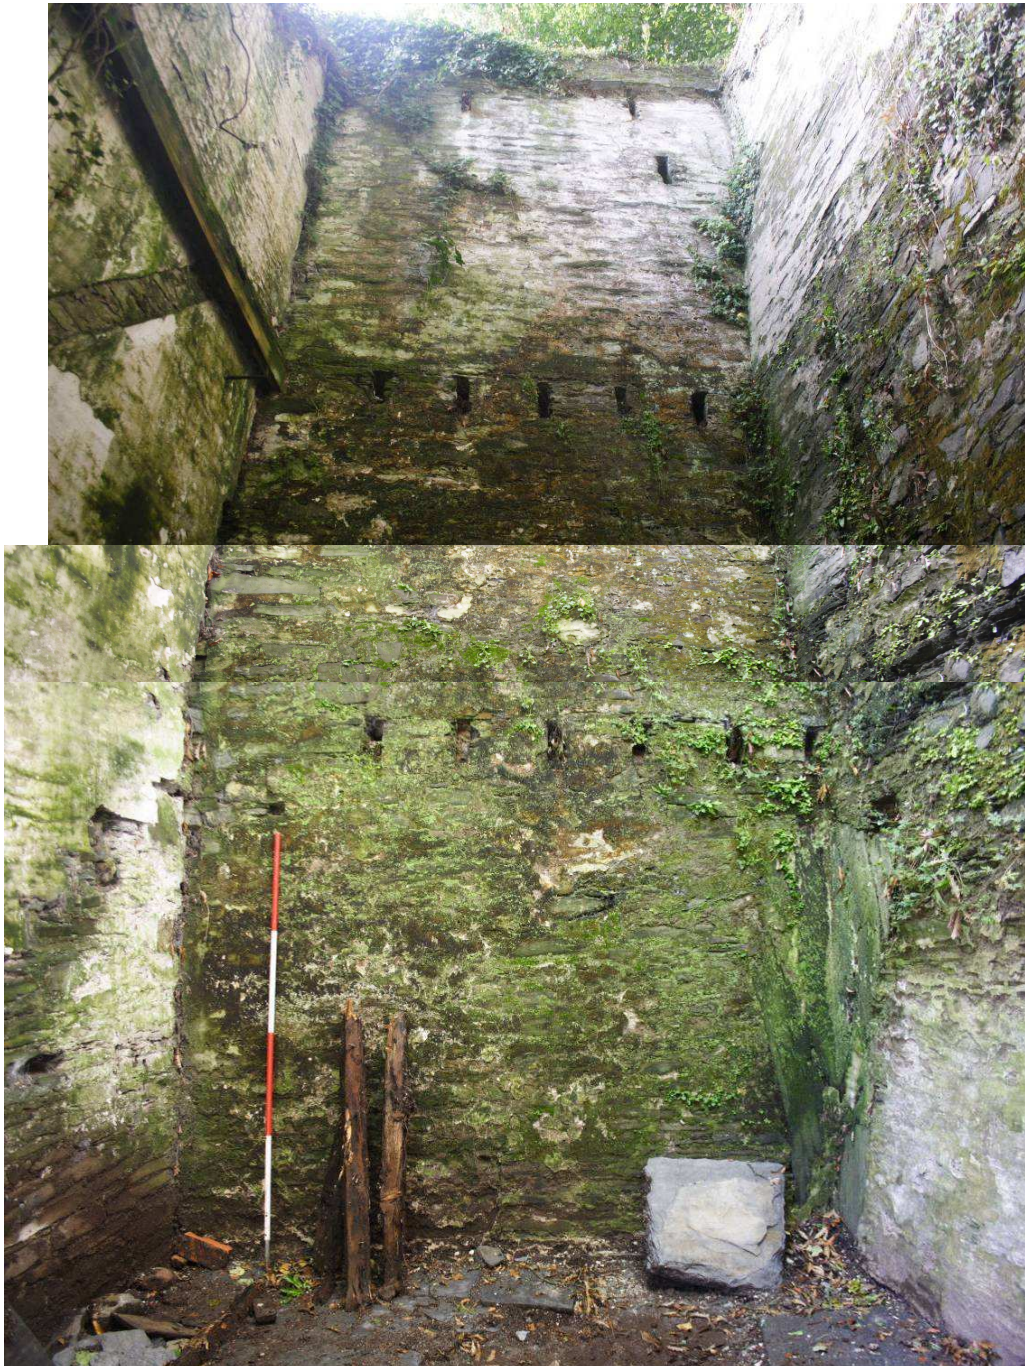
features visible within it. Two rows of beam slots are present in the elevation which relate to the former first floor and loft level of Room 3. Further beam slots are apparent towards the upper part of the elevation which relate to the former roof of the Room 3 (as can be seen with the surviving beam on the left hand side of Photo 2). The tower wall was relatively vertical, with only a slight splaying of the base of the wall. An outcrop of bedrock is visible in the lower right hand side of Photo 2 onto which the tower and Eastern Curtain Wall are built.

**Photo 2:** Composite photograph showing northern elevation of North East Tower within Room 3 of Stables, 2m scale

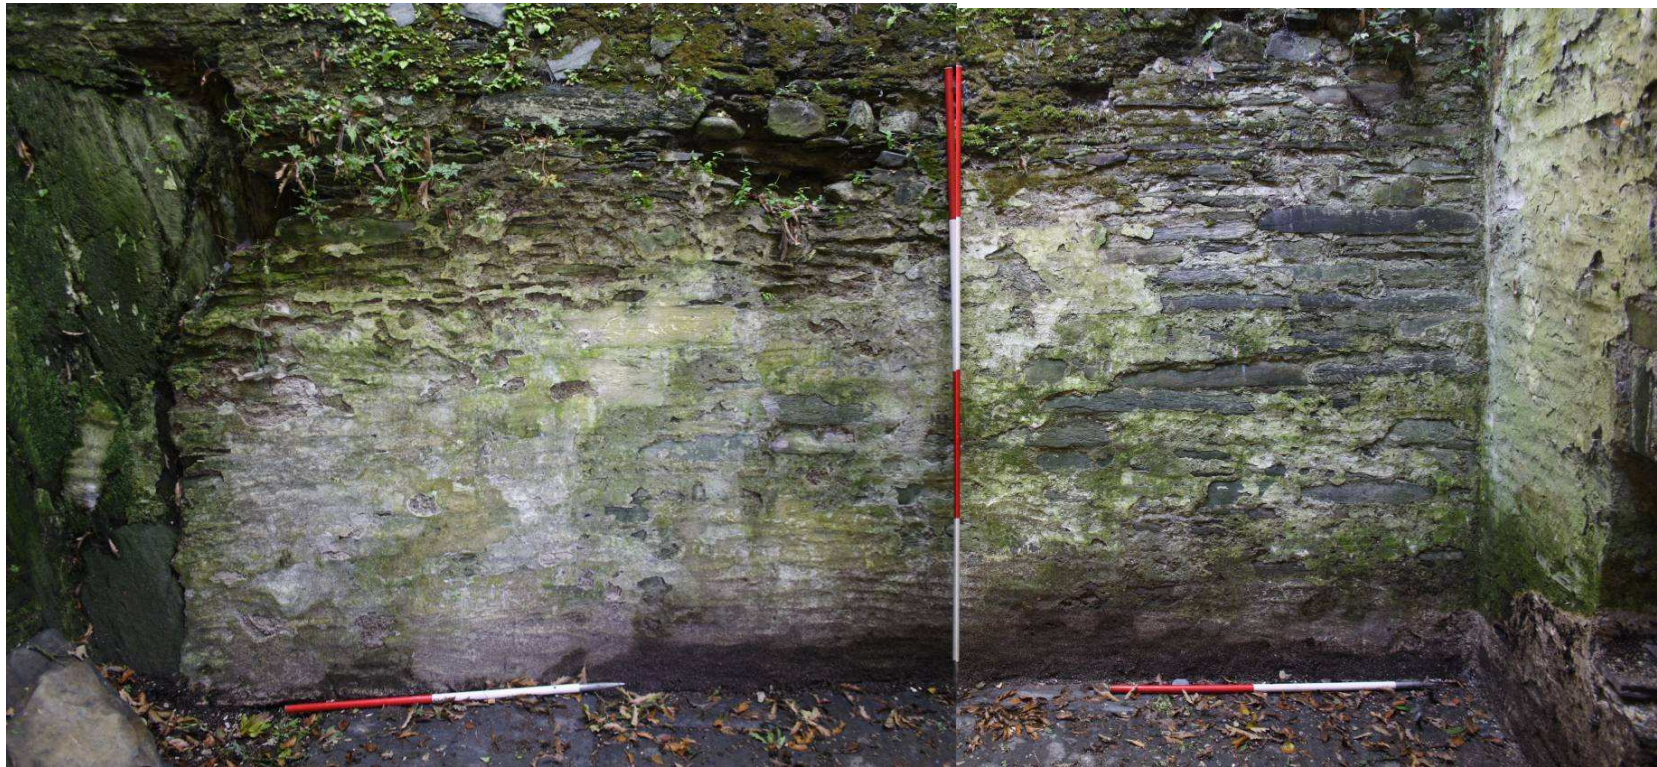
**Photo 3:** Composite photograph showing southeastern elevation of base of curtain wall in Room 3 of Stables, 2m and 1m scales

5.4.2 The southeastern elevation of the main Eastern Curtain Wall is also visible in Room 3, forming the northwestern wall of the room. A larger section of exposed bedrock is visible in this elevation, present in the southwestern base of the wall (Photo 3). It can be clearly seen in this area that much of the base of the curtain wall is merely a stone wall facade butting against the natural bedrock. This area of the wall was in a poor state of repair with the built facade beginning to peel away from the bedrock. The appearance of the lower part of the wall (Photo 3) is that it was rendered at ground floor level, presumably when the structure of Room 3 was in use. The pointing of the wall and relatively neatly laid stone in the lower part suggests that this area had been repaired and rebuilt previously.

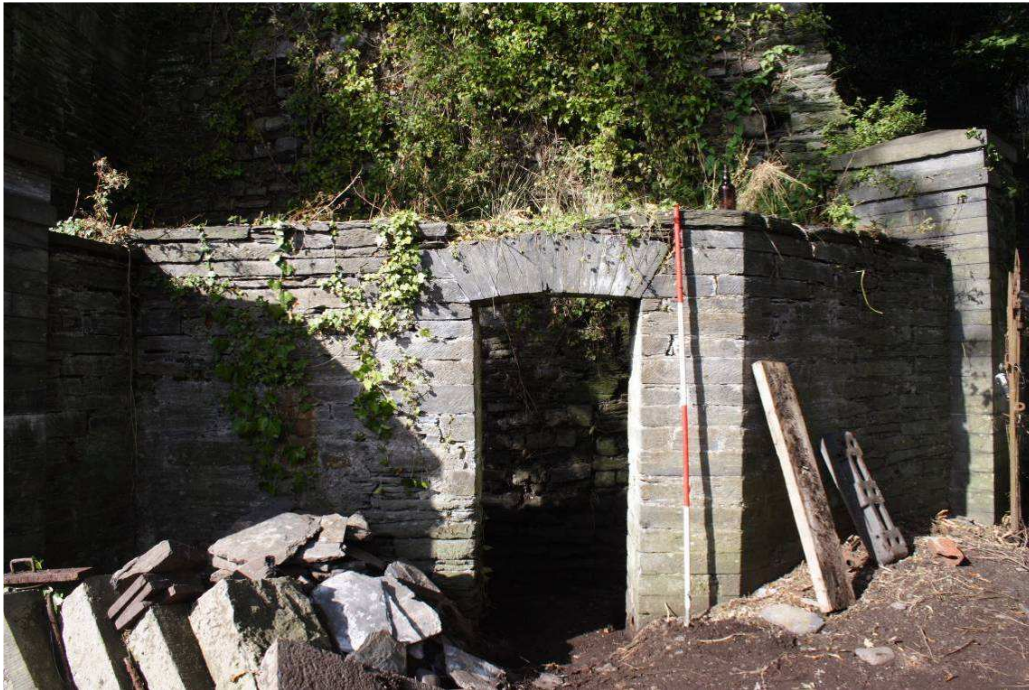
northeast where the return is situated (Photo 9). The very base courses of the bastion are very notably splayed (Photo 11).

**Photo 9:** Southeastern facade of Room 4 of the Stables, with Eastern Curtain Wall of Cardigan Castle behind, 2m scale

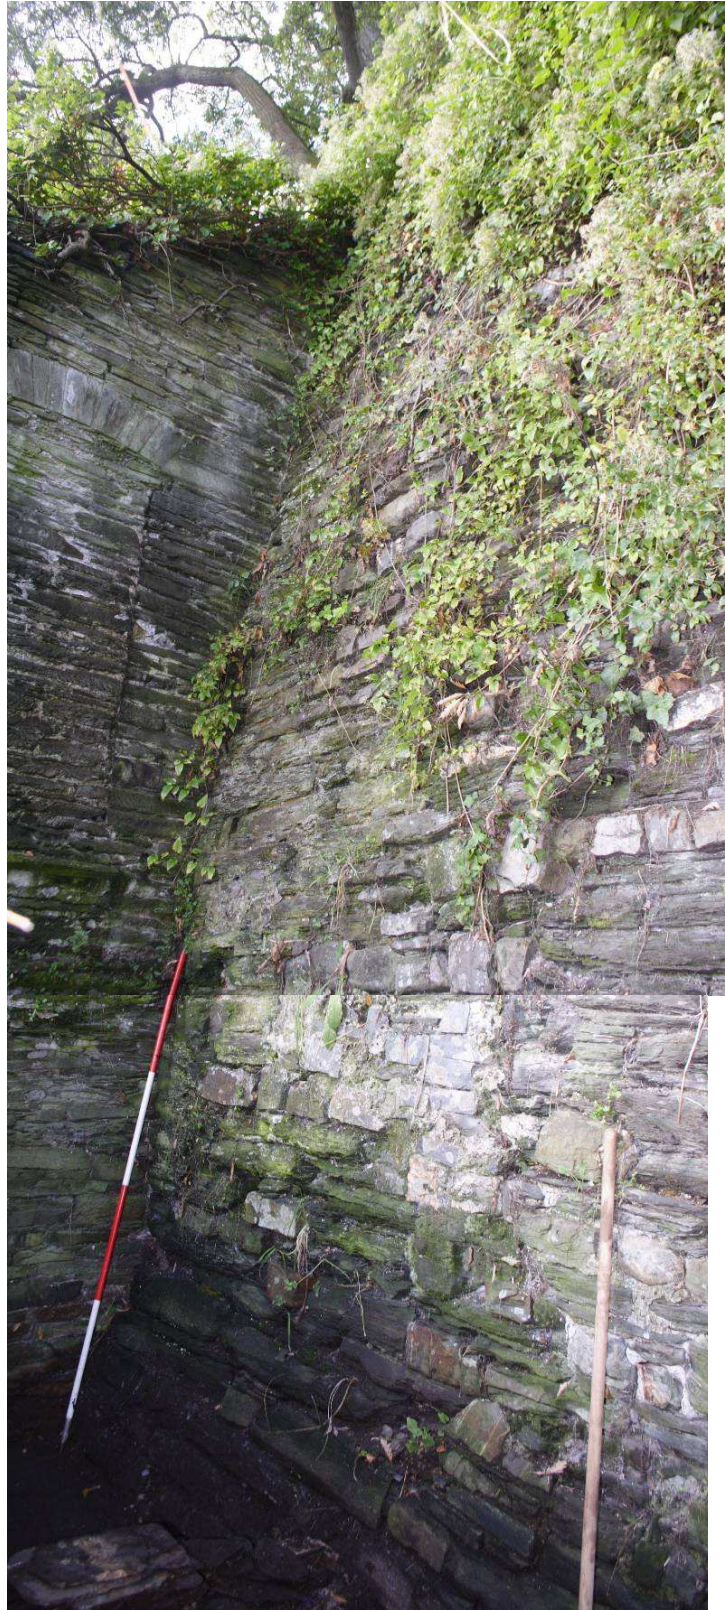
**Photo 11:** Composite photograph showing southeastern elevation of North East Bastion within southern half of Room 4 of Stables, 2m scale

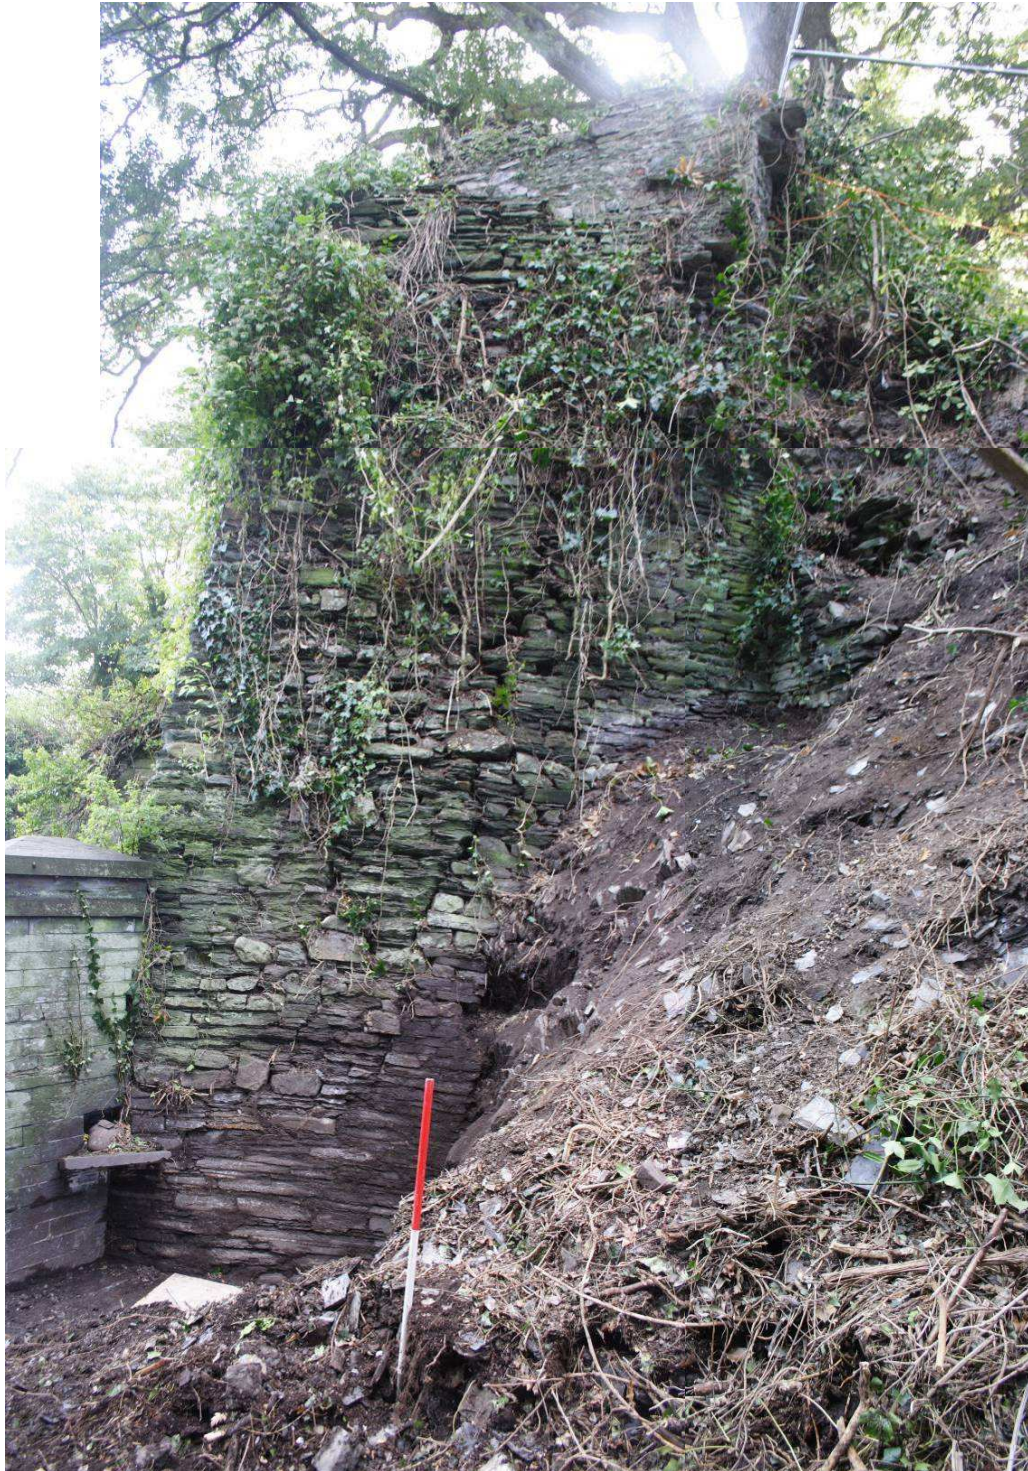
5.5.4 The northern facade of the North East Bastion (Photos 14 and 15) demonstrates how the curtain wall has been built against the natural rock escarpment on which the castle sits. This facade also suggests a number of previous repairs and rebuilds, most clearly at its base where neat coursing of thin slabs suddenly changes to areas of larger, less well mortared stone (Photo 14). A number of fissures in the wall indicate subsidence and instability (since repaired). The upper part of the Bastion has a number of walls at slightly different alignments which relate to rebuilding during the 19<sup>th</sup> century works.

**Photo 14:** Composite photo of the northern elevation of the North East Bastion wall, 1m scale

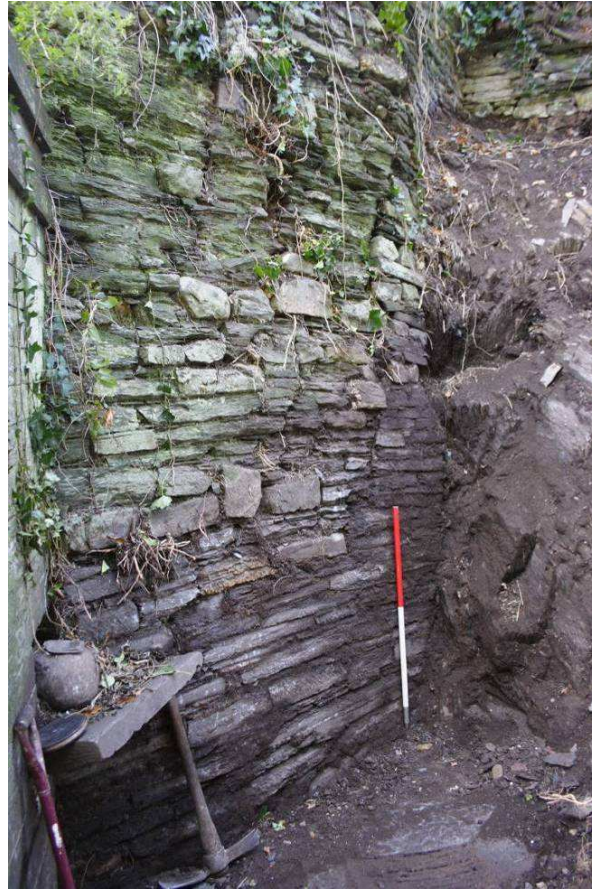
**Photo 15:** Base of the northern elevation of North East Bastion wall and bedrock, 1m scale

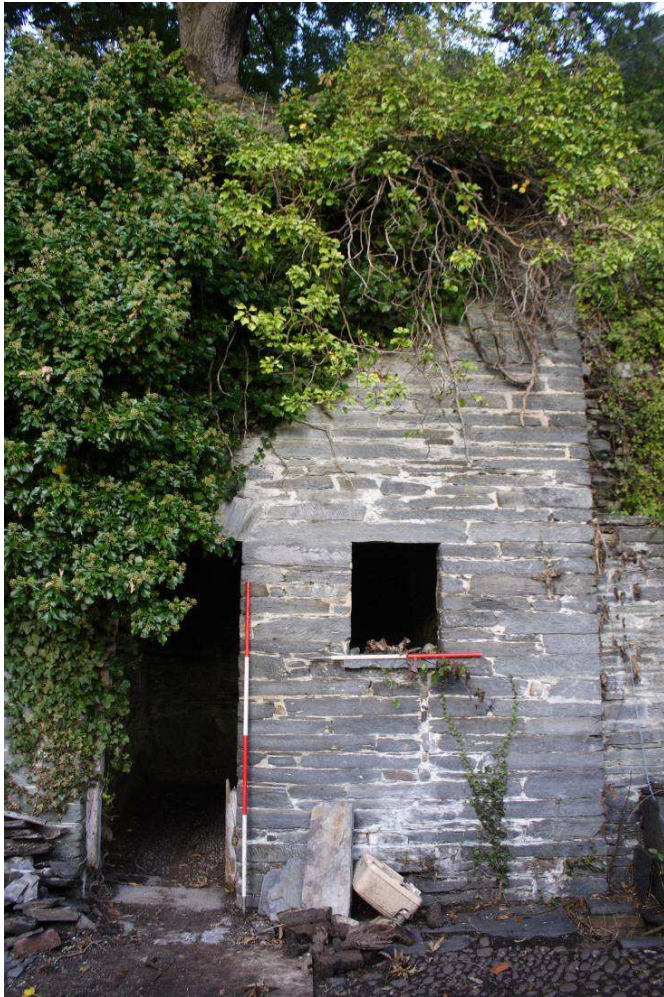
5.6.3 The doorway into Room 1 is in its original location, with the room having a single window to the northeast (Photo 16). This would appear to have been inserted at a later date, as a former blocked fireplace lies beneath it with a blocked flue visible above a rotten wooden lintel in the top of the window (Photo 17). On the exterior this window has a single stone slab lintel (as opposed to a stone arch like the others). A single window is present at the upper level directly above the doorway. A blocked doorway led into Room 2 to the southwest, with further blocked doorways at first floor level leading to the southwest (Photo 19) and to the northeast.

**Photo 16:** Doorway and window of Room 1,  
2m and 1m scale

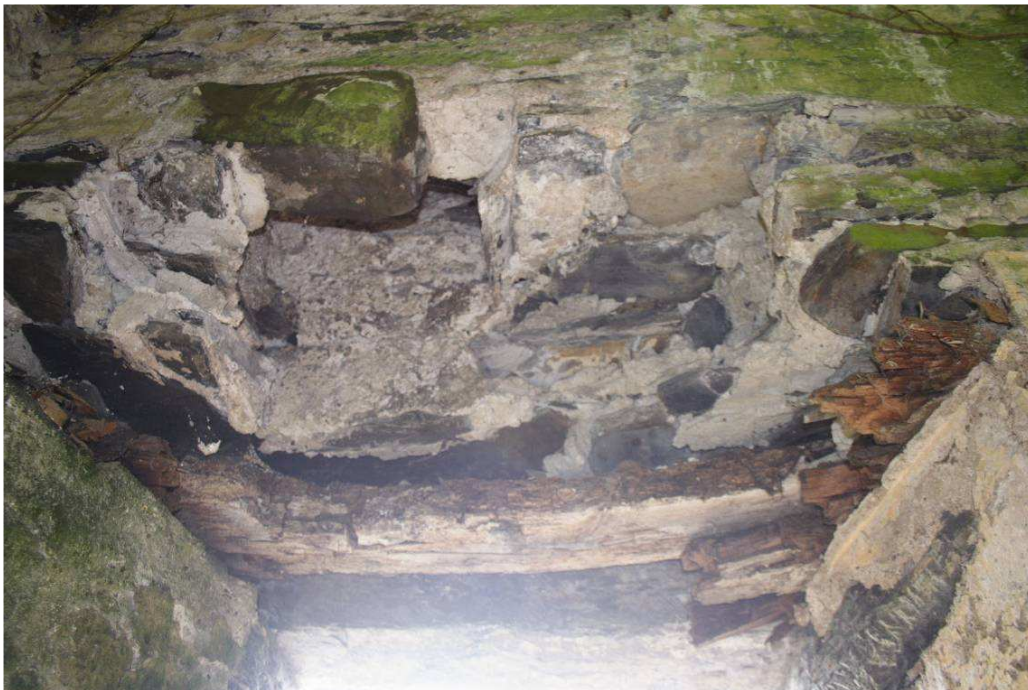
**Photo 19:** Blocked flue of chimney above decayed wooden lintel

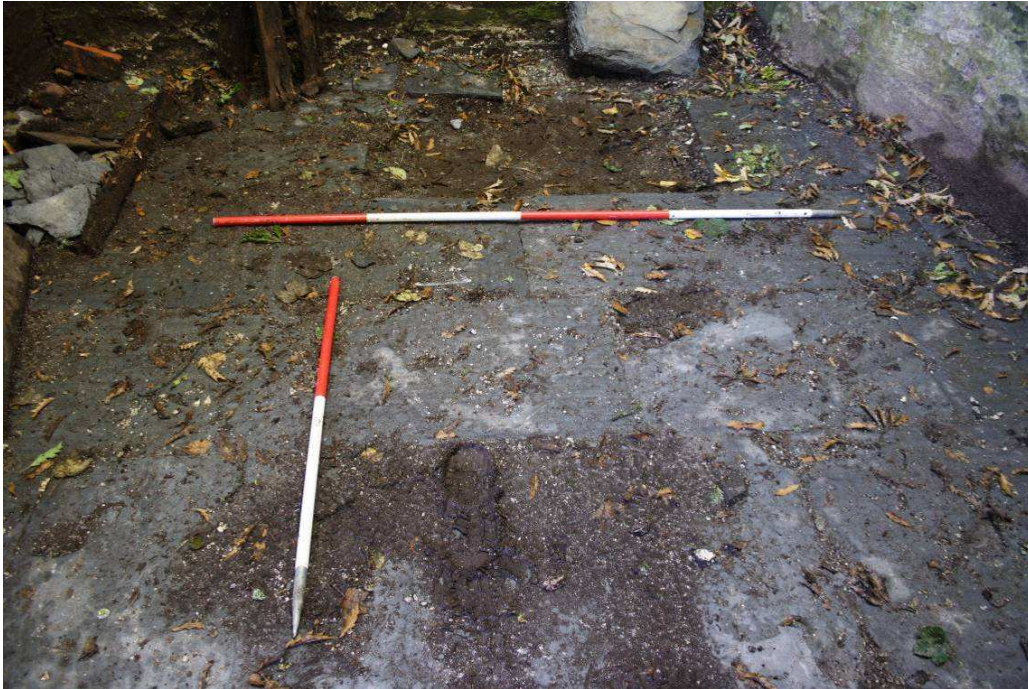
5.6.14 Remnants of a stone flagged floor survive in the room (Photo 26).

**Photo 26:** Floor of Room 3, 2m and 1m scale

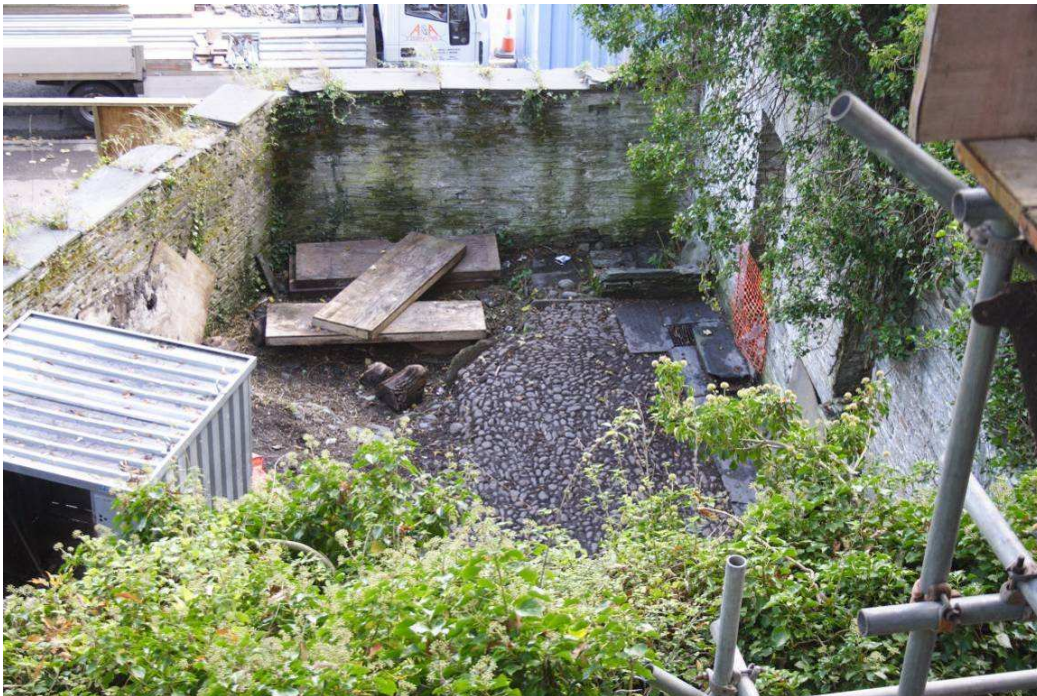
5.6.25 In the southeastern part of the courtyard the cobbles sloped to the southeast. A kerb of slate slabs formed the edge of this slope (Photo 32). The function of this slope is uncertain.

**Photo 32:** Cobbled courtyard of The Stables, southern half

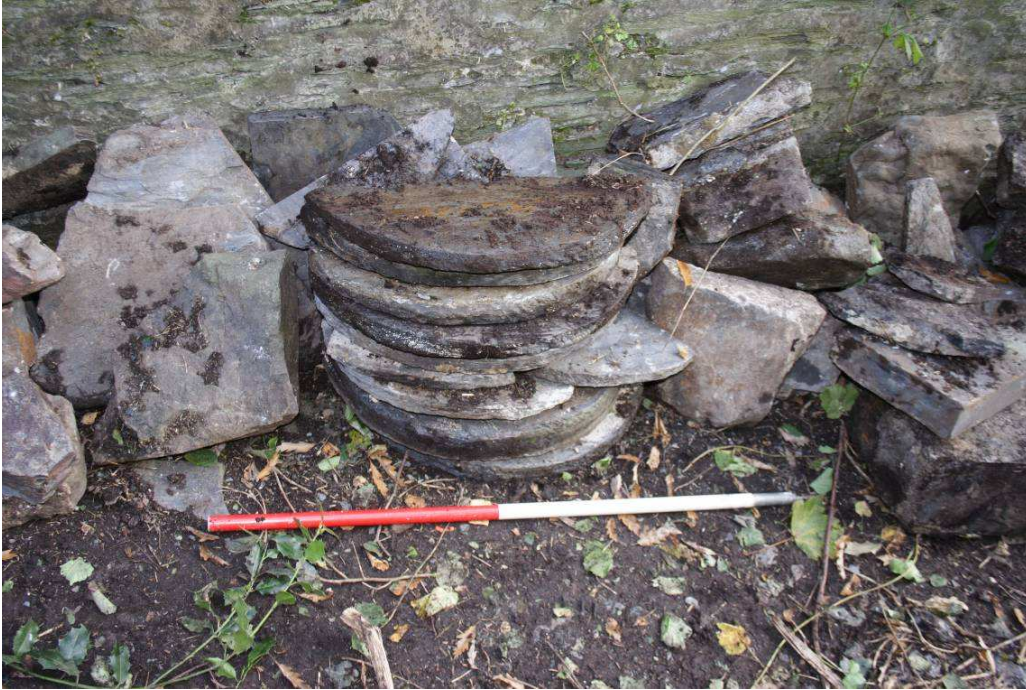
6.5.4 The material removed from this area contained numerous semi-circular slate slabs (Photo 36). The function of these stones is uncertain, but is presumed to have been decorative associated with the formal gardens.

**Photo 36:** Sample of the semi-circular stone slabs found in backfill, 1m scale

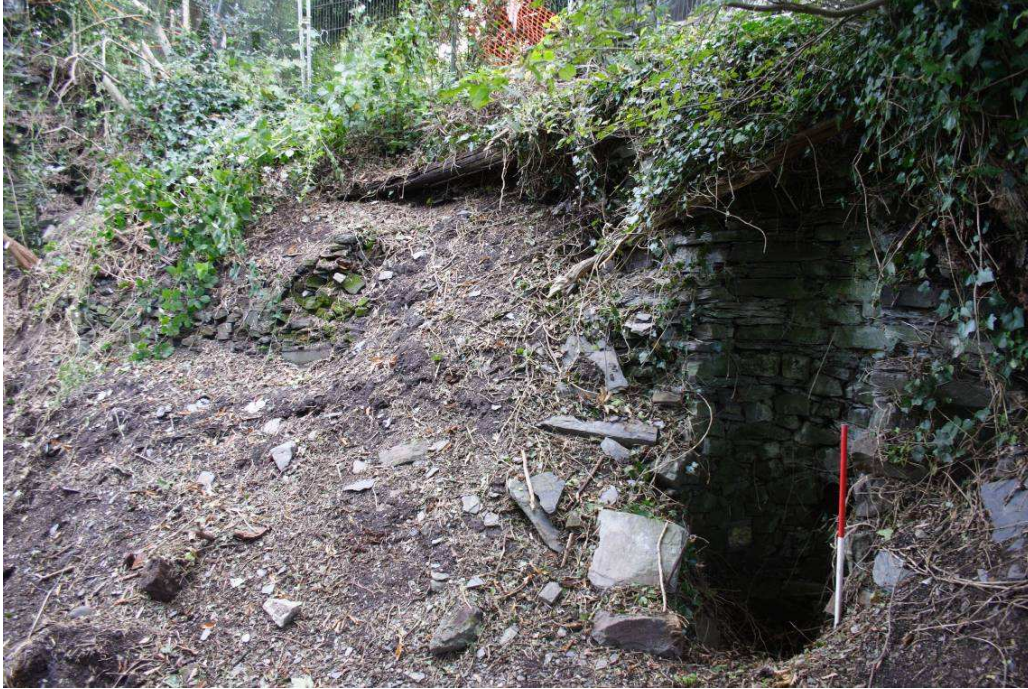
6.5.5 To the north of the North East Bastion further debris of the former retaining wall that ran alongside the sloped walkway from the stables to the castle was removed. The remains of a well had been exposed following the collapse of the retaining wall, which exposed a section through part of the vertical stone shaft (Photo 37). It was constructed of un-mortared stone with rough coursing, comprising rubble stone with dispersed levelling layers of thinner stones. The full depth of the well is unknown as it was covered for safety reasons.

**Photo 37:** Remains of well situated through former retaining wall to north of North East Bastion, 1m scale

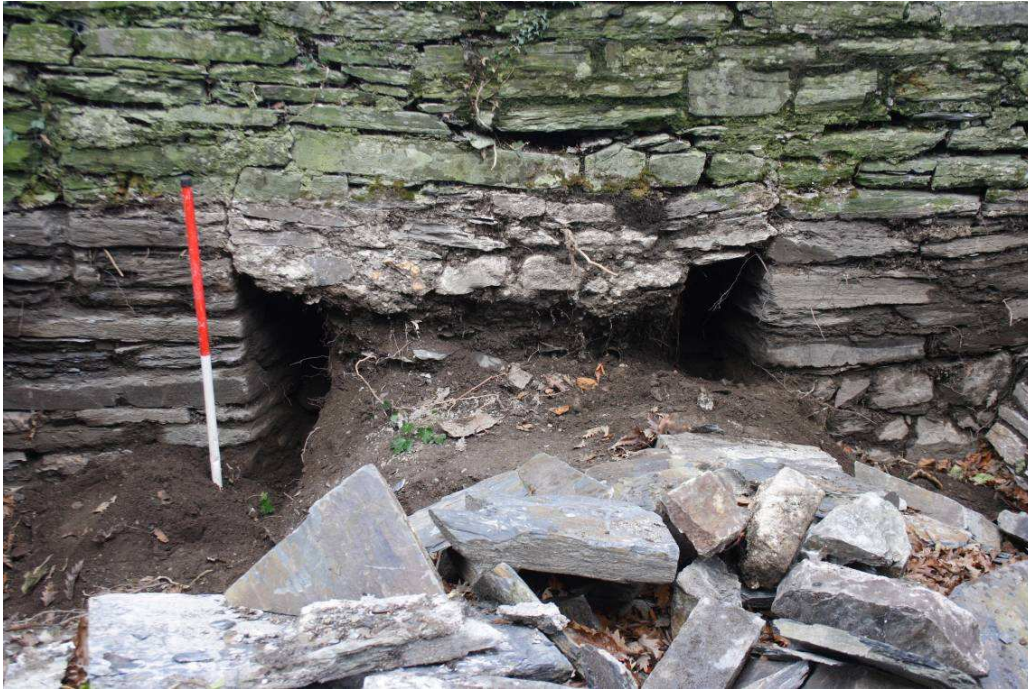
**Photo 41:** Alcove on inside of North East Bastion wall following removal part of infill prior to rebuild, 1m scale

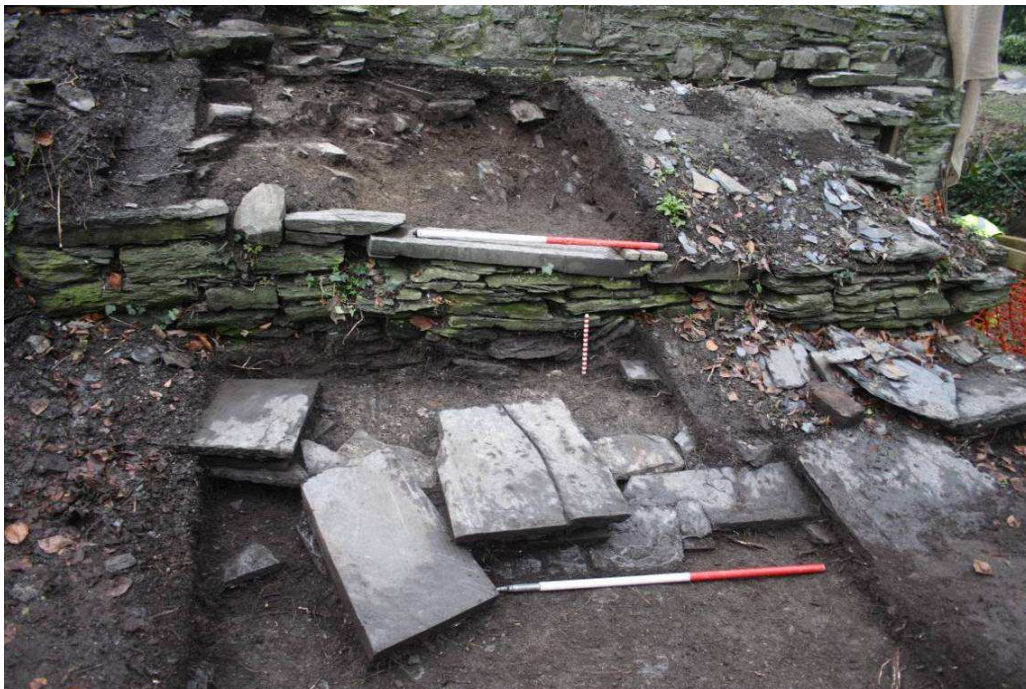
**Photo 52:** Southeastern plinth showing slumped stones and method of construction, 1m and 0.2m scales
