PLAS ABERMEURIG, ABERMEURIG, CEREDIGION

PHOTOGRAPHIC BUILDING RECORD AND WATCHING BRIEF

RHIF YR ADRODDIAD / REPORT NO. 2011/59
RHIF Y PROSIECT / PROJECT RECORD NO. 102584

Rhagfyr 2011
December 2011

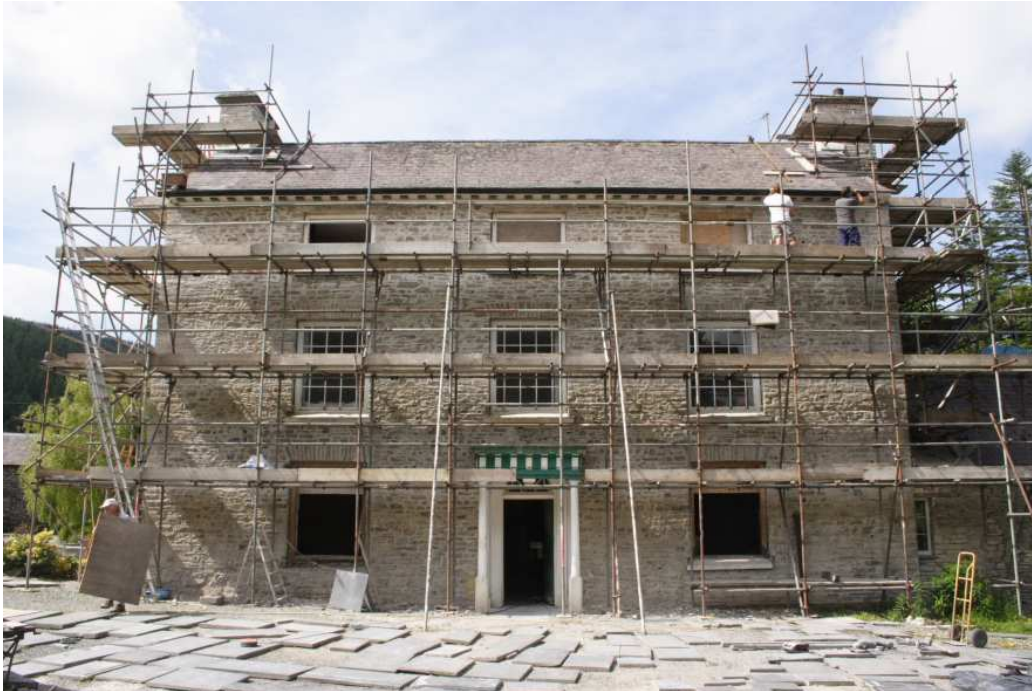
The main three-storey exterior of the house (Photo 1) appears to have been built in a single phase, with no visible evidence of alterations to door and window openings. The two storey western range of rooms may be a later addition, possibly when the house was re-modelled in the 19th century. Internally, however, there is some evidence, and some unexplainable features to suggest that there may have been an intermediate phase of building between the 19th

Photo 1: The East facing facade of Plas Abermeurig

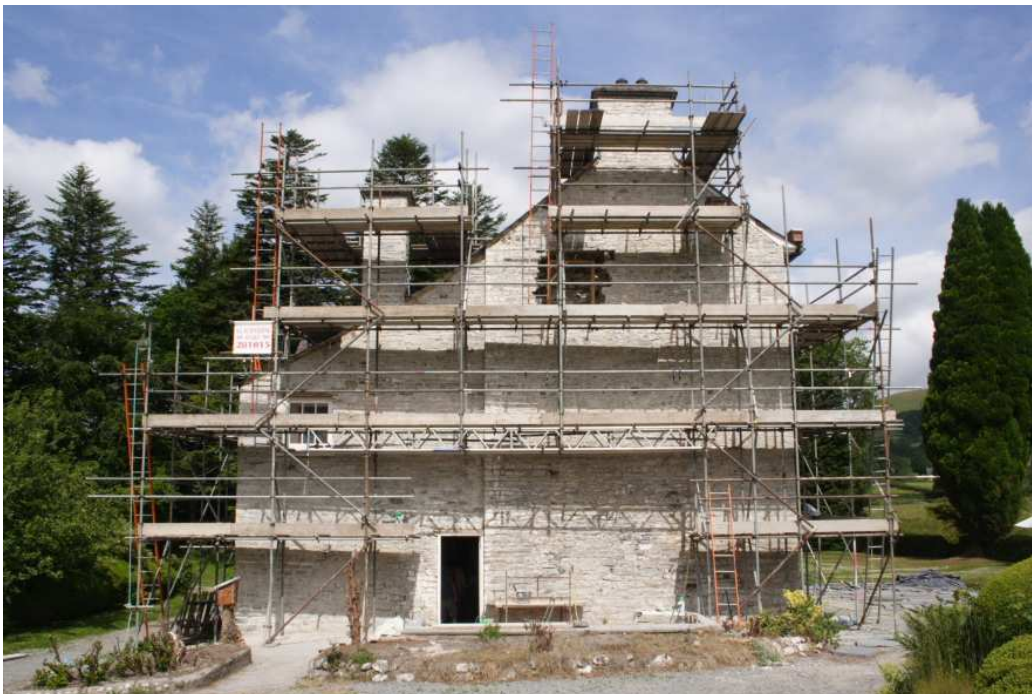
Photo 2: The south facing elevation

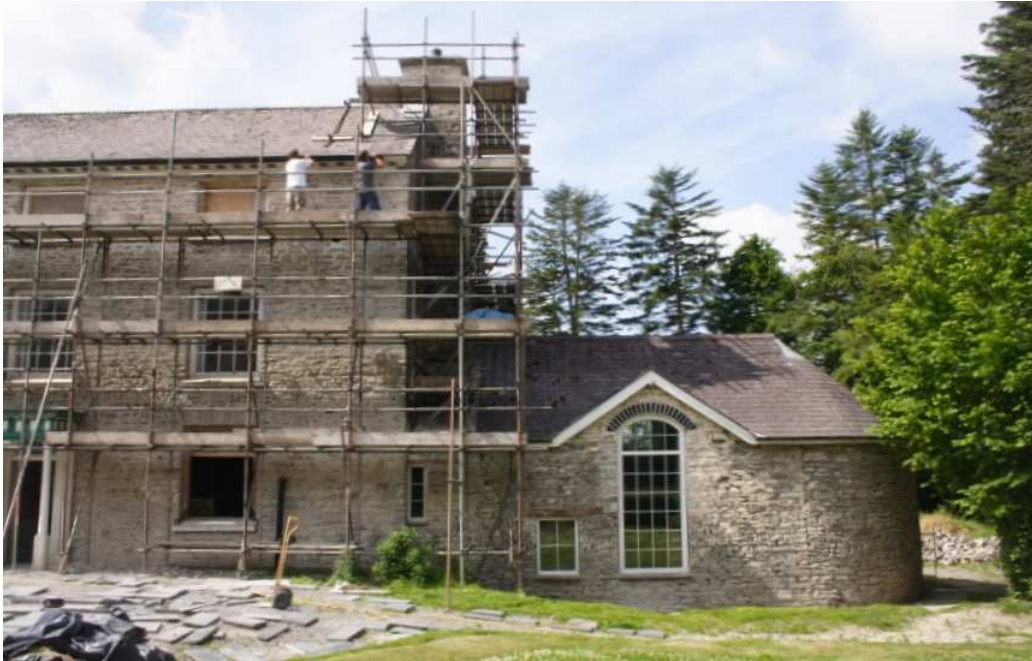
The north annexe, the single storey part of the house (Photos 3-6), is set back slightly from the main house and appears to be of earlier origin. A narrow window where the two building phases meet (Photo 8) appears to be part of what was originally a larger window in the earlier building, the south part of which has been truncated by the façade of the 19th century house. The base of this window is at a higher level than the window to the north (Photo 4). Originally, this wall would have continued northwards forming the northern part of a possible long-house style building, however, an irregular joint visible in the stonework to the north of this window (Photo 4) suggest that the east face of the north annexe has been substantially or even entirely rebuilt, flush with the earlier wall. On the interior, the wall of the rebuilt section is thicker than the section of wall containing the narrow window (Photo 11). A series of steps in the interior face of the rebuilt wall where it joins the earlier wall (Photo 12) are a curious detail which may have been intended to strengthen the join between the two phases of walling. Within the rebuilt section are a window opening with a wooden lintel and two straight joints indicating the former presence of a doorway (Photo 4). There is no evidence for a window ever having been present to the right (north) of the doorway.

Photo 3: The east facing north end of the house

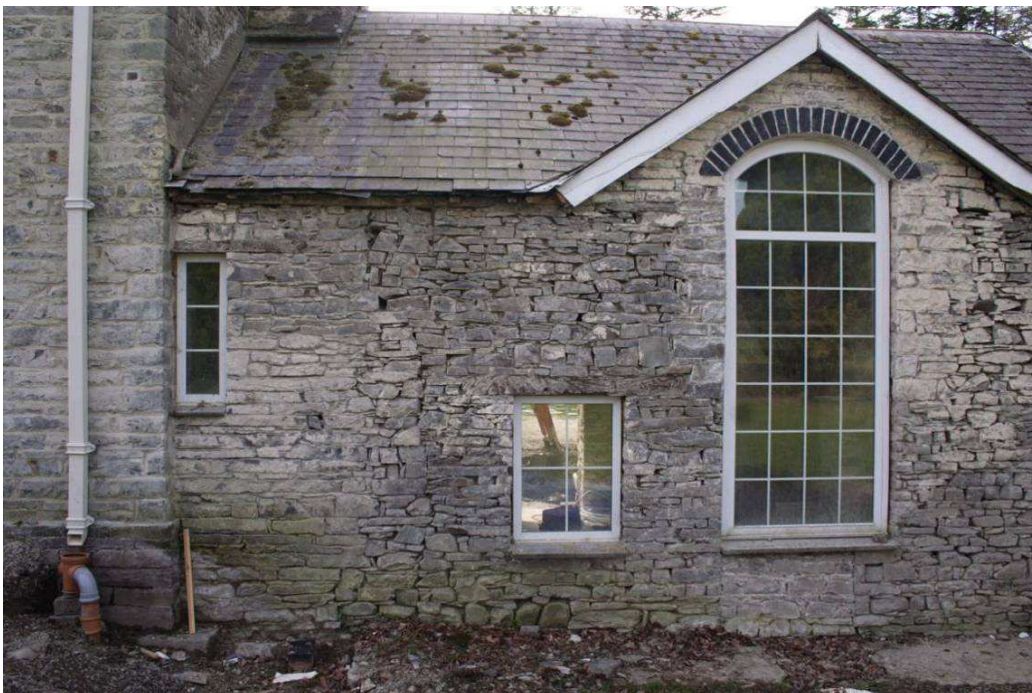
In a later phase of alteration (modern), this doorway was blocked and a tall arched window was inserted (Photo 4). The arched window is wider than the original door opening, and the exterior stonework of the northern door-jamb has been removed to accommodate the window frame. Internally, however, the original width of the doorway and the pad for the door lintel (indicating its height) appears to have been retained (Photos 10 and 18) (the sawn off stub of which is still present on the south side of the doorway). To the north of this window, a straight joint indicates the end of the building (Photo 7). The thickness of the walls at this point (and on the west side of the building) suggest they are contemporary with the window and former doorway. There is no surviving evidence to indicate whether the rebuilt walls of the northern annexe, correspond with the footprint of the earlier phase or not (although it is considered likely). In a later phase of alteration, the north wall of the annexe was demolished and replaced by a curved wall forming an apsidal end to the building, and including a window opening on the east face (Photo 3) and a doorway on the west face. This seems to be an early 20th century addition and may be associated with its purported use as a chapel for a short time.

Photo 4: The north end east facing elevation (note differences in stonework and window heights)

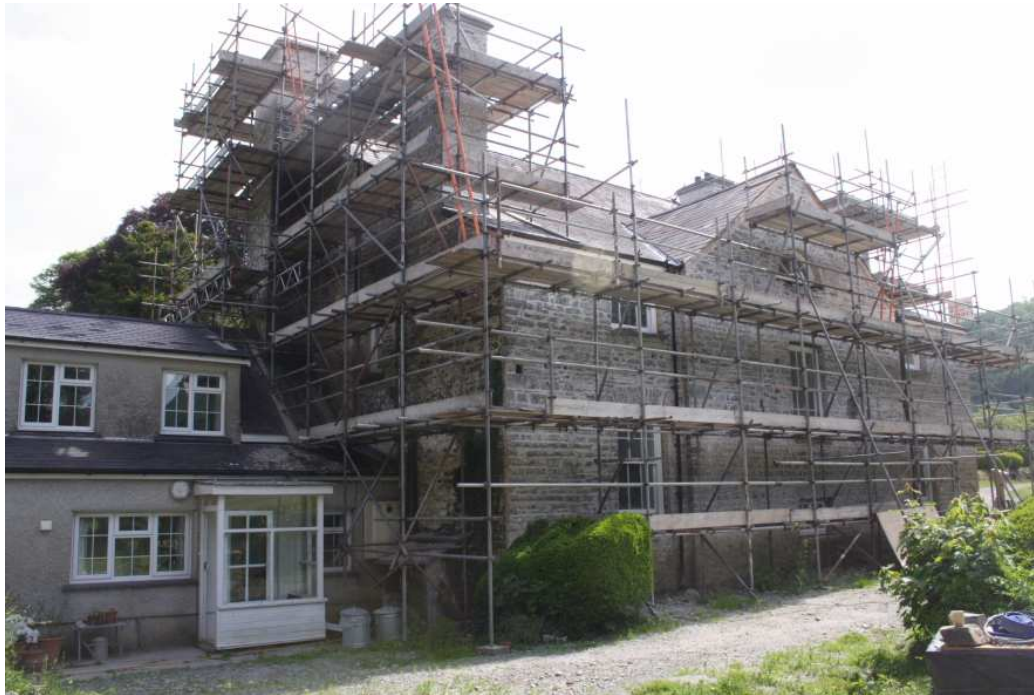
Photo 5: The west facing elevation

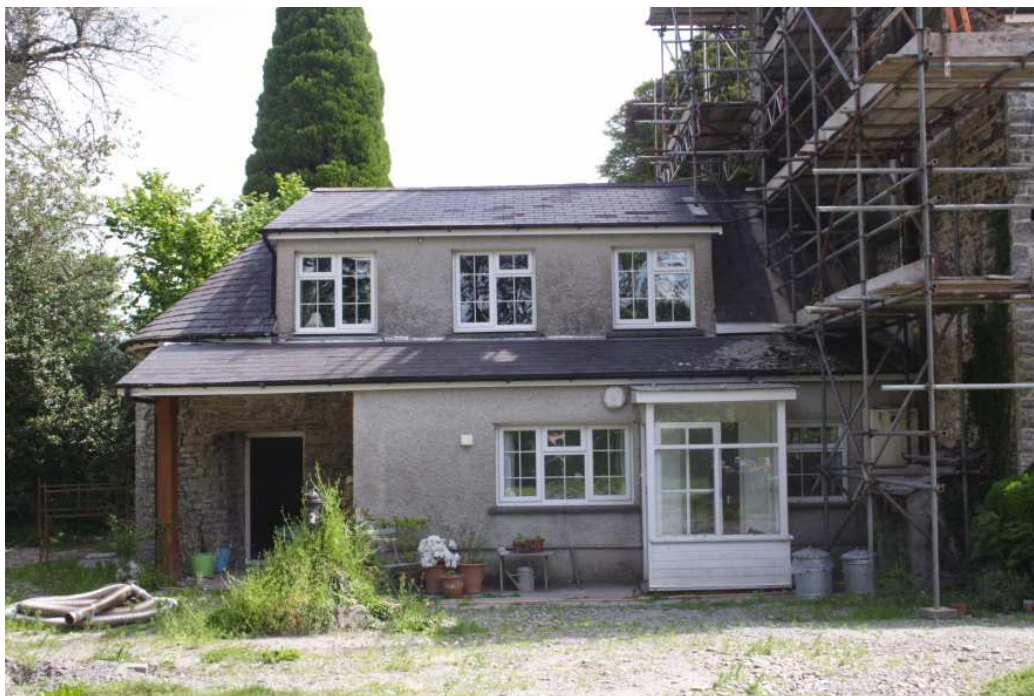
Photo 6: The north end west facing elevation

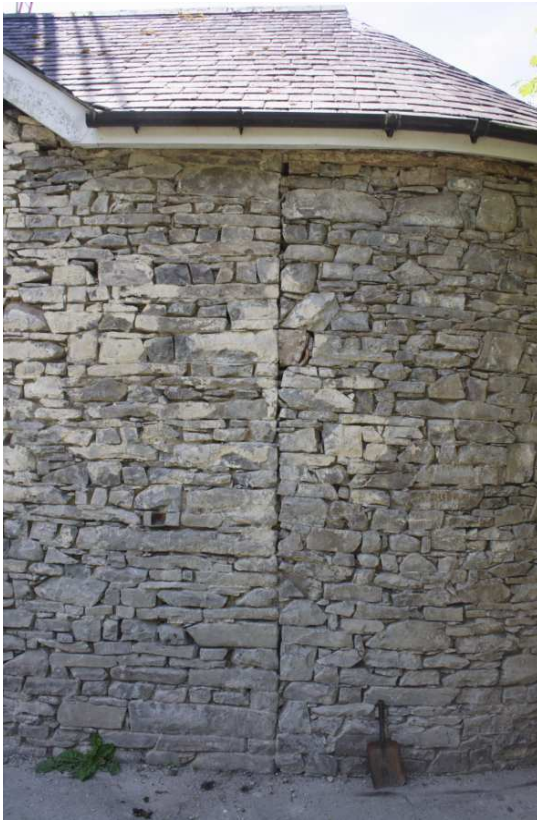
Photo 7: Straight joint between northern annexe and the apsidal end

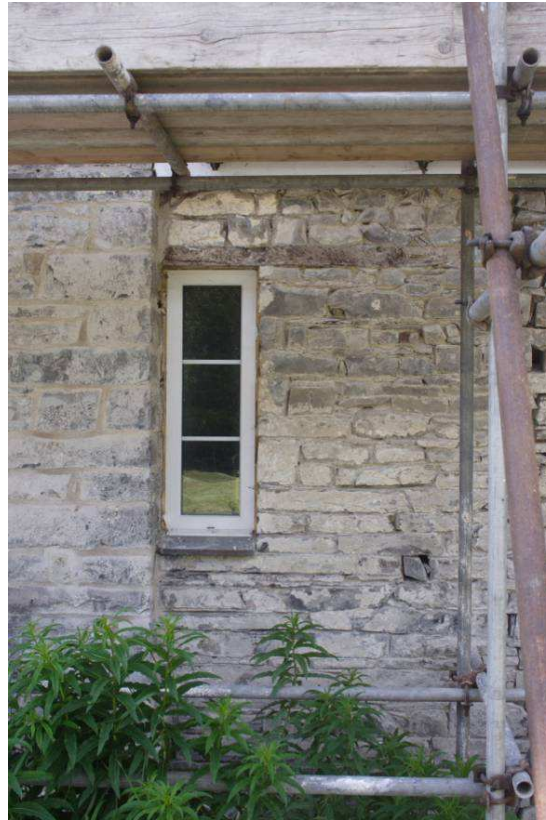
Photo 8: Possible truncated window (in location of former doorway?)

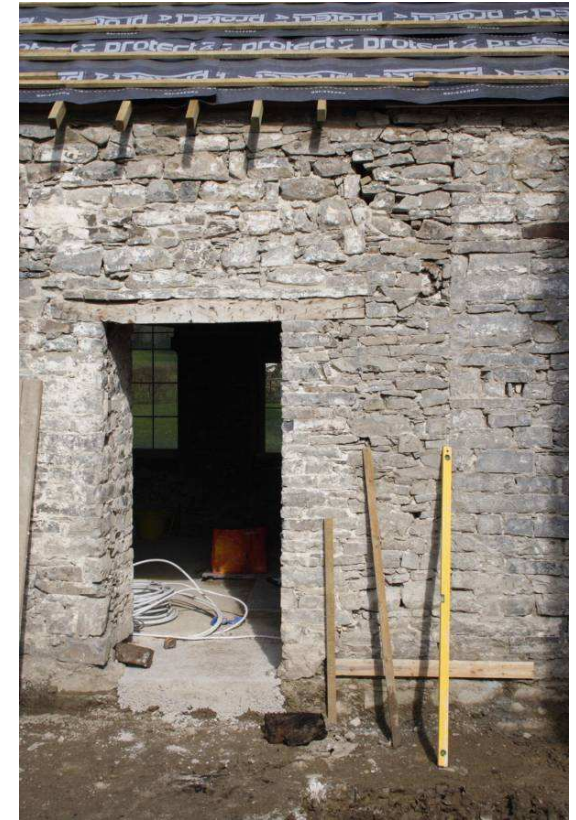
Photo 9: Doorway in west wall of northern annexe (note straight joint with chimneystack)

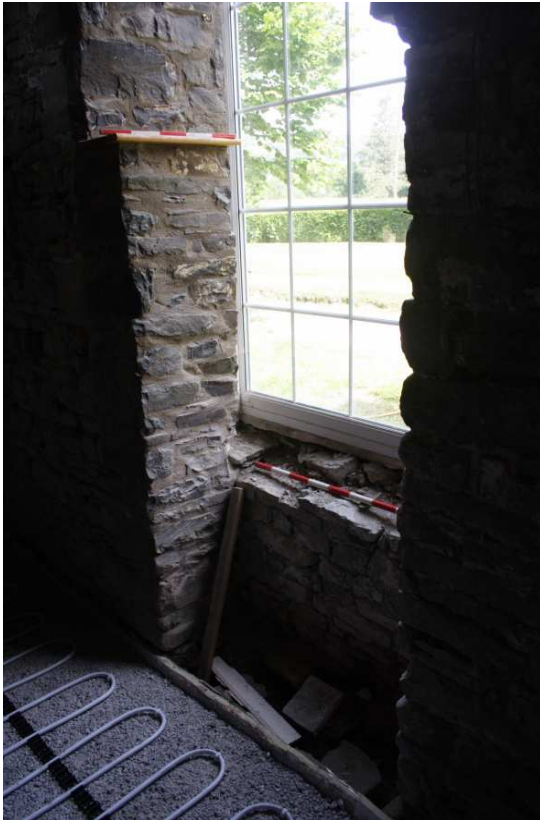
Photo 10: Interior view of arched window opening with 50cm scale resting on location of earlier doorway lintel.

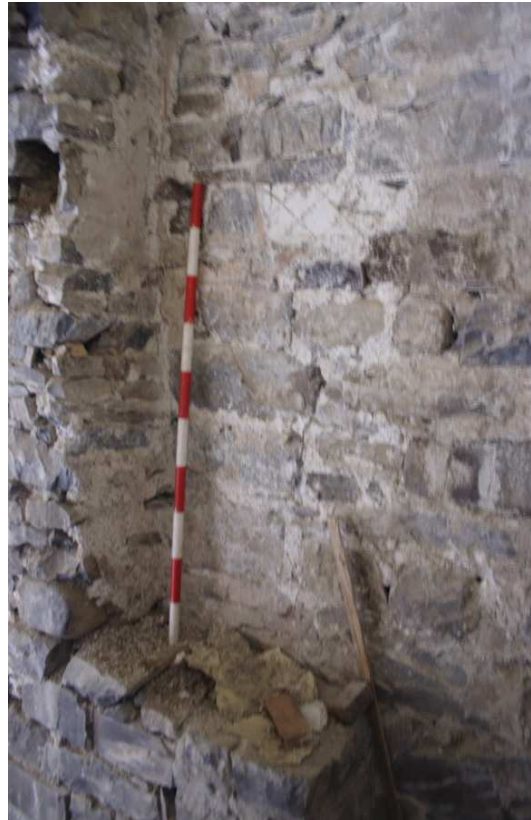
Photo 11: Interior view of interface between early and later walls of east face of northern annexe showing irregular joint in stonework.

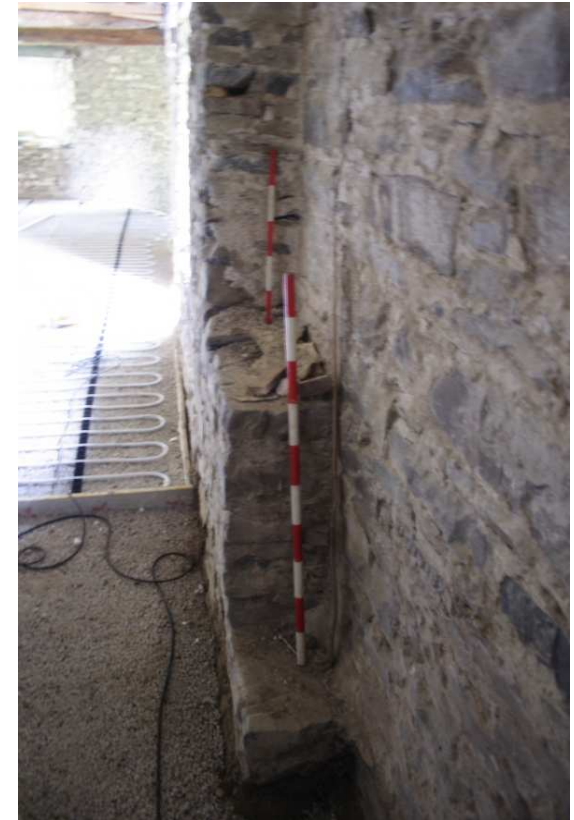
Photo 12: Interior view of interface between early and later walls of east face of northern annexe showing stepped later wall.

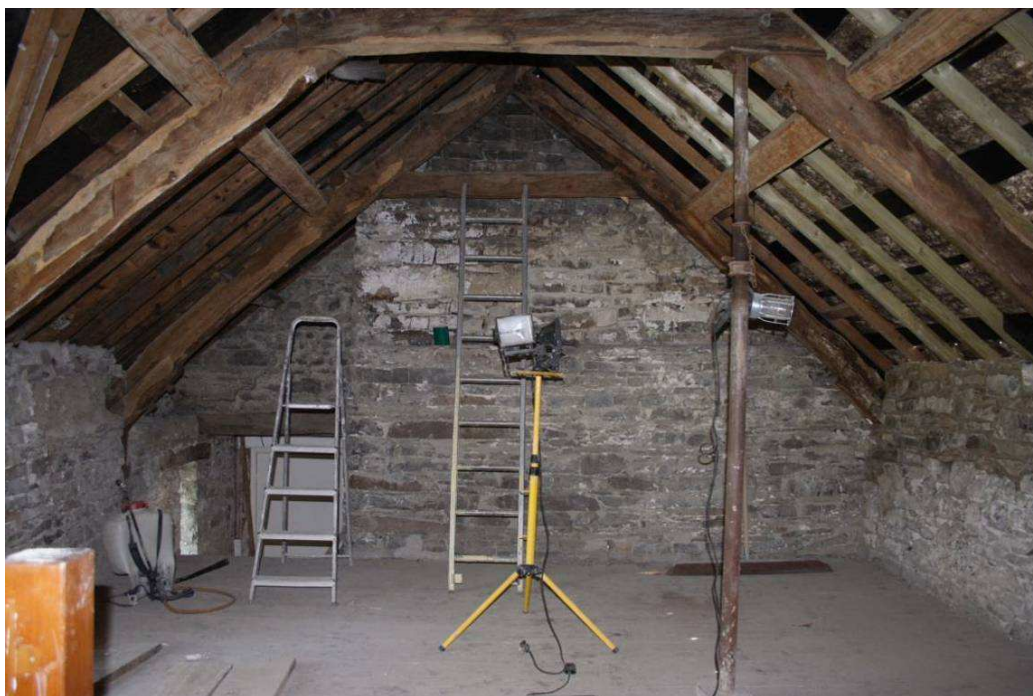
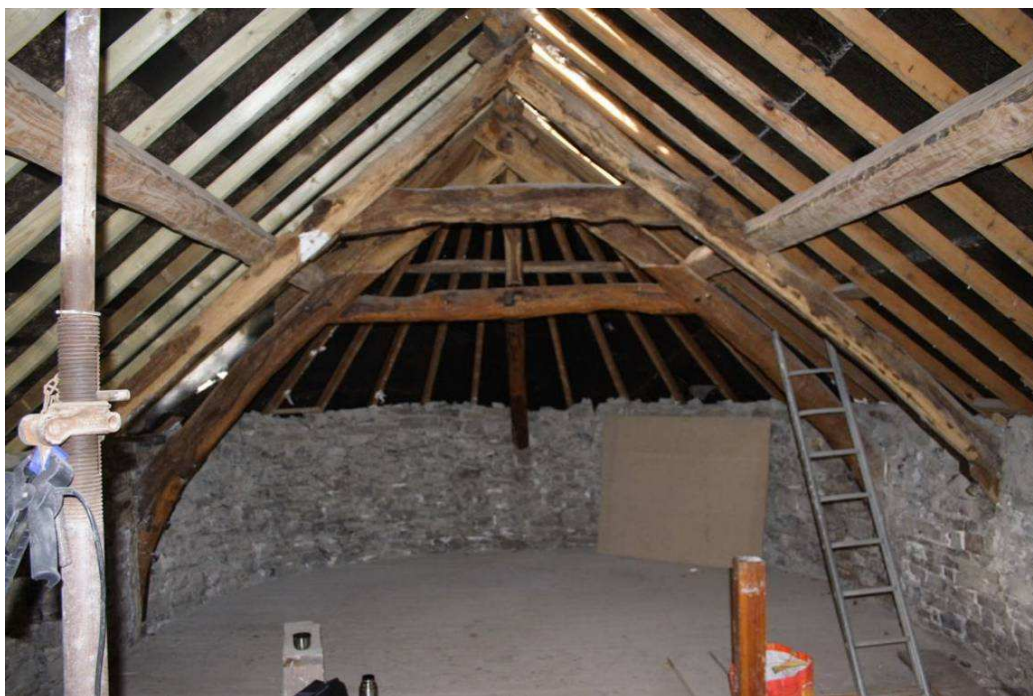
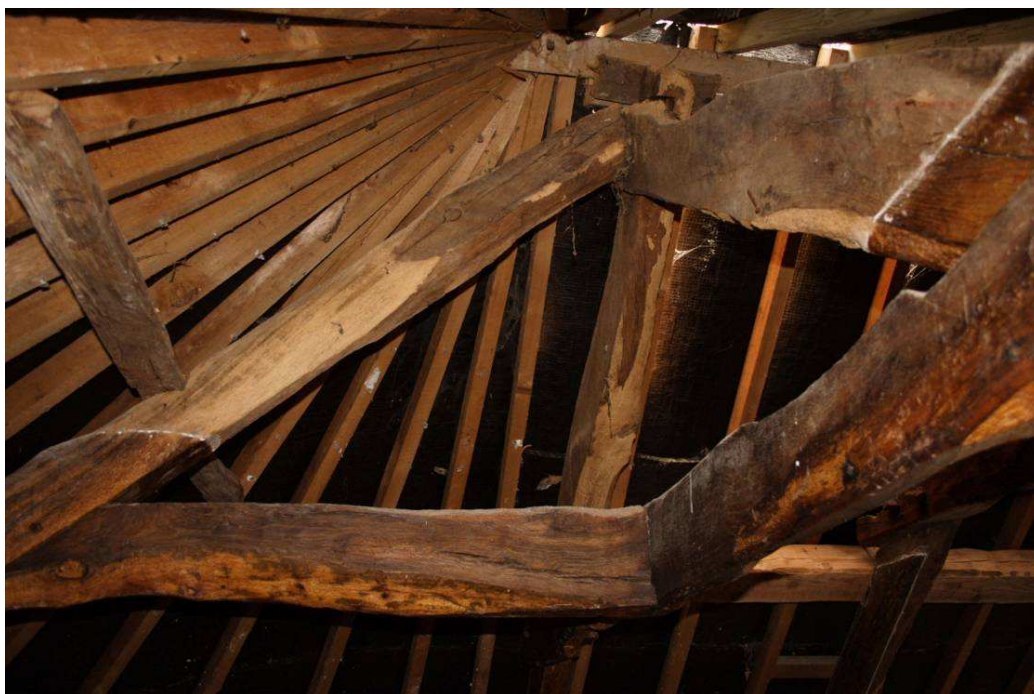
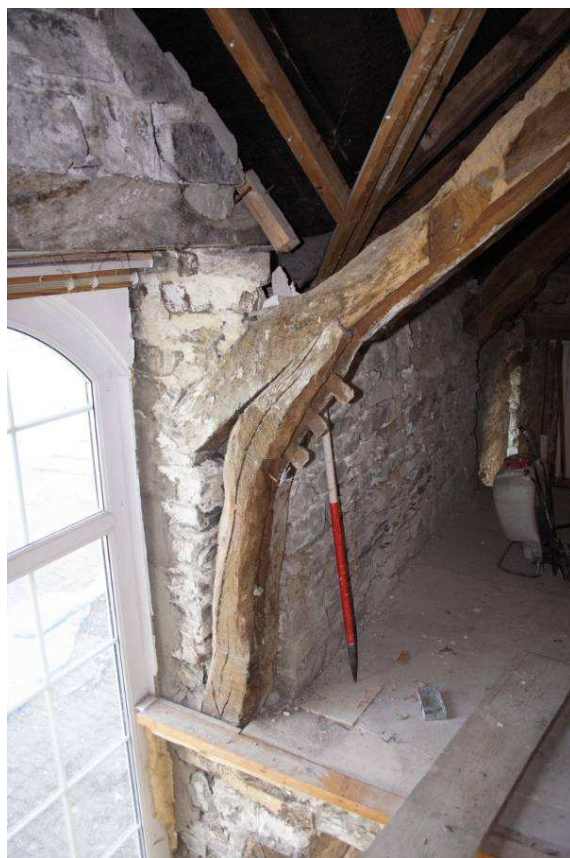
Wooden pegged scarfed (jointed) cruck roof trusses survive, apparently original and in-situ (Photos 13-16). Examples of this cruck style are often dated to between the 17th to early 19th centuries. It is possible that the crucks were originally part of the building that was demolished before the present walls were constructed. Although well constructed, the timbers used, and the absence of any decoration or finishing on the truss, suggest that the trusses were not intended to be a visible feature in the domestic part of a dwelling.

Photo 13: Roof timbers and back-to-back chimney stack. Facing south.

Photo 14: Roof timbers facing north towards apsidal end of northern annexe.

Photo 15: Detail of roof timbers at apsidal end (partially repaired)

Photo 16: Detail of pegged scarfed cruck

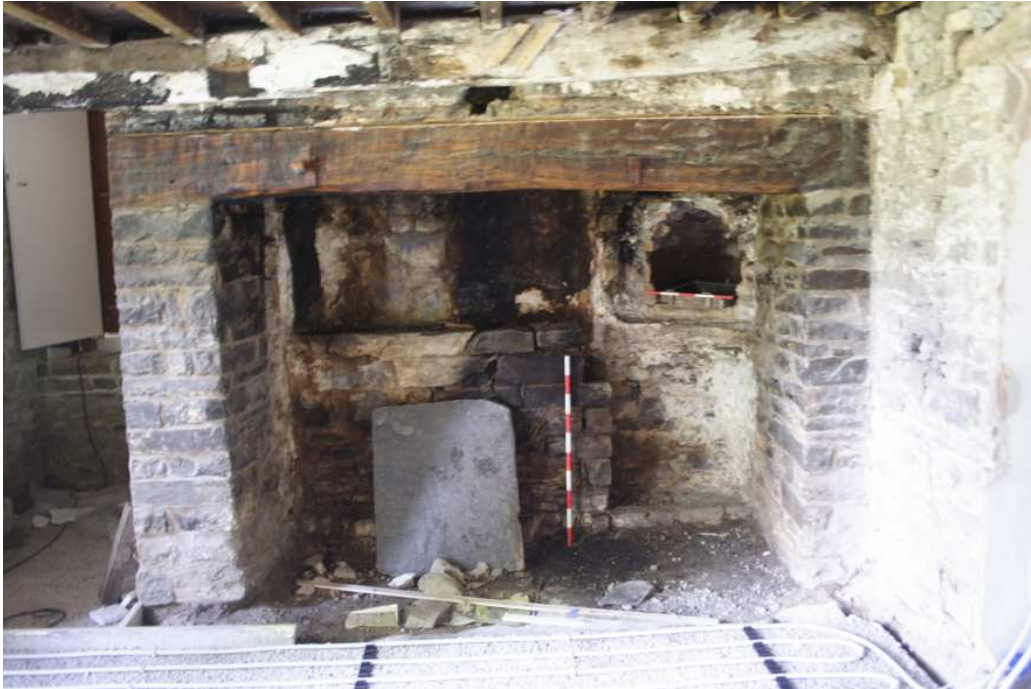
A large chimneystack forms the north wall of the present dining room of the main house (Photo 22), and the south wall of the northern annexe (Photo 17). The hearth in the annexe includes a bread oven which may be a later insertion. The large bressumer beam may also be a modification to an earlier form of hearth, although this is not certain.

Photo 17: North side of back-to-back chimneystack

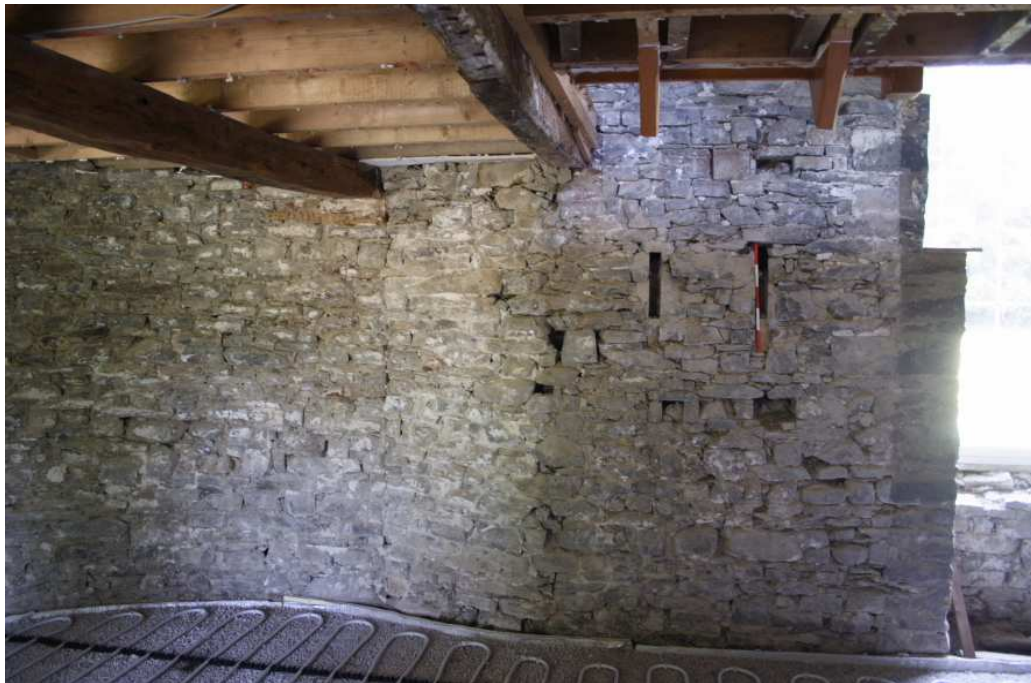
Photo 18: Interior east wall of northern annexe showing recesses in wall and joint to apsidal end

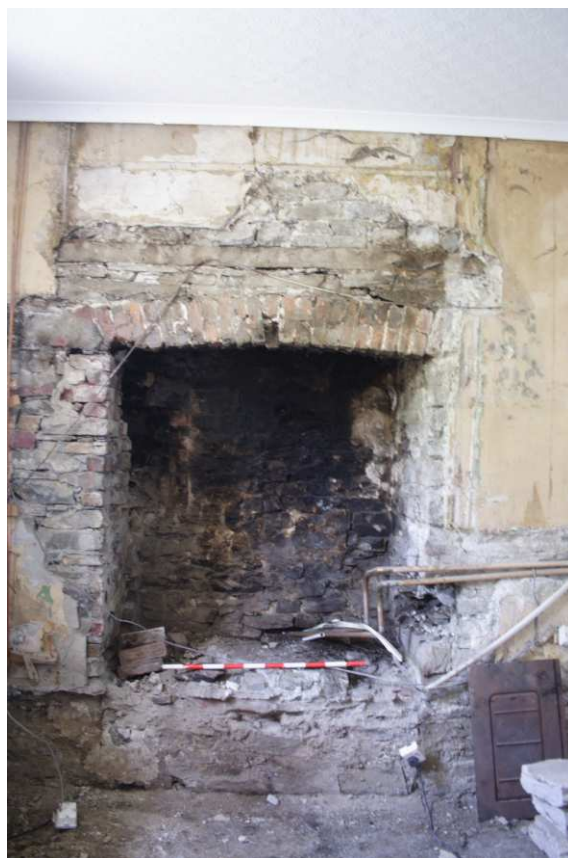
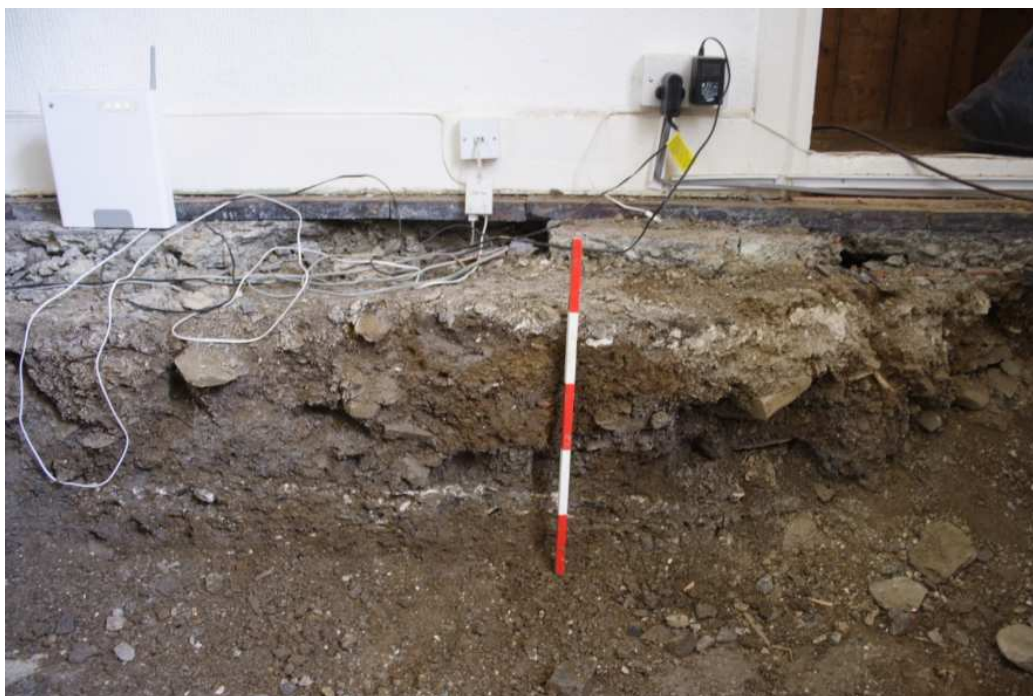
A part of the renovation works, the floor levels in the former kitchen in the western annexe were reduced. The material removed had all been redeposited, and although a lower horizon indicated by a layer of lime mortar was revealed, no more substantial floor deposit was revealed within the depth of material removed (Photos 19 and 20).

Photo 19: Fireplace on former kitchen (floor levels reduced)

Photo 20: Sub-floor deposits in former kitchen

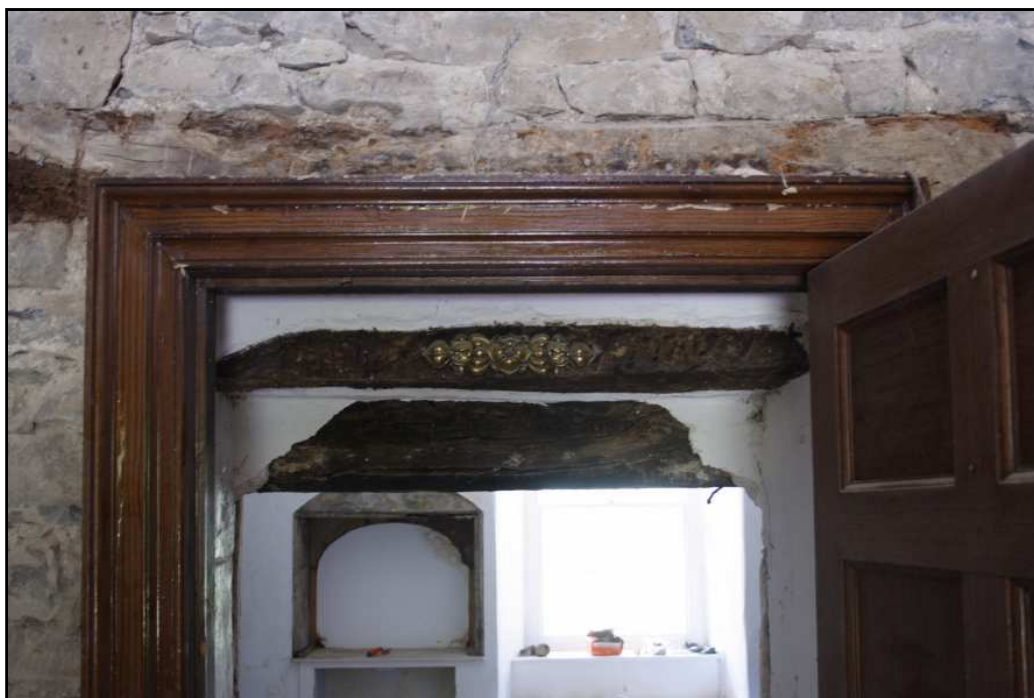
Photo 21: Three door lintels in doorway between dining room and former kitchen (equating to three phases of building?)

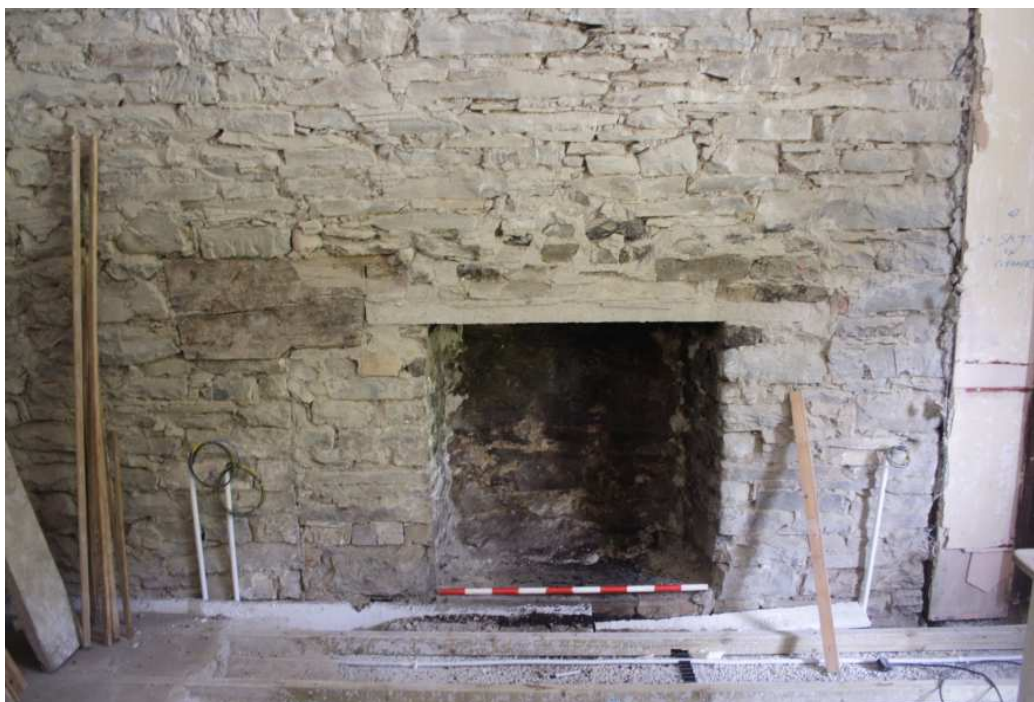
On the dining room side of the chimneystack, the removal of wall plaster revealed the presence of another early hearth with a large, chamfered bressumer beam (Photos 22 and 24). This hearth was blocked up and replaced by a smaller fireplace (which cut through the bressumer beam) during the later rebuilds of the house.

Photo 22: South side of back-to-back fireplace showing truncated bressumer beam and later inserted hearth.

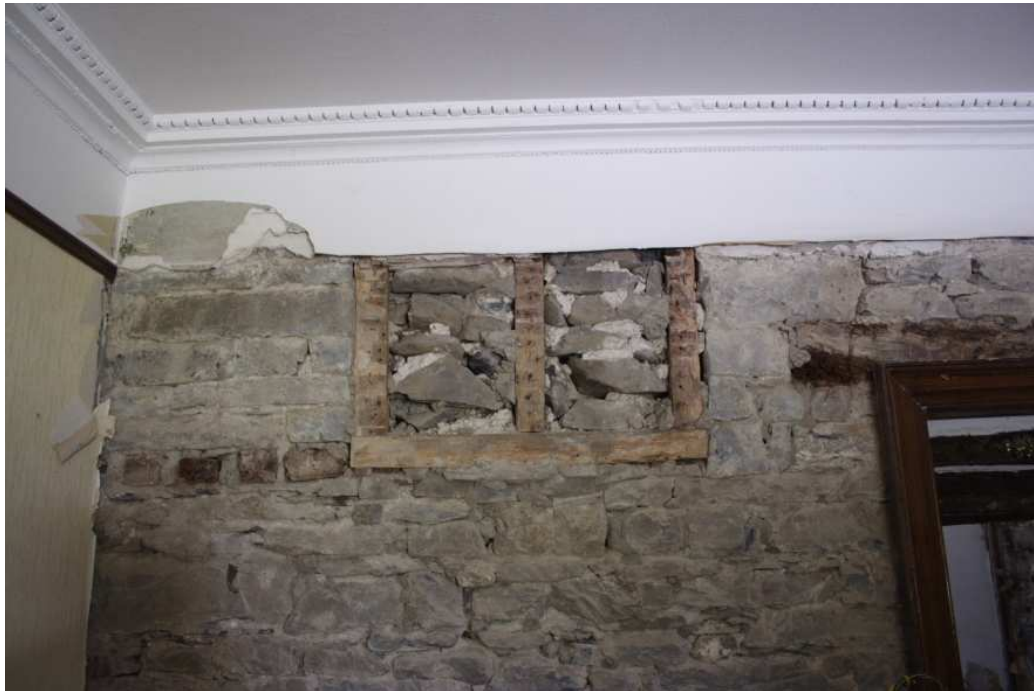
Photo 23: Blocked opening in west wall of dining room
(note height in relation to door lintels).

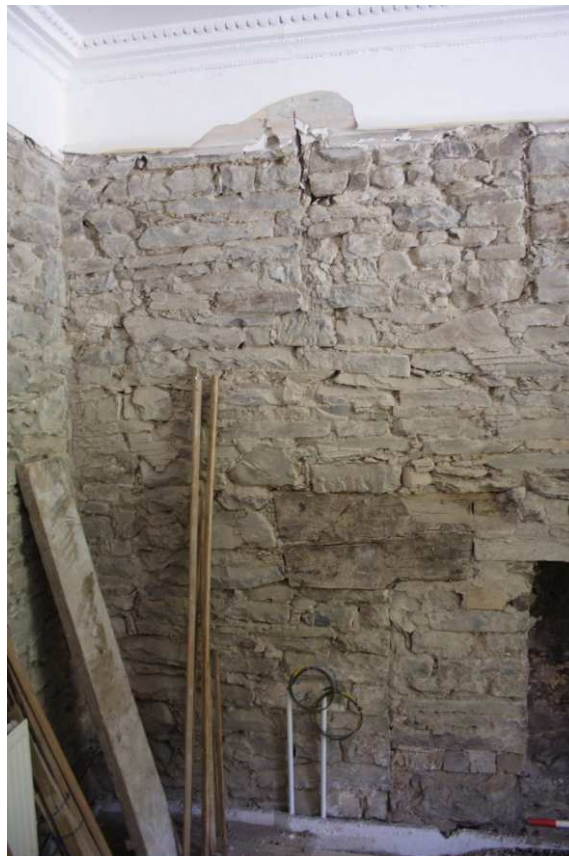
The lower part of a blocked opening visible to the upper left of the dining room fireplace (see Photo 24) may have provided access (via a ladder or stair) to a loft space above the northern part of the house.

Photo 24: Blocked opening in north wall of dining room above fireplace.

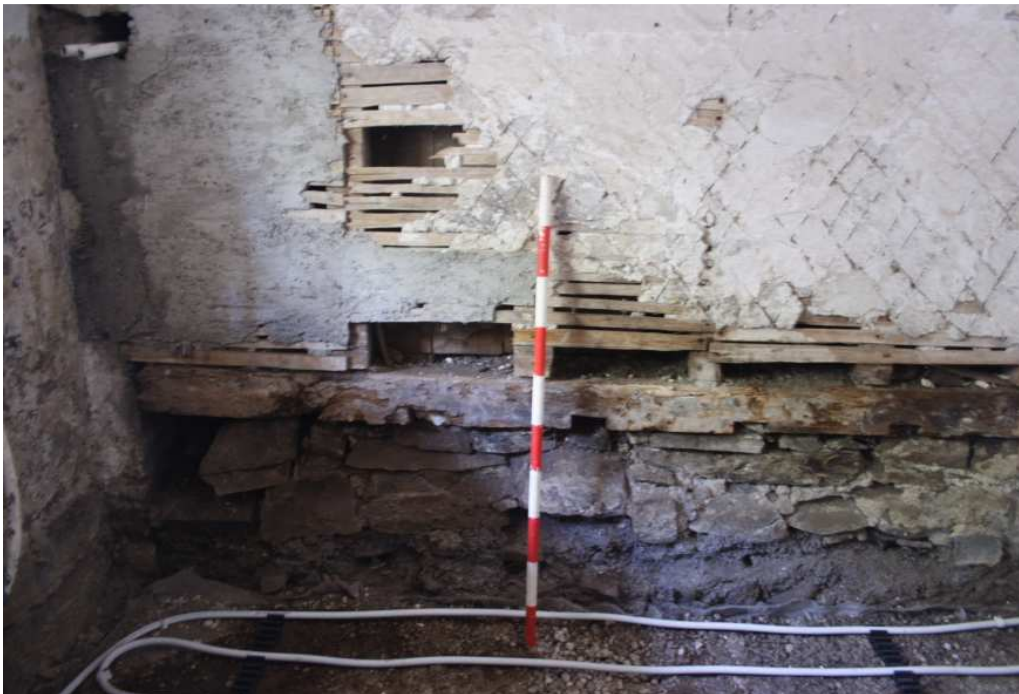
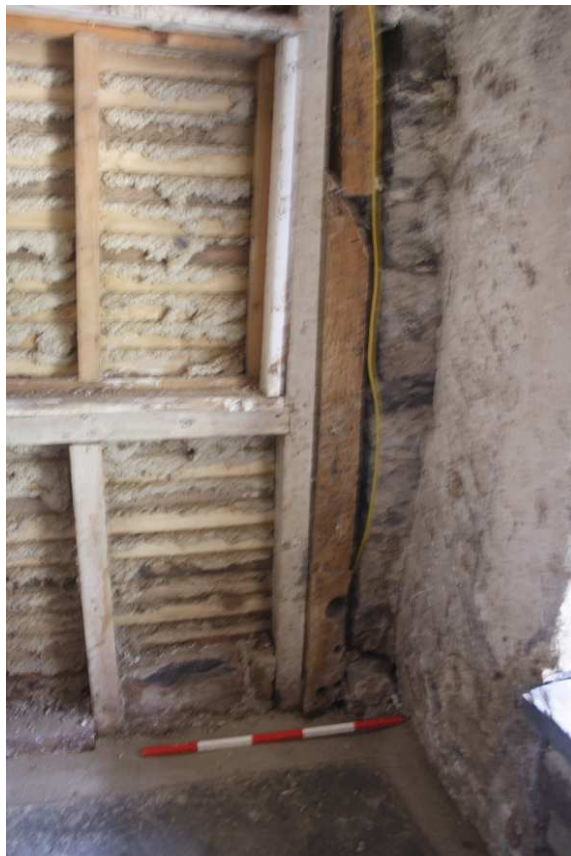
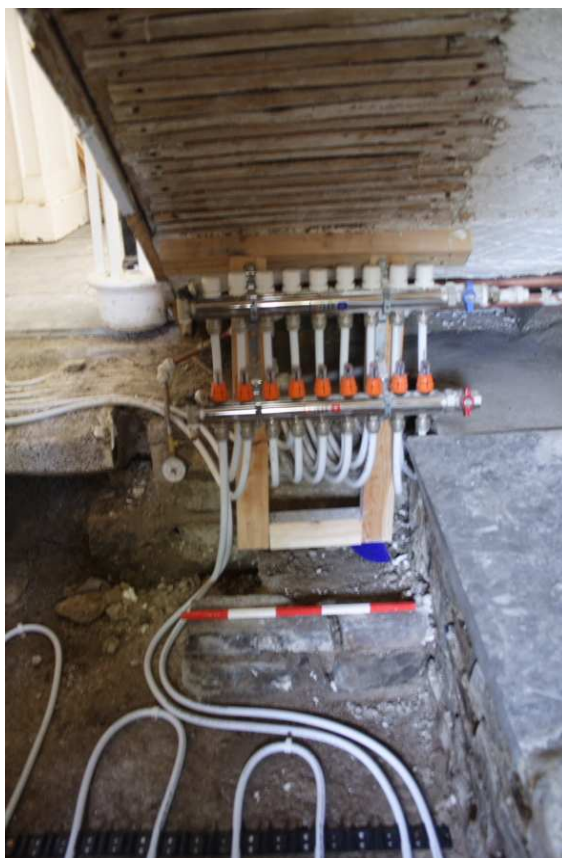
In the under-stair area, floor levels were also reduced. Straight joins visible in the stonework of the west wall suggest a former door opening. Other stonework hints at an earlier building plan, the details of which remain unclear. Being constructed from re-used timber, the 19th century stairwell panels appear to be a later modification (Photos 25-27).

Photo 25: Lath and plaster stairwell division utilising re-used timber (note straight joint to left). Looking north.

Photo 26: Stairwell looking south (note straight joint to right)

Photo 27: Wall stub below stairs (part of earlier building?)

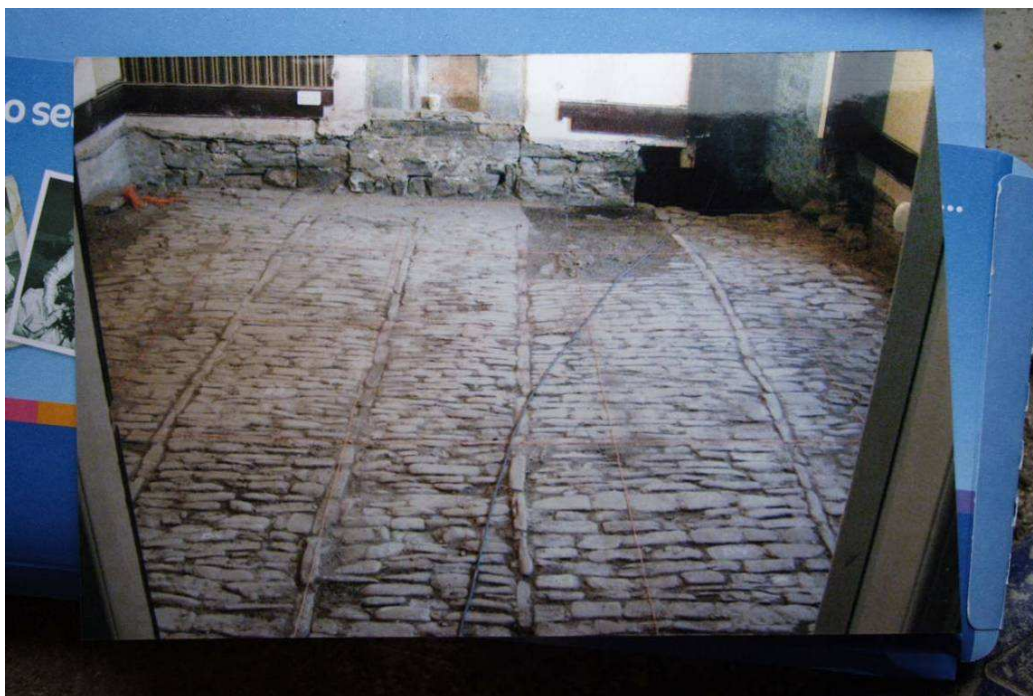
During the renovations, the 19th century floor levels in the dining room were reduced to reveal a fine, decoratively lain cobbled floor surface (Photo 28). This lower surface was associated with a hearthstone at the base of the fireplace (Photo 29), and was at a slightly higher level than the floor in the northern annexe (which was not cobbled).

Photo 28: Cobbled floor in dining room
(note hearth stone and base of original fireplace)

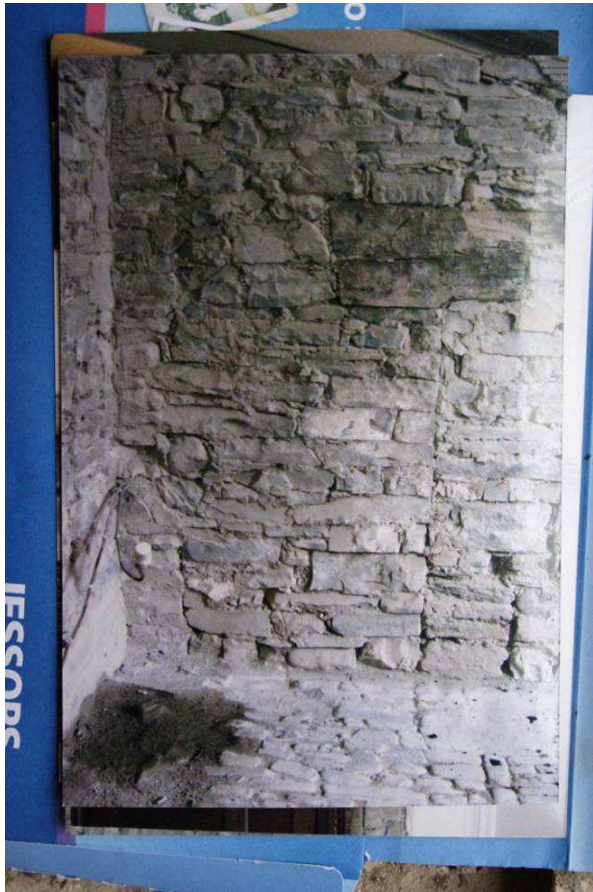
Photo 29: Cobbles in dining room (note hearth stone, blocked fireplace, straight joint to left and missing cobbles against wall)

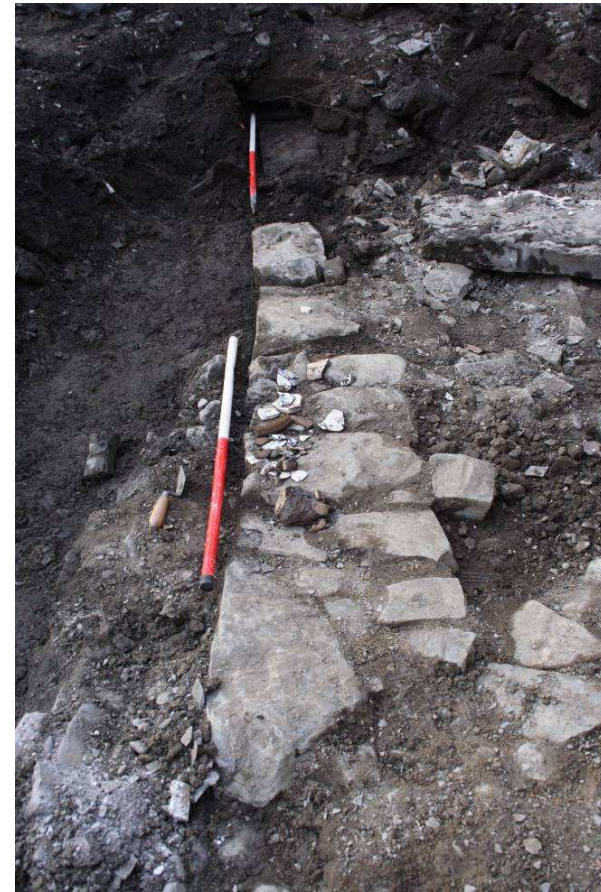
A small portion of wall footings on an almost northwest to southeast alignment were identified within the area of the demolished kitchen extension (Photo 30). This wall appears not to be associated with any of the standing remains, although it is aligned similarly to the northern annexe, but in the absence of further evidence, it is difficult to interpret its significance. It is possible that the wall represents a small extension or lean structure attached to the annexe. The wall measured at least 3m in length and between 0.55m and 0.4m in width, continuing beyond the edge of the excavated foundation trench. It had been truncated in the area of the footing trench prior to this phase of works, possibly when the previous galley kitchen extension was built. The wall was possibly clay bonded, but no clear evidence was present.

Photo 30: Wall revealed to west of northern annexe during watching brief

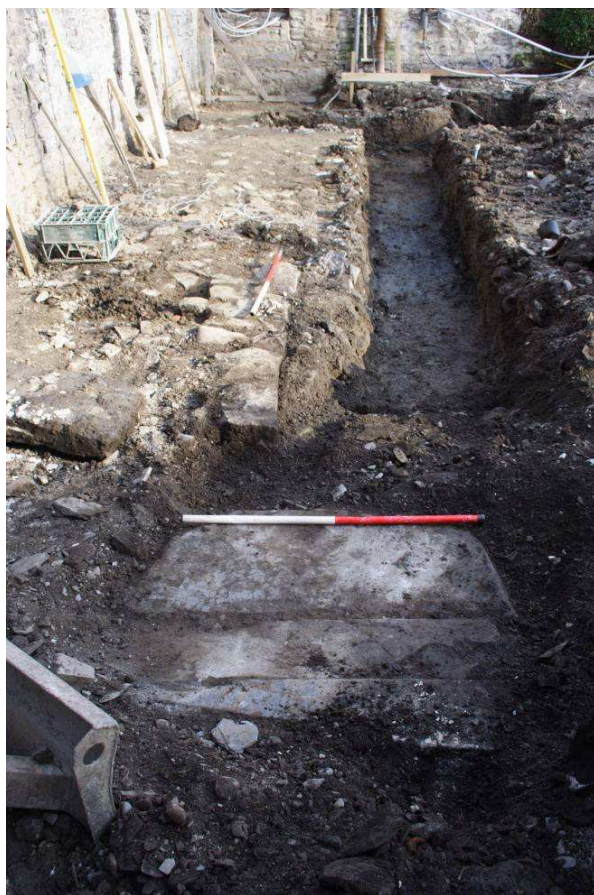
An area of large paving slabs was also identified at the northern end of the new extension footing trench (Photo 31). These appeared to continue beyond the area of the excavation and were neatly laid heading in roughly westerly direction. It is possible they are part of a former footpath leading from the building. They post-dated the wall footings as they were laid on top of the continuation of the wall beyond the edge of the excavated area.

Photo 31: Large slate slabs at northern end of new extension area

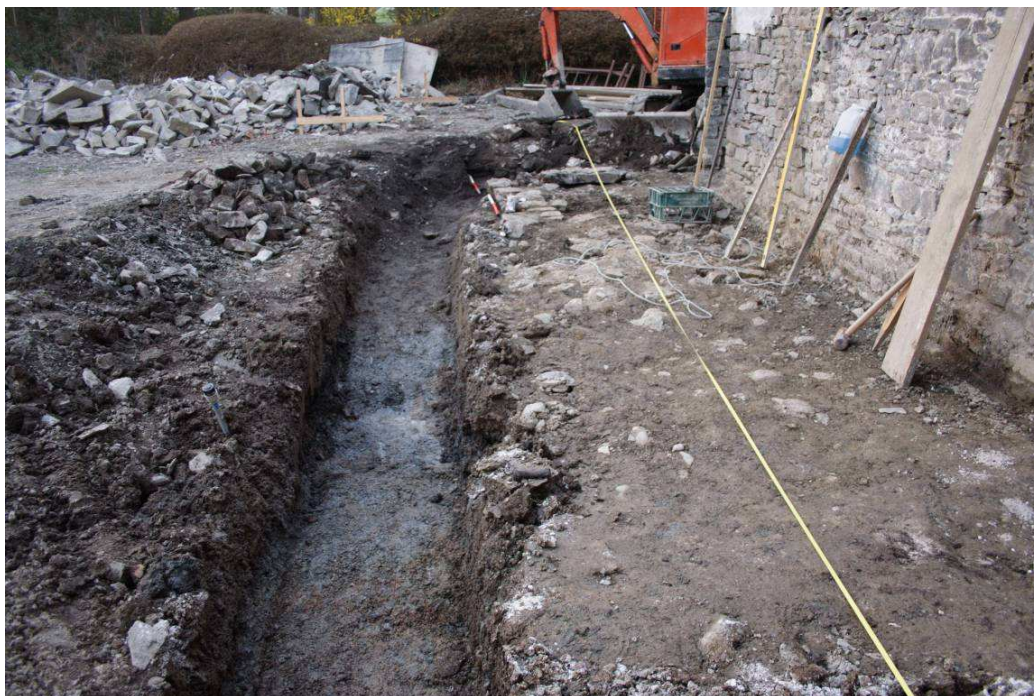
Areas of disturbed ground were noted within the footing trench, presumably associated with more recent construction works associated with the galley kitchen extension and other alterations to the building (Photo 32). Numerous fragments of pottery dating from the 18th century onwards were recovered (most of which has been retained by the house owners).

Photo 32: Overall view of new extension area to west of northern annexe
