THE OLD MILL, MYDDFAI, CARMARTHENSHIRE: ARCHAEOLOGICAL WATCHING BRIEF

RHIF YR ADRODDIAD / REPORT NO. 2011/61
RHIF Y PROSIECT / PROJECT RECORD NO. 102586

**THE OLD MILL, MYDDFAI,
CARMARTHENSHERE:
ARCHAEOLOGICAL WATCHING BRIEF**

DUNCAN SCHLEE

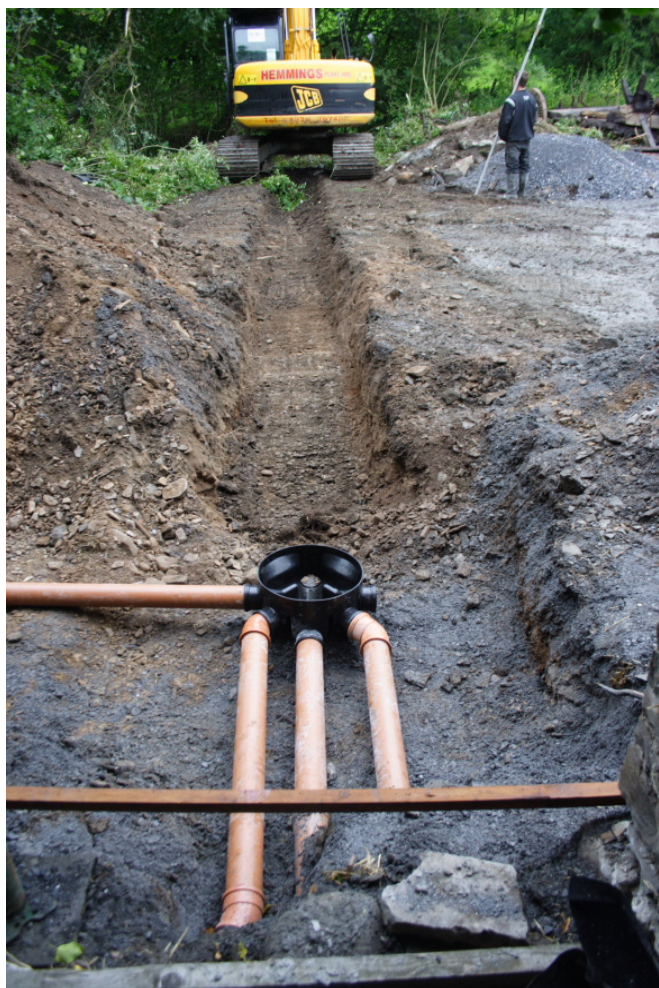
Ground levels in front of the mill had already been reduced and drainage pipes were being laid. The soil removed appeared to be primarily loose mixed dark grey humic topsoil approximately 0.50m deep, and overlying yellow shale bedrock (Photo 1).

The excavation of a drain run in a southwesterly direction from the mill to the stream was observed (Photo 1). The trench was cut to a depth of approximately 1.0m at the southern end of the trench. At this depth, the top of the underlying shale bedrock was exposed, overlain by the same loose dark grey topsoil. Towards the stream, a considerable quantity of stone rubble was mixed in with the topsoil (Photo 2). This rubble is presumed to be derived from the demolished remains of the former outbuildings (Figure 4). No evidence of surviving building foundations floor or ground surfaces was visible in the exposed trench sides. No cut features were observed.

Photo 1: Excavation for drains from mill to stream

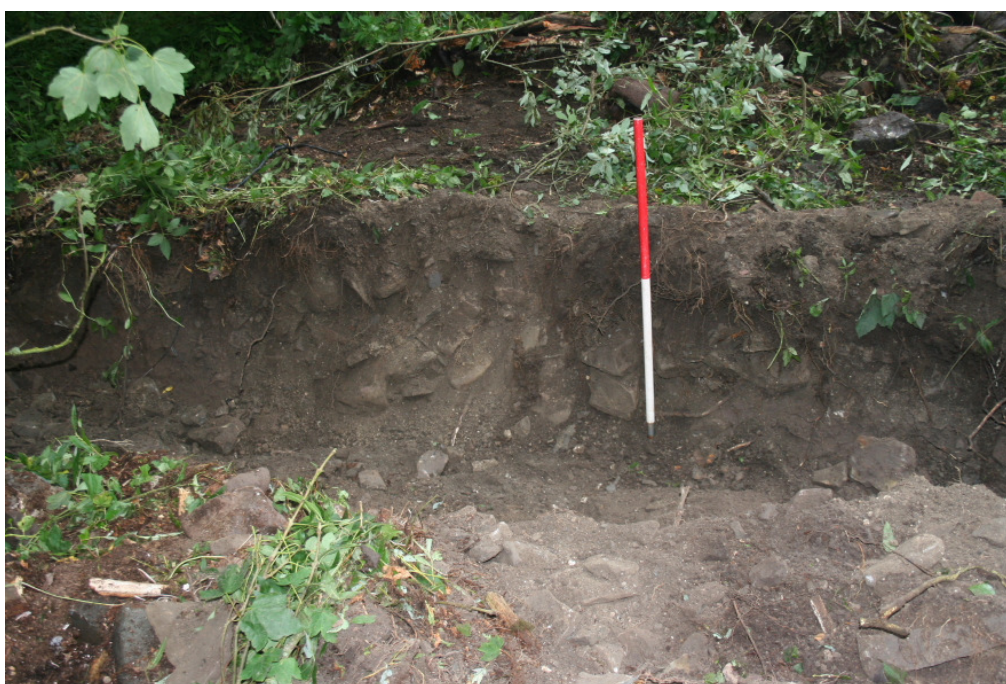
Photo 2: Building rubble in drain cut section next to stream

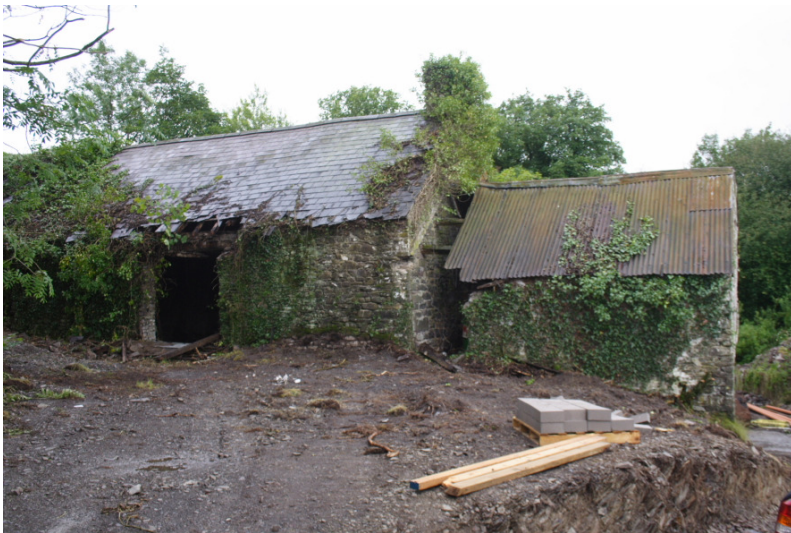
The exterior walls of mill building and the roof survive intact. The north side of the building is terraced into the slope (Photo 3), and is accessed at first floor height. The south side of the building is accessed at ground floor level (Photos 4 and 5).

Photo 3: North side of mill (corn drier to right)

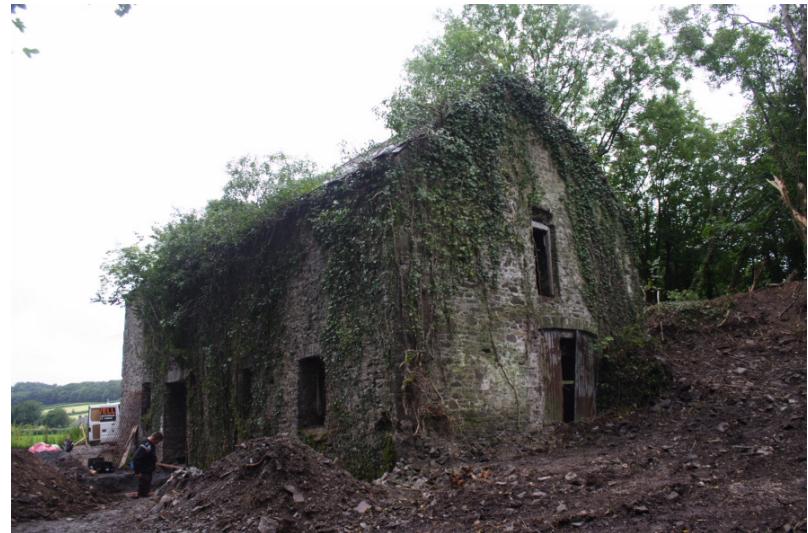
Photo 4: View of mill from southeast

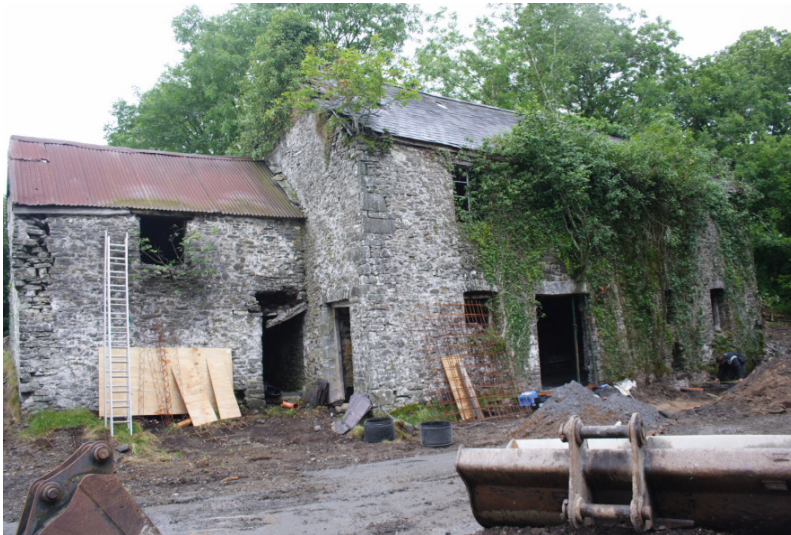
An outbuilding adjoining the mill on its northwest gable end was also investigated. This was found to have been a corn dryer. At ground level, the corn dryer was accessed by a doorway in the southwest facing wall (Photo 5) leading to a small corridor or access chamber. The corn dryer chamber had a narrow entrance with two opposing tapering side walls (Photo 14) with brick supports for the original corn dryer floor (Photo 15). This may have been a metal frame supporting perforated tiles. The corn dryer floor was later replaced with wooden planks and the upper floor was used as a store shed, accessed at first floor level by a doorway on the north side of the building (Photo 3). Again, a rudimentary photographic record of the structure was made.

Photo 5: View of mill from southwest (corn drier on left)

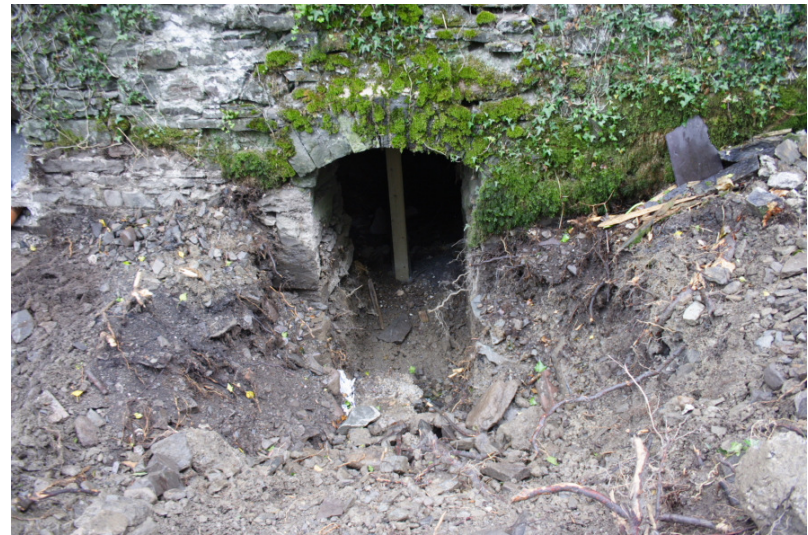
The mill leat leading from the mill building to the stream was also no longer visible as a surface feature (Photo 6).

Photo 6: Leat exit from mill

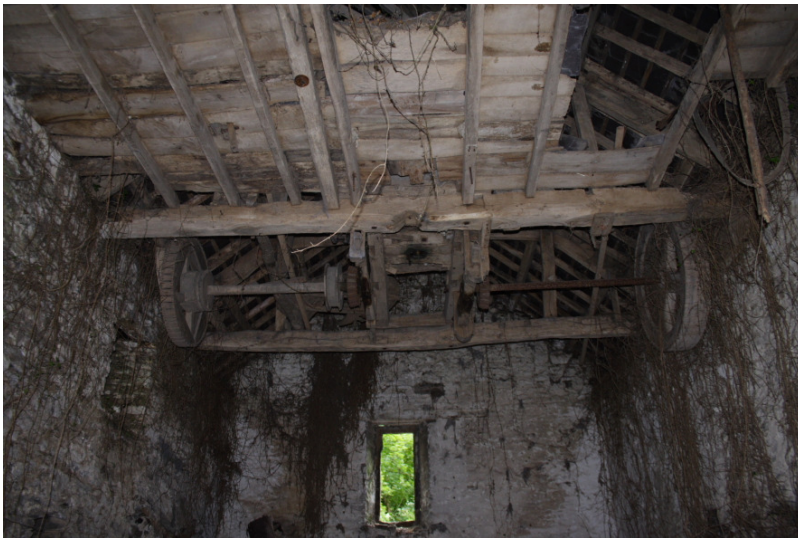
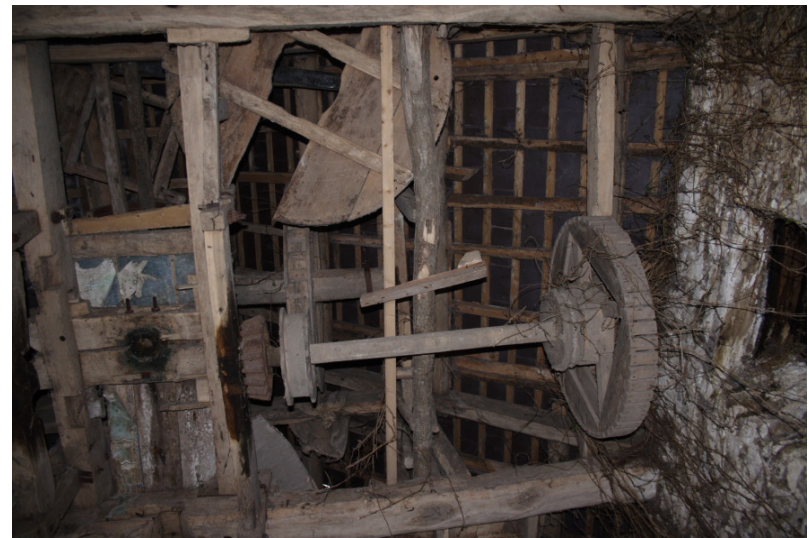
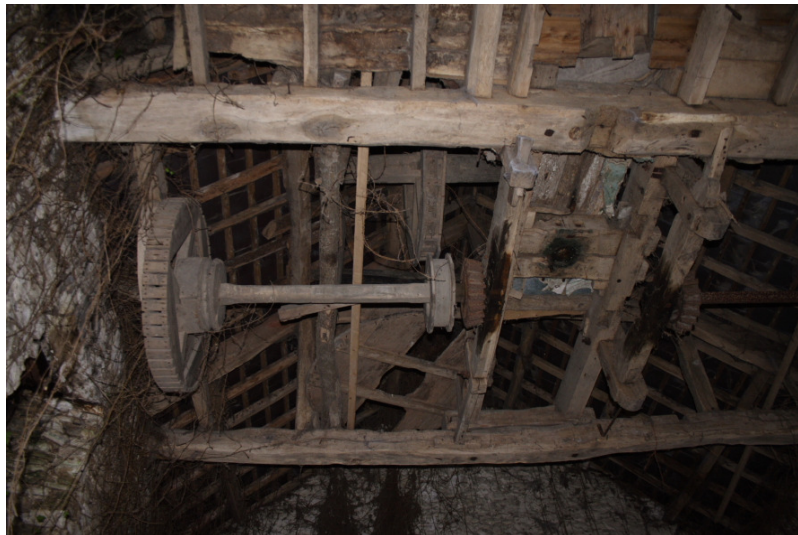
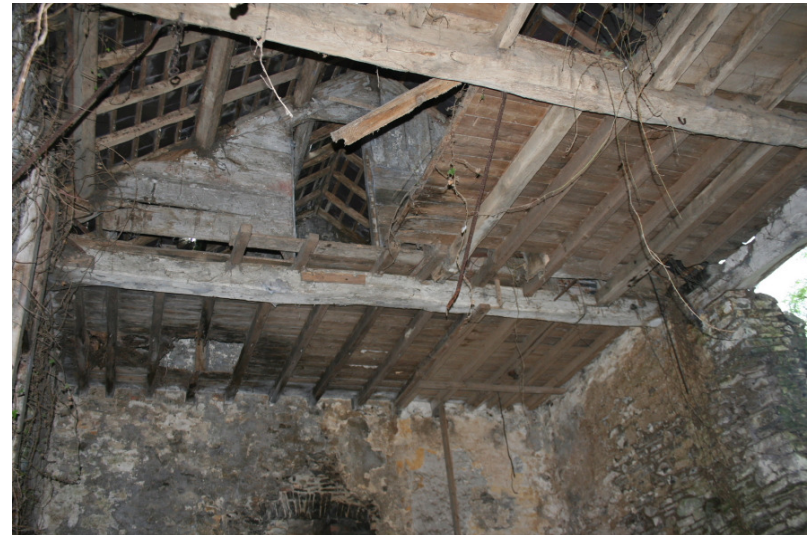
The second floor of the interior appears to remain largely intact, although in a precarious condition. Mill machinery and equipment appears to survive in-situ, but was inaccessible. A rudimentary photographic record was made (Photos 7 to 10).

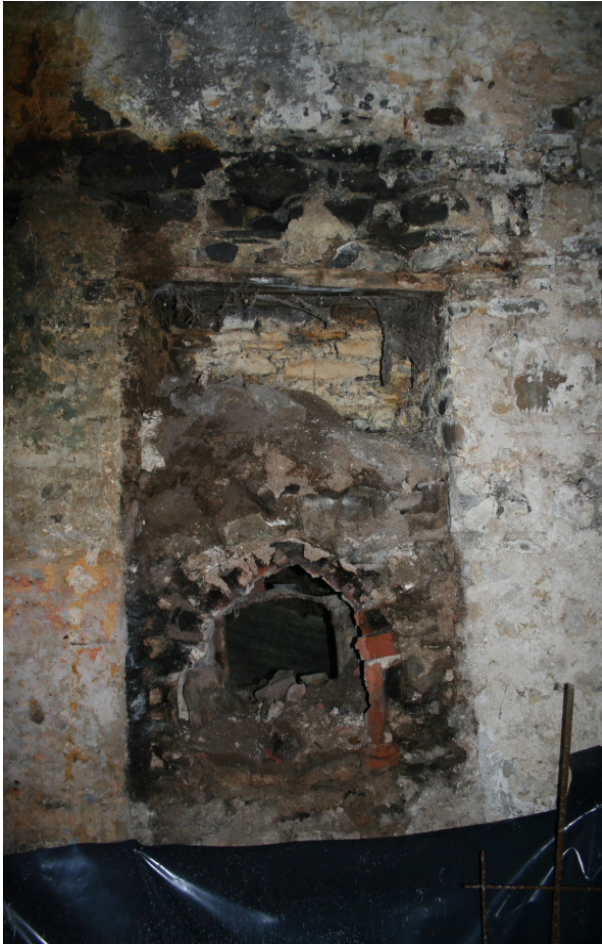
In the northwestern gable end wall of the mill building was a fireplace and the remains of a small bread oven at ground floor level (Photo 11). At first floor level was a fireplace that had been modified several times (Photo 12).

Photo 11: Bread oven in south wall of mill building

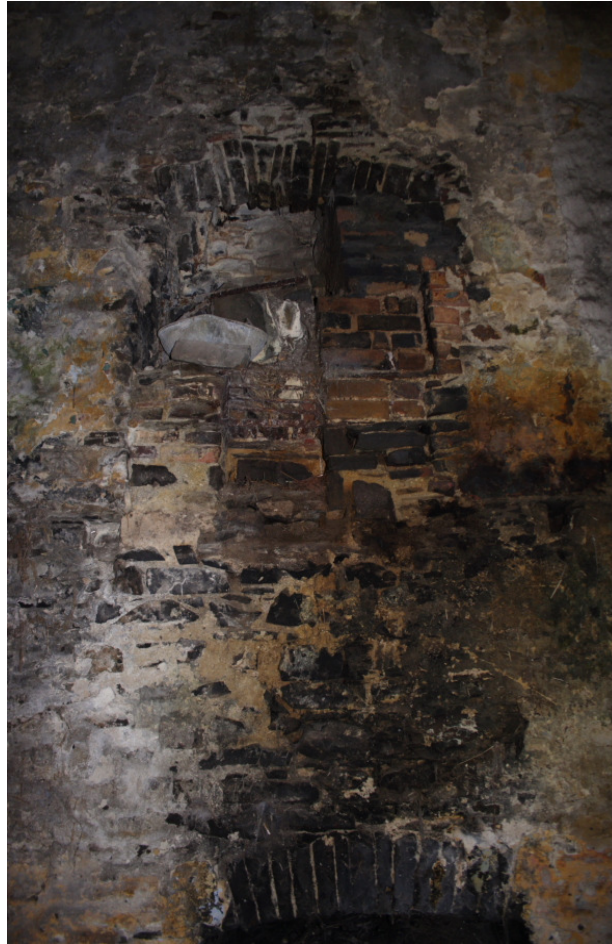
Photo 12: Former fireplaces in south wall of mill building (ground and first floors)

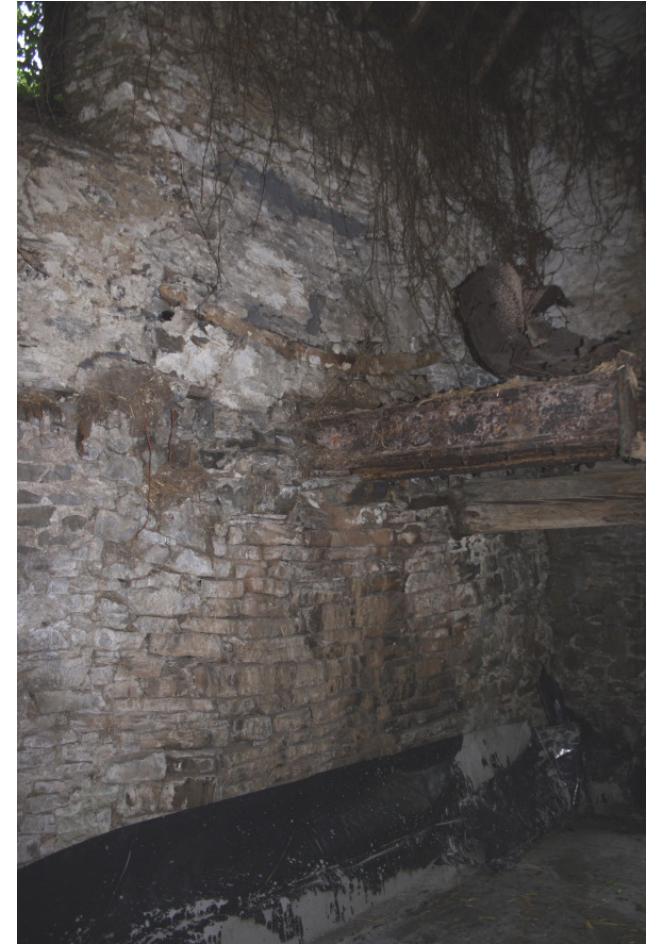
At the southeast end of the north wall an opening would have fed water from the mill pond to the waterwheel that powered the mill workings. A surviving metal lining to the water inlet (Photo 13) relates to the later use of the mill's water supply to power a turbine, possibly in the post war period (Chris Plummer pers. Comm.). When the turbine was installed, the waterwheel was removed, but is still in use somewhere north of Cilycwm (Chris Plummer pers. Comm.).

Photo 13: North wall of mill building showing metal inlet from mill pond

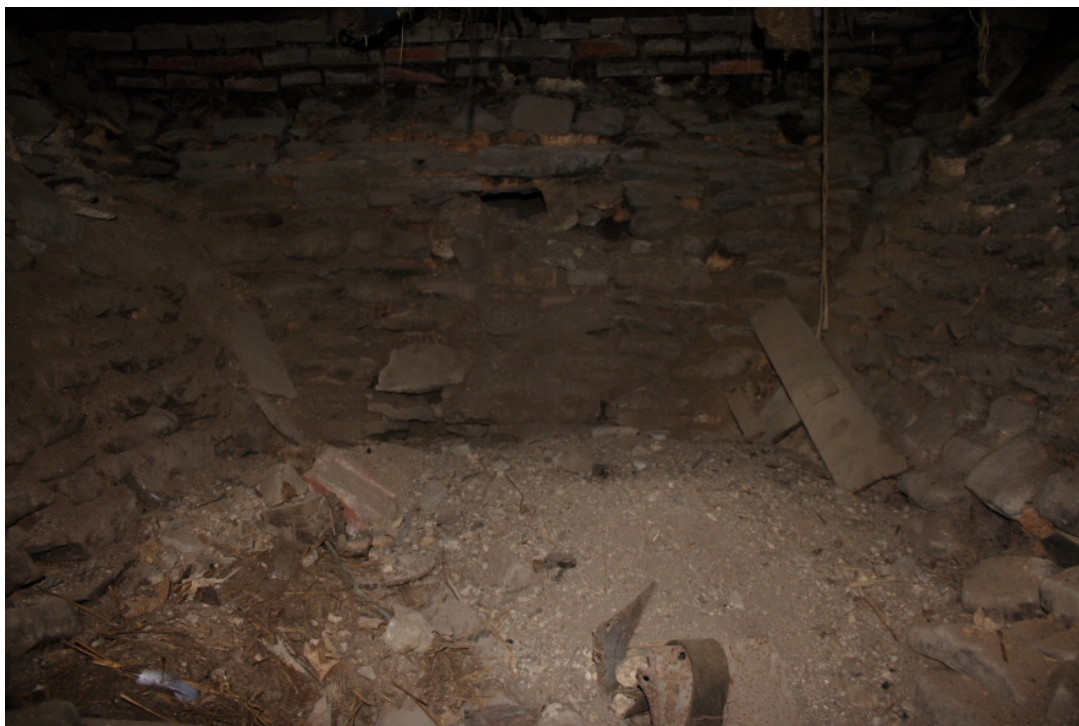
Photo 14: View of the interior of the corn dryer showing tapering sides

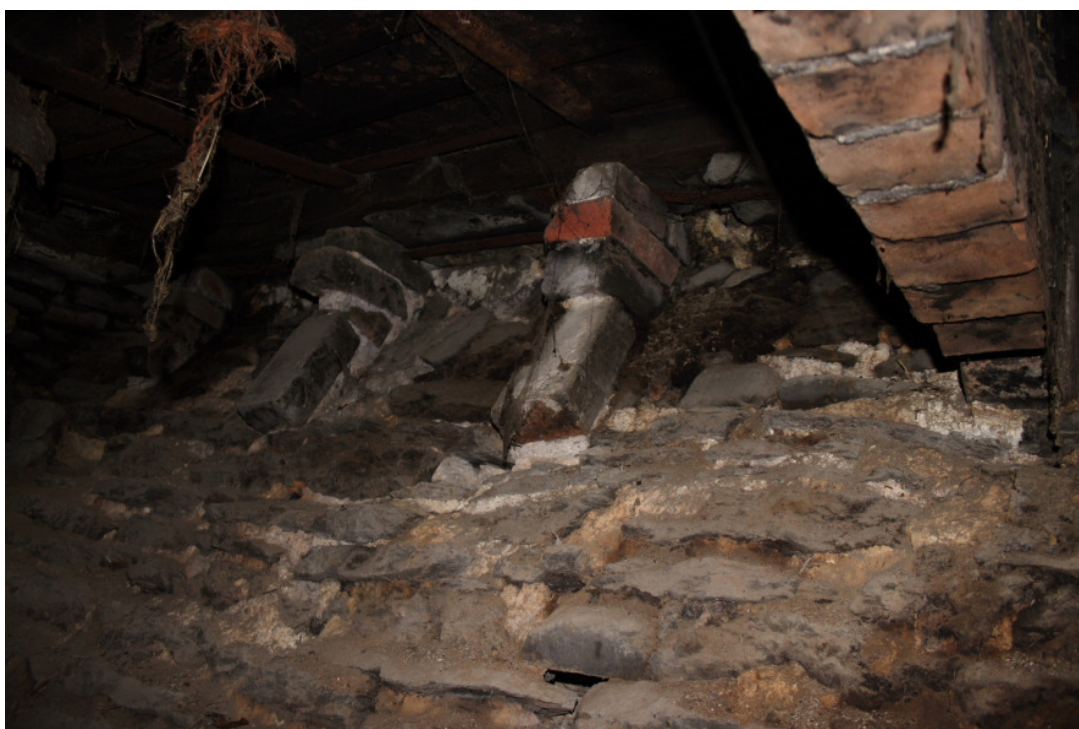
Photo 15: View of the original supports for the drying floor

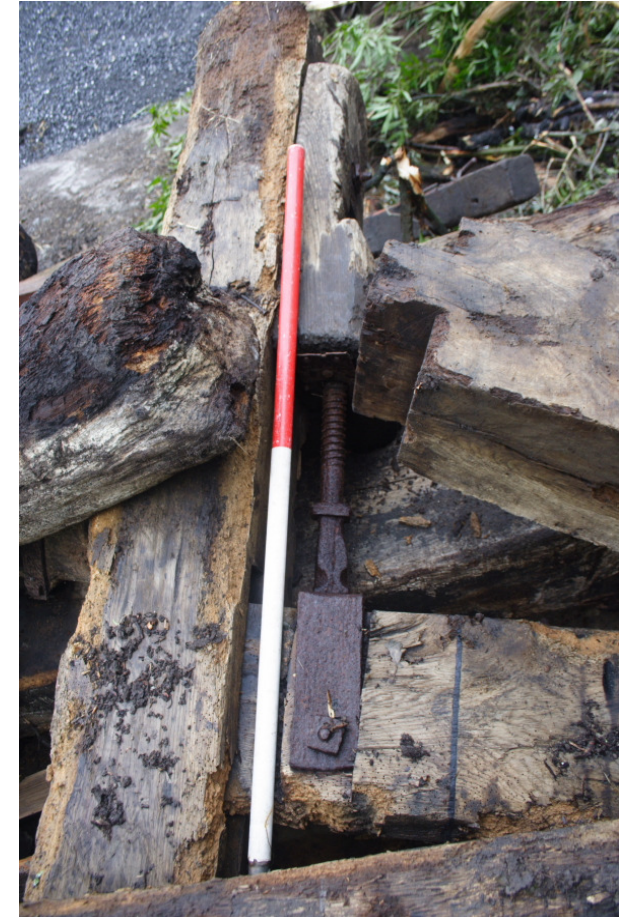
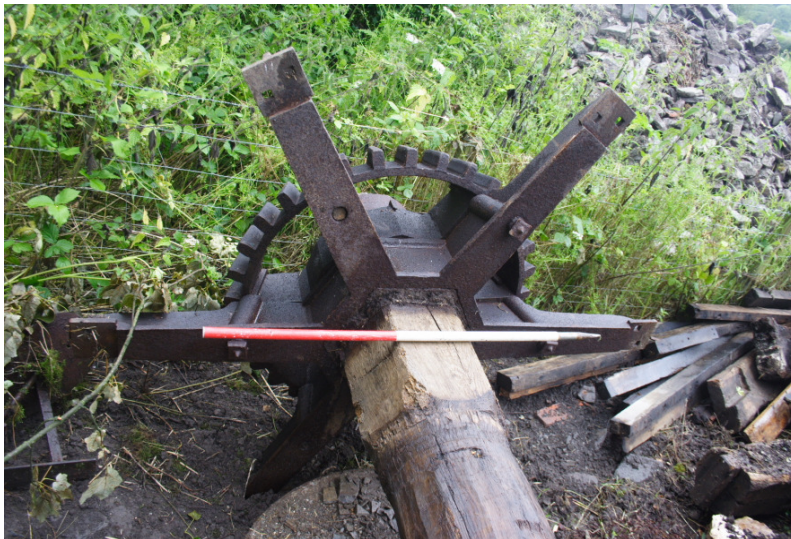
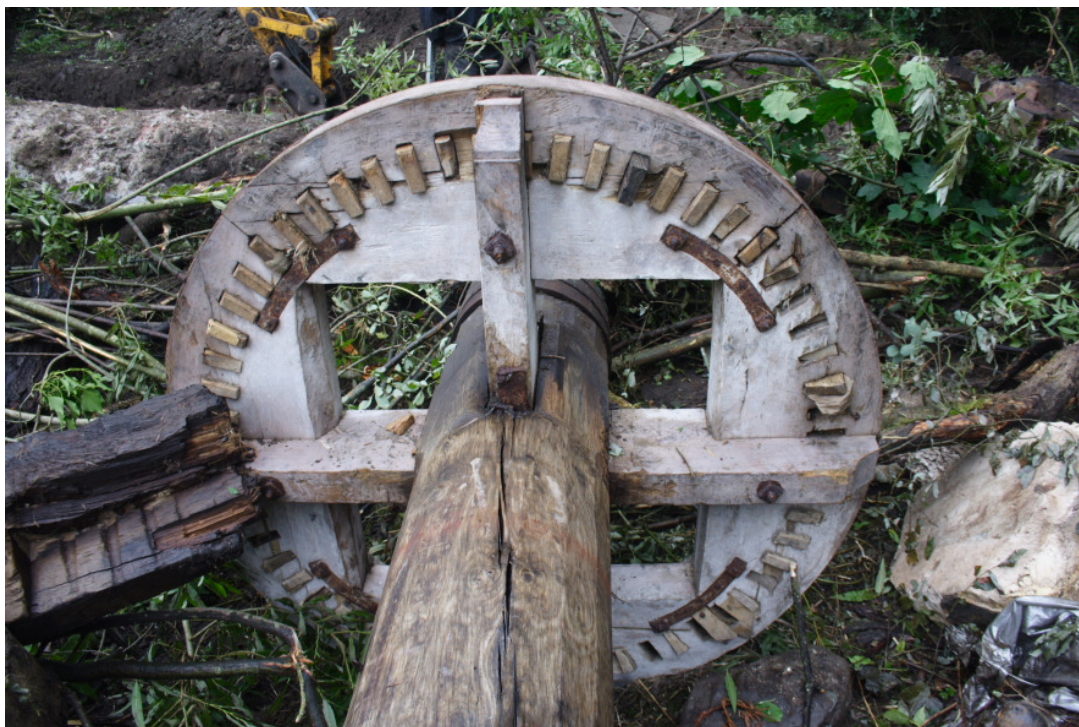
Worked timbers and mill machinery was piled up outside the standing building (Photos 16 to 21), close to the western side of the excavated drain run. These appeared to include the main grinding stones (Photos 18, 25 and 27), drive shaft, wheels and gears (22, 23 and 24 and 26), although the attending archaeologist has little technical knowledge of mill machinery. The opportunity was taken to photograph some of these items.

A date of 1865 is reported to have been written in pencil on a repair to the millstone. However, the gearing, a mix of wooden shafts and iron gears, may allow the corn mill to be dated closer to the C18th (Chris Plummer pers. Comm.).
