**THE NORTHERN COURTYARD,  
LLANUNWAS, SOLVA  
(SM 7931 2441):  
ARCHAEOLOGICAL  
BUILDING RECORDING**

RHIF YR ADRODDIAD / REPORT NO. 2012/10  
RHIF Y PROSIECT / PROJECT RECORD NO.102637

## THE NORTHERN COURTYARD, LLANUNWAS, SOLVA: ARCHAEOLOGICAL BUILDING RECORDING

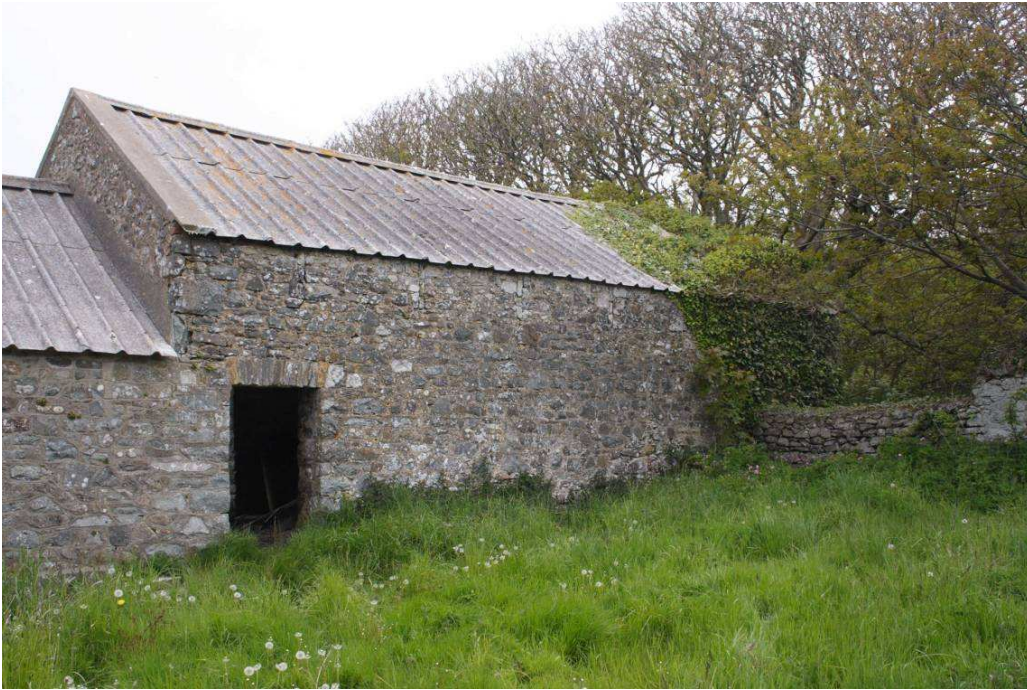
**Photo 1:** South facing wall of threshing barn

On the north side of the courtyard is the **threshing barn**, a large two storey building, aligned east-west of stone rubble brought to rough courses (Photo 1). The barn has a corrugated concrete roof over replacement (non-original) A-frame softwood trusses, some of which show signs of having been repaired.

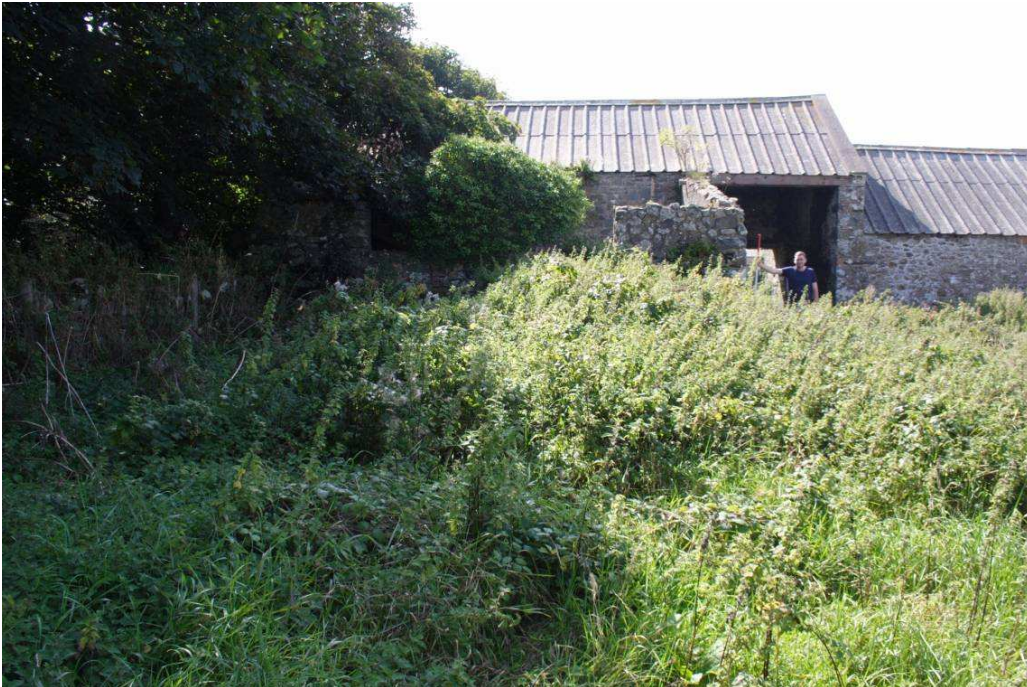
**Photo 2:** North elevation of threshing barn and engine house

Abutting the rear (north) wall of the threshing barn is an early 20<sup>th</sup> century **engine house** of random stone rubble construction (Photos 2), with roughly squared quoins with a single pitch corrugated concrete roof. The engine house has a wide entrance in the west wall and two window openings in the north wall. Inserted red brick dressings and use of concrete replacing lime mortar indicate that these openings have been modified in the past. Nothing remains of the engine although a small square opening for an axle shaft is situated approximately two metres high up in the south wall, linking to the threshing barn.

The present rectangular engine house replaced an earlier, circular structure depicted on the Ordnance Survey 2<sup>nd</sup> edition of 1906. A curved section of walling visible externally in the east wall is probably a remnant of this earlier building. The circular form suggests a likely function as a covered horse engine in a location where horses would have provided a more reliable source of motive power than, say water powered machinery, given the lack of suitable water supply.

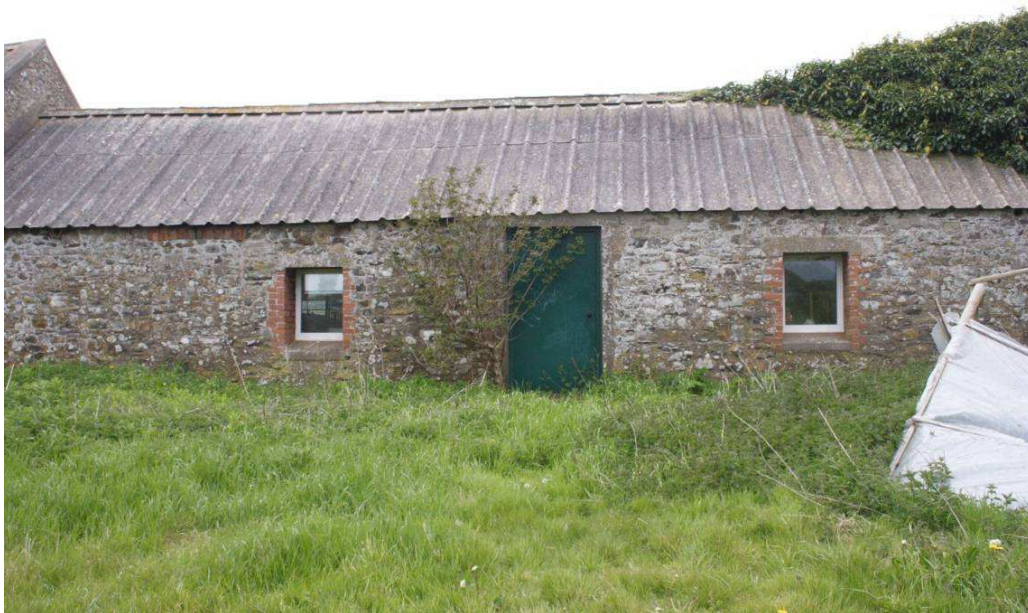
**Photo 4:** North elevation of stable

In line with the threshing barn and adjoining it to the left (west) is a long, low building, today much modified although retaining enough original features to suggest that it was a **stable** (Photos 3 & 4). The stable is of stone rubble construction with a corrugated concrete roof. The front wall was substantially rebuilt in modern brick meaning that the pattern of original openings is now altered (Photo 3). Original doorways, with red brick heads, remain in the middle of the front wall and at the left (west) end of the range. Three window openings spaced between the doorways with heads of modern brick are recent additions. The rear wall is also substantially modified and a doorway and two windows to either side are later additions (Photo 4). A blocked door opening to the left with original red brick head indicates the position of one of the original doorways (Photo 4).

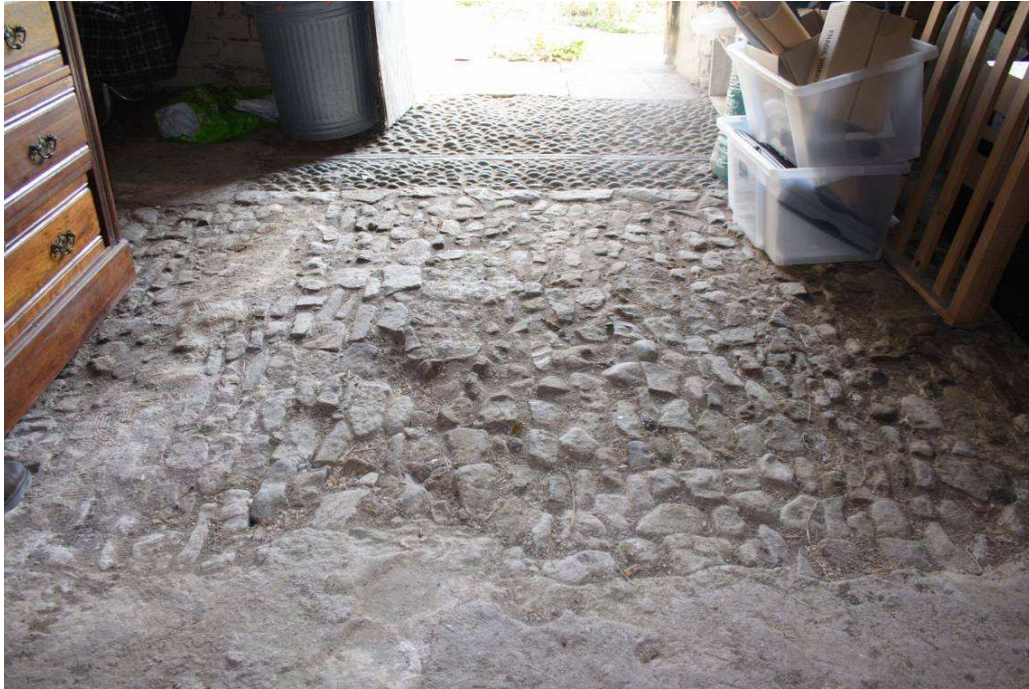
The internal fixtures and partitions have been removed and the original stalling arrangements cannot now be recovered in detail. The cobble floor remains and the pattern of cobbles indicating that horses were housed in stalls against the back wall (Photo 5). A drainage passage of river worn cobbles runs parallel to the front wall. Cobbles around the doorways show evidence of chipping, probably from damage by horse shoes.

**Photo 5:** Stable floor - stall platform, gutter and river worn cobbles

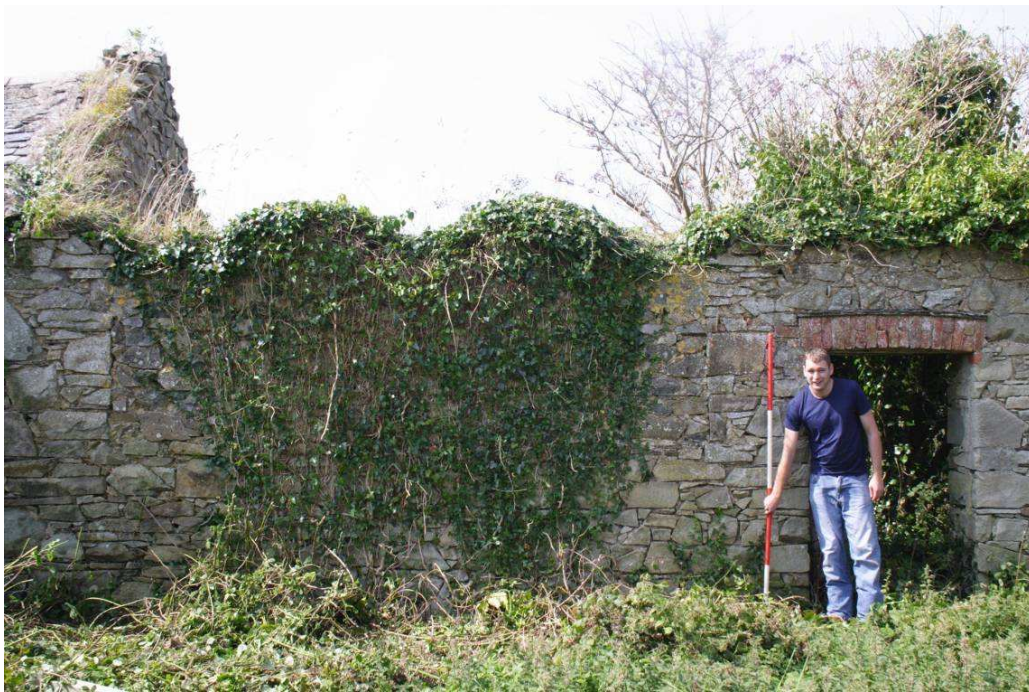
**Photo 6:** East elevation of cow house (north)

Adjoining the stables at right angles is a roofless and overgrown **cow shed**, aligned north – south (Photos 6, 7 & 8). The cow shed is of rubble stone construction, brought to courses and would have had a slate roof originally. Doorways have red brick heads in a similar fashion to the adjoining stable. The building interior is heavily overgrown and the original internal layout now difficult to discern.

It has, from left (south): three high window openings then a wide doorway (Photo 6), then four wide window openings then a wide doorway (Photo 7) (Figure 8). Another doorway exists in the south wall, offset to the left (west). The opposite north end of the building leads directly to a feed preparation room. Despite the loss of the historic stalling and tethering arrangements internally, some idea of the original layout can be inferred by the pattern of openings. Thus, it is likely that cattle were stalled facing across the length of the building onto a feed passage which ran the length of the rear wall. A doorway leads into the feed passage on the western side of the southern façade of the building (Photo 9).

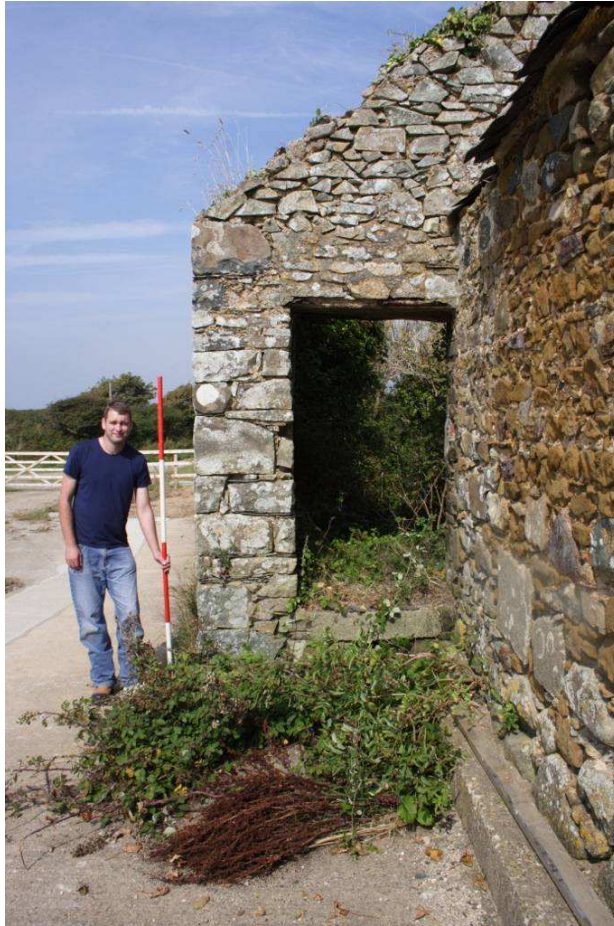
**Photo 9:** Cow shed detail - feed passage doorway

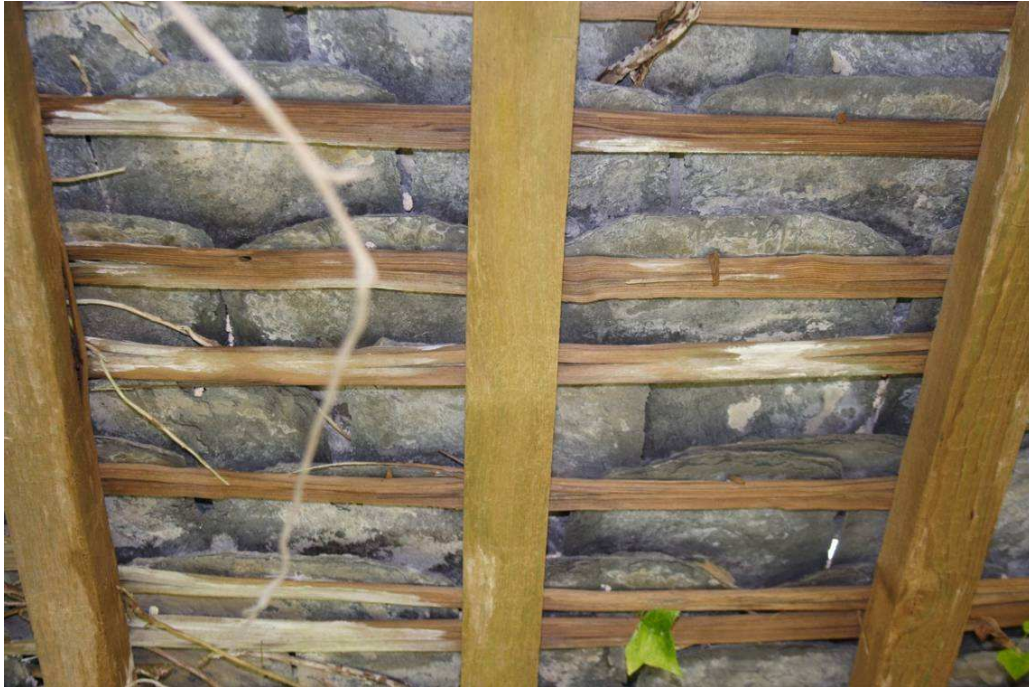
The **feed preparation room** adjoins the cow shed to the north, forming a right angle to the stable to the east (Photos 10, 11, 12 & 13). The building is now derelict with the roof in a state of semi-collapse. It is of random rubble stone construction with wooden pegged slates brought to diminishing courses over rough A-frames (Photo 13). It is a small single storey building, with a small axle shaft opening in the east wall (Photo 10), a wide cart entrance in the north wall (Photo 11) and blind in the west wall, although a small window has since been filled in (Photo 12). The large wooden lintel over the cart opening shows evidence of re-use in cut off wooden pegs and nail holes.

**Photo 13:** Feed preparation room interior -peg hung slates on split oak battens

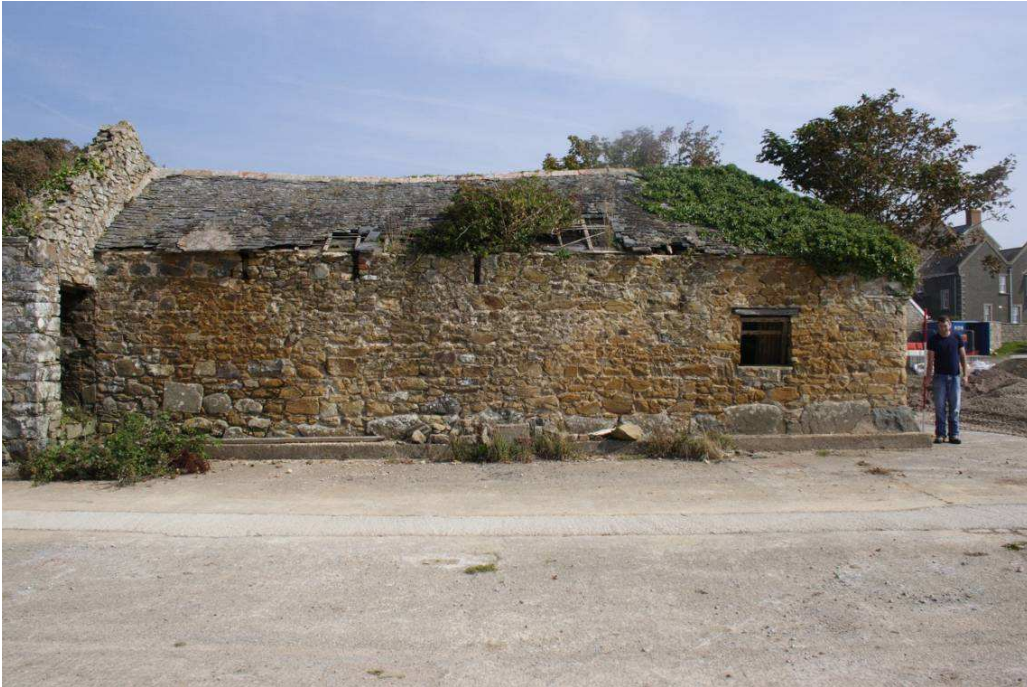
**Photo 15:** West elevation of loose box

The loose box was lofted originally and had a doorway and two windows to the right (north) in the front wall. The windows were partially blocked to form ventilation slits but the original doorway remains (Photo 15).

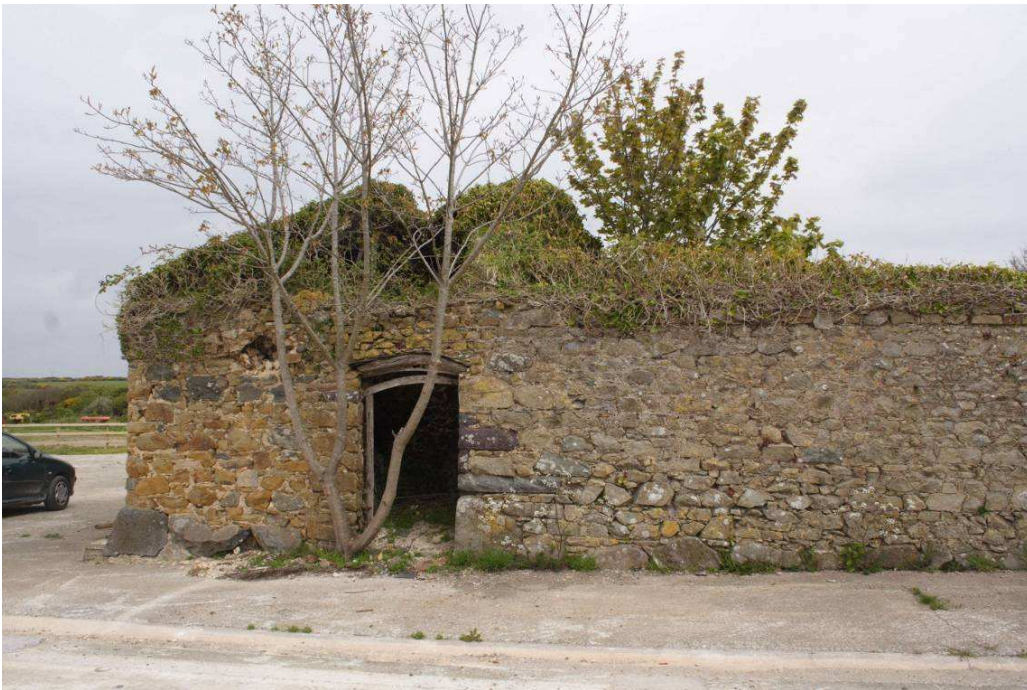
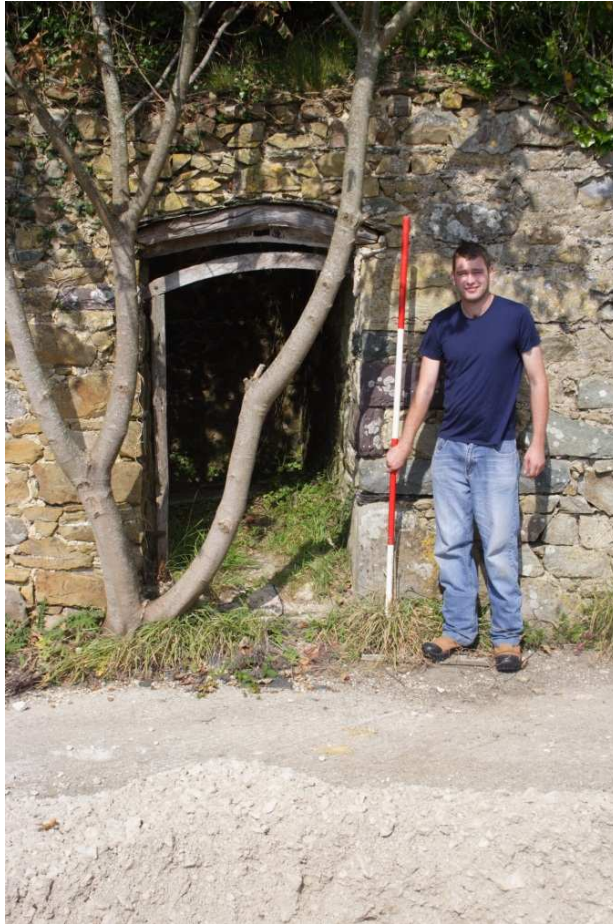
The **stable** is to the south of the loose box, entered from the farmyard in the south wall (Photos 16 & 17) and has a small window in the west wall (Photo 15). In common with the loose box the roof is of rubble stone construction with a wooden pegged grouted slate roof, brought to diminishing courses over wooden pegged A-frame trusses and follows a hipped design. The smallest unit within the group, it has a manger and hay rack against the south wall (Photo 18).

**Photo 16:** South elevation of stable

**Photo 17:** Detail of stable - south elevation

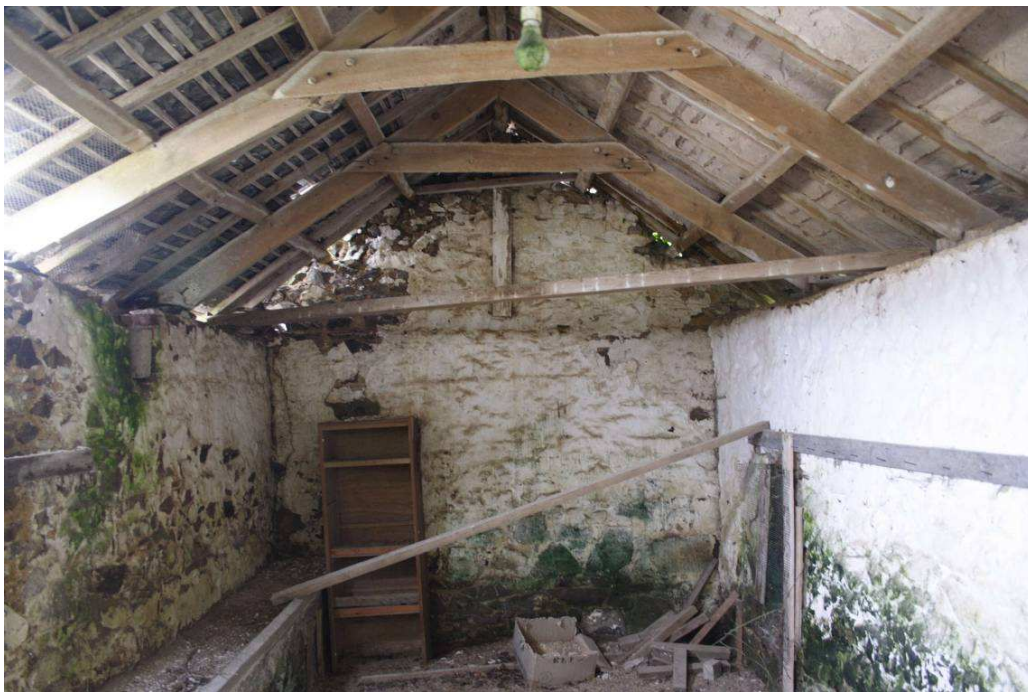
**Photo 18:** Stable interior - facing north

Loose boxes provided open housing for young stock or fat stock. The example at Llanunwas has a manger running along the west wall. A former hayrack above the manger is evidenced by an impression in the layers of limewash (Photo 18).

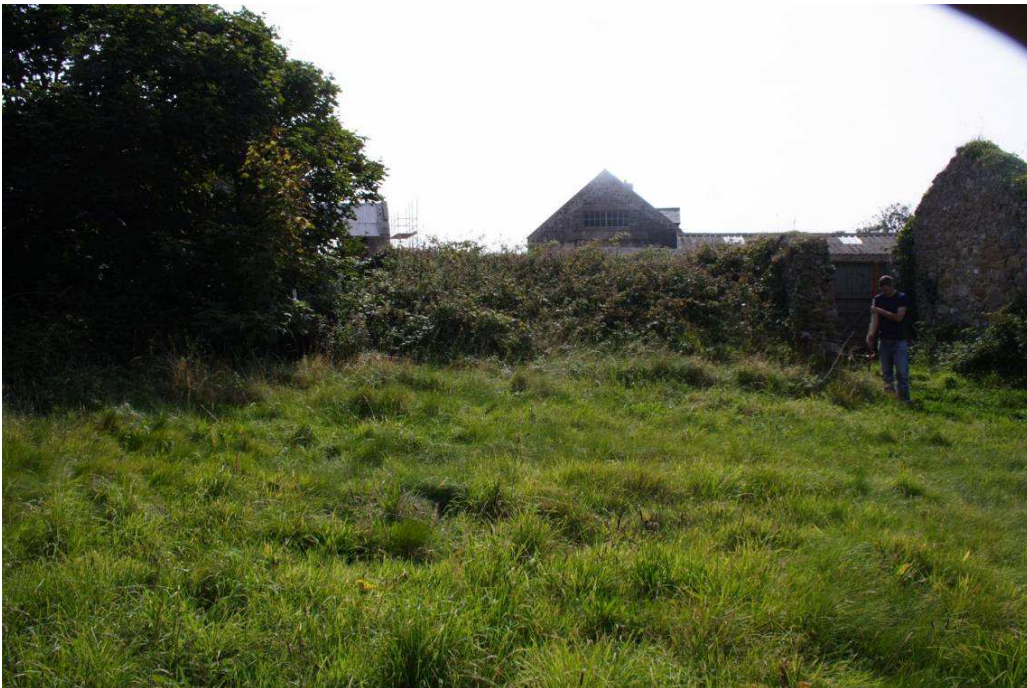
**Photo 20:** North elevation of former building to west of stock shed

The eastern range is now a ruin and only the rubble covered wall bases survive (Photo 20). Having similar dimensions to the western range, it may have been a second stock shed. Our knowledge of this building may be enhanced when the rubble is cleared in future.

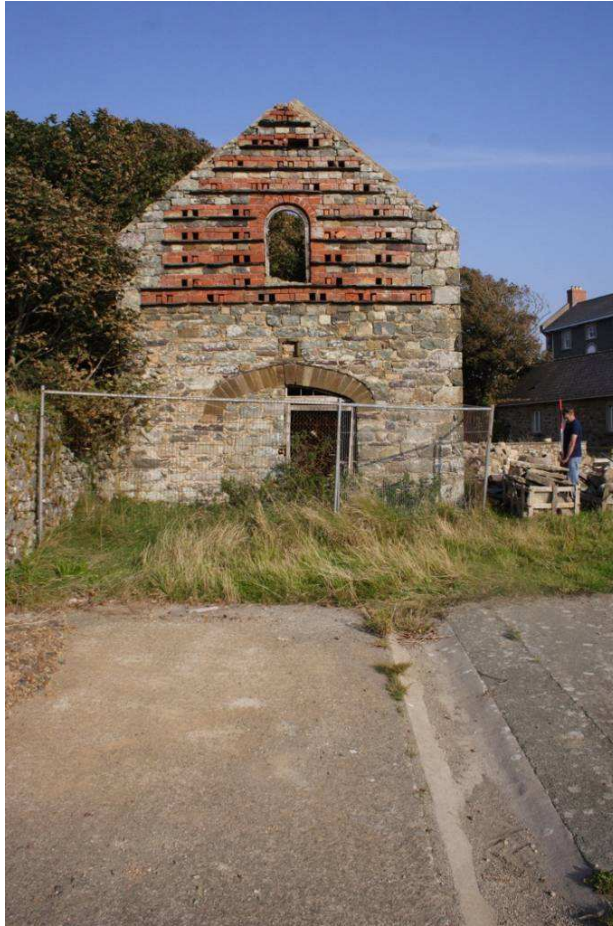
**Photo 21:** West facing elevation of cart house/ stable/ granary

The derelict, roofless cart shed/ stable/ granary is situated outside the farm courtyard to the south (Photos 21, 22 & 23). It is a two storey building of rubble stone construction brought to rough courses with roughly squared quoins. The show piece of the farmstead complex, the building shows greater elaboration in design than the others within the group in the fine cut stone arch to the cart shed and red brick dovecote (nesting holes) in the west gable wall, situated around an ornate arched brick window opening (Photo 21).

The west gable wall has a wide arched entrance in dressed stone giving access to the **cart shed** (Photo 21). A recess positioned centrally above possibly would have held a date stone.

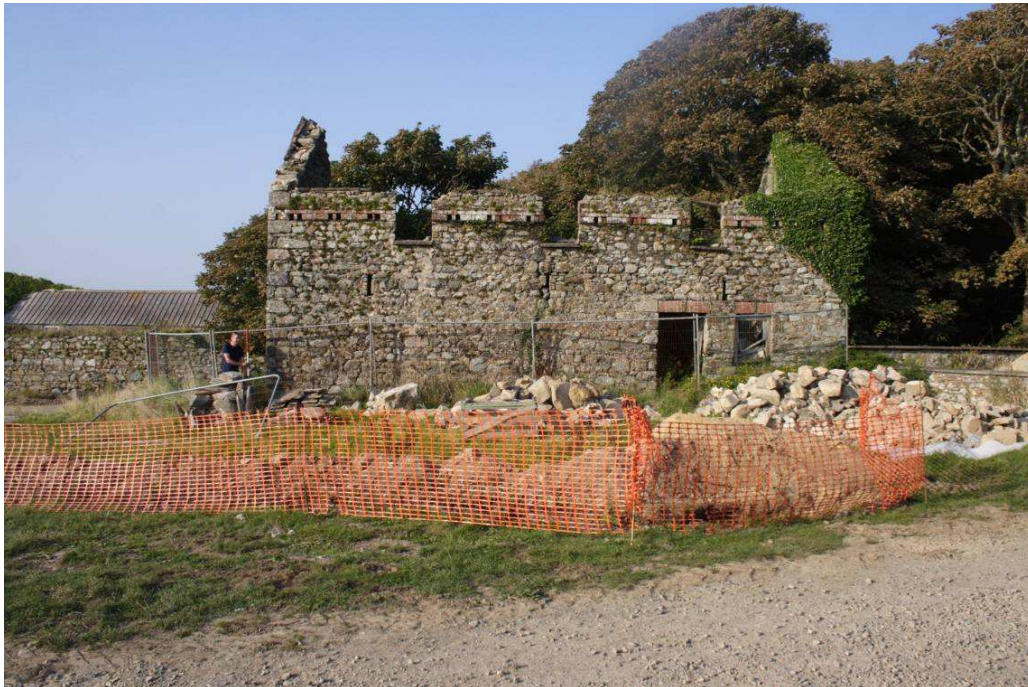
**Photo 22:** South elevation of cart house/ stable/ granary

The rest of the ground floor provided stabling. The south wall has a doorway then a window at the right end (Photo 22). Three evenly spaced ventilation slits

provided additional ventilation (Photo 22). This arrangement is mirrored in the opposite (north) wall (Photo 23). The interior of the building was not seen.
