FRONGOCH METAL MINE REMEDIATION PROJECT ARCHAEOLOGICAL ASSESSMENT

RHIF YR ADRODDIAD / REPORT NO 2012/11
RHIF Y PROSIECT / PROJECT RECORD NO. 102638

FRONGOCH METAL MINE REMEDIATION PROJECT

ARCHAEOLOGICAL ASSESSMENT

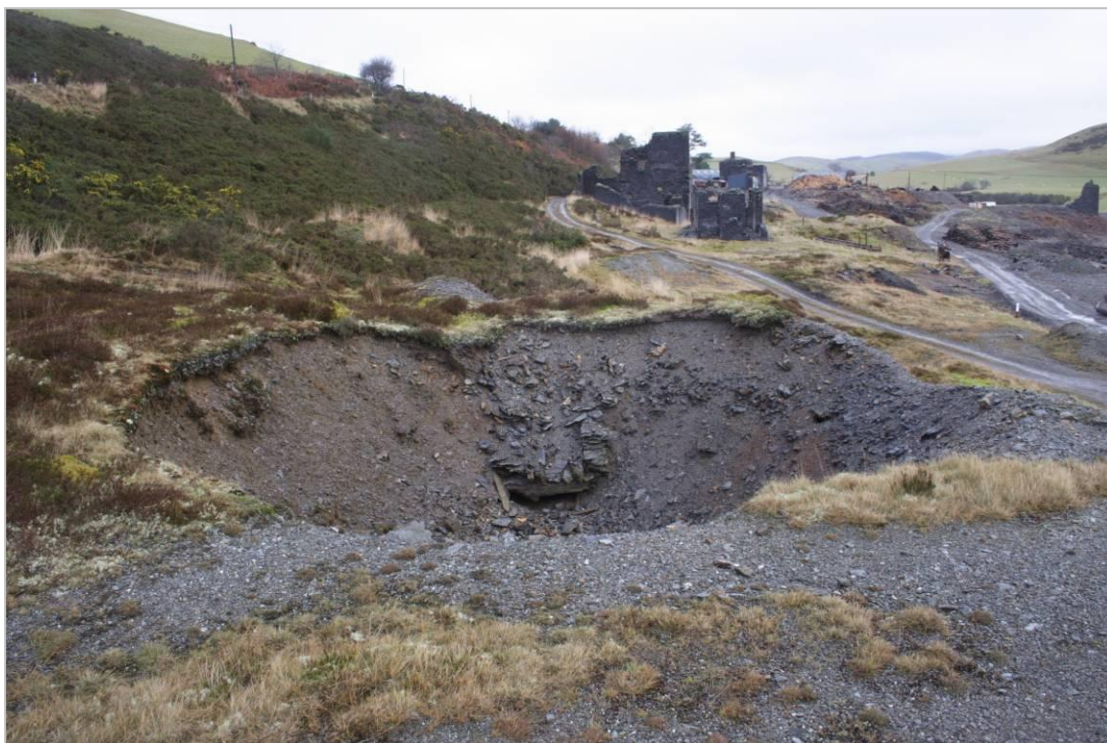
3.4.3 Passing through the Iron Gate which leads into the upper workings, one passes a heap of spoil on the left, at the top of which is a rubbish filled depression. This is Williams Shaft that has opened up since 1993 when it was not visible (Photo 3)

Photo 3: View of subsidence around Williams Shaft that has occurred since last recorded in 1993. Looking north-east.

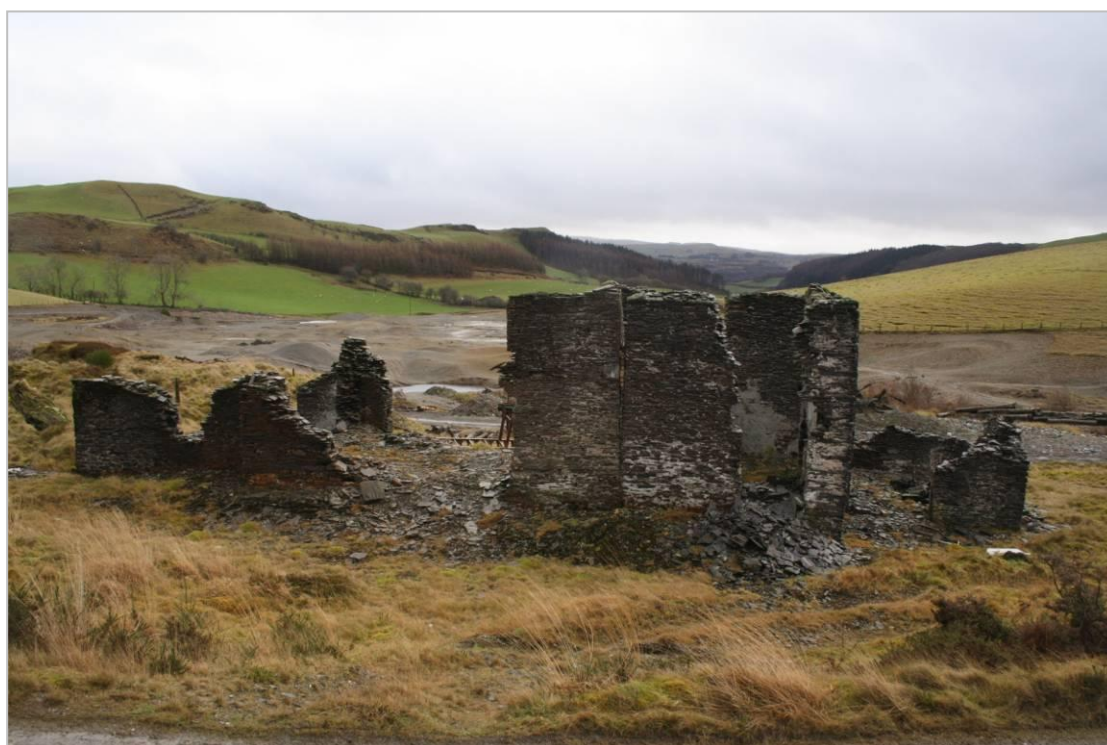
1) An office, the last phase of which was built c.1900. This building has largely collapsed (Photo 4) apart from the main masonry areas of the walls.

3.4.7 The majority of buildings and other structures recorded in 1993 were identified during the site visit, although a store building recorded as lying approximately 80m southeast of the large pump engine house is no longer visible. In 1993 the eastern wall of the office stood to over 1 metre high.

Photo 4: View of office building. Looking approximately south.

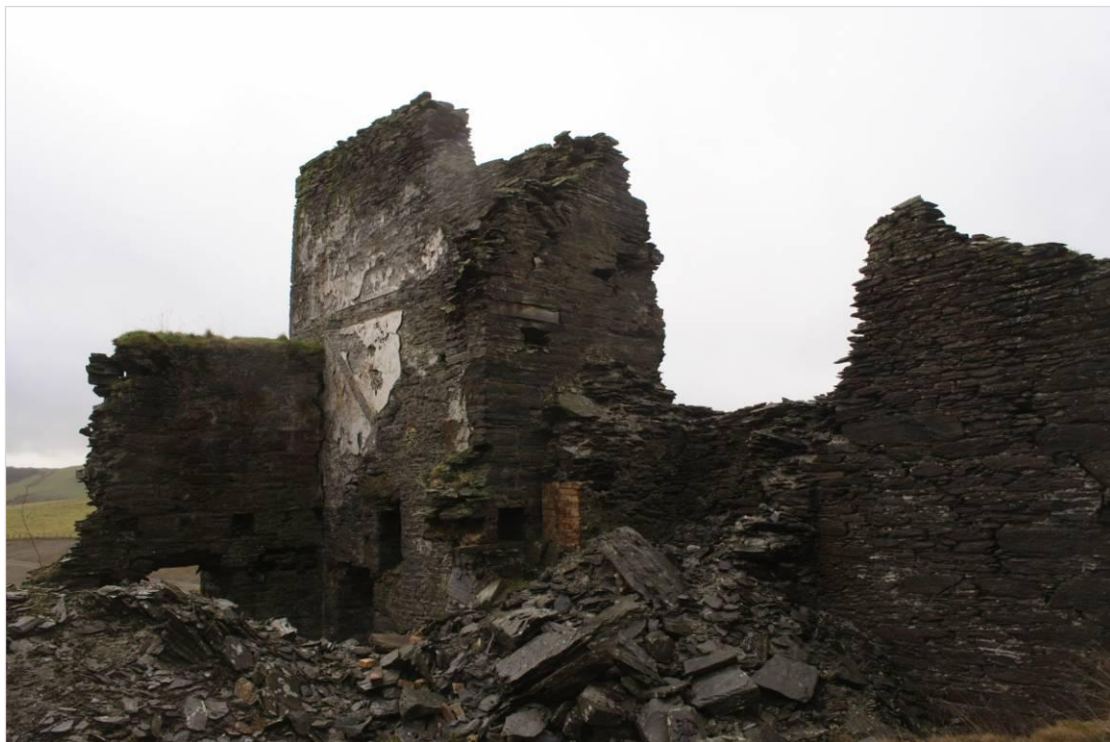
2) A pumping engine house c.1863. On its southeast side are 2 balance bob pits running in almost opposite directions, adjoining the shaft itself. The building is largely reduced to the main areas of masonry walls, and of these the more solidly-built pump house (on the northeast) survives better than the adjoining boiler house and coal store (Photo 5). The pumping engine house chimney collapsed during a storm in 1990.

3.4.4 The condition of all the buildings within the area of Scheduled Ancient Monument Ceredigion 146 has worsened. As the wooden lintels are rotting so the walls are sagging and many of them are sitting at precarious angles. The foundations of the large pumping engine house appear to be seriously undermined as observed within the north face of the engine shaft, where water pours into the shaft below.

Photo 5: View of collapsing walls of pumping engine house built c.1863.
Looking south-west.

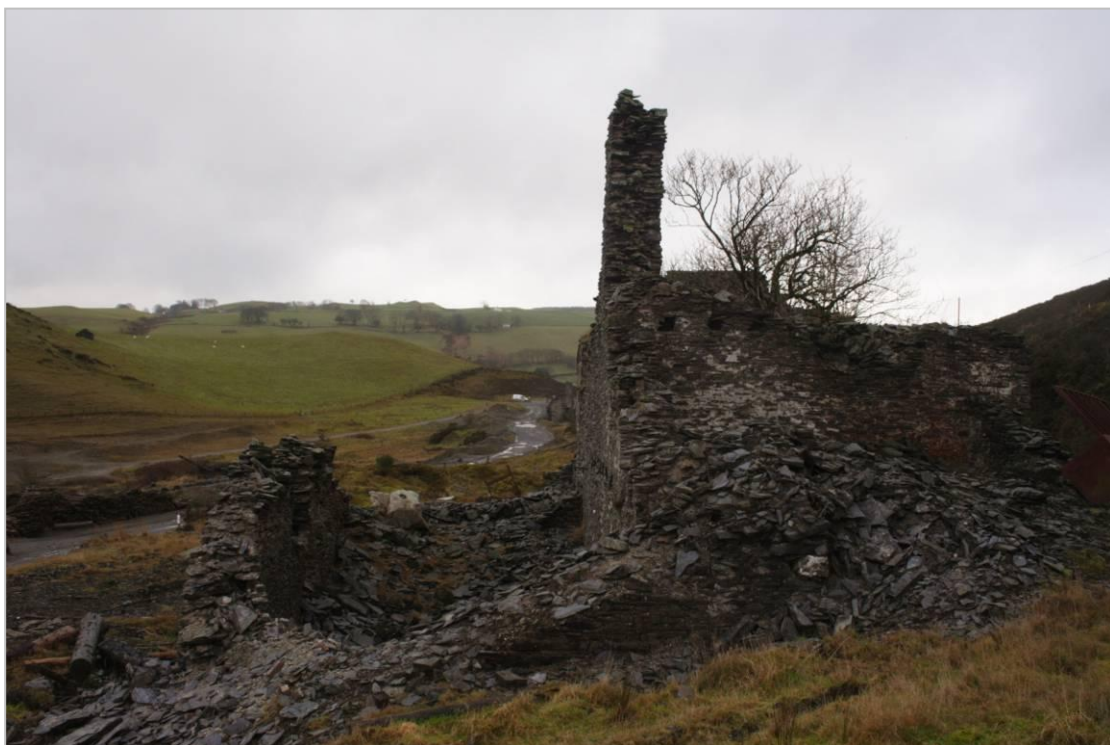
3) An older engine house, somewhat more ruined than the other. The northwestern room appears to have been built from larger stones, more solidly than the remainder, and this survives best, together with a corner of the northern room (Photo 6).

Photo 6: View of former pumping engine house built c.1841. Looking west.

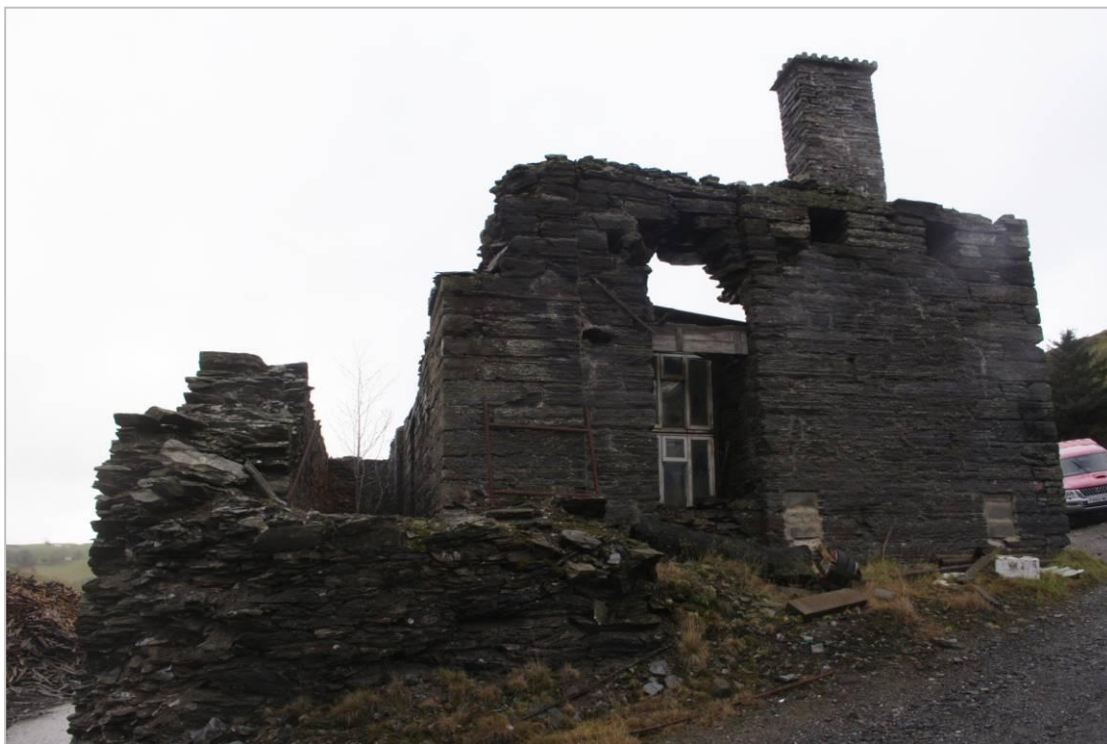
4) A crusher house, originally constructed around 1860, and later used as a winding house, perhaps after it was extended in about 1900. This building survives to a height of about 3m and a makeshift building has been constructed within the three walls of the original building. The wheel pit on the south side is nearly intact (Photo 7).

Photo 7: View of the crusher/winder house. Looking north-west

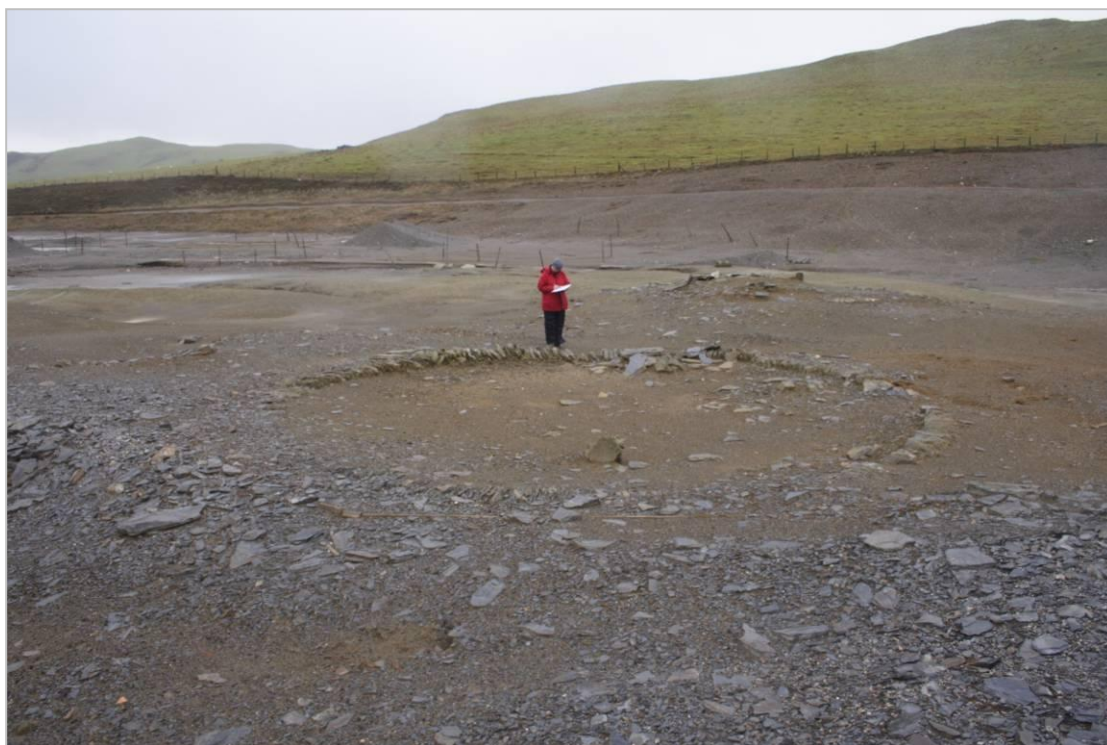
3.4.8 To the southeast of the line of the former tramway evidence of circular buddles (ore cleaning devices) (Photos 11 & 12) and slime pits can be seen protruding through the ground. There also appears to be evidence of a series of rectangular slime pits protruding through the ground surface further to the southeast that were not recorded during the 1993 survey, but are shown on the 1888 OS 25" map. This would suggest that archaeological features survive well below ground level (Photo 13).

Photo 11: View of circular kerb of 'buddle' with area of former reservoir in background. Looking south-east

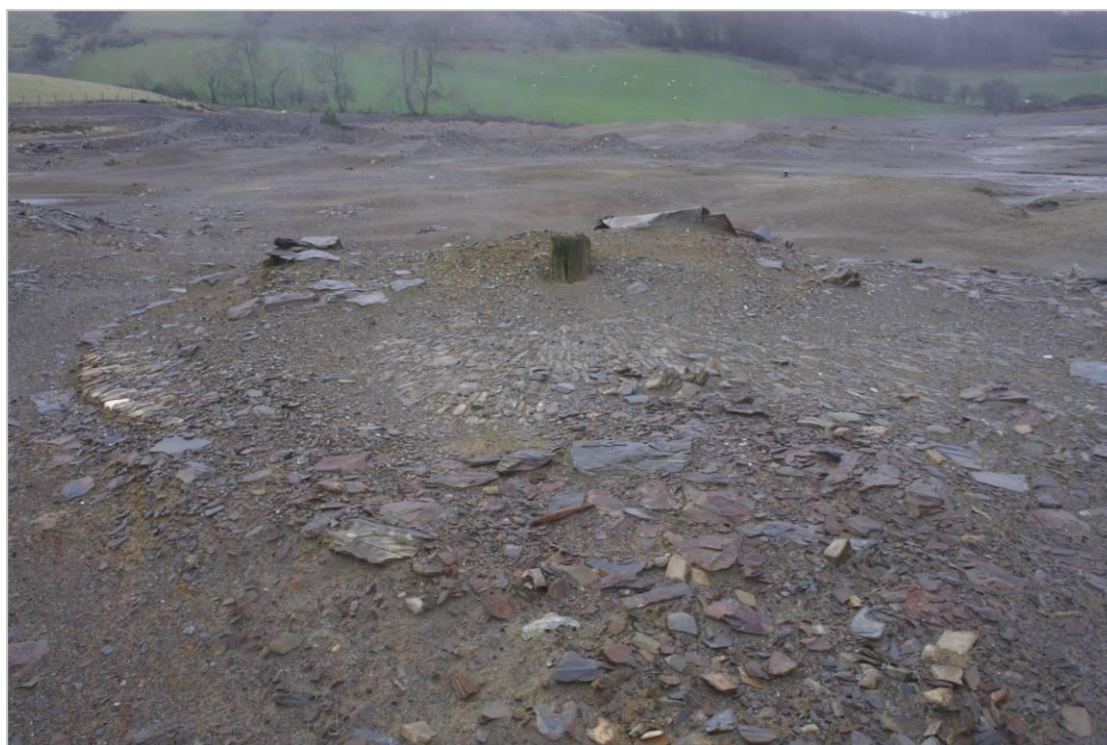
Photo 12: View of circular floor of 'buddle' with area of former waste tips in the background. Looking south-west.

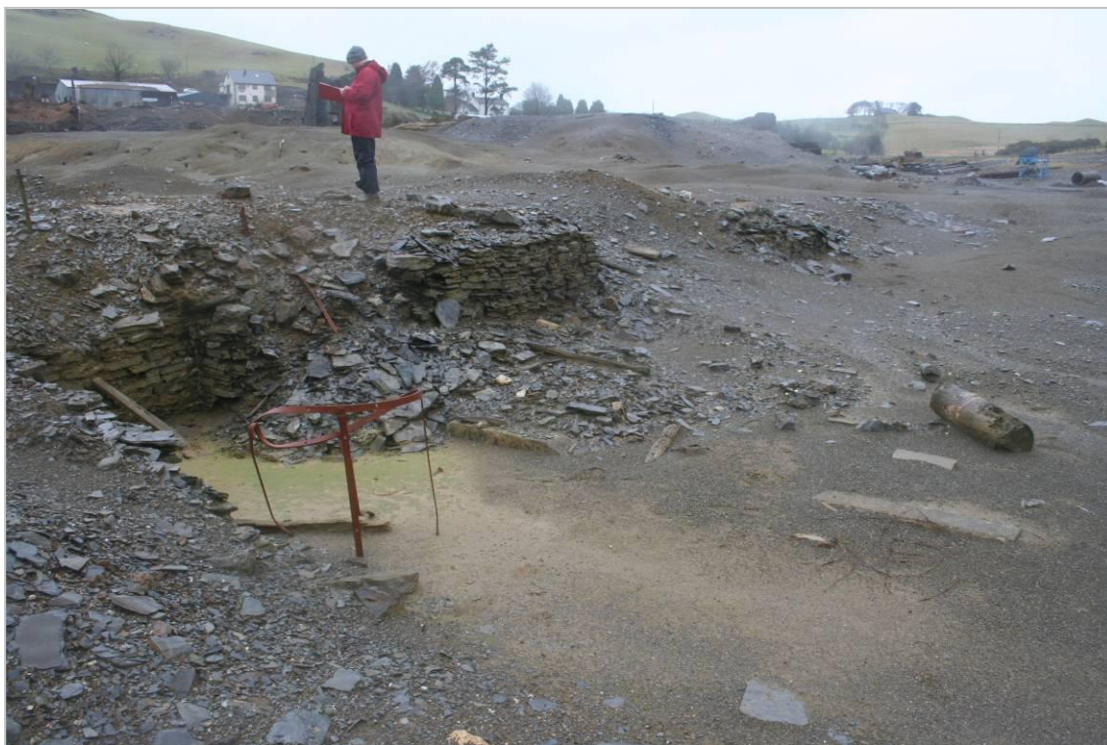
Photo 13: View of remains of rectangular slime pits. Looking east

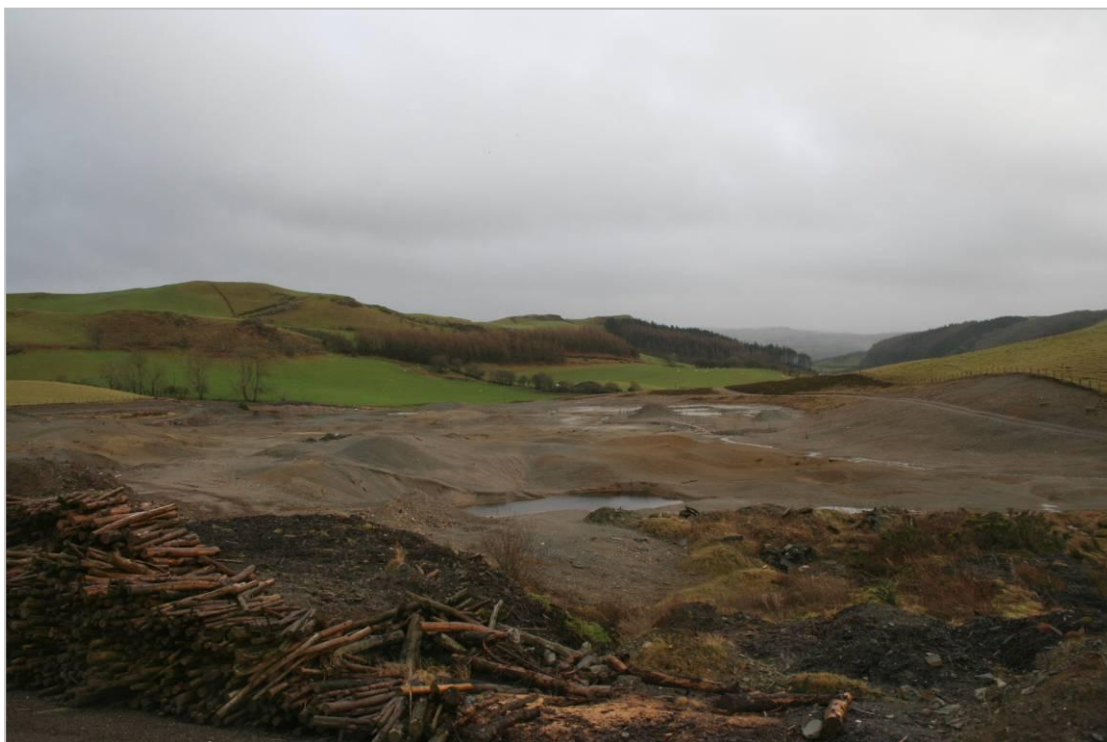
Photo 15: View to south showing the remaining waste dumps of Frongoch Mine in the back ground and the more recent waste from the saw mill in the foreground.

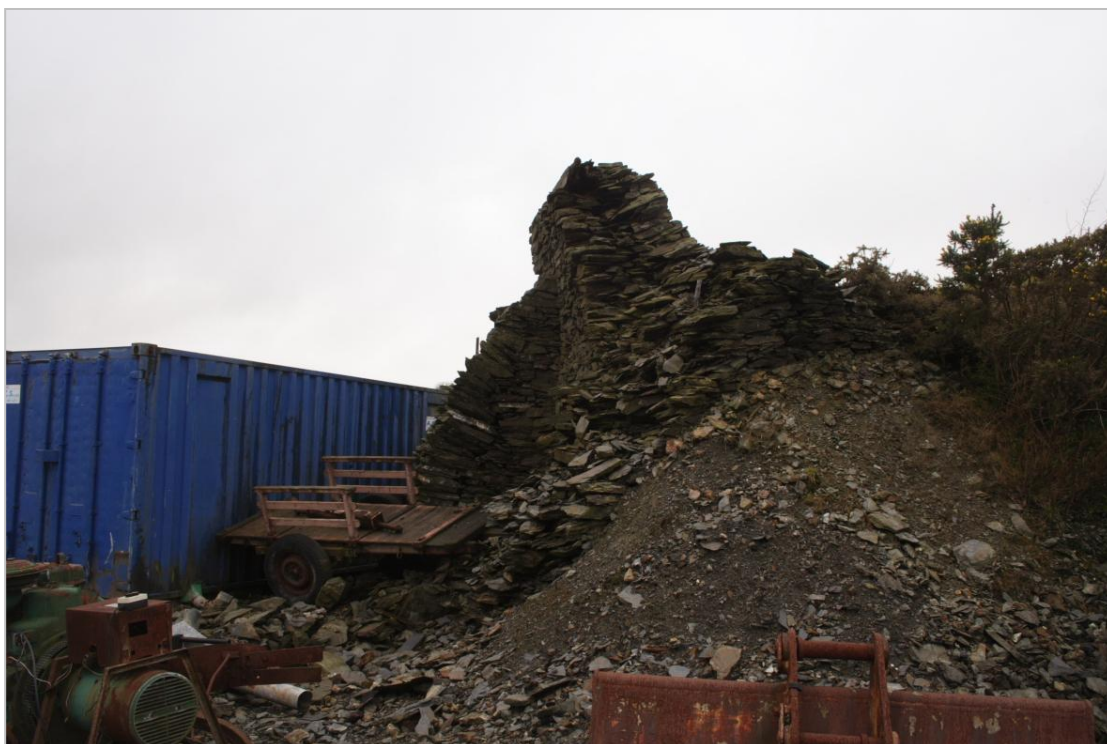
3.4.6 In the area to the south and east of the saw mill there has been much moving of waste tips, including those of the saw mill and there are large dumps of rubbish, including many porta-cabins, steel lock ups filled with rubbish and old machinery that obscure archaeological features and in some cases appear to be compromising the survival of any remaining buildings (Photo 16).

Photo 16: Collapsing mine building surrounded by redundant steel lock ups and accumulated rubbish.
