FRONGOCH METAL MINE GEOTECHNICAL TEST PITS ARCHAEOLOGICAL WATCHING BRIEF 2012

RHIF YR ADRODDIAD / REPORT NO. 2012/17
RHIF Y PROSIECT / PROJECT RECORD NO. 102666

Chwefror 2012
February 2012

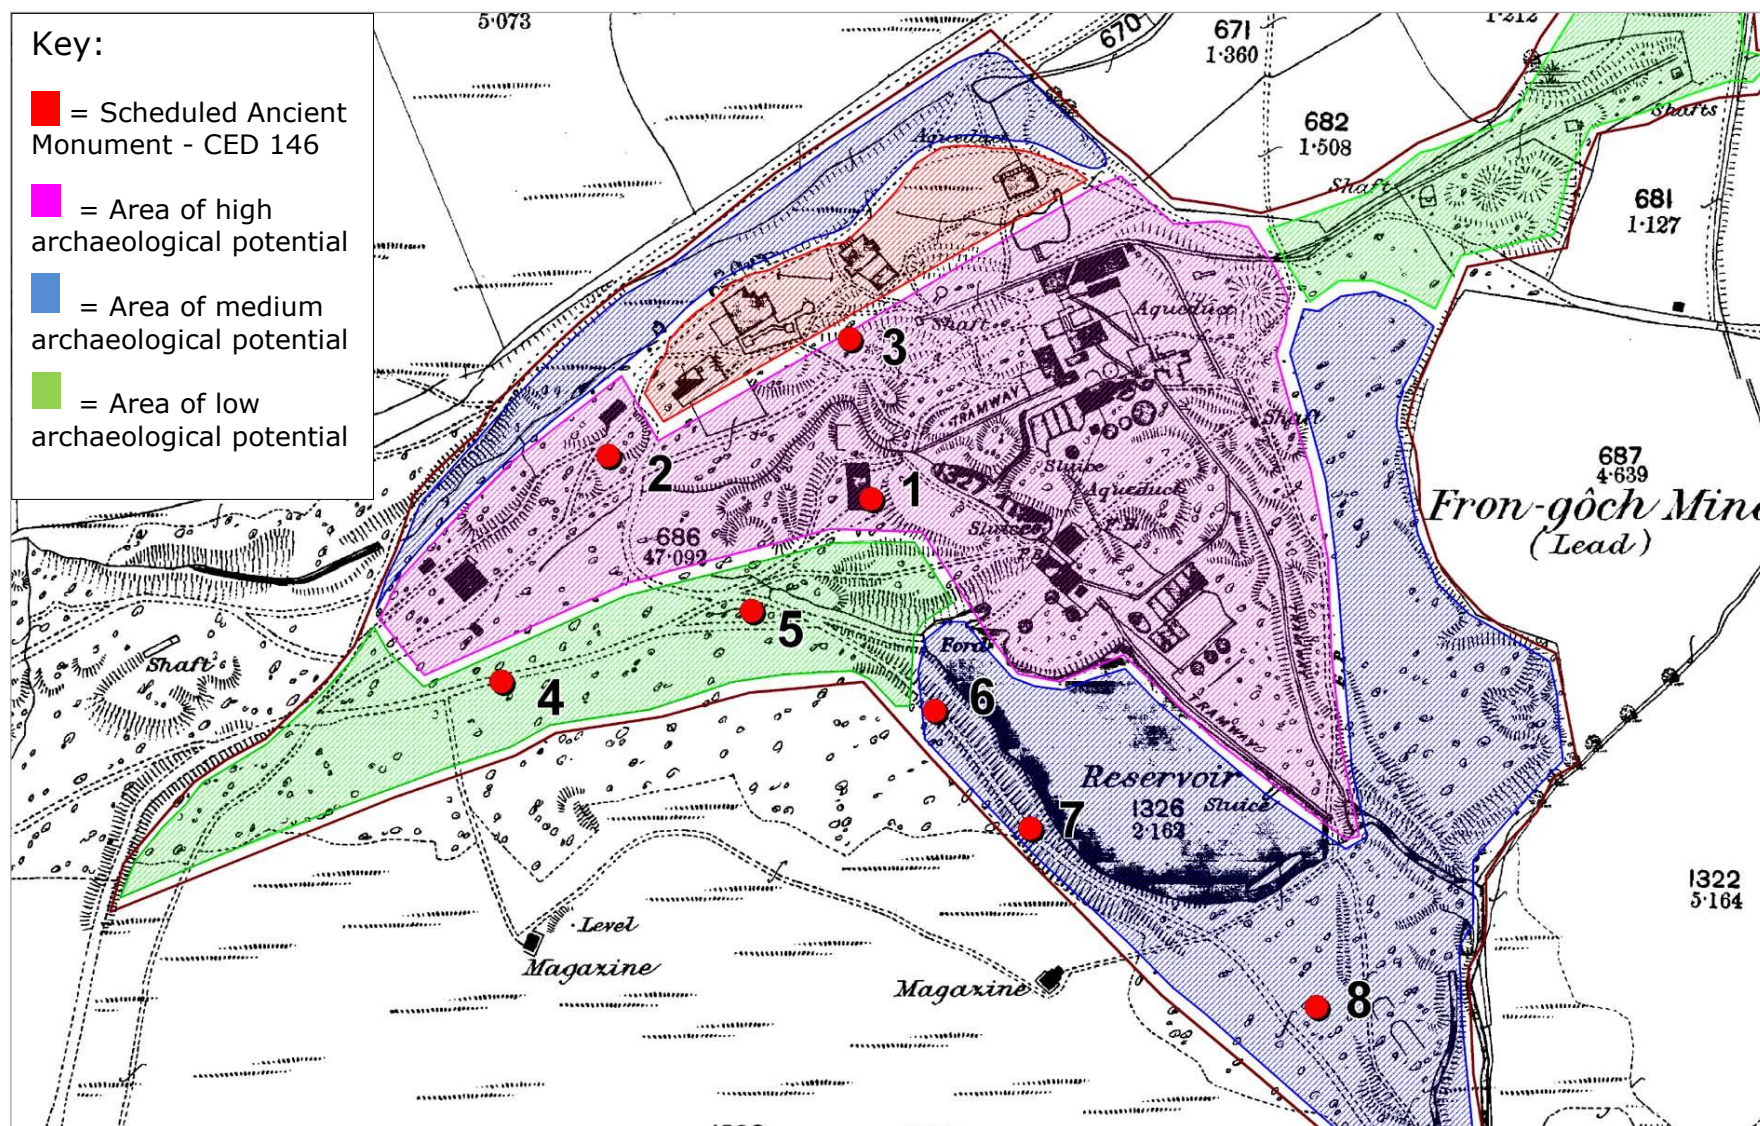
Figure 2: Plan of location of test pits as recorded during excavation. The areas of archaeological potential are as defined by DAT-FS (2012) and overlie an extract of the 1888 1st Ordnance Survey 25-inch map of Cardiganshire.

- 5.2 The results from Test Pit 3 confirmed the high potential for disturbing archaeological deposits in this area, and emphasised the difficulty in avoiding archaeological deposits if undertaking ground works in areas near the scheduled mine buildings and the former dressing floors of the mine. This trench fell in an area of high archaeological potential as shown in Figure 2.

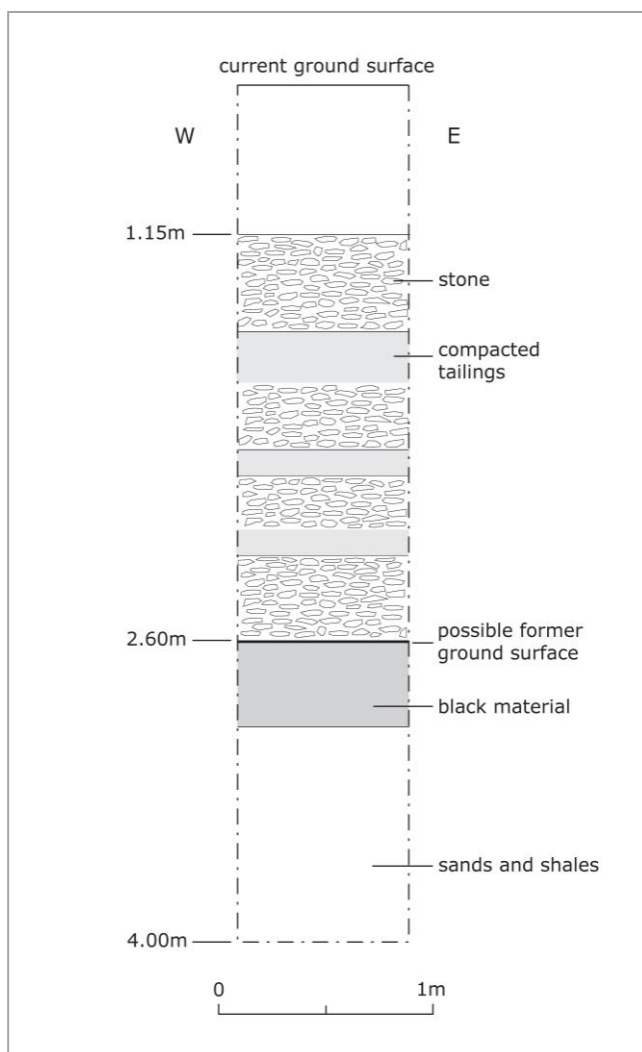
- 4.3.2 In the west, east and south facing sections could be seen a series of deposits that formed at least 3 layers of compacted tailings separated by layers of similarly sized pieces of ore bearing rock (Photo 8, 9 & 10). These deposits lay between 1.15m and 2.60m below the ground surface (Figure 3). Underneath this group of deposits was conceivably an old ground surface at approximately 2.60m, below which a darker layer containing rounded pebbles and pieces of quartz. Within this darker material at an approximate depth of 2.7m were the remains of a wooden drain/conduit visible in the west facing section of the test pit running in an east-west direction. The test pit was excavated to a depth of approximately 4.0m.

Figure 3: Sketch plan of south facing section of Test Pit 3 showing the accumulated layers of compacted tailings interspersed with layers of ore bearing stone. All measurements are approximate.

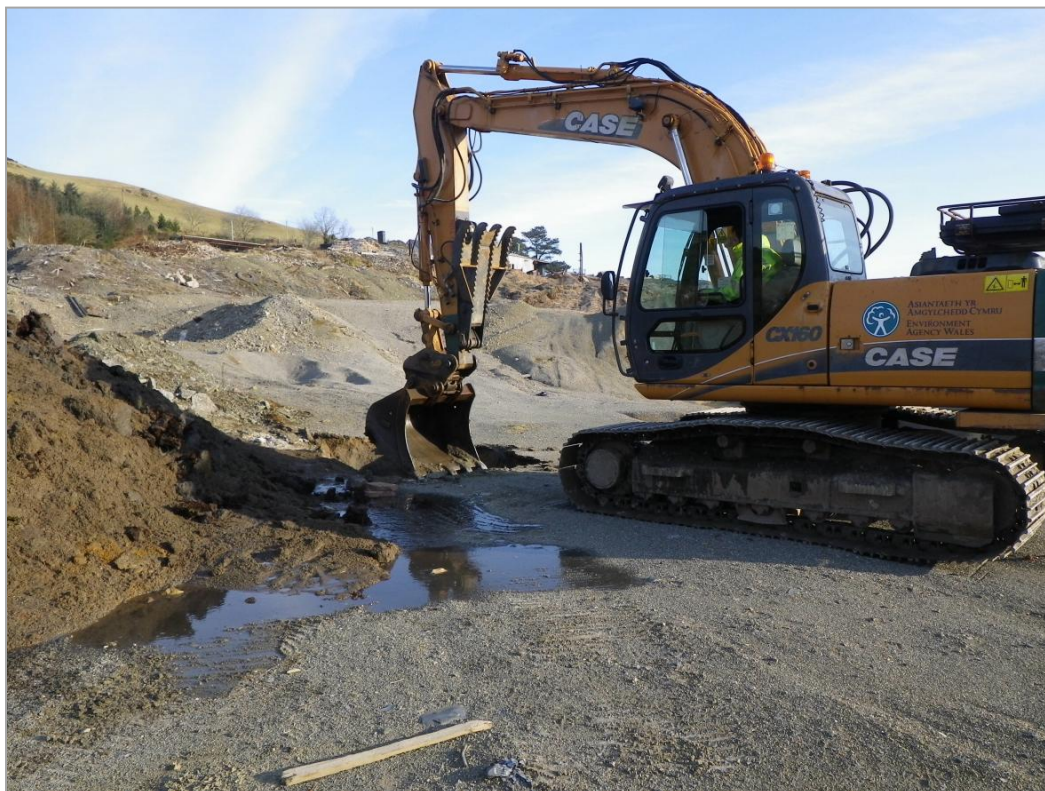
- 4.1.1 Test pit 1 was excavated in the area of mine tailings (Photo 1) in close vicinity to the position of a former store building that can be seen in Figure 2. In 1996 this building, though a ruin, was still identifiable but since then it has been completely demolished and cannot now be identified on the ground. Excavation of the test pit was hampered by the character of the unstable material through which the pit was dug. The fine nature of the tailings and the large quantity of water flowing into the pit caused the sides to collapse and quickly undermine.

Photo 1: Excavation of Test Pit 1.

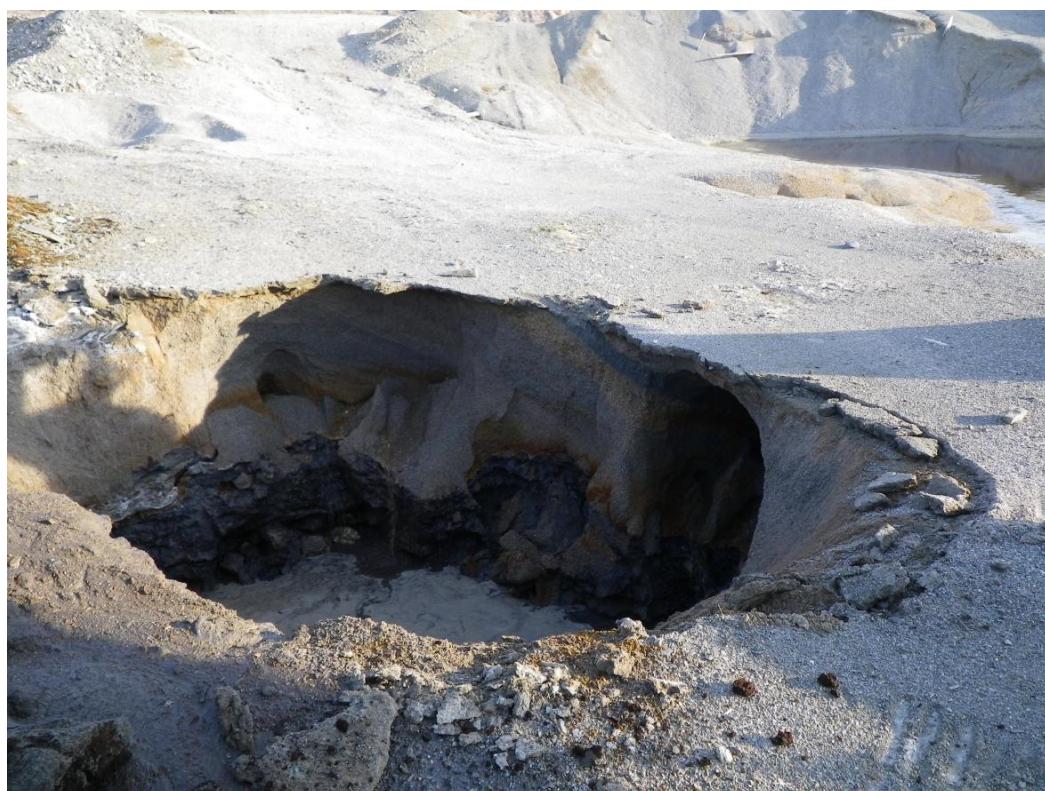
- 4.1.2 It was very difficult to see anything clearly, but in summary from the ground surface down approximately 1.5m of fine tailing material could be seen (Photo 2). Below this appeared to be a hard compact surface, possibly made of concrete. Underneath this surface was a much darker mixed deposit that contained a lot of peaty, humic material containing roots and pieces of wood. At about 3.20m depth within this darker material a wooden structure, conceivably a drain/conduit for water, could be seen in section, probably running in an east-west direction. The machine bucket had cut through it and lifted up what appeared to be wooden stakes that could have come from this structure (Photo 3).

Photo 2: View of Test Pit 1 looking east showing sides subsiding into pit.

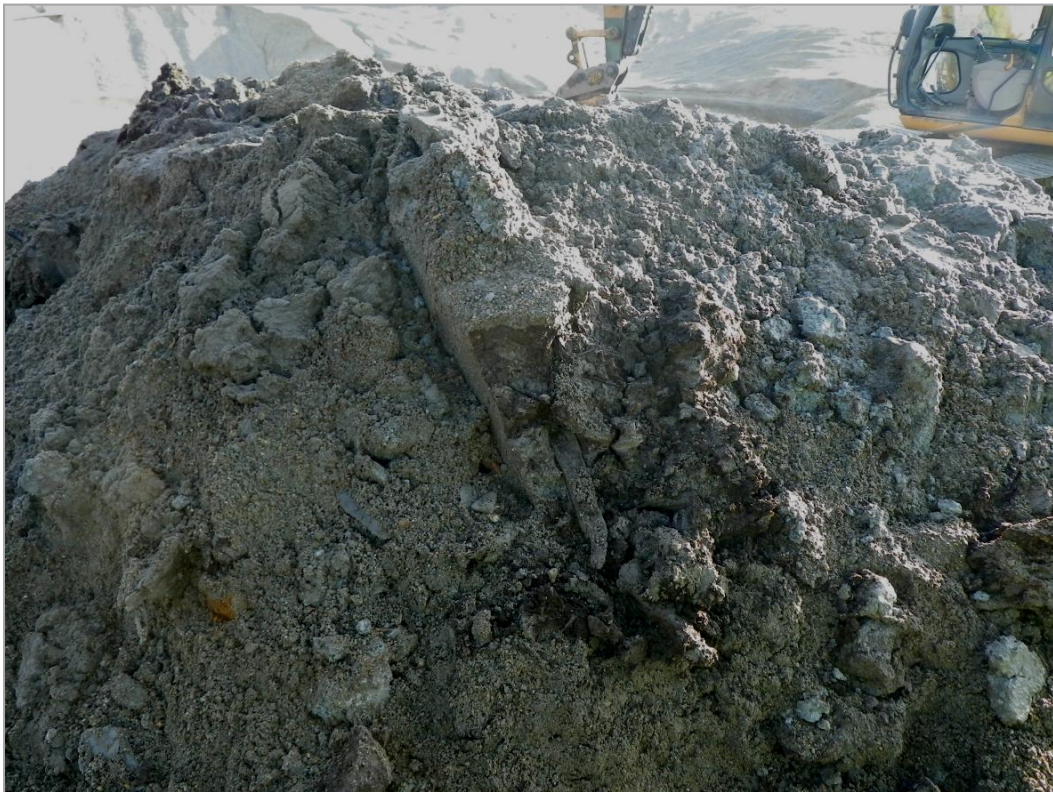
Photo 3: Wooden stake recovered from Test Pit 1.

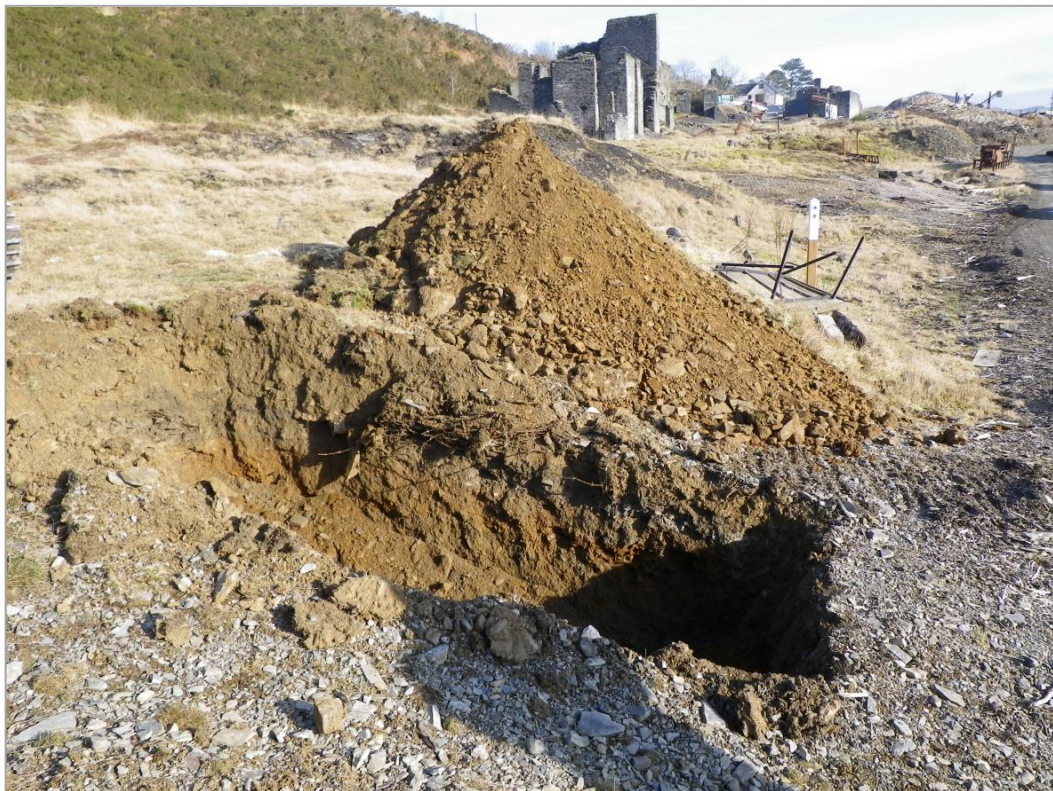
- 4.2.1 Test pit 2 measured roughly 2.0m by 0.80m and was aligned approximately northwest-southeast (Photo 4). It was located to the southwest of the ruined 'smithy' building. In section approximately 0.80m of mine waste, containing amongst other materials a great deal of barbed wire, lay above iron rich orange coloured silt that may indicate the presence of an earlier ground surface (Photo 5 & 6). Below this layer appeared to be undisturbed natural sands and shales that were excavated to a depth of 3.0m.

Photo 4: View of Test Pit 2 looking east.

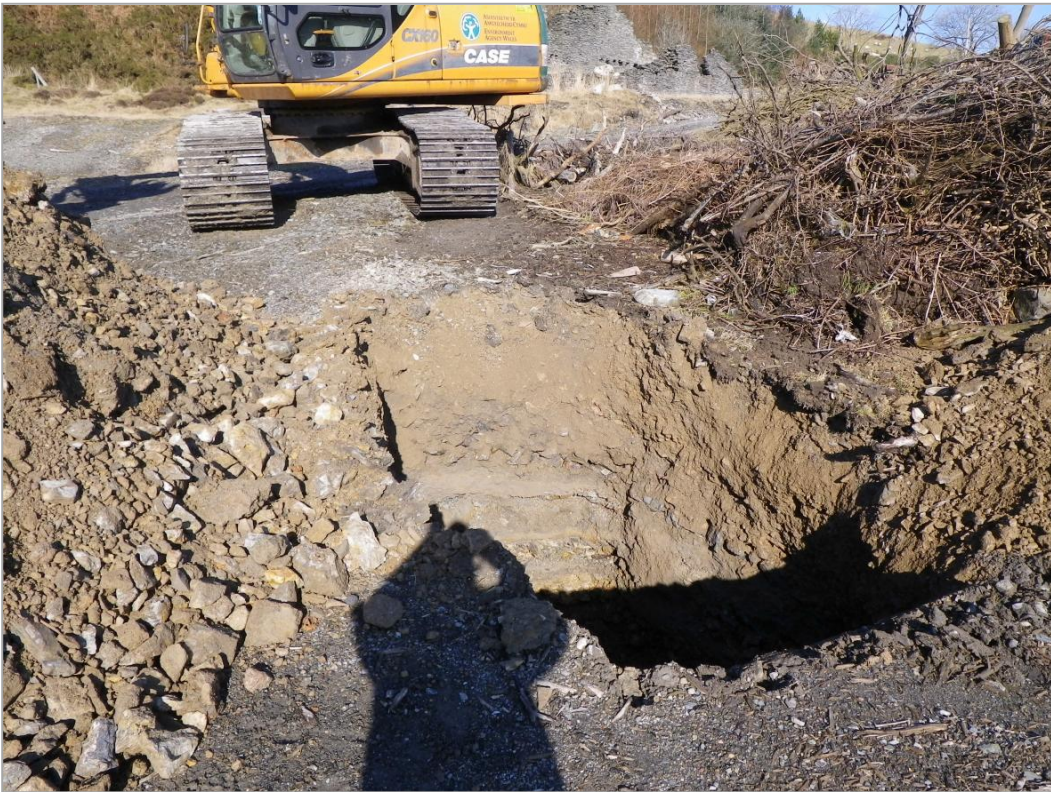
- 4.3.1 Test pit 3 was excavated in the most sensitive archaeological area (Figure 2). The test pit measured roughly 2.0m by 0.80m and was aligned approximately northwest-southeast (Photo 7).

Photo 7: View of Test Pit 3 looking northeast.

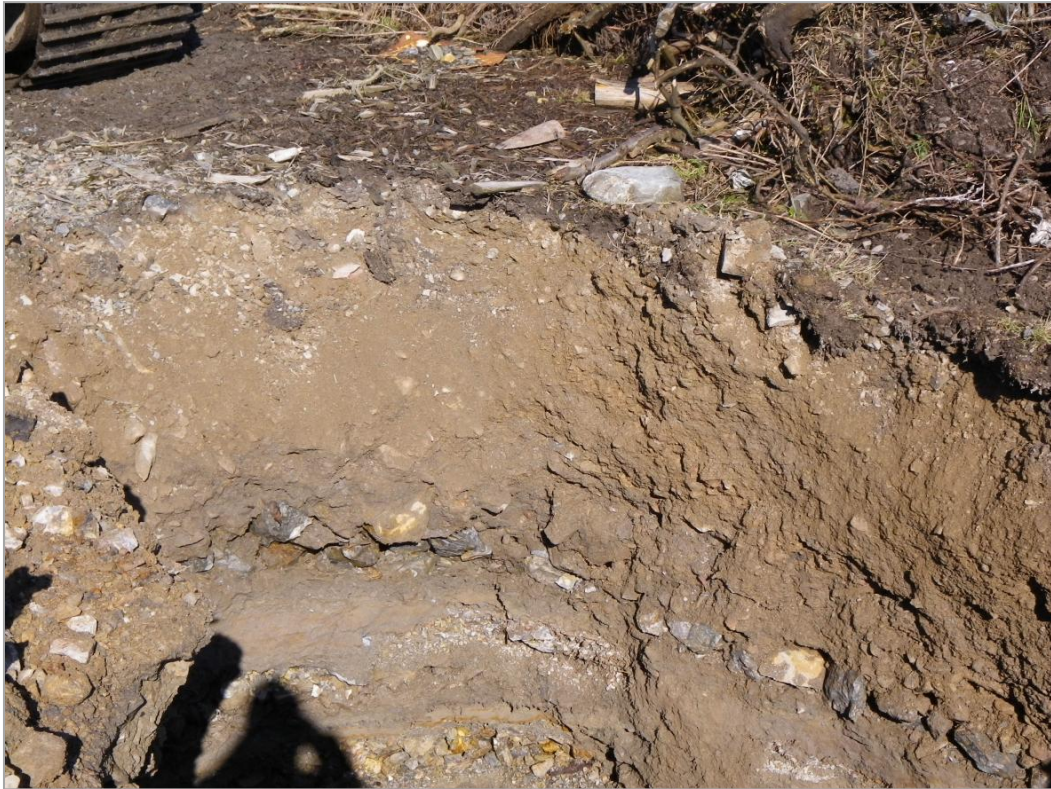
Photo 8: View of Test Pit 3 looking northeast showing detail of layers of compacted tailings interspersed with layers of ore bearing stone.

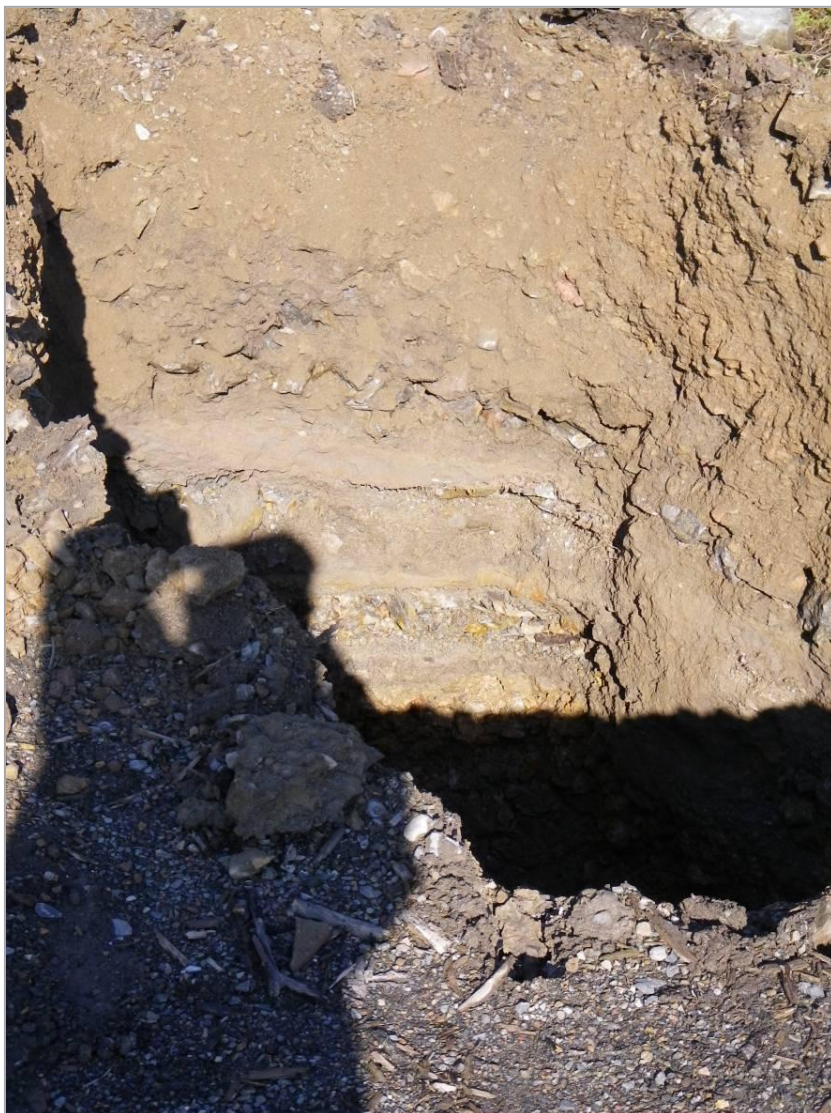
Photo 9 (left): View of Test Pit 3 looking northeast showing detail of layers of compacted tailings interspersed with layers of ore bearing stone.

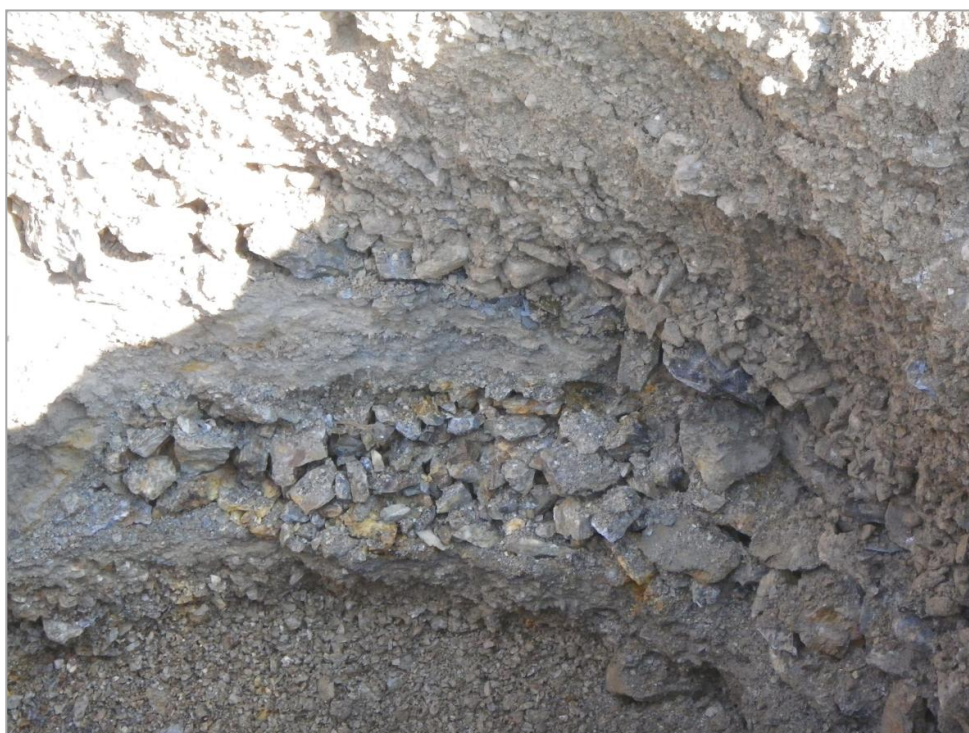
Photo 10 (below): View of Test Pit 3 looking southeast showing detail of layers of ore bearing stone.

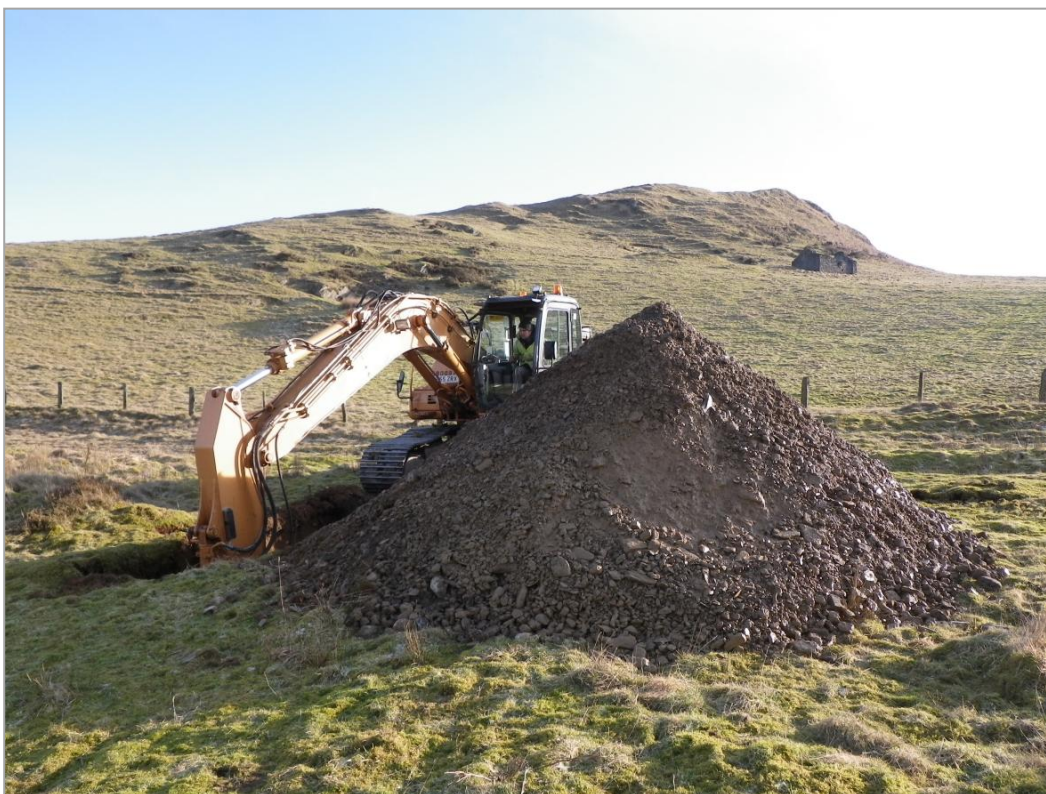
4.4.1 Test pit 4 measured roughly 2.0m by 0.80m and was aligned approximately north-south (Photo 11). The test pit was excavated to depth of roughly 4.5m (Photo 12). No features of archaeological significance were seen during the excavation.

Photo 11: Excavation of Test Pit 4.

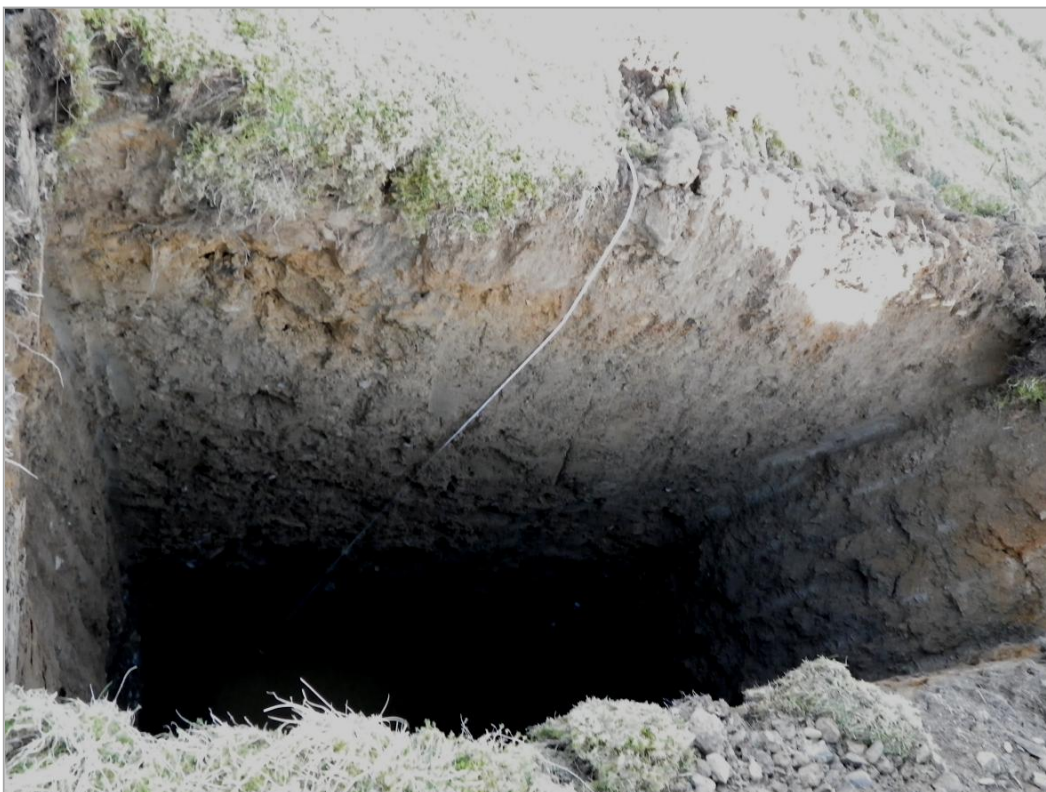
Photo 12: View of fully excavated Test Pit 4 looking approximately east.

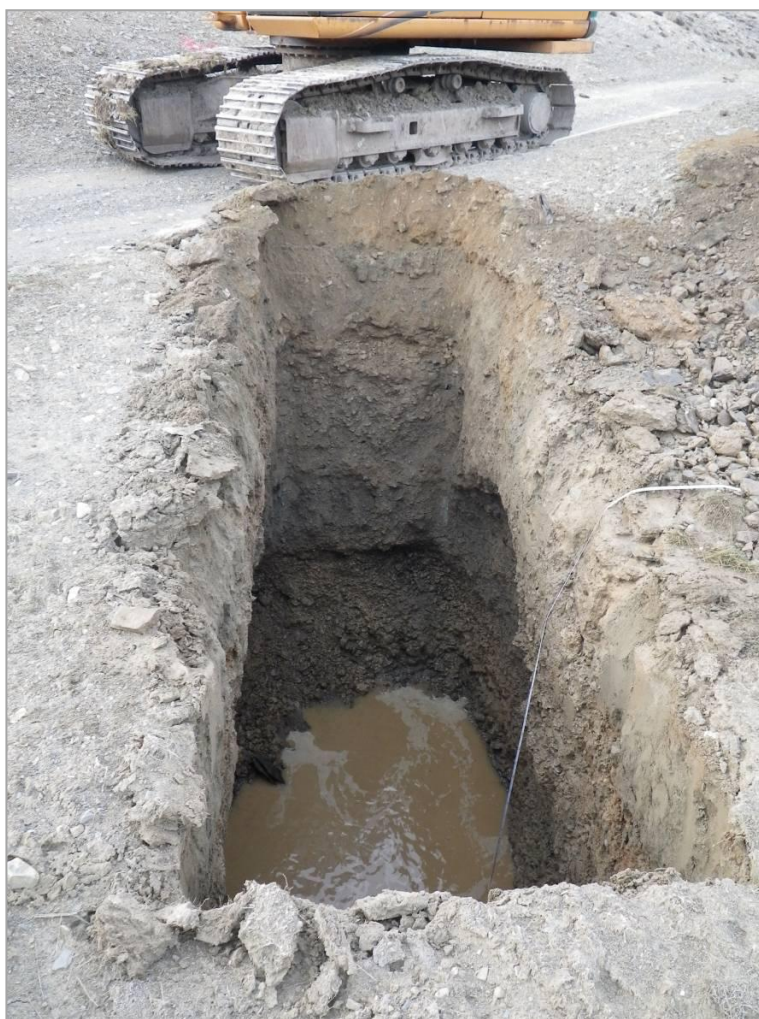
4.5.1 Test pit 5 measured roughly 2.0m by 0.80m and was aligned approximately east-west (Photo 13). This test pit was excavated in the vicinity of the tramway that extended from Frongoch Mine to Wemyss Mine to the west. Although located to avoid hitting any significant archaeological deposits associated with the tramway, a 'U-shaped' linear

Photo 13 (left): View of
Test Pit 5 looking
approximately west.

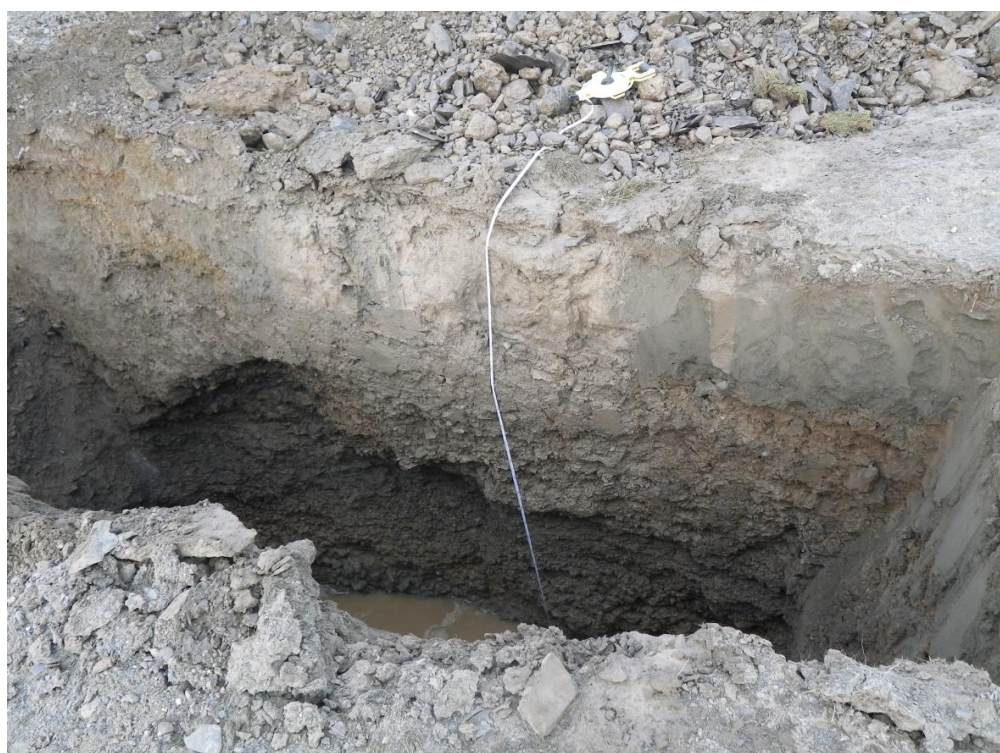
feature or ditch running roughly northeast-southwest was seen clearly in the south facing section, at the western end of the trench. It measured around 0.75-1.00m wide. The bottom of this linear 'ditch' was at approximately 1.50m from the ground surface. It is possible that the 'ditch' ran parallel to the tramway on its north side. It might even have been a result of scraping up material, perhaps on either side, to construct the bank on which the tramway sat. Below this at approximately 1.80m from the current ground surface were signs of an old ground surface, indicated by much darker gravelly material (Photo 14). The test pit was excavated to a depth of roughly 3.0m.

Photo 14 (below): View of
Test Pit 5 looking
approximately north.

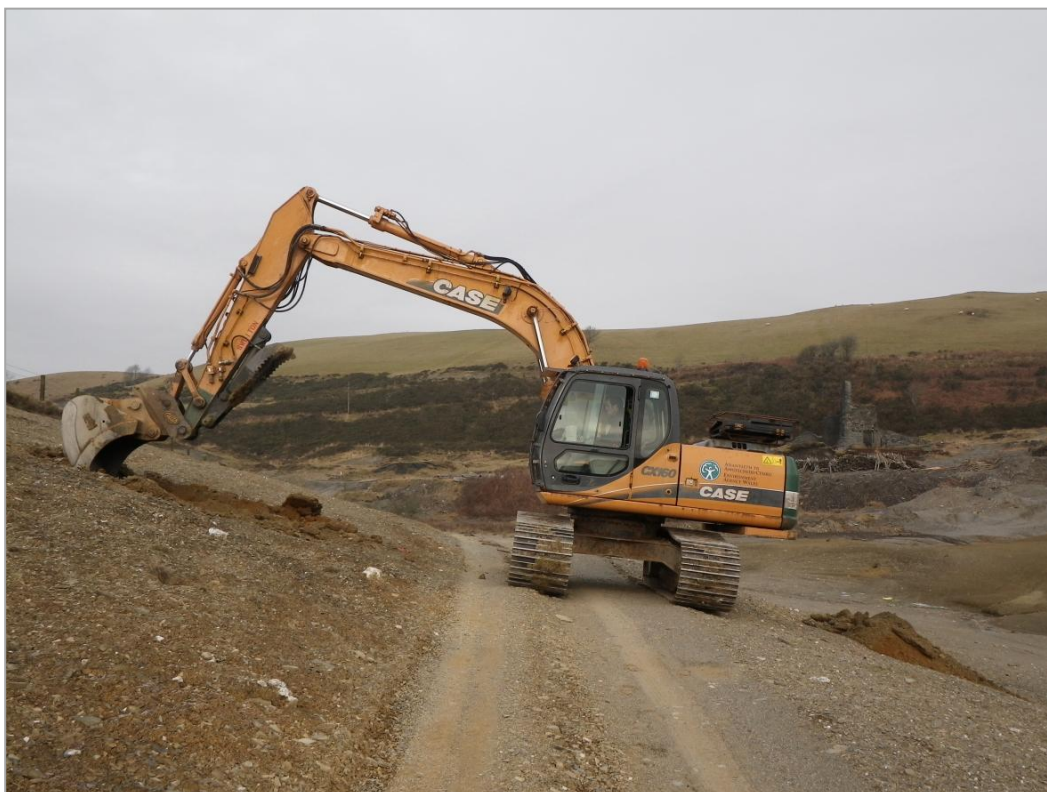
- 4.6.1 Test pit 6 measured roughly 2.0m by 0.80m and was aligned approximately northeast-southwest. It was located on sloping ground to the west of the outer track (Photo 15). The test pit was excavated to a depth of roughly 3.5m (Photo 16). No features of archaeological significance were seen during the excavation.

Photo 15: Excavation of Test Pit 6.

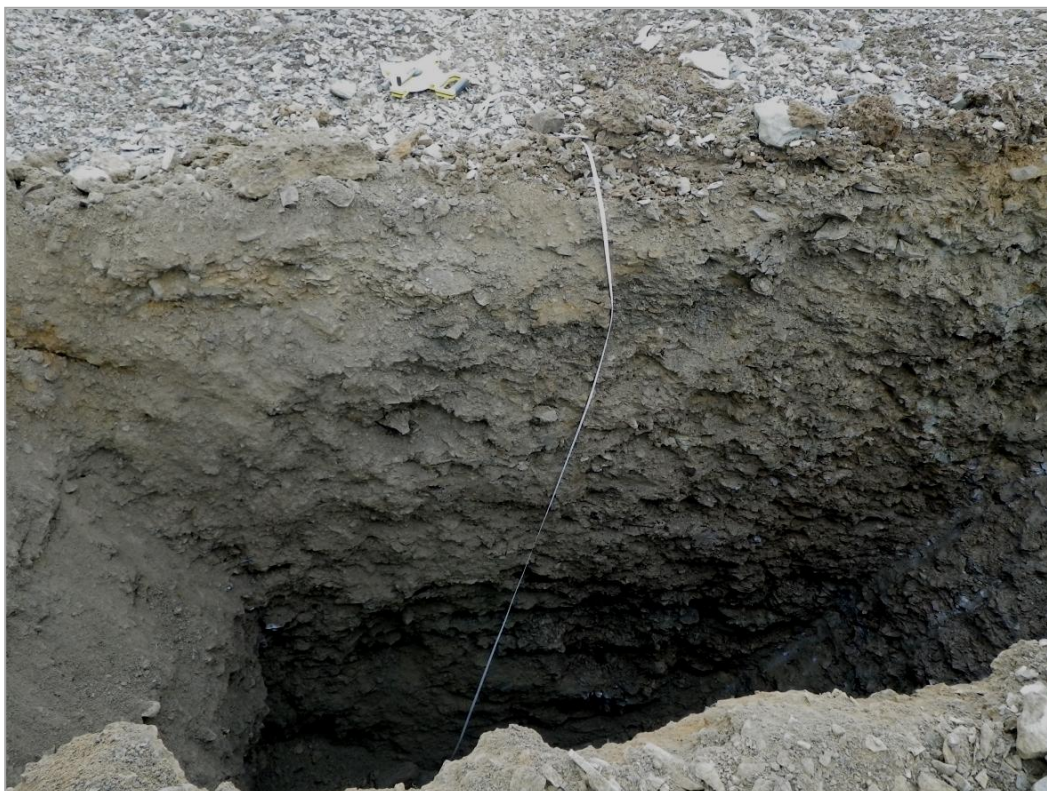
Photo 16: View of fully excavated Test Pit 6 looking approximately northwest.

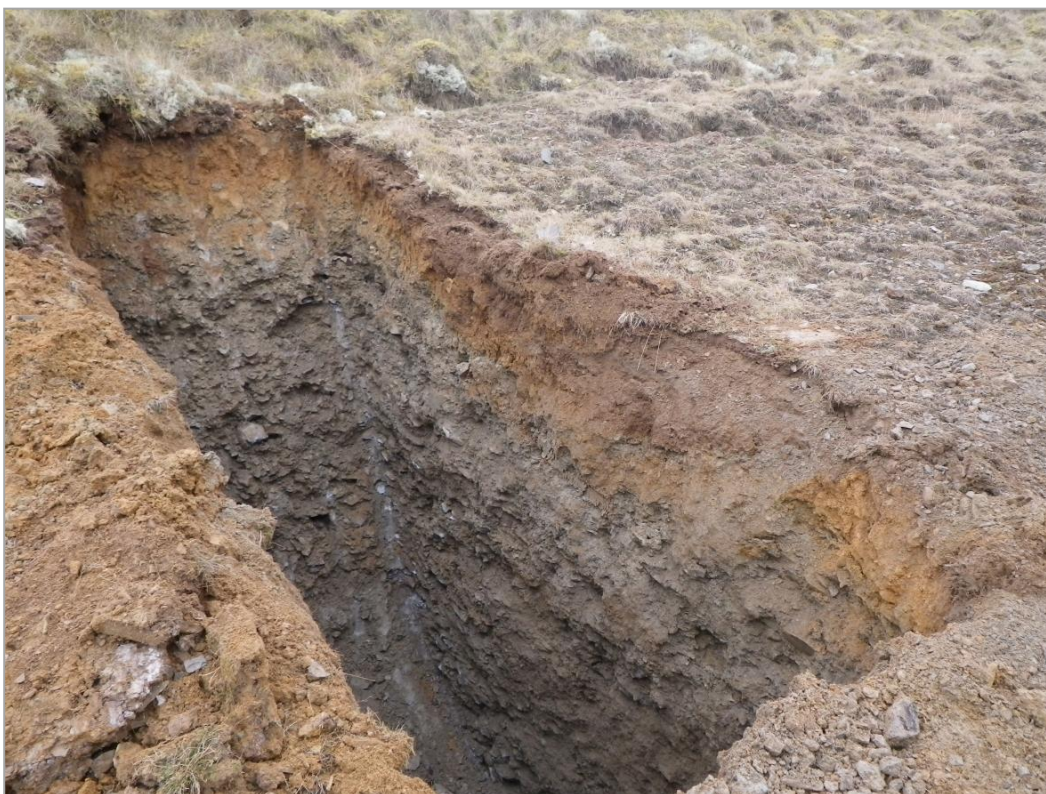
- 4.7.1 Test pit 7 measured roughly 2.0m by 0.80m and was aligned approximately northeast-southwest. It was located on sloping ground to the west of the outer track. The test pit was excavated to a depth of roughly 2.7m (Photo 17). No features of archaeological significance were seen during the excavation.

Photo 17: View of fully excavated Test Pit 7 fully looking approximately west.

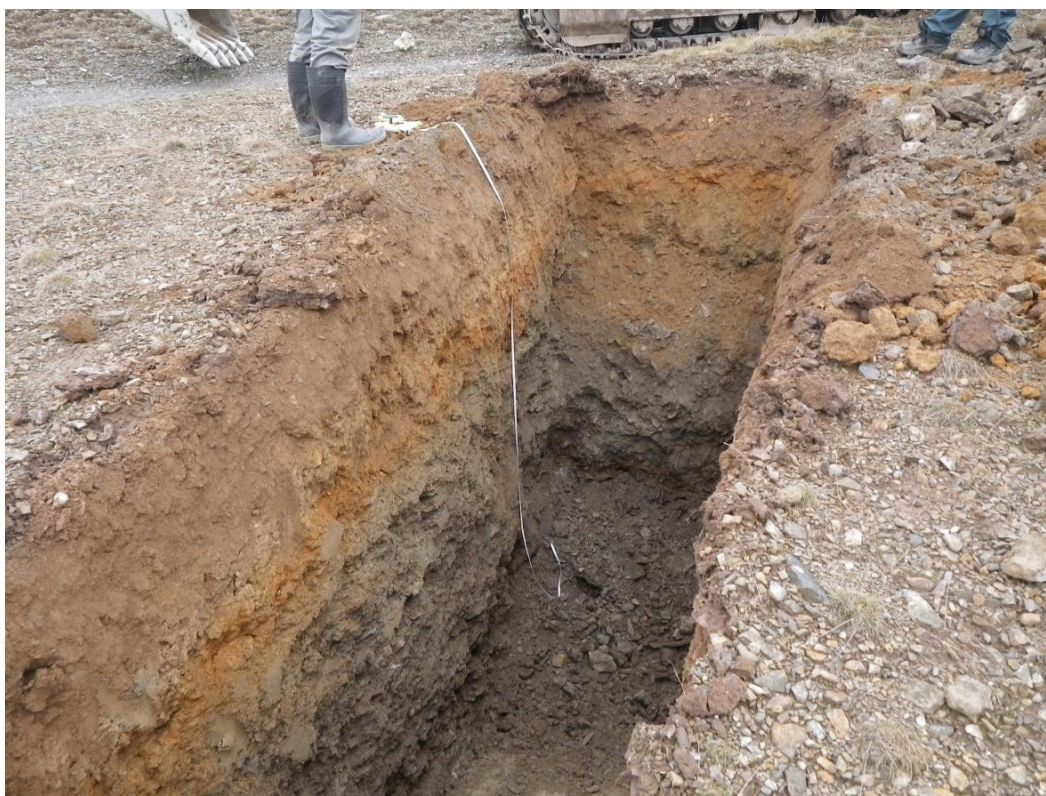
- 4.8.1 Test pit 8 measured roughly 2.0m by 0.80m and was aligned approximately east-west. The test pit was excavated to a depth of roughly 3.0m. It was located in the far southeast area of the mine workings. A bright orange, iron rich silt layer seen clearly in section (Photo 18) could indicate the presence of a former ground surface. Above this lay re-deposited mine waste material and below it were layers of natural shales and sands. No features of archaeological significance were seen during the excavation

Photo 18: View of fully excavated Test Pit 8 looking approximately west.
