THE OLD SCHOOL, QUICKWELL HILL, ST DAVID'S, PEMBROKESHIRE:

PHOTOGRAPHIC SURVEY AND WATCHING BRIEF 2011

RHIF YR ADRODDIAD / REPORT NO. 2012/32 RHIF Y DIGWYDDIAD / EVENT RECORD NO. 102869

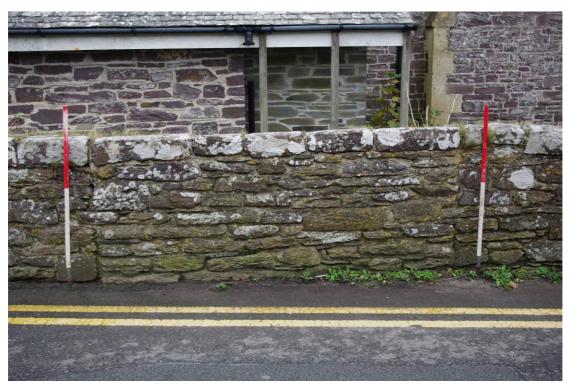
Photo 4: Straight joints seen in wall at southern end of original school building, viewing west (image number 136)

Two straight joints visible in the wall corresponding with the southern end of the original school building also suggested a former entranceway into the school ground, which has subsequently been blocked (Photo 4). No evidence for gate posts was present.

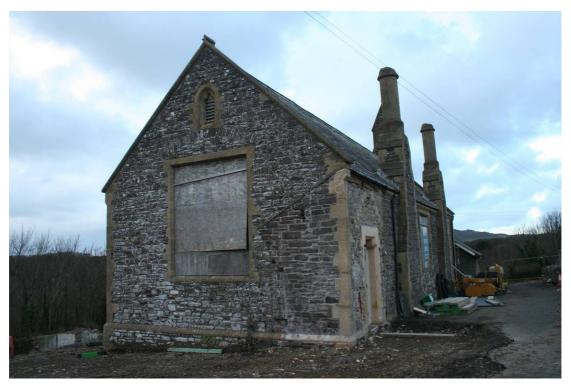
The south wall has one three-light window, slightly larger in size than the others on the east and west sides, above which is a relieving arch and cusped lancet vent (Photo 5).

Photo 5: Southeast corner of school after removal of modern extension

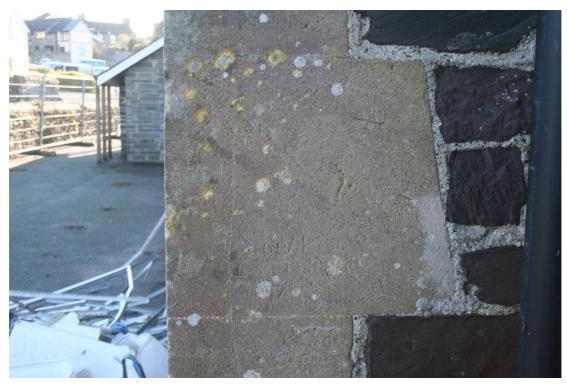
The east side has two external chimney breasts with ashlar circular shafts and two three-light windows with yellow limestone chamfered quoins, mullions and transoms. The removal of the extension on the south-east corner revealed the original shoulder-headed doorway and the remnants of a surrounding porch (Photo 6). Some graffiti (presumably made when the school was operational) can be seen scratched into a limestone quoin at the north-east corner of the building (Photo 7).

Photo 7: Graffiti scratched into quoins in northeast corner of school.

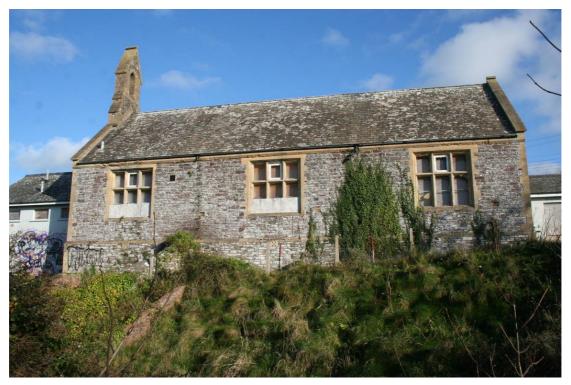
The west side has three, three-light windows of similar construction to the ones on the east side (Photo 8). A small stone wall abutted the west side, running down the garden slope and joining the toilet block, dividing the garden into two. The first 4 to 5m of this wall adjacent to the school has been demolished to facilitate the building of a pentice. There is some modern 'paint-spray' graffiti on this side of the building.

Photo 8: Windows in west wall; note modern graffiti on stonework.

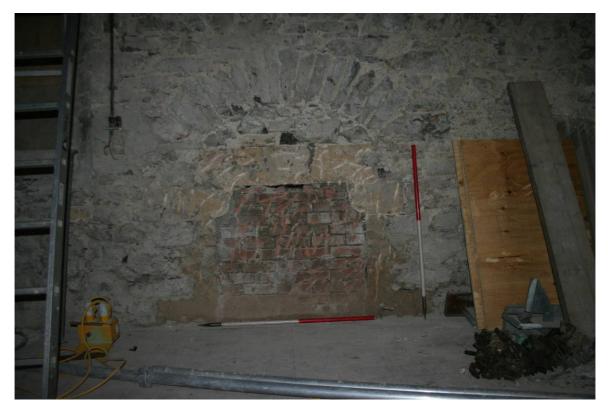
On the east wall the removal of the render exposed two blocked-up fireplaces and their shoulded-headed surrounds (Photo 11).

Photo 11: Blocked fireplace in east wall.

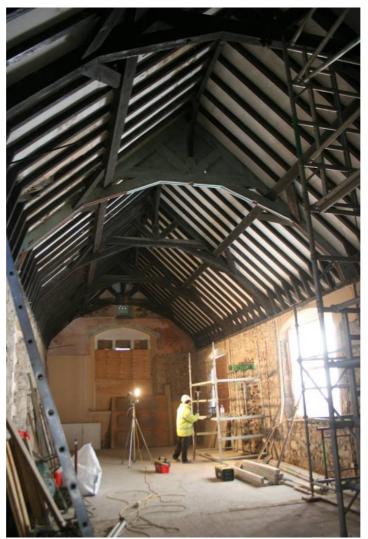
The dismantling of the suspended ceiling revealed a timber roof strucure consisting of six king-post trusses with exposed purlins and rafters (Photo 12).

Photo 12: View south; king-post trusses in roof structure.

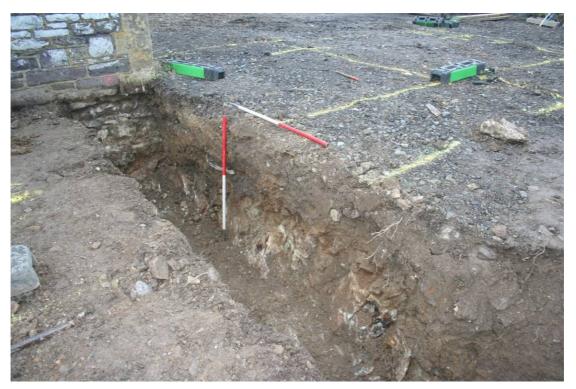
A simple, identical, inert soil profile was observed in all of the trenches (Figure 11, Photos 15 & 17). This consisted of a firm, brown silty-clay with a moderate amount of small to medium angular stone (01) overlying degraded bedrock. This layer (01) is consistent with redeposited material lacking, as it does, any topsoil or subsoil horizons. Furthermore, no cut for the school wall was visible in section, further supporting the evidence that this material (01) has been imported from elsewhere.

Photo 15: Looking east at north facing section of trench A.

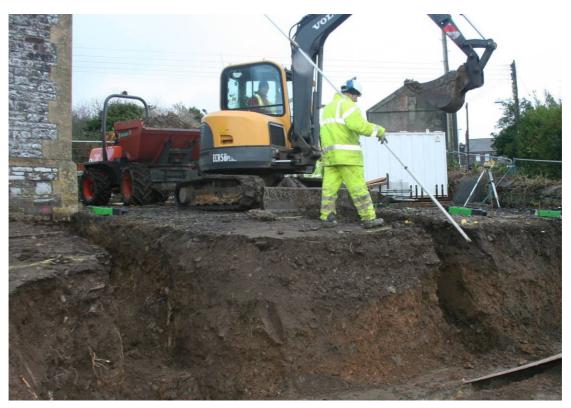
Photo 17: Looking east at west facing section of trench D.

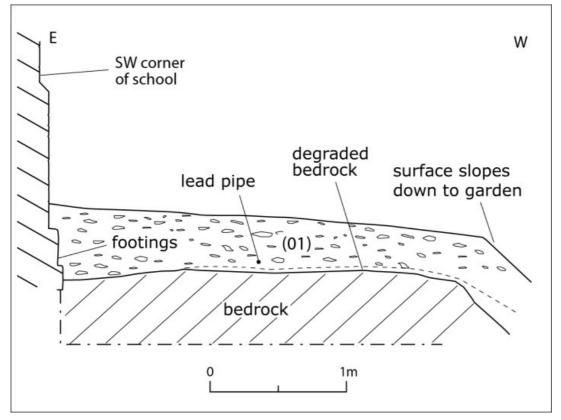
Figure 11: North facing section through trench A showing soil profile exposed during groundworks, and underlying bedrock
