Historic Environment Feature Management Report:

Pentre Mill and Mill Cottage

Customer Reference Number: A0026781

UID: 311417

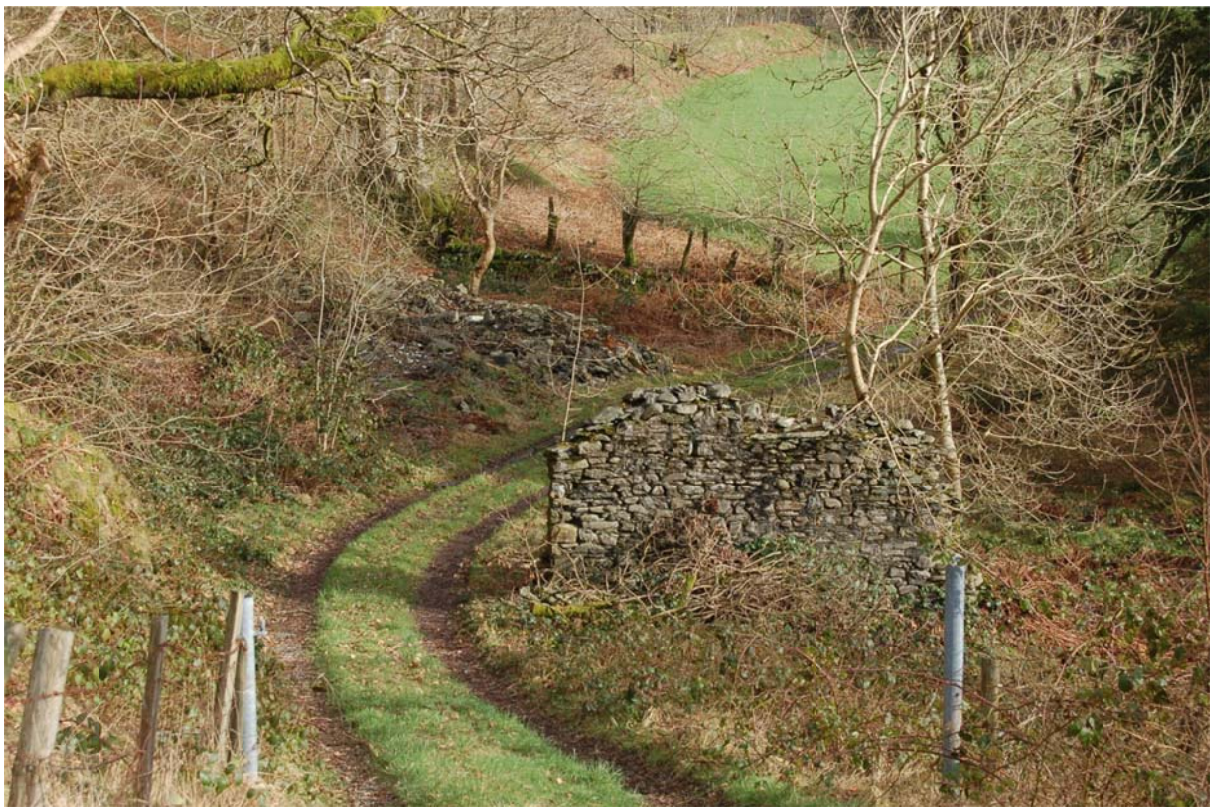
Surviving wall of mill cottage (in foreground) with ruinous mill behind, to left of track (DAT,2013)

'Mill Farm' and 'Mill Cottage' are recorded on the 1st and 2nd edition Ordnance Survey maps respectively, together with associated building that is the mill, powered by a leat (PRN 42633). A possible waterwheel is depicted alongside the east side wall on the 1st edition OS. (M.Ings, 2013, from various sources). The mill cottage and its associated buildings are now completely ruinous and have either collapsed or been demolished. The mill is now a rectilinear mound of stone with many of the roof timbers mixed in with the rubble. The cottage, to the west, has largely disappeared, with only the western gable wall standing to c.2m in height

The main management issue for this site is the control of tree and/or scrub growth, which has the potential to damage buried archaeological remains through the disruptive activity of root development, and built structural remains by prising apart masonry bonds or wind throw.

- Remove mature trees which are at risk of wind throw and could threaten upstanding remains of the mill and cottage through uprooting (root plate damage) or falling limbs.
- Remove any young trees or vegetation growing out of the wall tops but cutting by hand. Spot treat to prevent re-growth. Do not pull-up by the roots as this is potentially destabilising to masonry bonds.
- Cut any scrub back by hand in order to retain the visibility of the building ruins.
- Where present maintain a canopy of mature trees over the site. This will reduce light reaching the ground, inhibiting scrubby vegetation growth.
