Historic Environment Feature Management Report:

Millin Mill, Ruined Corn Mill and Mill Race

Customer Reference Number: A0030021

UID: 300, 787 and 300, 788

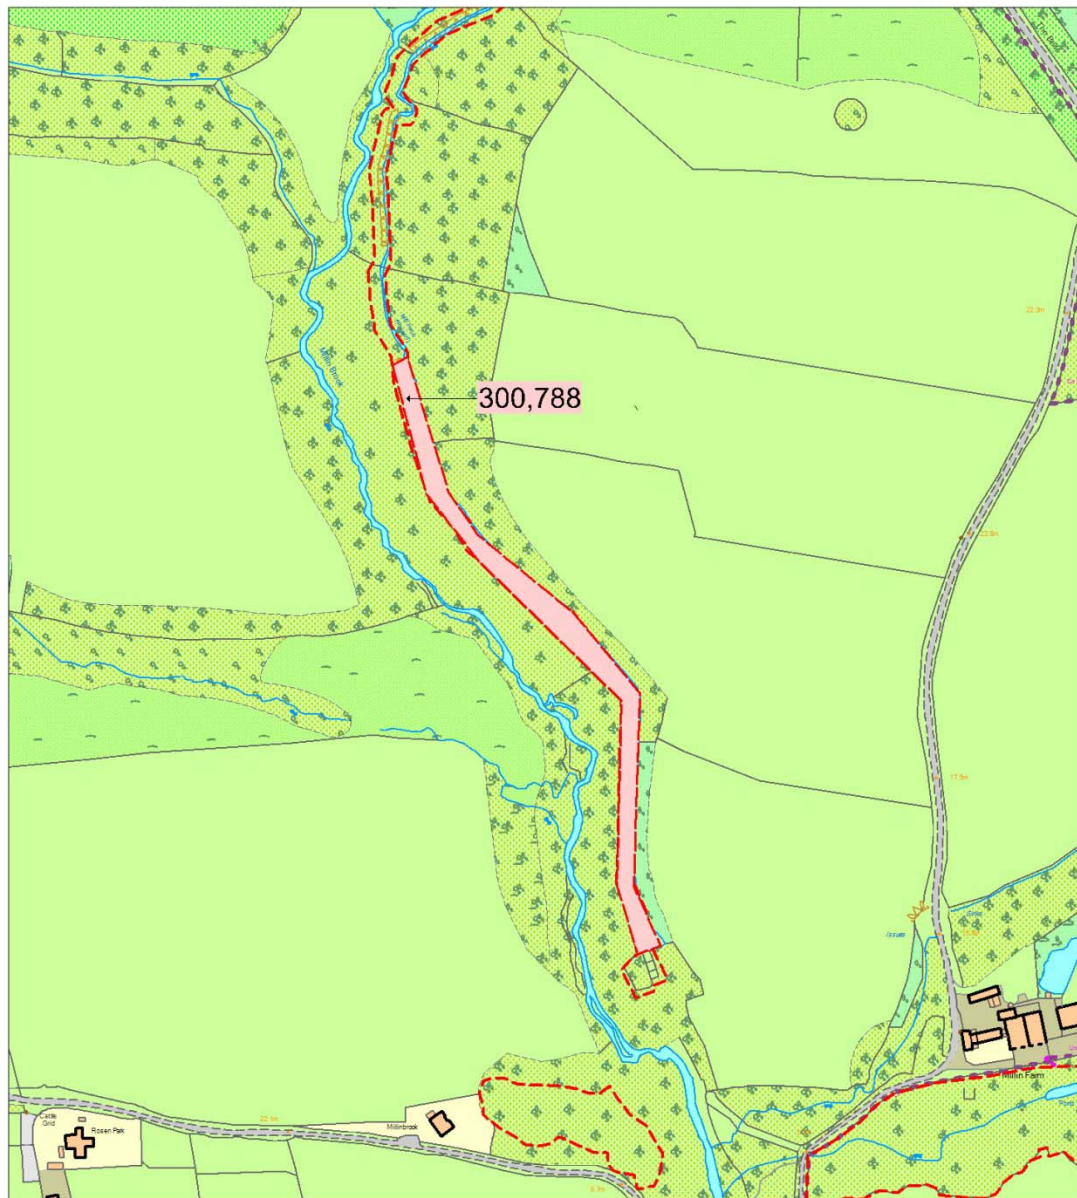
Map of UID 300,788 Management Zone

Mill Race The remains of the mill race survive as earthworks and are at risk from root damage, wind throw and insensitive woodland management. Excessive vegetation cover can also obscure the remains from view. The area of the mill race beyond the engineered embankment is part of an active agricultural drainage system, is not considered to have a high archaeological potential or significance and is not considered to be under a threat which can be mitigated by the Glastir scheme, thus no management action has been identified for this section.

Historic Environment Feature UID 300 788
Zone of active management

- Any harvesting or thinning of trees to avoid heavy and protracted extraction leading to ground disturbance
- Avoid leaving trees vulnerable to wind throw
