# **ST CARADOG'S CHURCH, LAWRENNY, PEMBROKESHIRE: ARCHAEOLOGICAL OBSERVATION**

RHIF YR ADRODDIAD / REPORT NO. 2013/32  
RHIF Y DIGWILLIAD / EVENT RECORD NO. 105580

**ST CARADOG'S CHURCH, LAWRENNY,  
PEMBROKESHIRE:  
ARCHAEOLOGICAL OBSERVATION**

**James Meek**

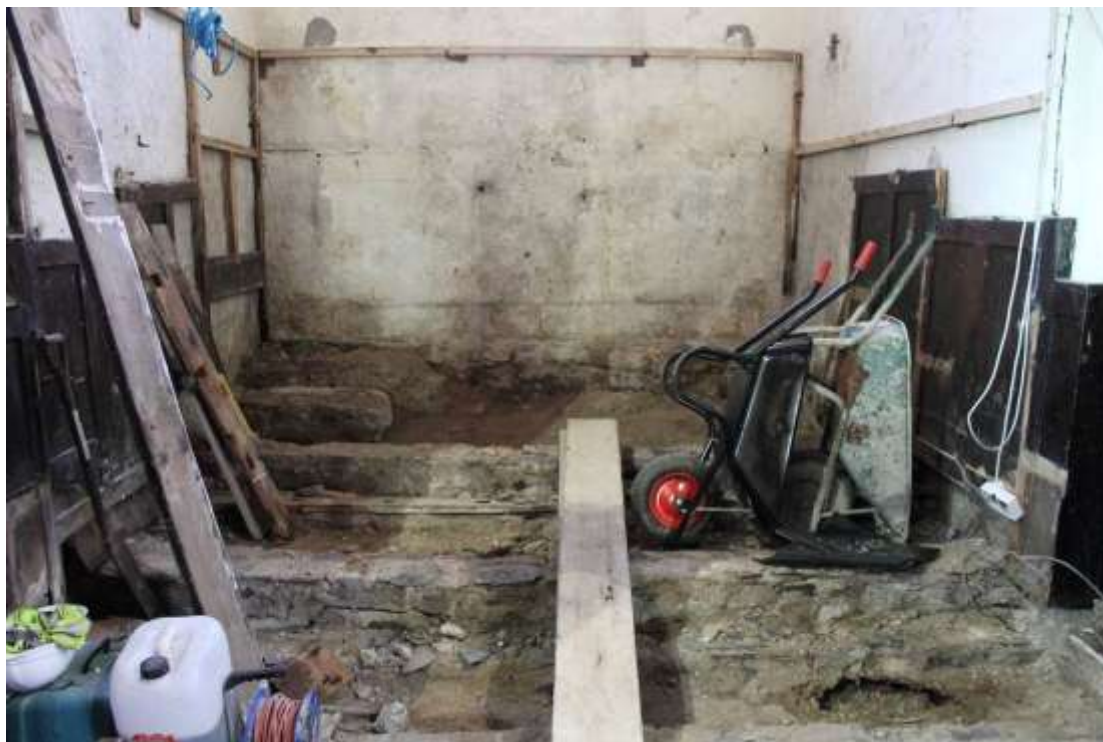
Photo 1: The inside of the West Tower at the start of the works showing the stepped nature of the floor and sleeper walls

3.1.2 The tower floor was separated into four levels rising from the main floor level of the church to the east to its highest point at the western end of the tower (Photo 1). Each level was separated by a sleeper wall constructed of rough rubble stone in a brittle cement mortar, each aligned north to south. The walls were poorly constructed, their function to support the floor joists. The central two sleeper walls were separated into two levels to support the stepped floors. As noted above a further sleeper wall had been present at the western end of the tower to support the upper floor level, but this had been removed (as stated by the site contractor).

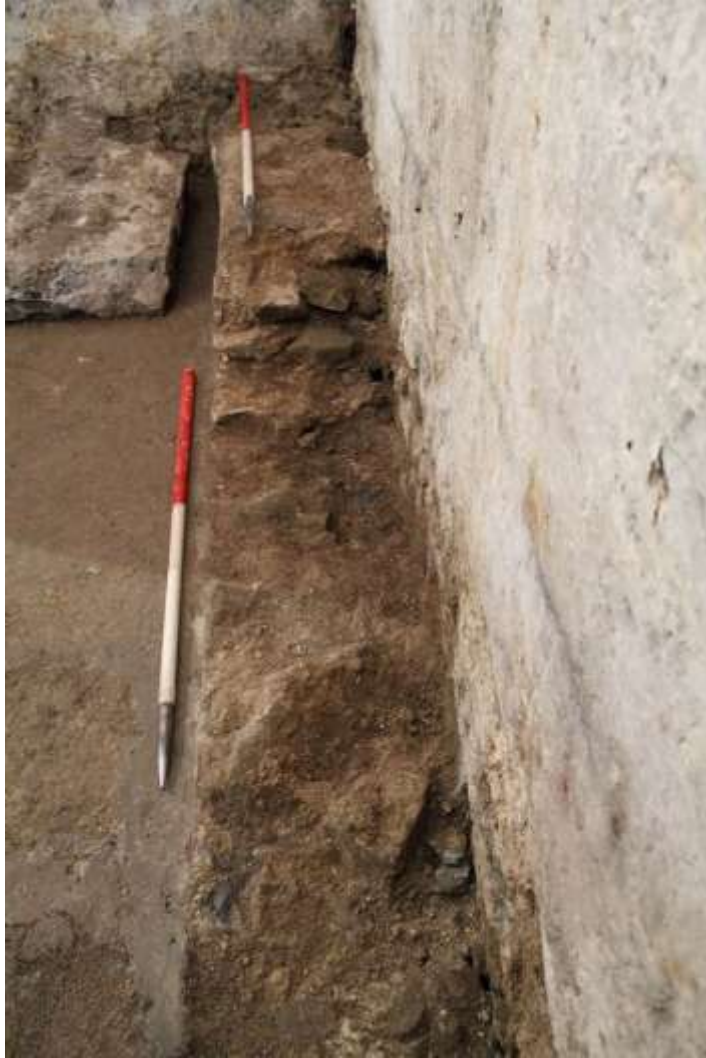
3.1.3 The remains of the plinth wall along the inside of the west wall of the tower comprised a section of upstanding masonry and the remains of foundations (Photo 2 and 4). The wall measured 0.40m in width at its widest point, but did seem to narrow at its northwestern end as though it had been partially truncated. This wall was of a different character to the sleeper walls, the surviving section of masonry being rendered on its internal face, constructed of larger limestone blocks and bonded with a hard lime mortar. The mortar contained small pieces of crushed anthracitic coal (available locally) which may have been used for its properties as a pozzolan, speeding up the setting time of the mortar and making a firmer mortar. The coal had not been burnt.

Photo 2: The remains of the plinth wall along the inside of the west wall of the tower (viewing south)

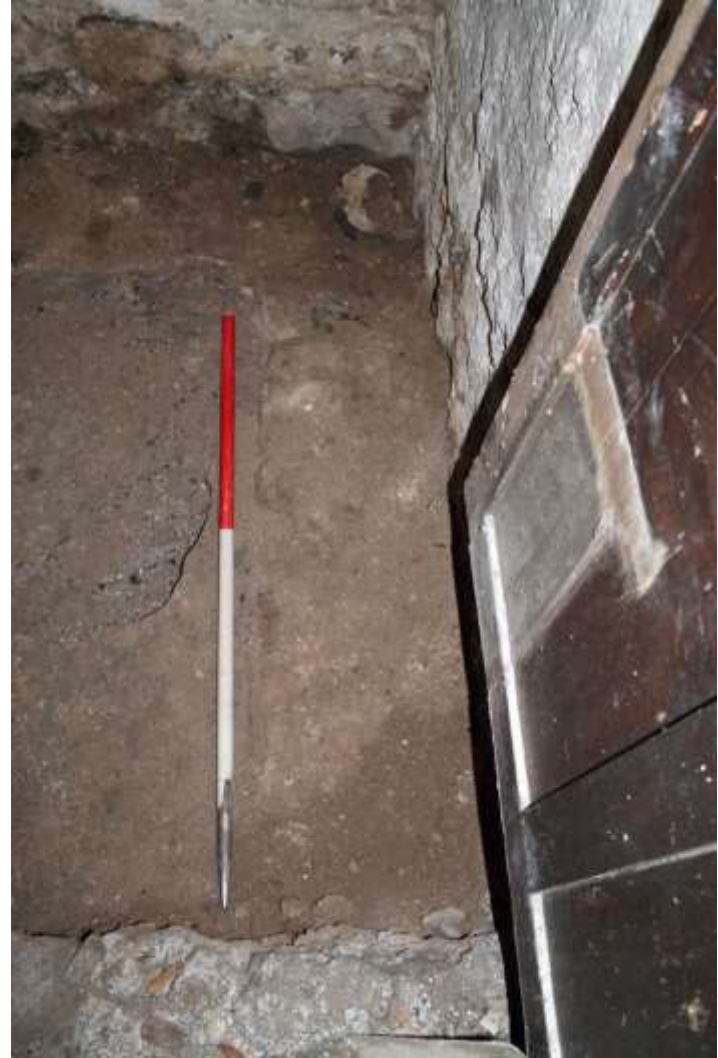
Photo 3: The foundations for the wall along the inside of the north wall of the tower (viewing west)

3.1.5 The foundation for the plinth wall was also present on the inside of the north (Photo 3) and south walls within the upper section of the tower. No superstructure had been removed from these areas during the present phase of works and it is presumed they had been removed during an earlier phase of works at the church, probably when the stepped floor levels had been added.

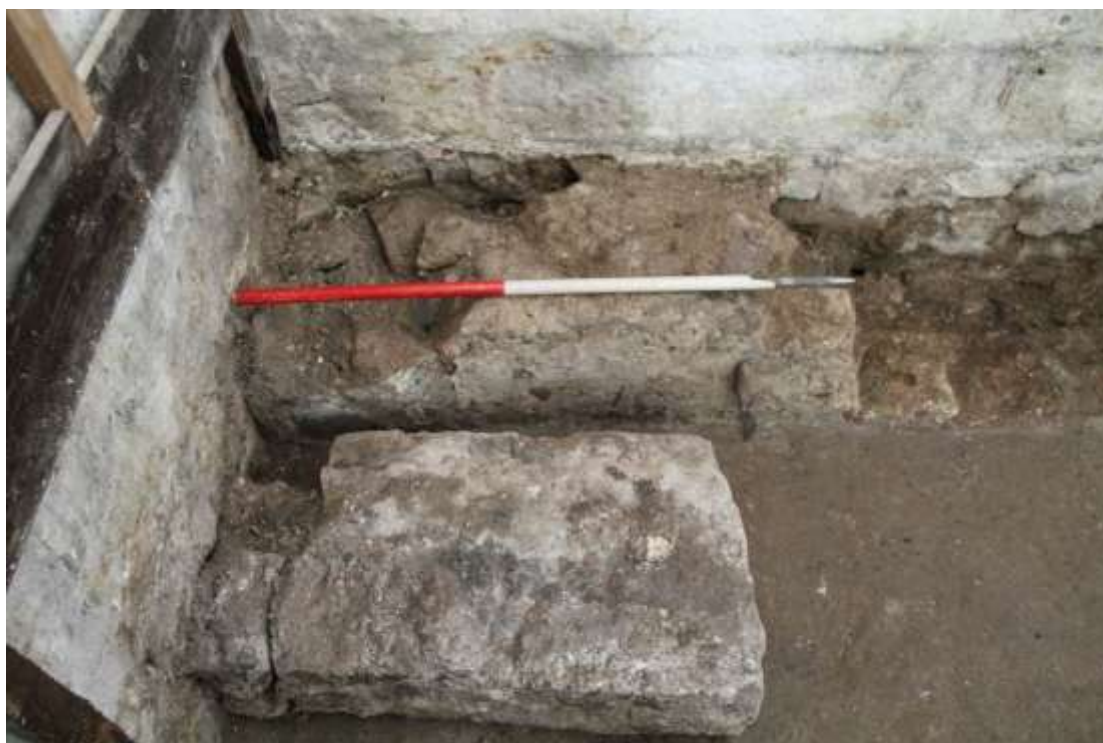
3.1.7 To the east of the western plinth wall was a large fragment of masonry, again of around 0.40m in width and of very similar construction. This fragment was not in-situ and had been placed loosely on the mortar floor (Photos 4 and 5). It is presumed this originated either the north or south walls on the inside of the tower, but was either too large to move or was left on the mortar floor to support a timber floor above. The removed sleeper wall had been located directly to the east of this fragment of masonry (as stated by the site contractor). It was also noted in this area that there was a break in the foundations on the inside of the tower wall and that the mortar flooring continued directly up to the inside of south wall of the tower (Photo 5). This gap in the foundations was around 0.75m in width.

Photo 4: Surviving part of superstructure of western plinth wall and adjacent fragment of loose masonry on mortar floor (view west)

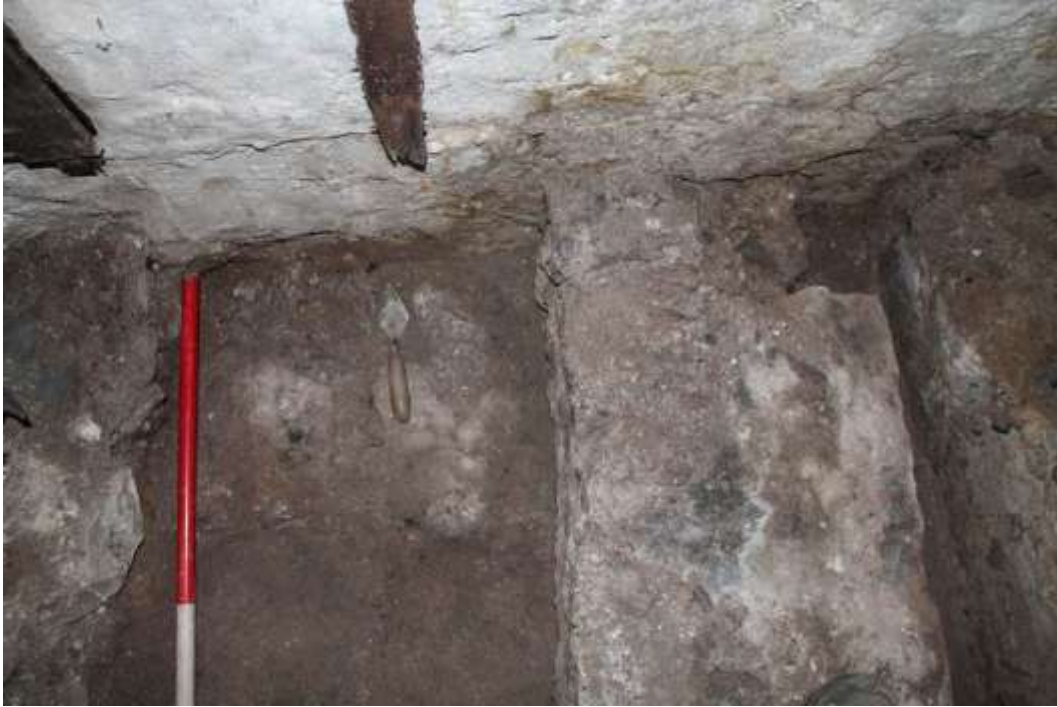
Photo 5: Foundation of wall on the inside of the south wall of the tower (with trowel upon it), with the gap in the foundation to the west with the large fragment of masonry upon it, and plinth wall to west (view south)

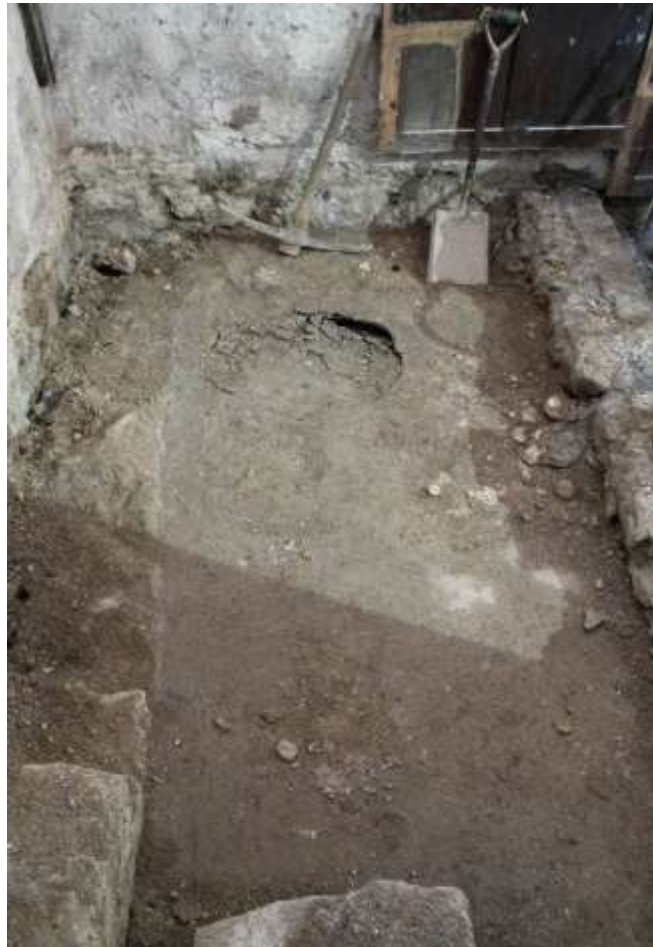
Photo 6: Collapsed area in mortar floor in northwest corner of tower

3.1.8 It was evident that a number of voids or areas of loose material were present below the mortar floor, due to hollow sounding areas and a small partial collapse of the floor level in the northwestern corner (Photo 6). This collapse was at most 0.14m deep onto firmer ground below. The implication is that a number of burials are present below the floor which have subsequently settled and caused small voids to form beneath the flooring above them. At least three of these voids were present. The collapse in the floor enabled the make-up of the mortar floor to be recorded. This showed that it was made of a number of different layers of mortar (perhaps repairs, re-flooring or merely the construction method needed to create a firm level) and was 0.01m in depth at its maximum thickness.

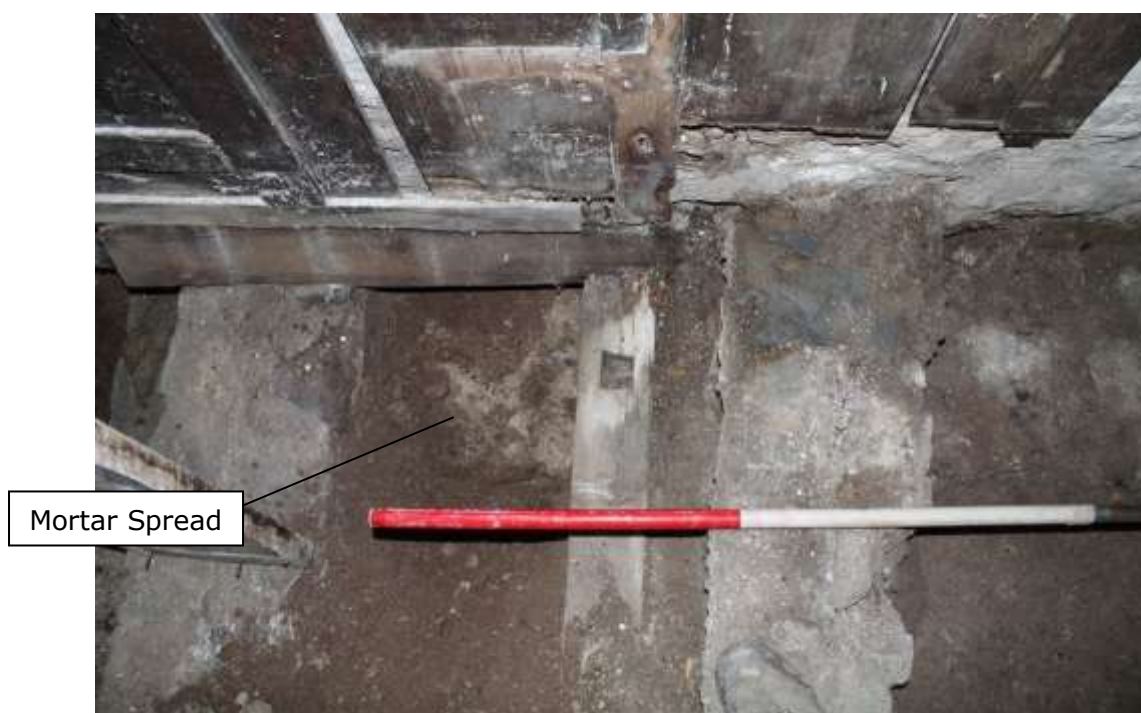
3.1.9 Within the lower floor level to the east of the upper western level the mortar floor level did not survive, presumably having been dug out when the stepped floor levels for the tower were inserted. The base of the foundations for the southern wall around the inside of the tower was visible as a fragmentary spread of mortar 0.40m in width and 0.02m in depth maximum (Photo 7).

Photo 7: Remains of foundations for southern wall around the inside of the tower, with fragmentary mortar spread to east of sleeper wall (view south)

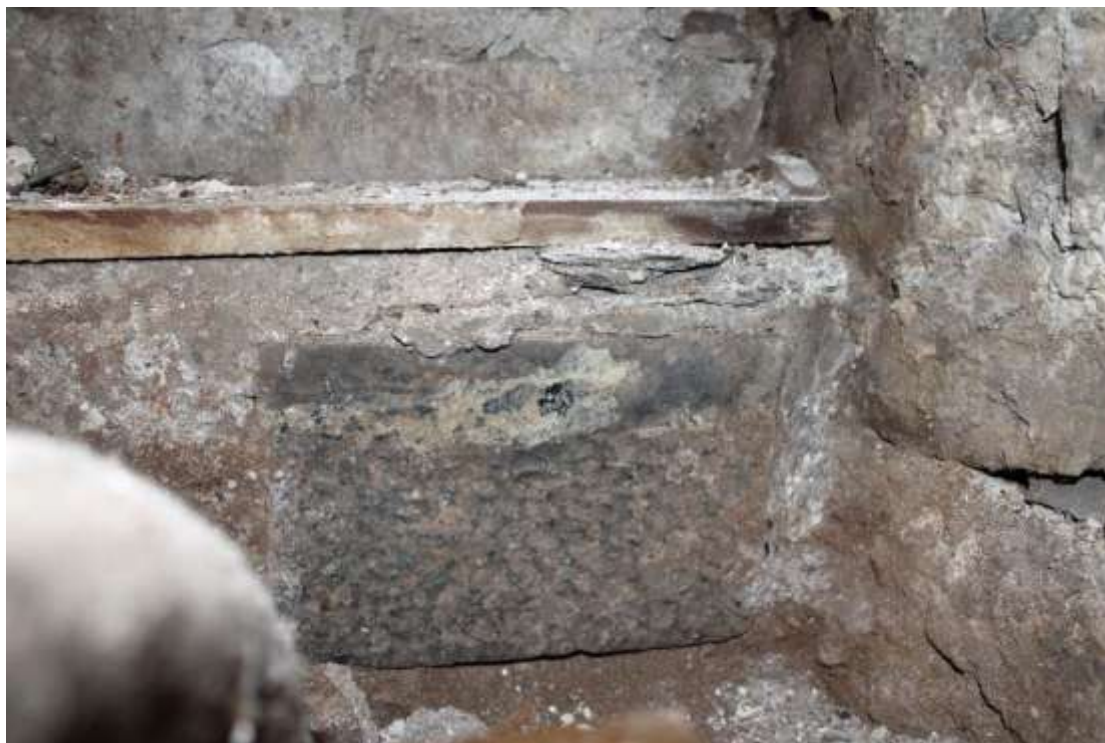
3.1.10 The northern wall on the inside of the tower could not be seen within the next part of the floor level, although a single large dressed stone block was present directly below the sleeper wall which was aligned with the foundations (Photo 8). The dressed stone block was 0.30m in width and 0.20m in depth and was unlike any of the other stones used in the construction of the sleeper walls. If it is associated with the northern wall, it could imply a former feature in the internal wall.

Photo 8: Dressed stone block aligned with northern wall around the inside of the tower, with rough rubble sleeper wall above (view west)

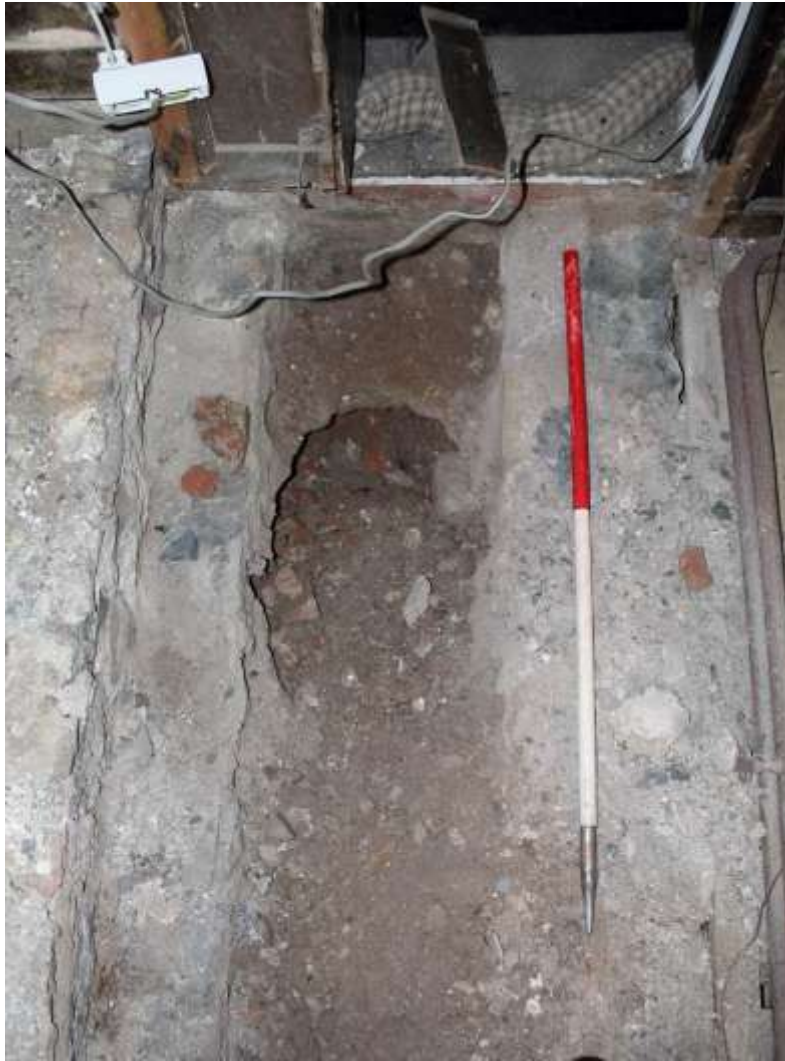
Photo 9: Collapsed area in third step down within church tower adjacent to stair tower doorway (view north)

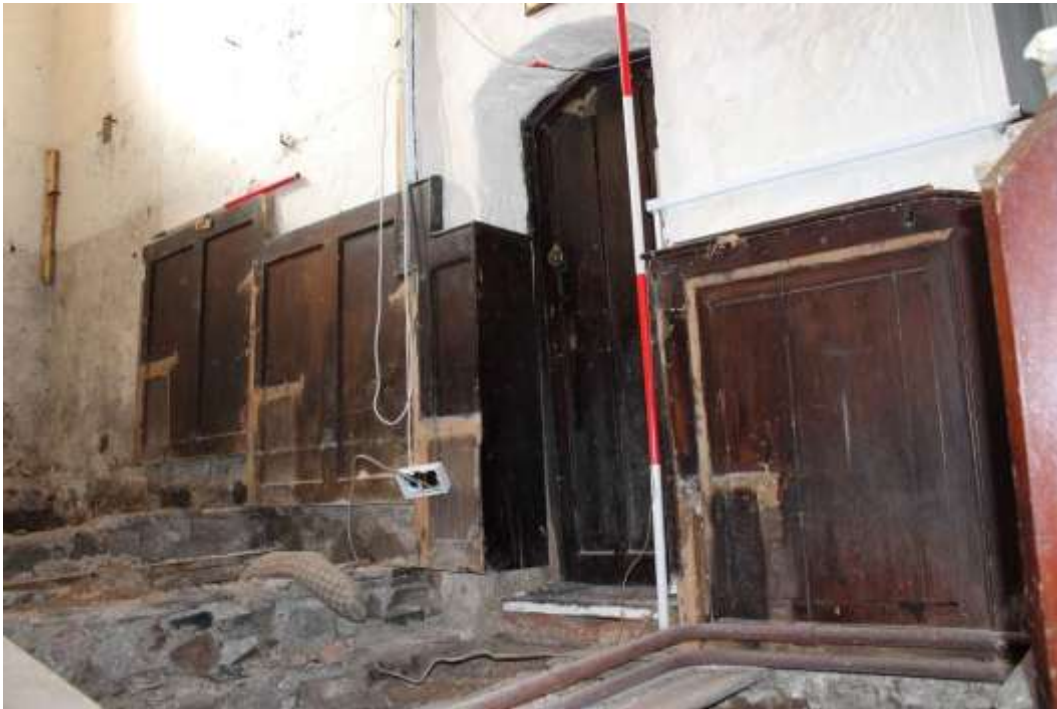
Photo 10: View of northern wall of West Tower, showing panelling, stair tower doorway and outlines of former pews (view north-northwest)

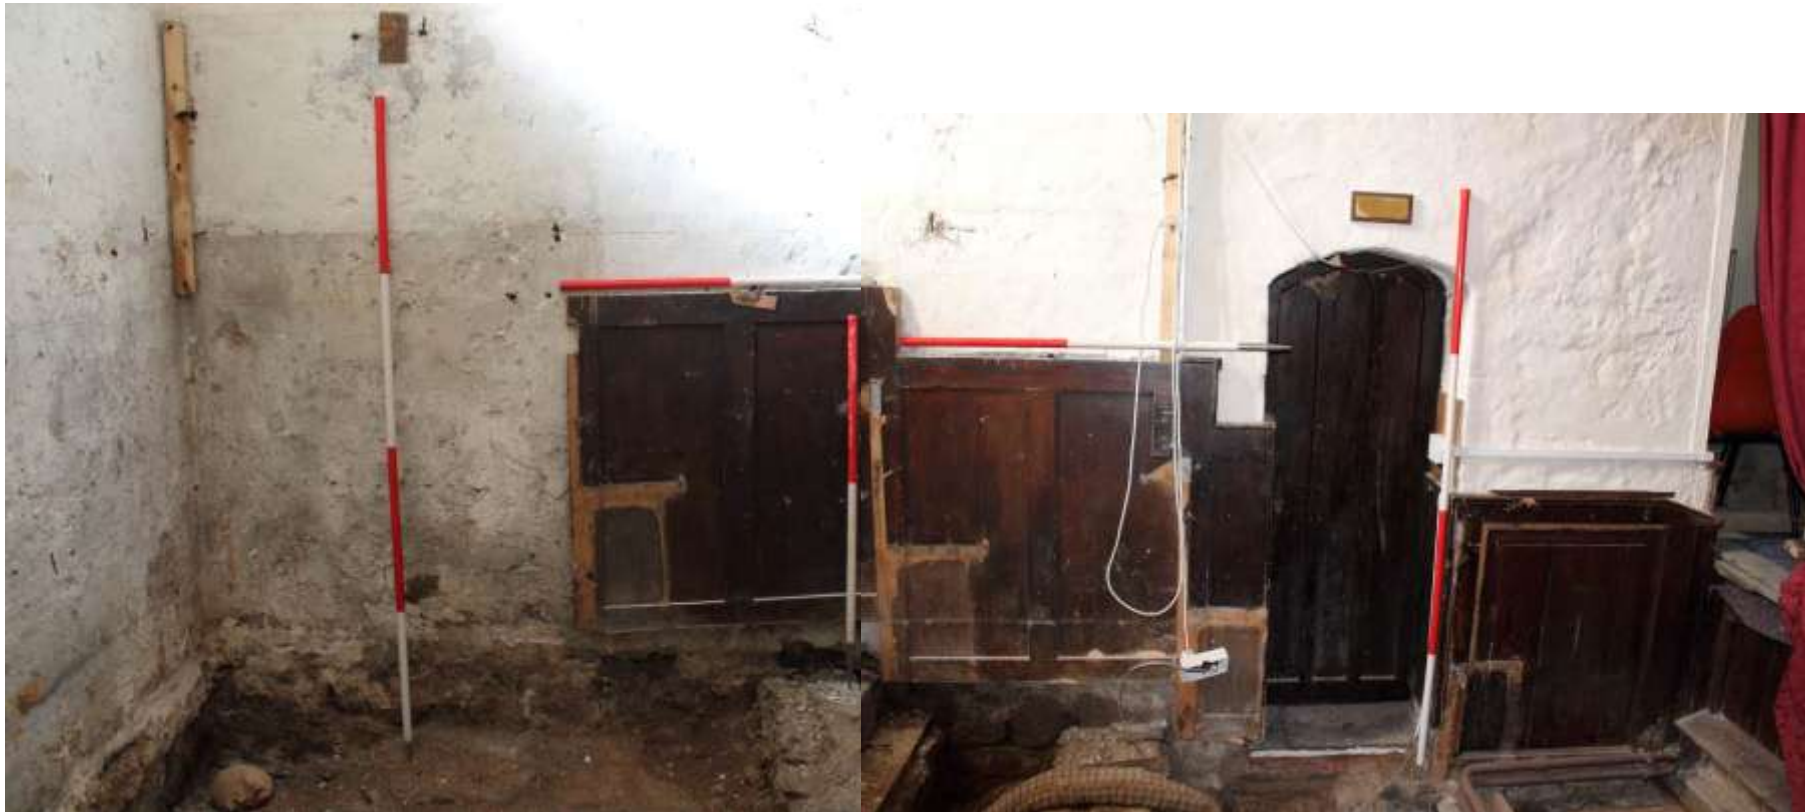
Photo 11: Composite photograph showing full width of North wall (view north)
