STORM DRAINAGE INSTALLATION AT ST. CAWDRA'S CHURCH, JORDANSTON, LETTERSTON, PEMBROKESHIRE: ARCHAEOLOGICAL WATCHING BRIEF

Prepared by Dyfed Archaeological Trust
For: Christopher Thomas Architects

RHIF YR ADRODDIAD / REPORT NO. 2013/33
RHIF Y DIGWILLIAD / EVENT RECORD NO. 105581

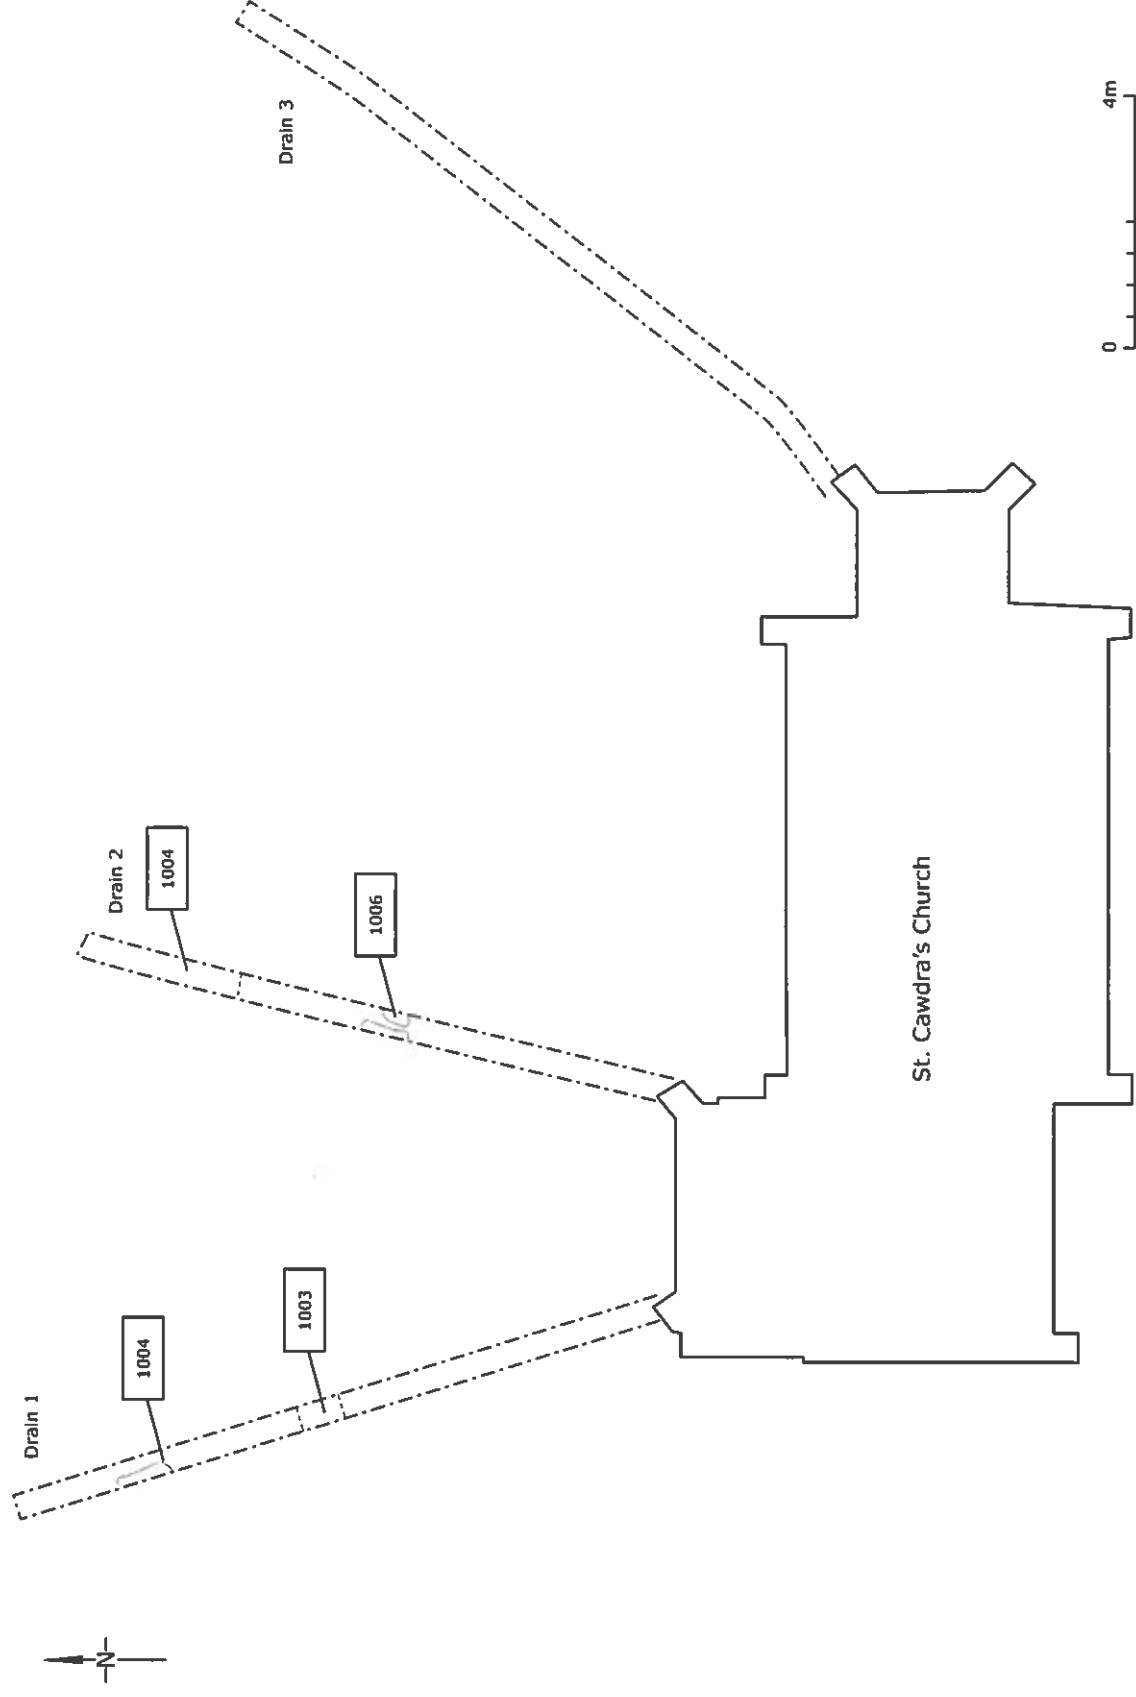
3.1 Three drains were excavated and observed, Drain 1 lay on the northwestern corner of the church running to the north-northwest. Drain 2 was positioned west of centre aligned roughly north to south. Drain 3 projected from the northeastern corner of the church running roughly to the northeast.

Figure 2: Plan showing locations of the drains and areas of grey clays with mortar (1003), exposed building rubble (1004), and natural stone area (1006)

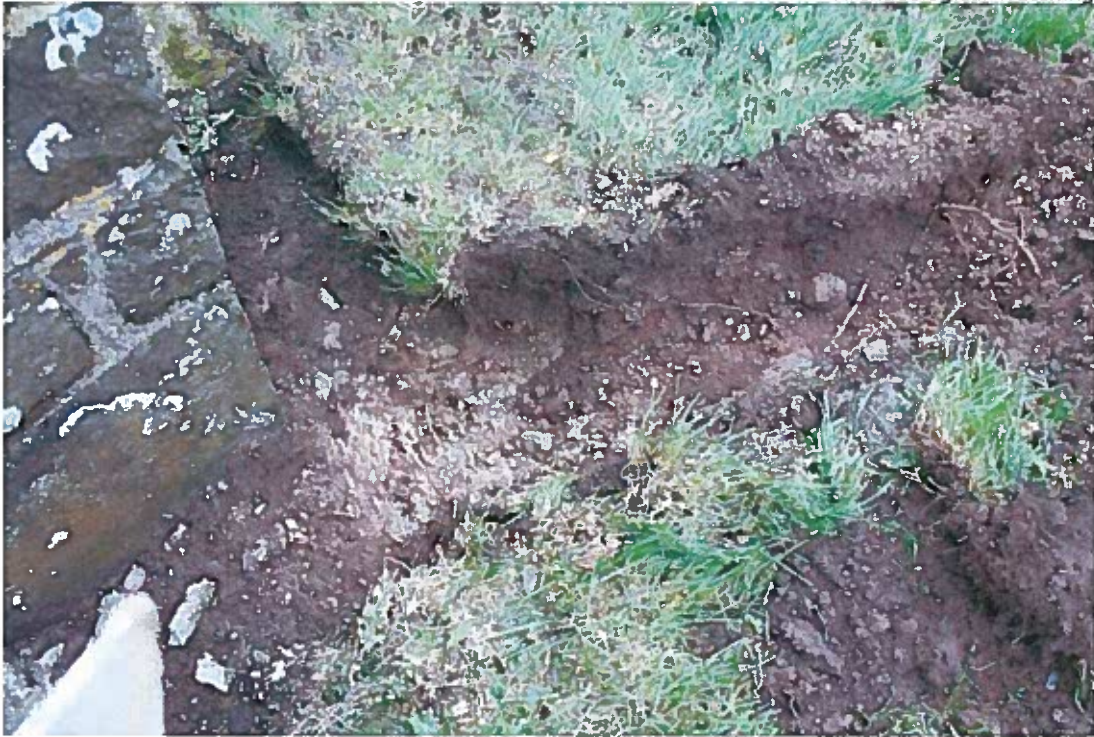
3.4 The excavation of all three drainage channels exceeded depths of around 0.50m when close to the church's buttresses. Whilst undertaking these initial deep excavations a pale grey clay (1002) was revealed at the start point of each drain. The pale grey clay contained flecks of mortar and slate fragments which indicate the deposit is not of a natural origin. It is very likely that this deposit is re-deposited natural thrown back into the church foundations.

Photo 1: View of grey clay deposit (1002), located in Drain 1 near buttress

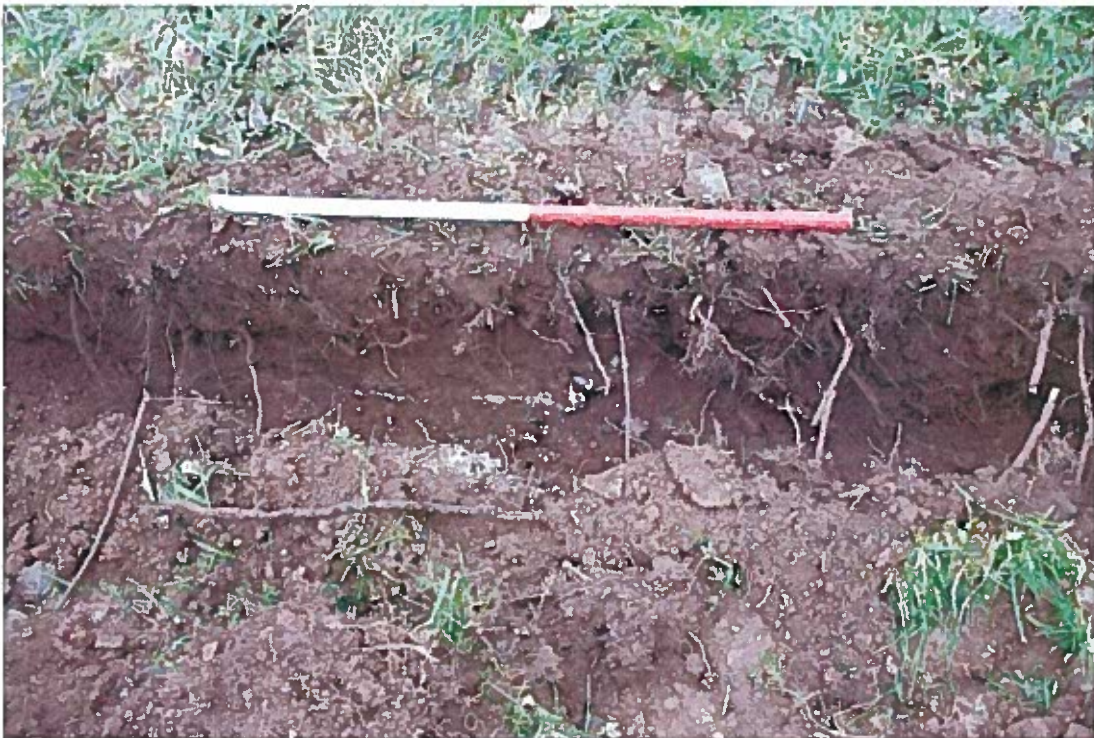
3.5 Drain 1 led from the northwestern corner of the Vestry through the grave yard for a total of 10.50m. It was excavated to a constant depth of 0.40m. During the excavation of the drain a mixed deposit of lime mortared stone and roofing slates (1004) was encountered at a point 2m from the northern terminus of the trench. It is considered that this deposit may relate to demolition of the original pre-1778 church. A pale grey clay (1003) similar to that of (1002) was also found within the mid-section of Drain 1. The origin of this deposit is questionable, but may have been produced through the landscaping of the churchyard within the Victorian period.

4.2 A number of faced pieces of building stone were recovered from amongst this demolition deposit (1004). The facing of the stone was considered to be of a different type to that which is found within the present day church. This would indicate that the material probably originates from the earlier stone church, demolished and rebuilt in 1797 as opposed to later refurbishments.

Photo 2: View of rubble deposit (1004) found within Drain 1

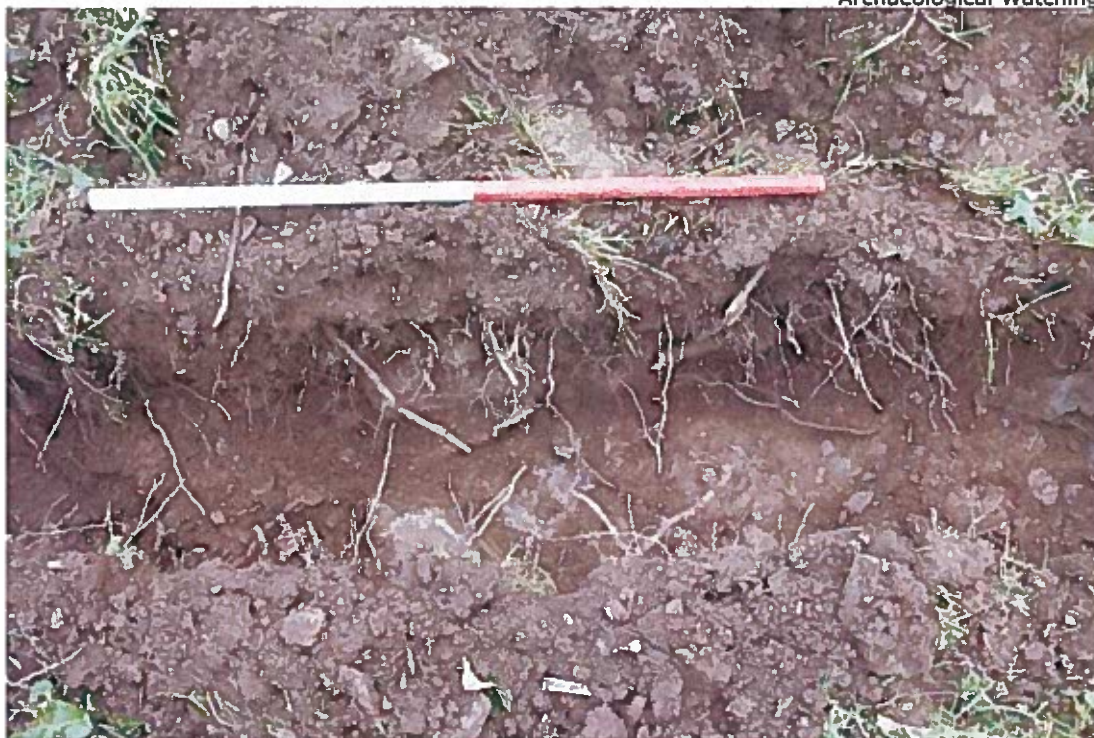
3.6 Drain 2 led from the northeastern corner of the Vestry heading on a northerly route through the grave yard for a total of 10.50m, excavated to a constant depth of 0.40m. Similar to Drain 1, Drain 2 also contained a large amount of building demolition (1004) located c.5m from the northern terminus of the trench and is probably again associated with demolition of the pre-1778 church or as a result of later Victorian refurbishment of the church. Two large stones were found within the mid-section of the channel and were initially thought to be part of an in-situ wall foundation [1006]. Upon further investigation this it was noted that these remains were very slight and appeared to correspond with the natural geology found within the area.

Photo 3: View of natural stone (1006) found in Drain 2.

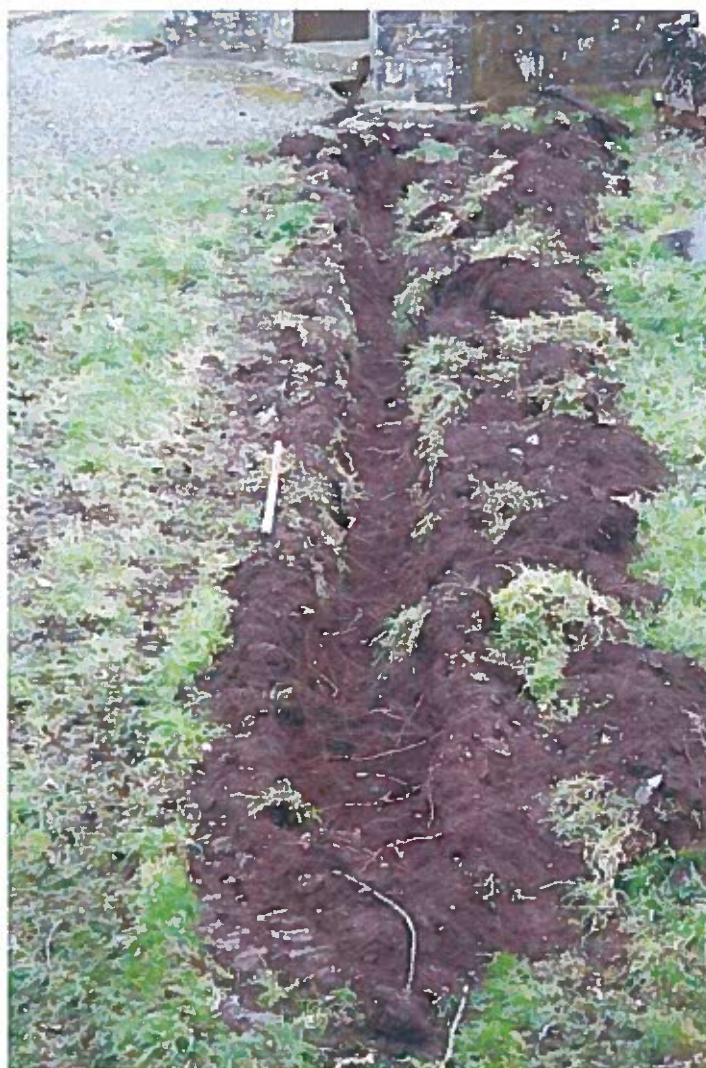
3.7 Drain 3 led from the northeastern corner of the church eastern porch leading on a northeastern route through the graveyard for a total of 7.20m at a constant depth of 0.40m. This drain seemed to contain less building demolition material than the other two. It was noted that the trench did contain occasional small flecks of lime mortar (1005) that appeared to be slightly more yellow in colour than the mortar found in the other two drains.

Photo 4: View of Drain 3 following excavation
