Historic Environment Feature Management Report:

Trefayne, Cliff Colliery

UID: 300351

PRN 7266 Name TREFRANE CLIFF COLLIERY
Period Post-medieval **Site Type** Coal mine
NGR SM85701970

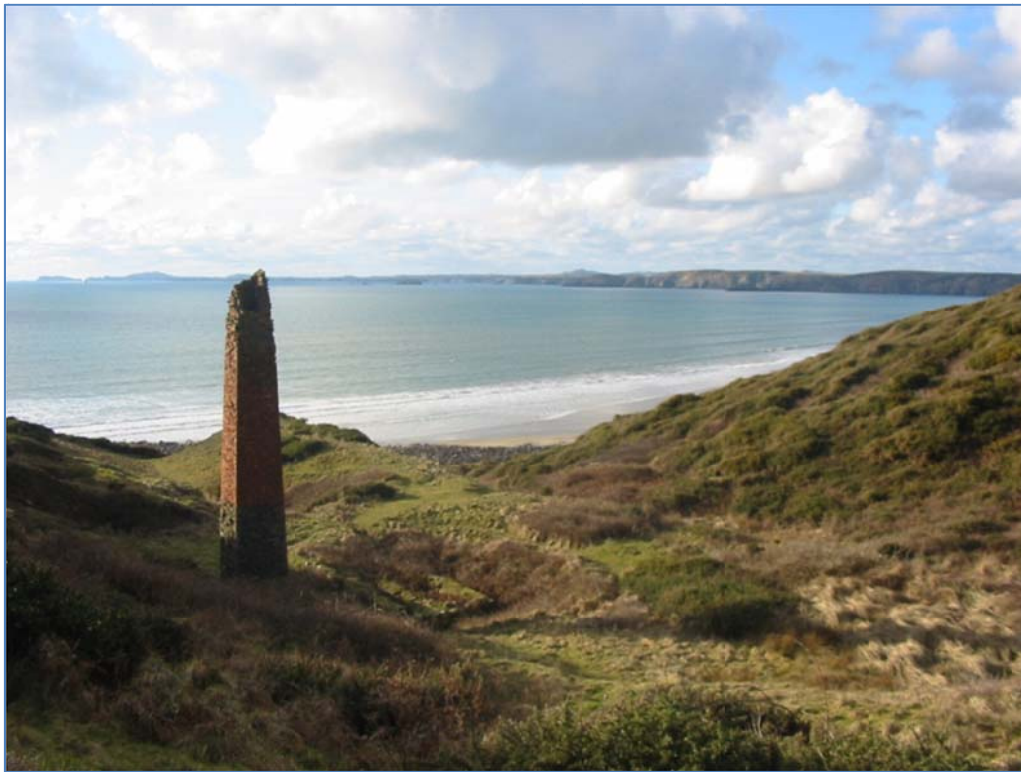
An 18th century colliery located on the sea shore overlooking Cardigan Bay. The site includes extensive surface and shaft workings as well as significant remains of ancillary structures including a stone and brick built chimney stack and stone foundations for an engine house operating winding gear. Other stone foundations in the vicinity indicate the position of other buildings. A large spoil heap is present on the seaward side. (KM 1996). The site is currently overgrown which masks the remains making the site both hard to understand and hazardous to the unwary visitor. The Pembrokeshire Coastal Path passes through the site.

The main management issue for this site is the control of vegetation and the management of visitors. The former has the potential to damage both buried archaeological remains and the built structures through the disruptive activity of root development. The surviving stonework appears to be relatively sound although the brick top to the chimney needs attention.. It is, however, partially covered by vegetation, which makes it impossible to view it in its entirety. The exposed spoil heaps have very steep sides and have been eroded where a path has been trodden. Further un-managed visitation can only further erode the site. The site, as it is at the moment, is potentially hazardous to the visitor. There appears to be some deep holes in and surrounding the stonework next to the chimney which are possibly part of the structure. The wheel pit is a large deep narrow hole into which the unwary could easily fall. There are possible shafts hidden in the vegetation, but at the moment they are not easily visible.

- The chimney needs to be consolidated by re-pointing the brick work before any more bricks are lost from the top.
- The site should be cleared of the vegetation which obscures the surviving remains and also hides several potential hazards. This will make the site easier to understand and safer to visit.

- Erect footpath signs to manage visitors through the site. PCNPA can be consulted on appropriate signage.
