Historic Environment Feature Management Report:

Troedyrhiw farmstead and long hut, Esgair-wen field system and long hut.

Customer Reference Number: A0027426

UIDs: 311862, 311863, 311864

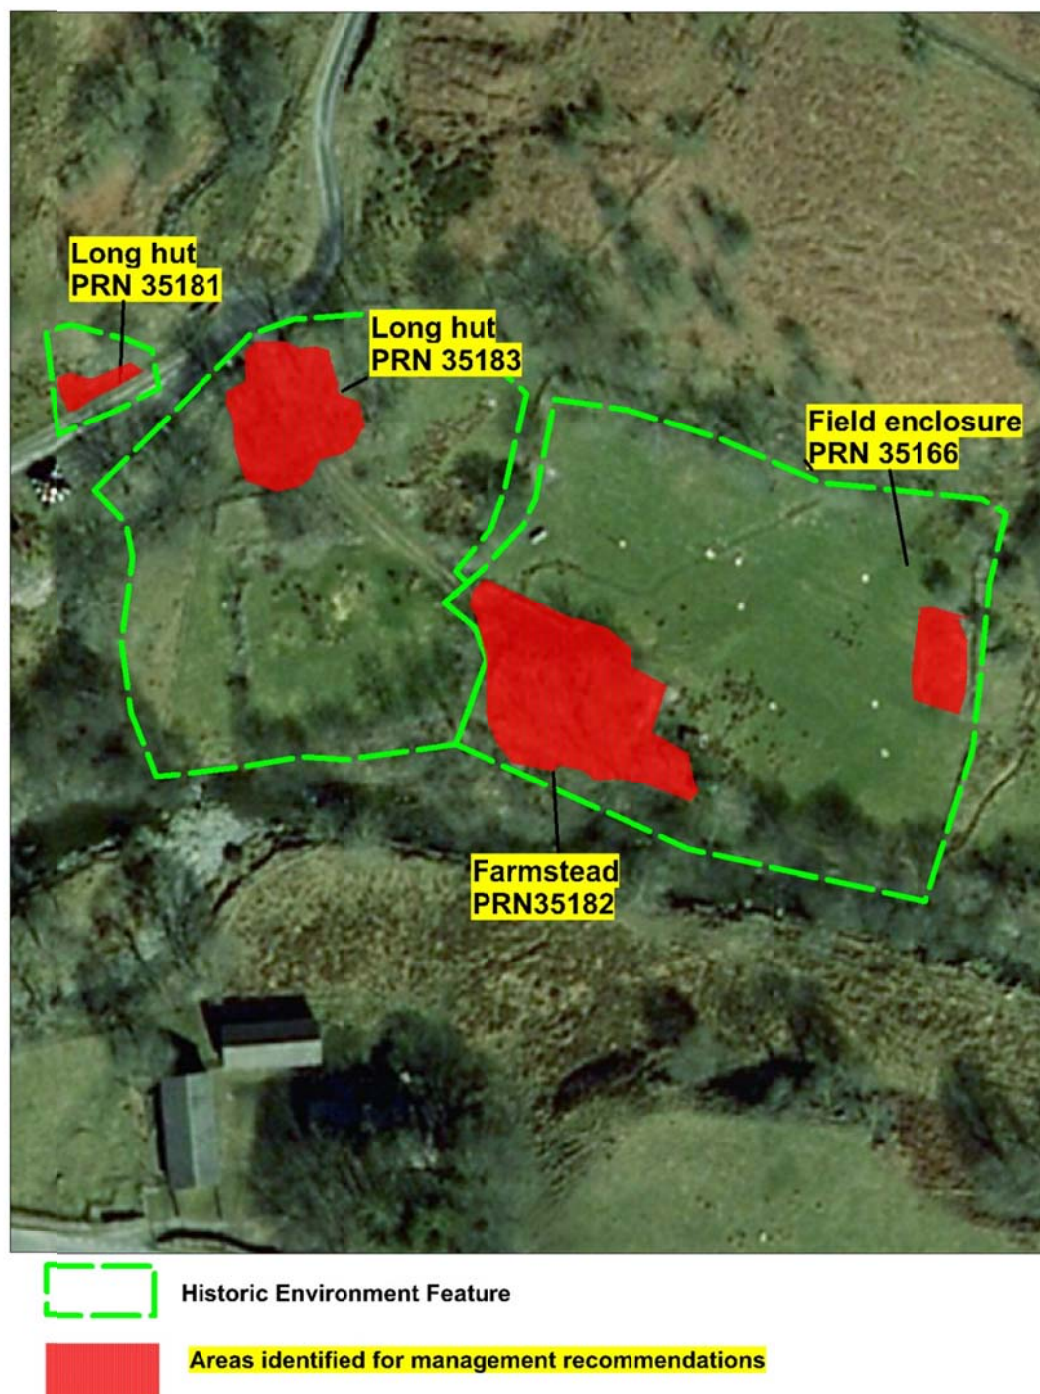
Recent aerial photographs (Ordnance Survey Next Perspectives, 2009) indicate the enclosure is generally under low-intensity grazing but there are apparent areas of scrub. These need to be controlled to maintain the site in a stable and visible condition.

Recent aerial photographs (Ordnance Survey Next Perspectives, 2009) indicate the site as lying within an area under scrub and possible tree growth. The main management issue for this site is the control of damaging vegetation which has the potential to damage buried archaeological remains through the disruptive activity of root development, and built structural remains by the prising apart of masonry bonds.

Aerial photograph illustrating areas identified for management recommendations. These may change depending on the current condition at time farm visit.

- Cut any scrub back by hand in order to retain the visibility of the enclosure.

- Remove mature trees which are at risk of wind throw and could threaten the site through uprooting (root plate damage) or falling limbs.
- Remove any young trees or vegetation growing out of the wall tops but cutting by hand. Do not pull-up by the roots as this is potentially destabilising to masonry bonds. Spot treat to prevent re-growth.
- Cut any scrub back by hand in order to retain the visibility of the long-hut.
- If present maintain a canopy of mature trees over the settlement. This will reduce light entering the ground, inhibiting scrubby vegetation growth.
