**REPLACEMENT AND IMPROVEMENT WORKS TO
EXISTING REVETMENT WALL AT
ST TYBIE'S CHURCH, LLANDYBIE,
CARMARTHENSHIRE
ARCHAEOLOGICAL WATCHING BRIEF
(NGR: SN 6186 1555)**

Prepared by Dyfed Archaeological Trust
For: Llandybie Church
Churchyard Committee

RHIF YR ADRODDIAD / REPORT NO. 2013/72
RHIF Y PROSIECT / PROJECT RECORD NO. 105879

ARCHAEOLOGICAL WATCHING BRIEF

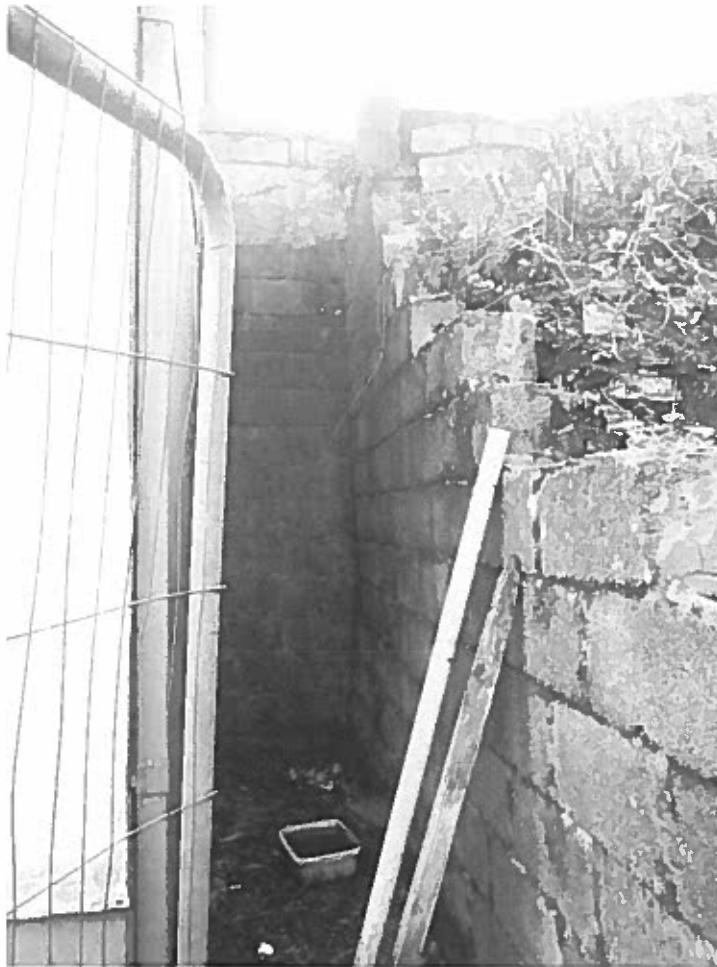
1.1.2 The area of the retaining wall is located on the eastern side of the churchyard at SN 6186 1555. The wall in this area is located adjacent to a domestic property, and forms a c.2.5m vertical drop. The wall was cracked and structurally unsound. The revetment wall was built of breeze block with some stonework incorporated in the top courses (including reused architectural fragments from the church). The wall dog-legged to the north forming a two levelled terraced area dropping down from the churchyard.

2.1.2 The retaining wall itself was built in at least two phases. Adjacent to the existing building (Vicarage) on the southeastern side of the churchyard, the revetment wall was some 2.5m in height, dropping vertically from the churchyard (Photo 1). Further to the north the breeze block revetment wall dog-legged and was lower, with a terrace in the ground level mid-way up towards the churchyard level (Photo 2). This steep drop forms a small passageway along the northern side of the modern extension to the eastern end of the Vicarage (Photo 1)

Photo 1: Area of failing breeze-block revetment wall adjacent to neighbouring property

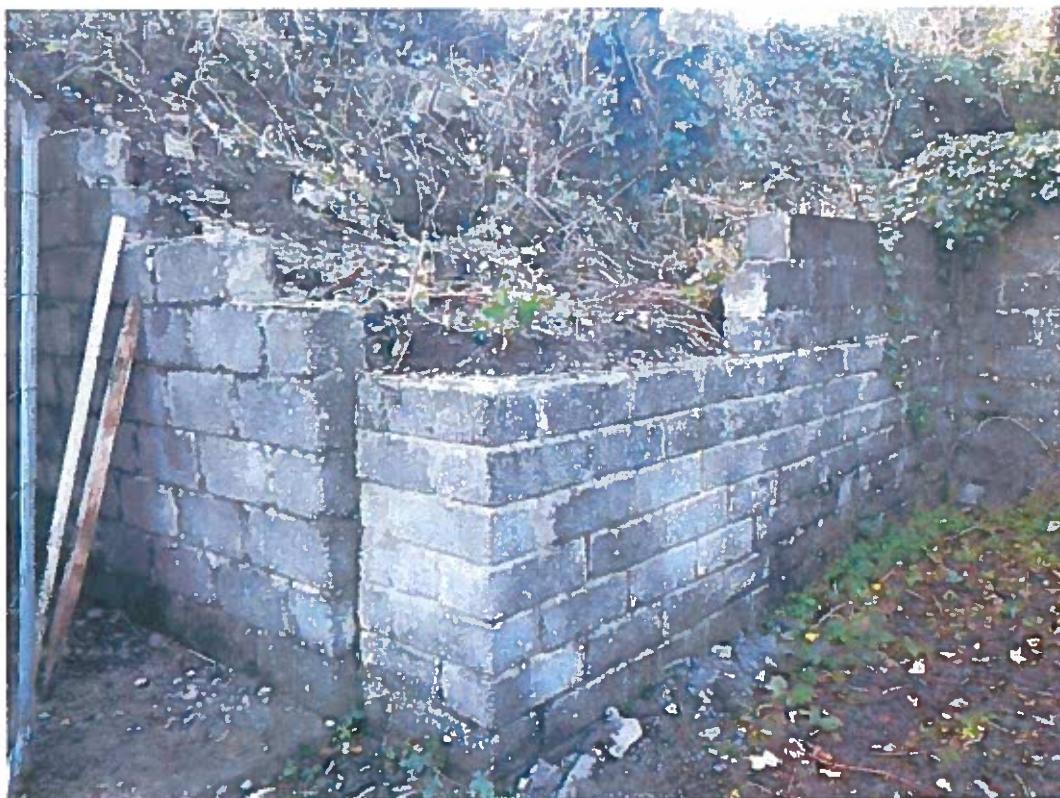
Photo 2: Dog-leg in revetment wall with lower level terraced area

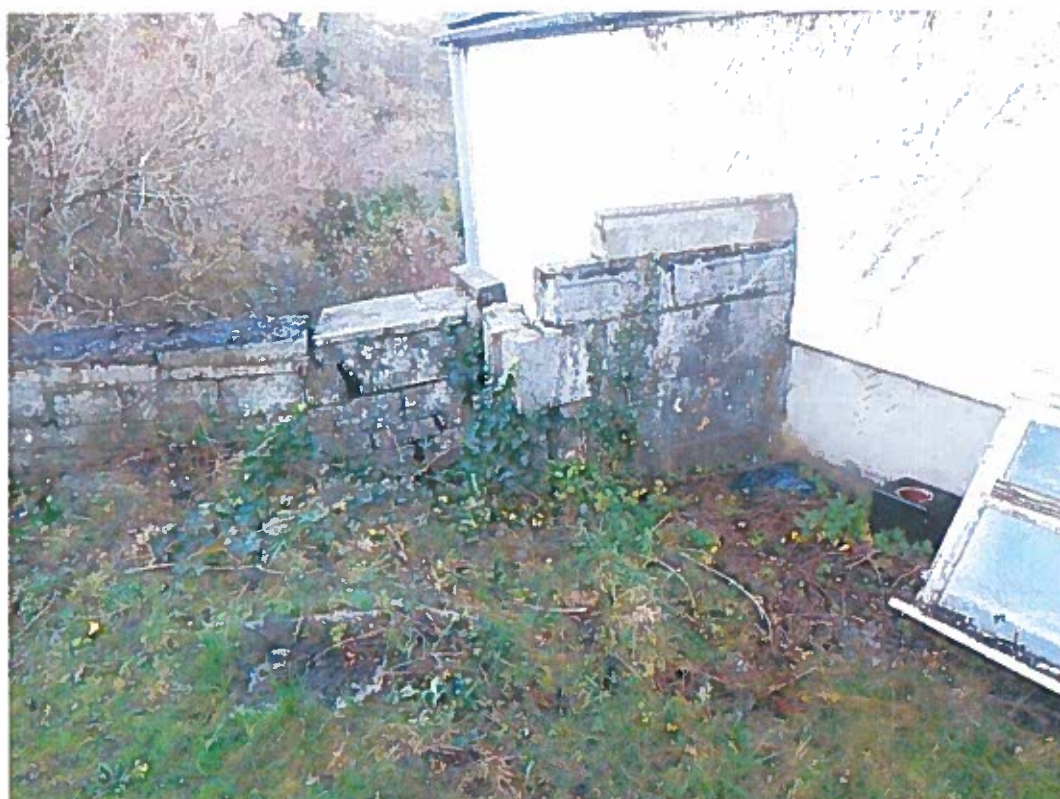
2.1.3 At the churchyard level a stone wall formed the boundary of the churchyard except where the revetment wall was present to its full height, where the wall had evidently been rebuilt using a mix of breeze block and architectural fragments (Photo 3).

Photo 3: Top of revetment wall with reused architectural fragments

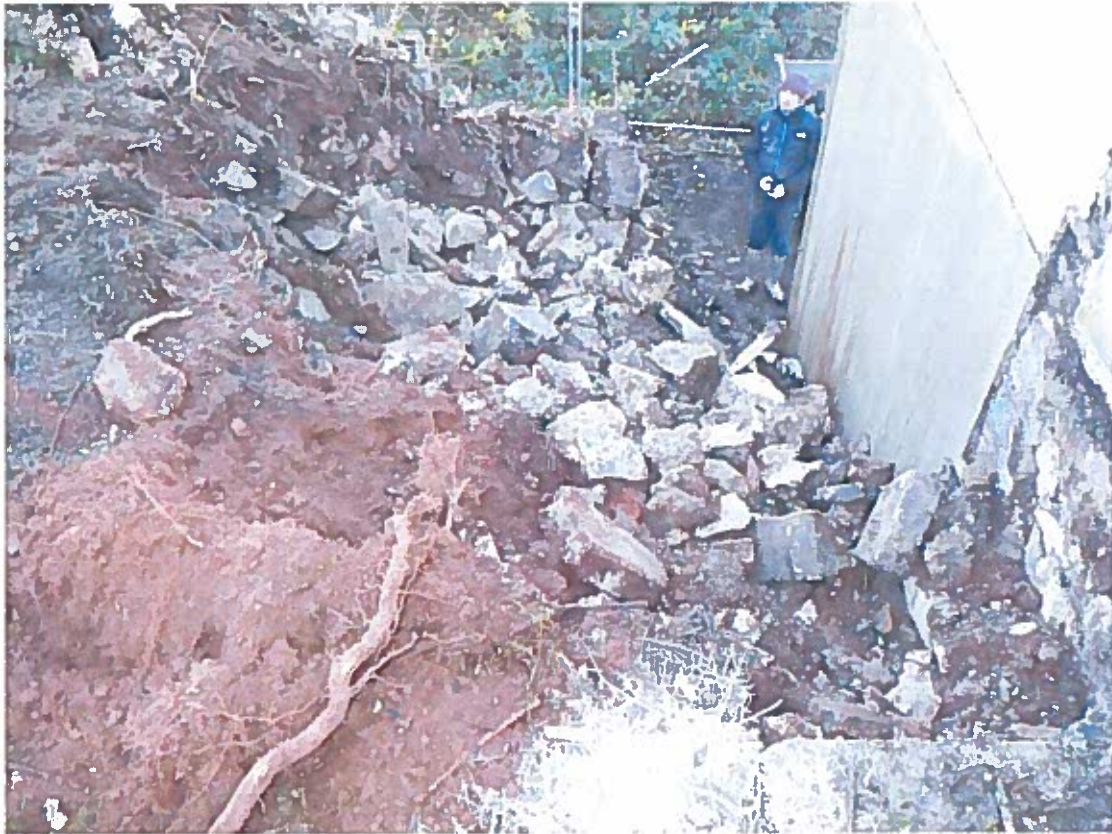
4.2 The first visit was carried out on the afternoon of Tuesday 19th November 2013 to monitor removal of the existing retaining wall. This revealed substantial quantities of rubble, consisting of former building stone (Photo 4) and fragmentary grave stones (Photo 5), associated grave furniture and modern rubbish. This material appeared to be infill behind the breeze block retaining wall.

Photo 4: East facing view of rubble and made up ground deposit.

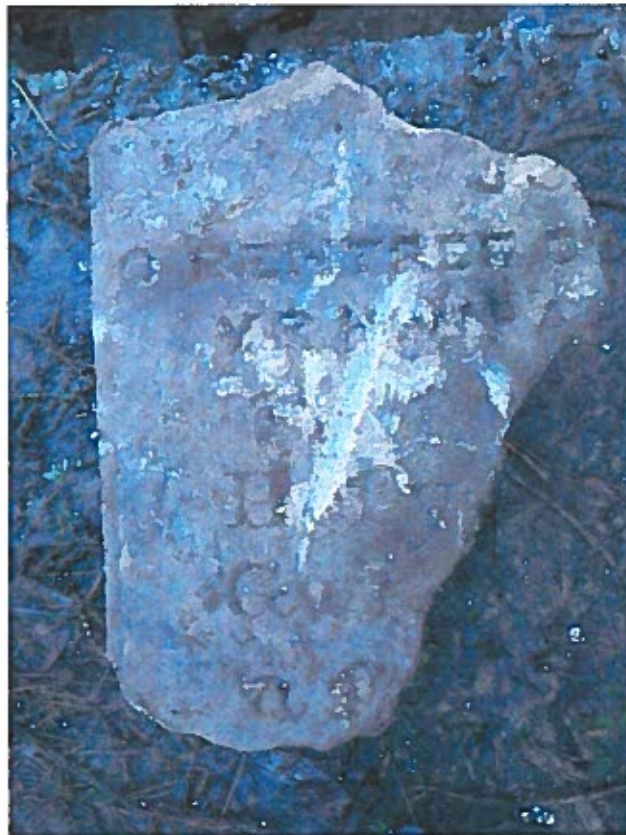
Photo 5: Fragmentary gravestone of probable 19th century date.

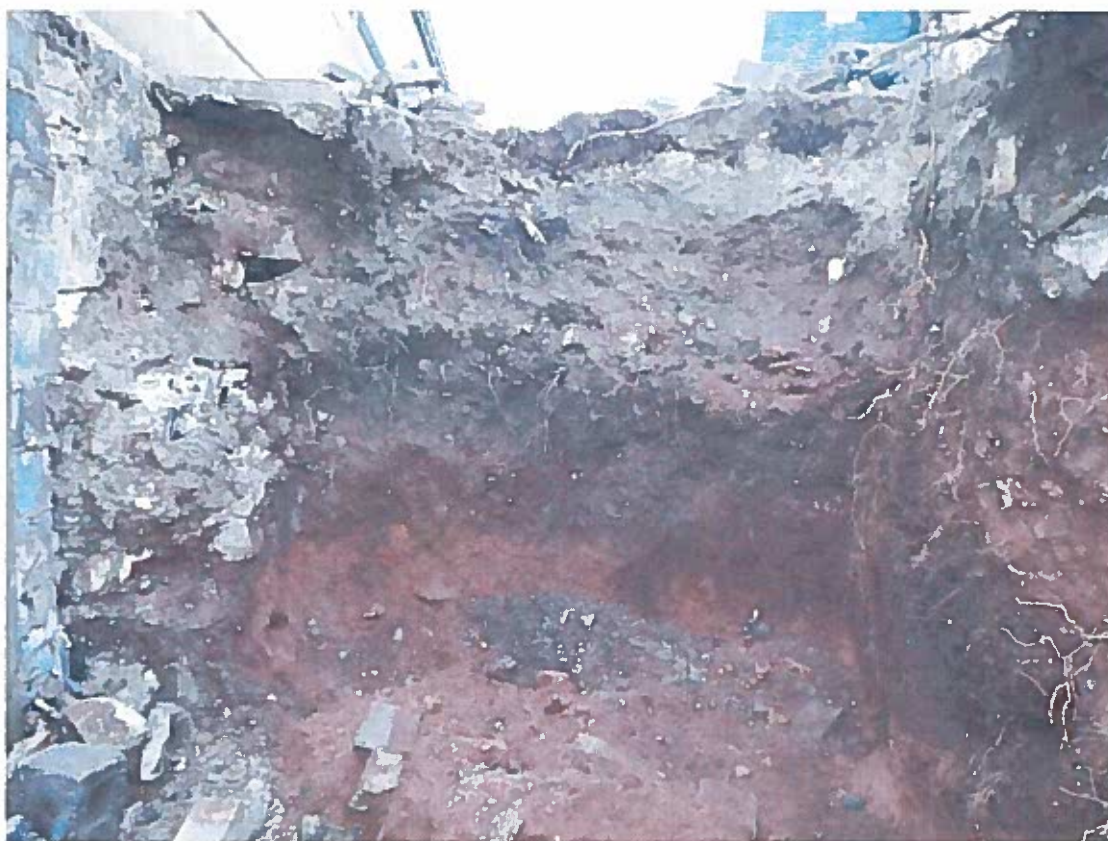
4.4 On arrival at the site it was found that a number of human and animal bones had been uncovered within the infill material. Excavation works were then restarted under the direction of the watching brief archaeologist. As work progressed further disarticulated human bone was recovered from the area. At a depth of c.1.4m a c.1m thick dark brown clay silt was revealed. This seems to be a buried soil layer. This buried soil overlay a mid-red brown clay silt which had a visible thickness of c.0.60m (Photos 6 and 7)

Photo 6: East facing section of excavation area showing darker buried soil layer

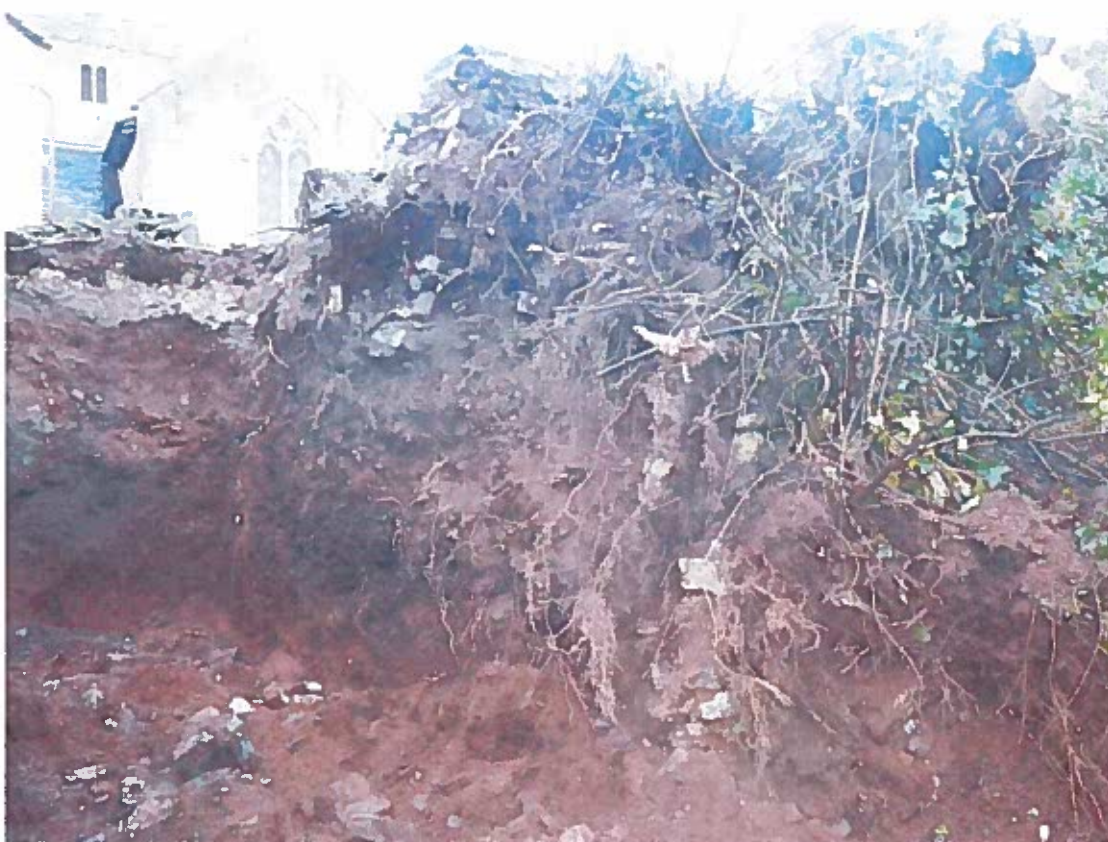
Photo 7: South facing section of excavation area with darker buried soil layer to left and loose infill material in section

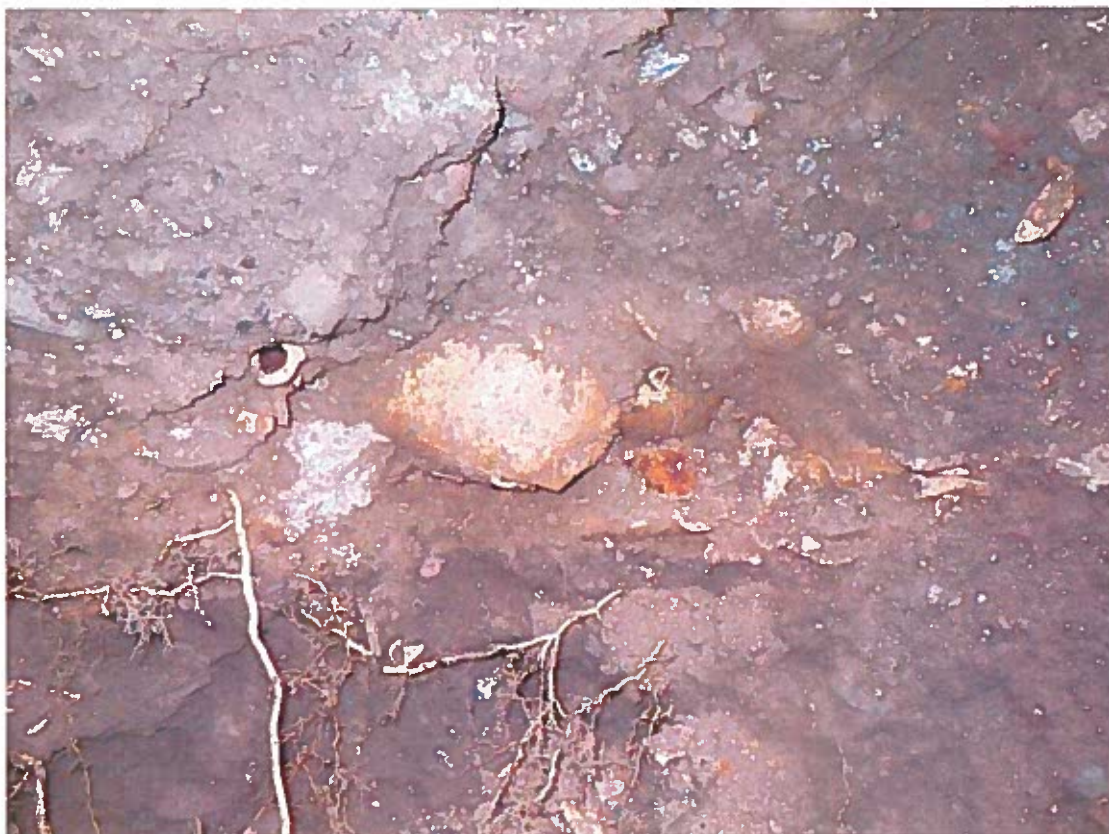
4.5 Within the southwest corner of the excavation area a large number of disarticulated human bones were revealed at the interface between the made up ground deposit and underlying buried soil (Photos 8 and 9). It is possible that the human remains were interred within a shallow pit but given the deep nature of the excavation close inspection was not possible. It is possible that the human remains revealed were initially disturbed during the construction of the retaining wall and were reinterred followings its construction. The human remains that were disturbed by the excavation works were carefully collected and handed back to the church for reburial within the churchyard. Those which were not disturbed were left *in situ*.

Photo 8: Disarticulated human bone revealed within northwestern corner of excavation area (south facing section).

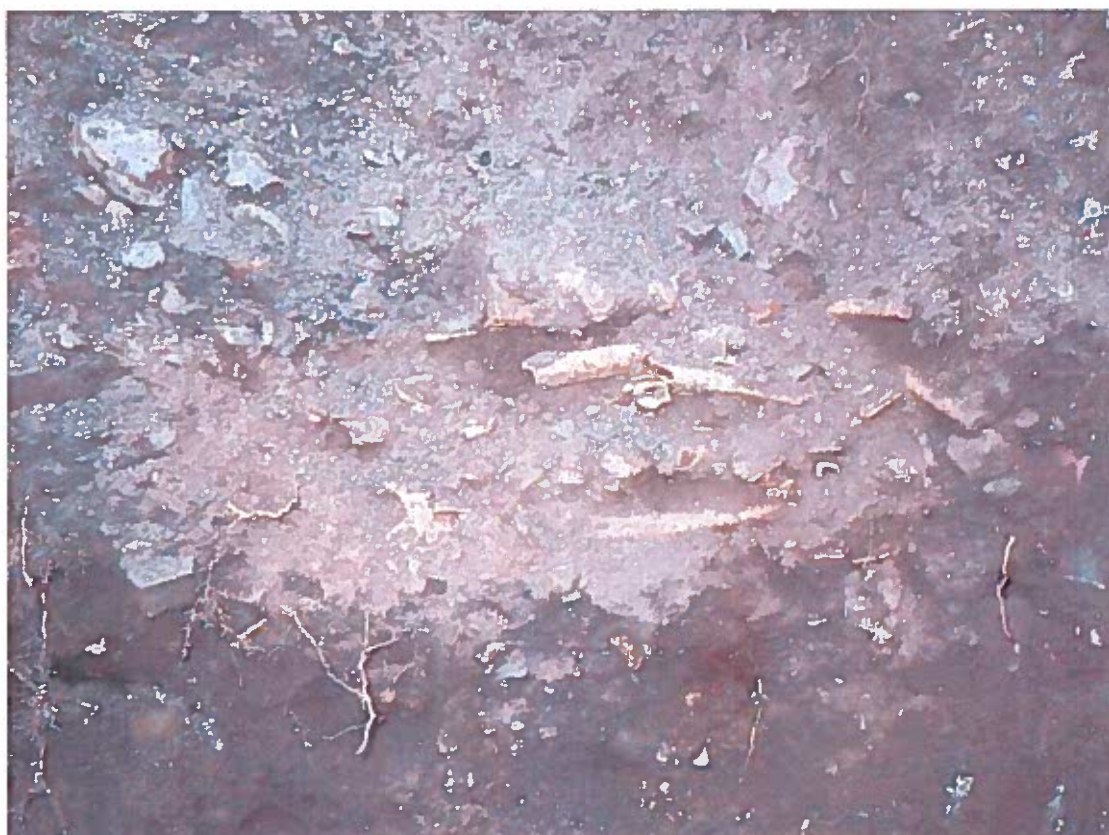
Photo 9: Disarticulated human bone revealed within northwestern corner of excavation area (east facing section).
