ST MICHAEL'S CHURCH, MYDDFAI, CARMARTHENSHIRE: ARCHAEOLOGICAL WATCHING BRIEF 2014

Prepared by:
DAT Archaeological Services
For: Roger Clive-Powell Architects

RHIF YR ADRODDIAD / REPORT NO. 2014/40
RHIF Y DYGWILLIAD / EVENT RECORD NO. 107510

Hydref 2014
October 2014

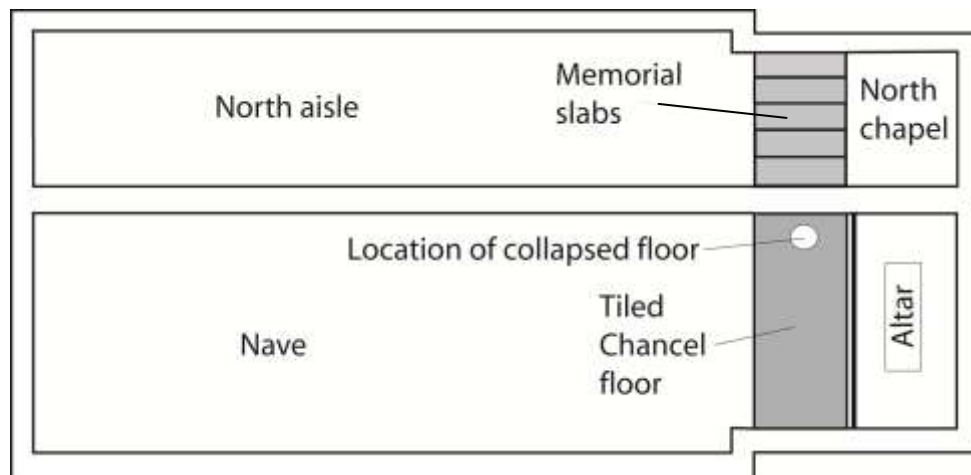
Figure 2: Schematic plan of the church indicating location of the collapsed floor of the chancel (not in proportion, not to scale, not all elements represented)

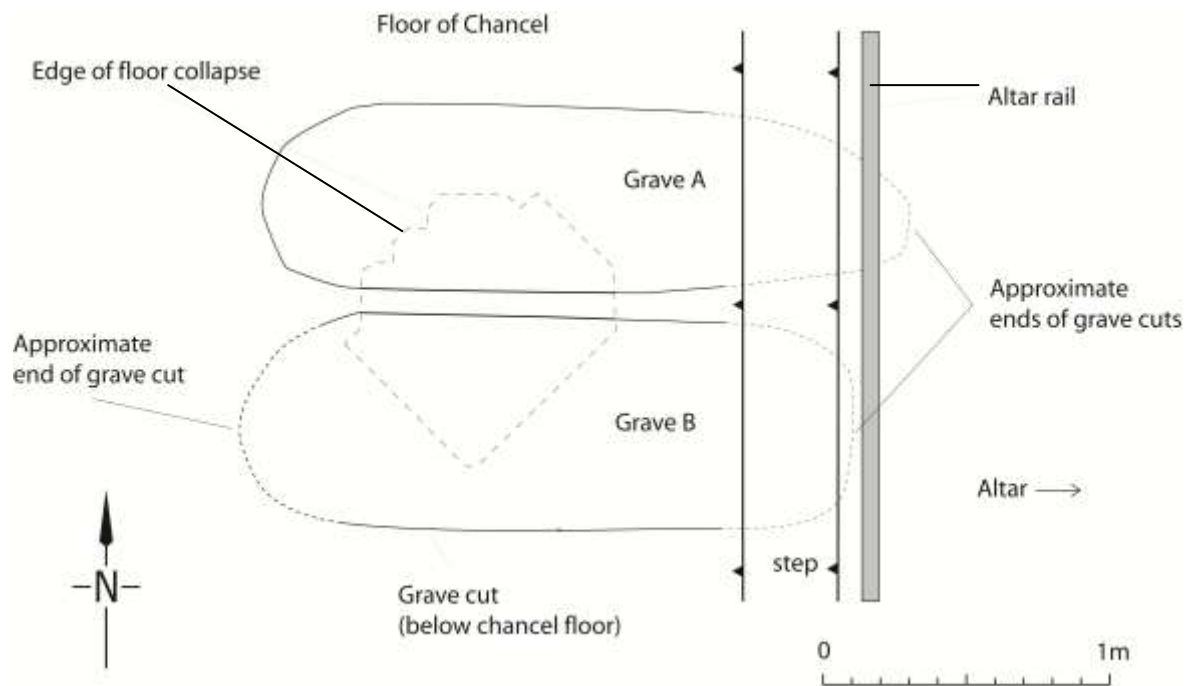
- 4.5 Within the working area, enough of the collapse deposit was removed to ascertain the approximate dimensions of the grave cuts separated by approximately 0.10m of 'cemetery soil'. The northern grave cut (Grave A) measured approximately 2.2m by 0.7m. The southern grave cut (Grave B) measured approximately 2.15m by 0.75m. The length of both graves could only be estimated because it was not possible to fully excavate them, for reasons of safety.

Figure 3: Plan of excavated graves below chancel floor

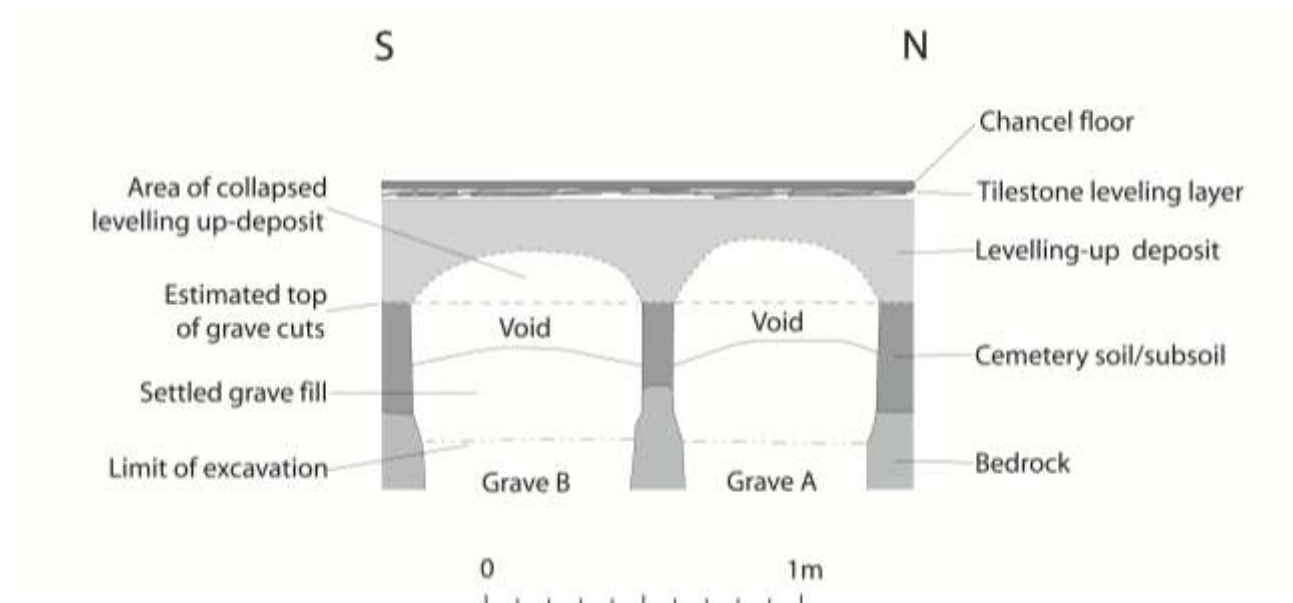
- 4.3 Having removed all the loose subsided material, no evidence of a stone or brick vault was revealed. Instead it became apparent that beneath the floor tiles was a layer of local tilestone roof tiles (no more than 0.05m thick) acting as a levelling deposit upon which the tiled floor was originally constructed. The stone roof tiles were presumably originally from an earlier roof of the church.

- 4.4 Beneath the tilestones was an approximately 0.4m thick layer of light brown, dry, loose friable clayey silt containing numerous redeposited human bones and occasional clay tobacco pipe fragments. This deposit appears likely to have been a 'levelling-up' layer, deposited when the floor levels at the east end of the church were raised. Approximately the bottom half of this levelling-up deposit had collapsed into voids formed within two underlying east-west aligned grave cuts. The voids appear to have formed as backfill deposits within the two grave cuts, had settled down (presumably as the coffins within the graves decayed and collapsed).

Figure 4: Schematic section through deposits and features below the chancel floor

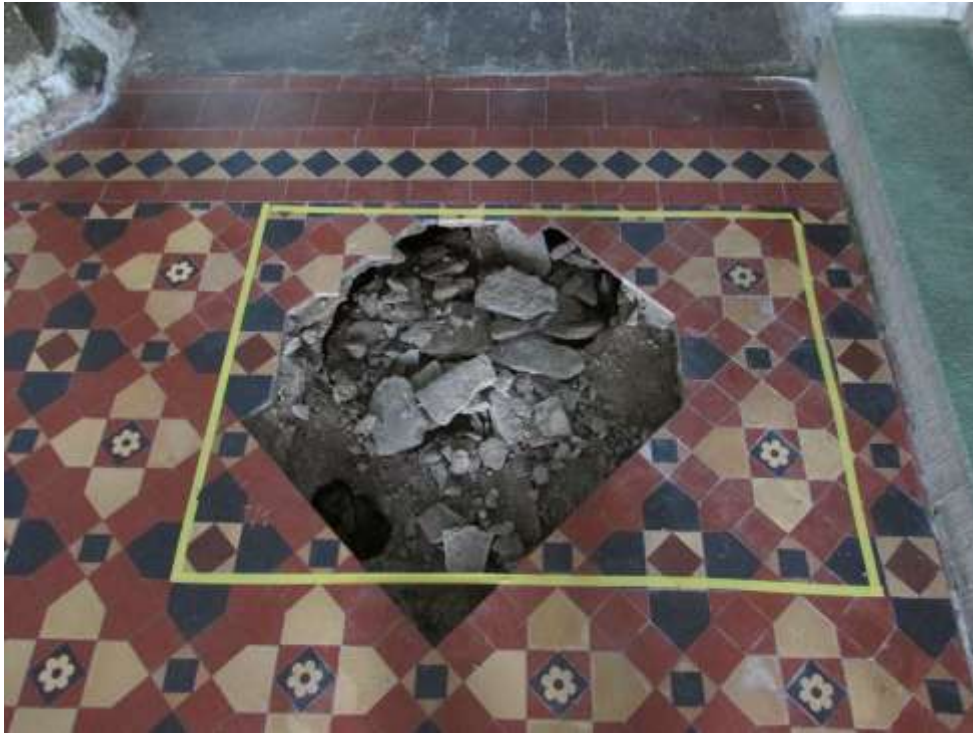
- 4.2 The area of collapsed tile floor measured approximately 0.8m by 0.75m and was found to have subsided into a void extending beyond the edges of the hole in all directions.

Photo 1: The area of floor collapse prior to excavation (facing north)

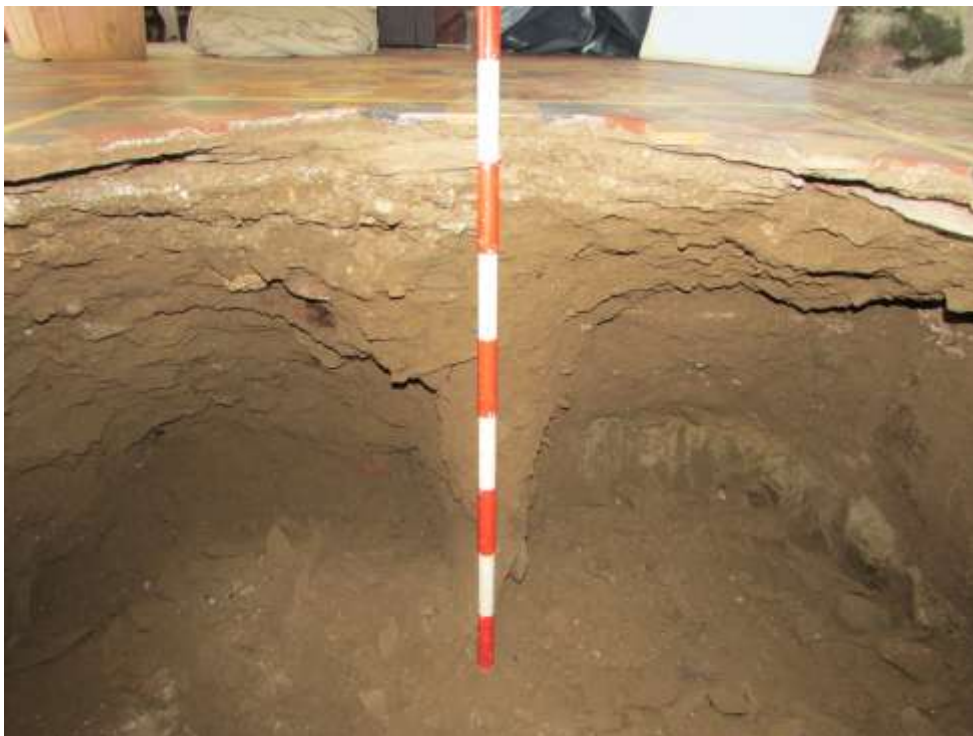
The subsidence was found to have been caused by the backfill of two graves having settled, creating a void beneath the tile floor. The grave backfill and other material that had collapsed into the voids from the sides was removed down to the level at which natural bedrock was exposed in the sides of the grave cuts.

Photo 2: The void (having removed the collapsed and loose material to reveal the two grave cuts) facing west. Note the grey shale bedrock visible in the side of Grave A (right side).

- 5.7 The use of the metal grill suspended across the natural bedrock has meant that further below ground disturbance is unnecessary and the identified burials will remain undisturbed.

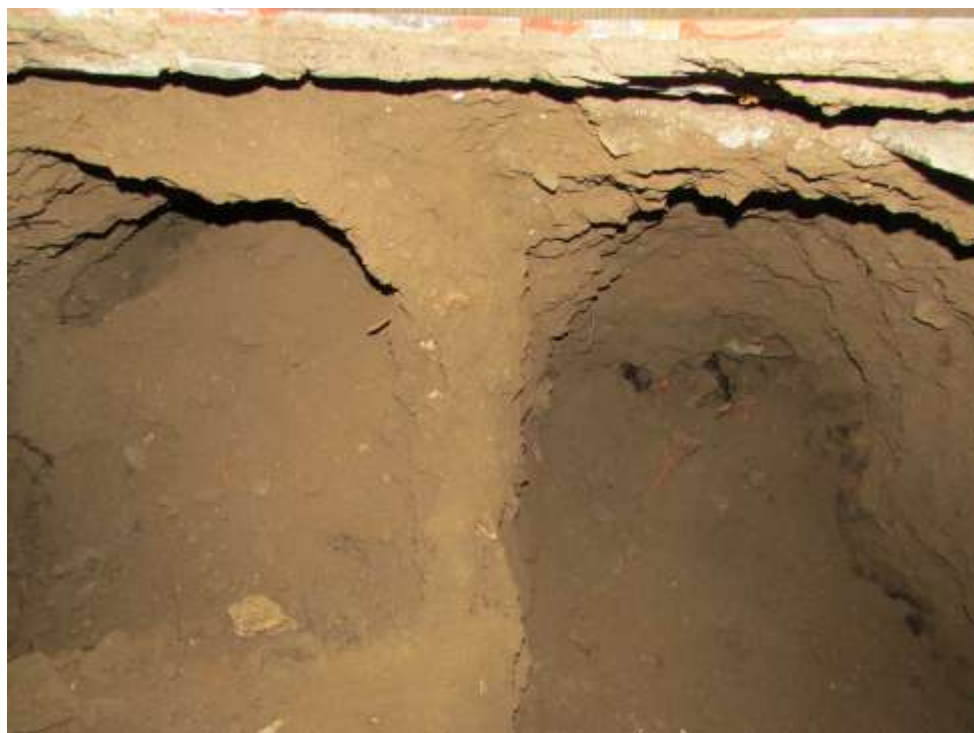
Photo 3: The two grave cuts (facing east) containing partially removed loose fill (Grave A on left).
