**ST ISHMAEL'S CHURCH,
LAMBSTON, PEMBROKESHIRE
ARCHAEOLOGICAL WATCHING
BRIEF
(NGR SM 90707 16945)**

RHIF YR ADRODDIAD / REPORT NO. 2015/1
RHIF Y DIGWYLLIAD / EVENT RECORD NO. 107538

Tachwedd 2015
November 2015

ST ISHMAEL'S CHURCH, LAMBSTON, PEMBROKESHIRE ARCHAEOLOGICAL WATCHING BRIEF

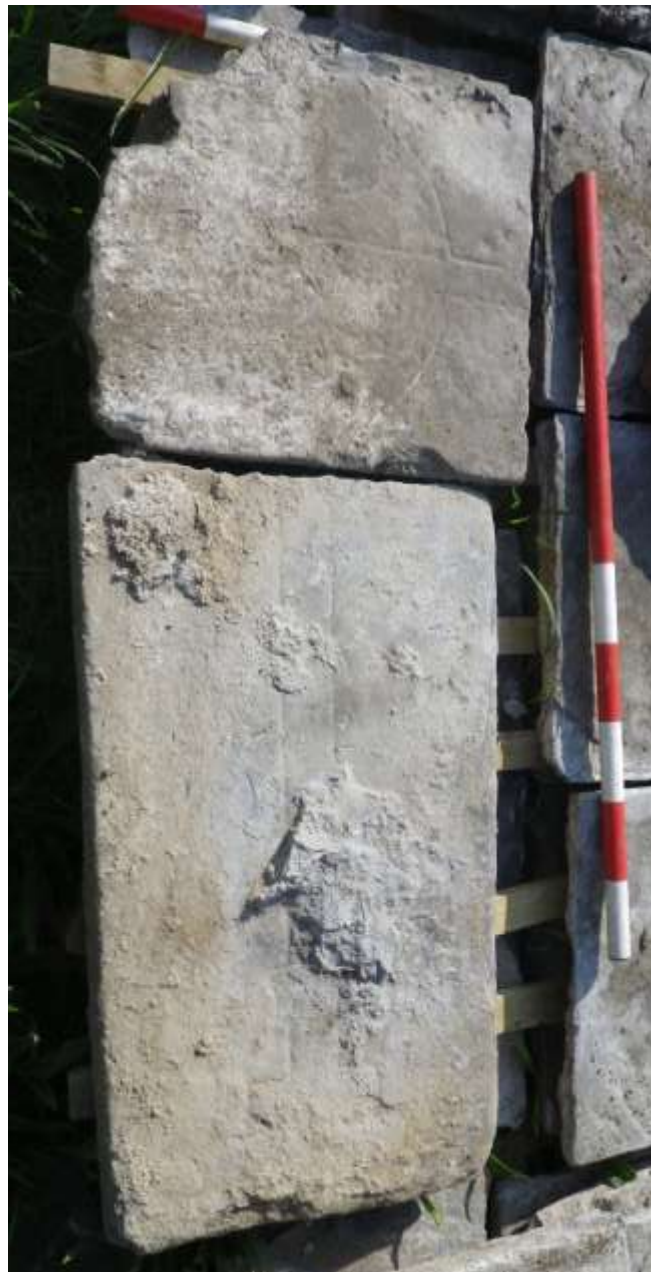
- 5.1.4 The large floor slabs were removed from the west end of the church. Three of these floor slabs were re-used fragments of grave slabs; two of the floor slabs seemed to belong to the same grave slab (Photos 7 & 8). The style of the grave slabs suggests a medieval date. One of the grave slabs appeared to be a simple incised cross with a circle around, a second with a long cross stem sitting on a base. It seems likely these were part of the same slab, but had been broken and moved (Photo 7, the upper cross part is at 90° clockwise to the adjacent cross stem). The second slab shows a simpler incised cross, with a possible faint circle, but part of the cross stem still visible. Unfortunately all of the slabs were partially covered in cement/mortar from when they were laid as floor slabs. They are to be retained at the church.

Photo 7: Two fragments of grave, possibly part of the same slab that had been re-used as floor slabs. An incised cross in a circle with cross stem is visible

- 6.3 Inside the church the large floor slabs were removed which revealed at least two reused incised cross grave slabs. The style of the crosses would suggest they date from the 12th to 14th centuries. These will be retained at the church and hopefully displayed in some way.

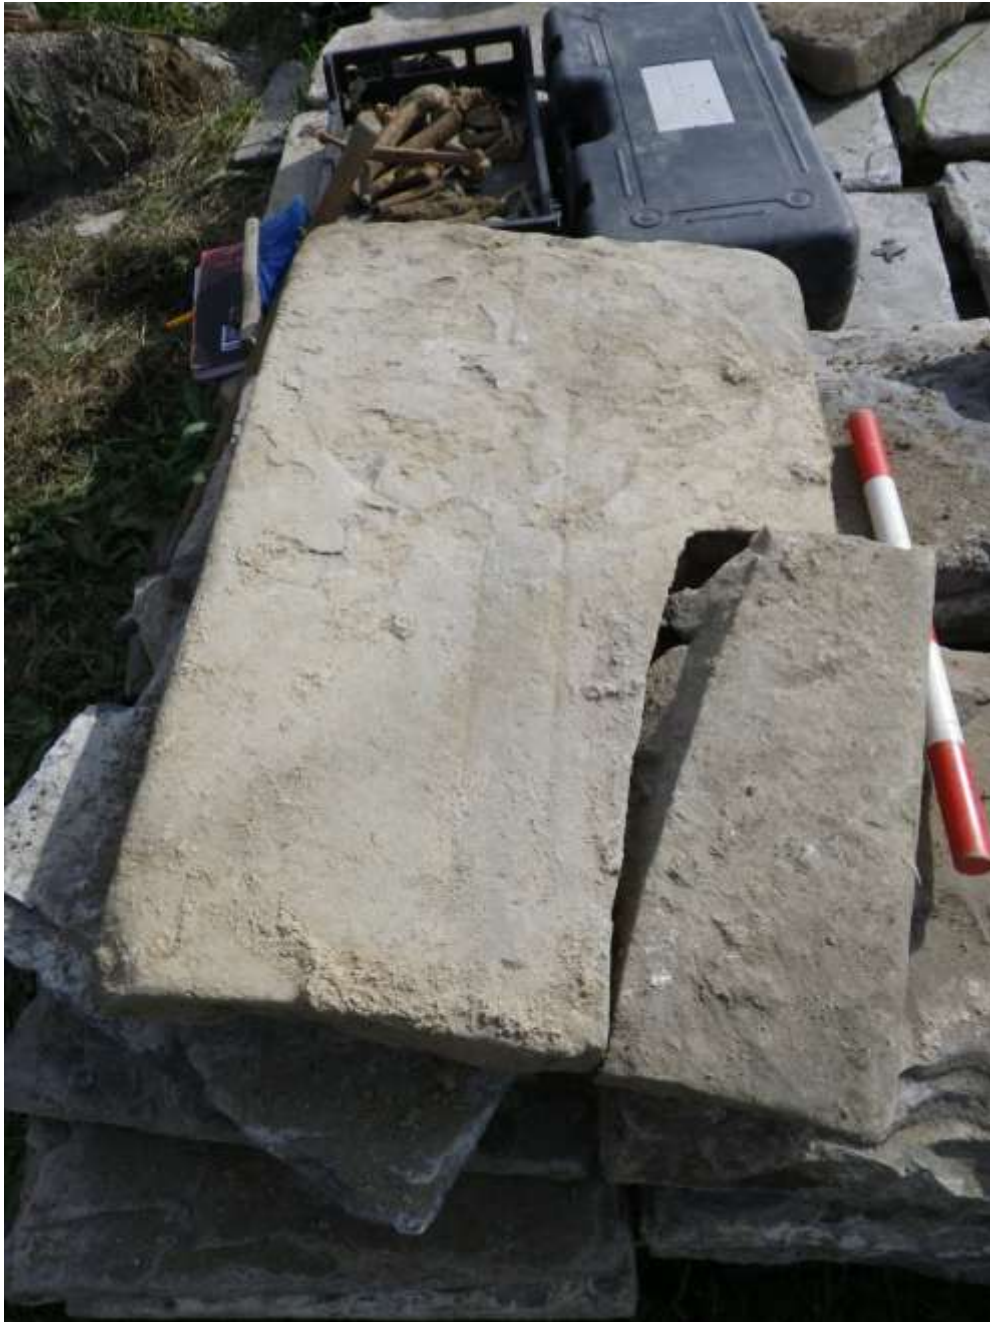
Photo 8: A fragment of another smaller grave slab, re-used as a floor slab, with simple incised cross in a circle and part of the cross stem

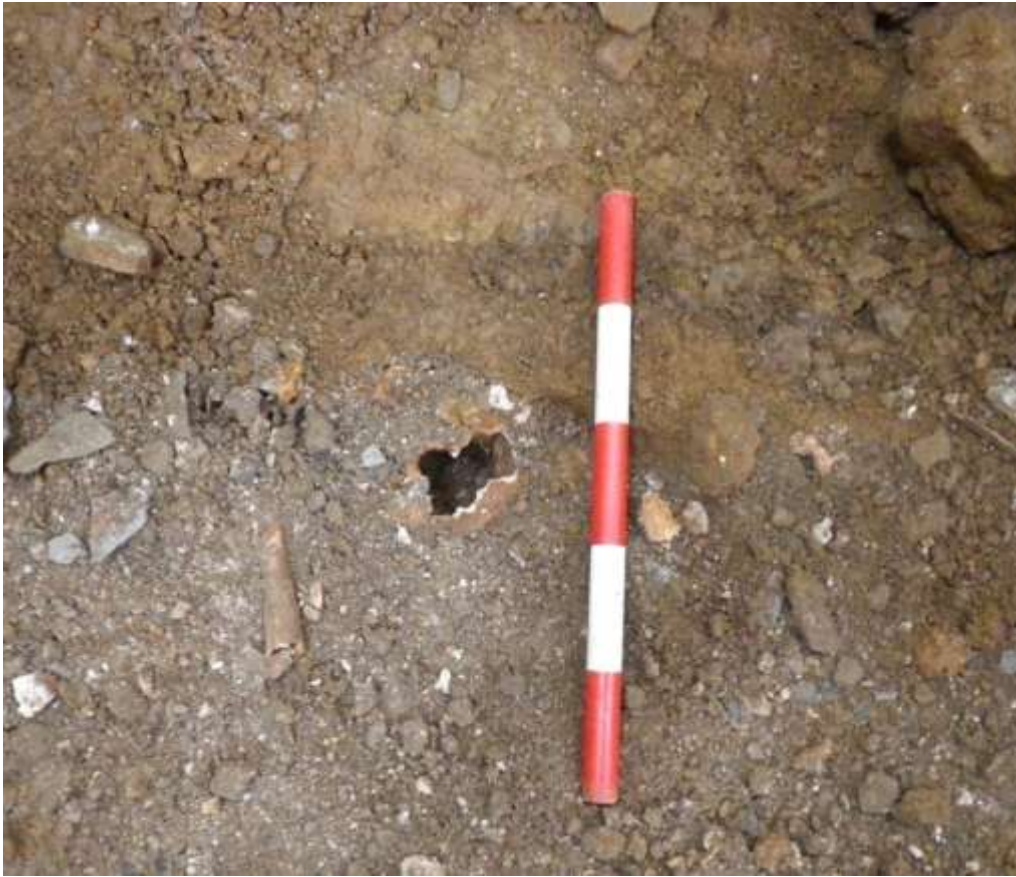
- 5.1.5 The deposit beneath the floor slabs was excavated to a depth of approximately 0.3m and the footings (possibly lying on bedrock) of the church's west wall were revealed, which extended less than 0.5m into the church. A skull, probably in situ, was revealed at the base of this layer which had been partially disturbed by the excavation 1.1m north of the south wall and 0.6m east of the west wall (Photo 9). The burial was covered back over and left in situ.

Photo 9: Top of skull seen at the base of the layer beneath the floor slabs, probably in situ, discovered near to the west wall of the church (note the disarticulated human bone in the area)

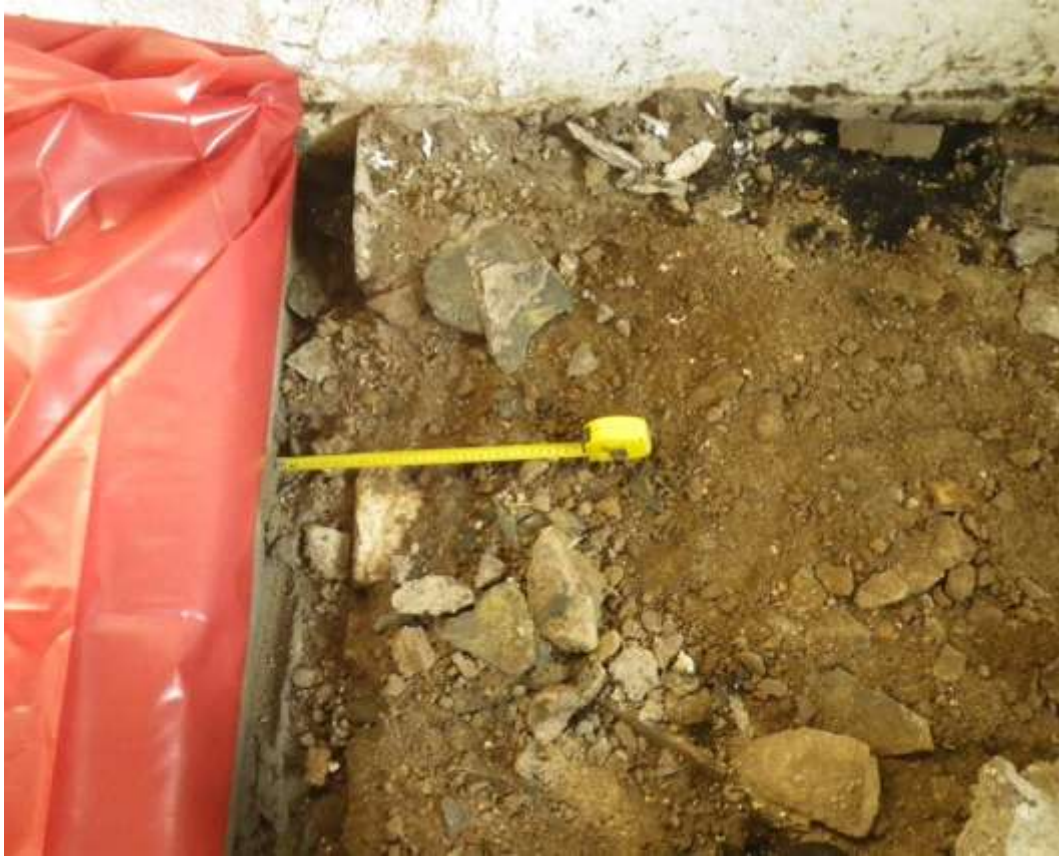
Photo 10: Deposit beneath floor slabs at east end of church next to the north wall. Possibly a previous floor or part of the altar step

- 6.5 At the east end of the church a possible earlier floor or alter step was revealed beneath the floor slabs.
- 6.6 The probable remains of two inhumation burials were noted beneath the church floor. These became visible when the tops of the skulls were exposed and partially damaged at the base of the groundworks. These burials were covered over and left in-situ. Bone survival appeared good within these burials.

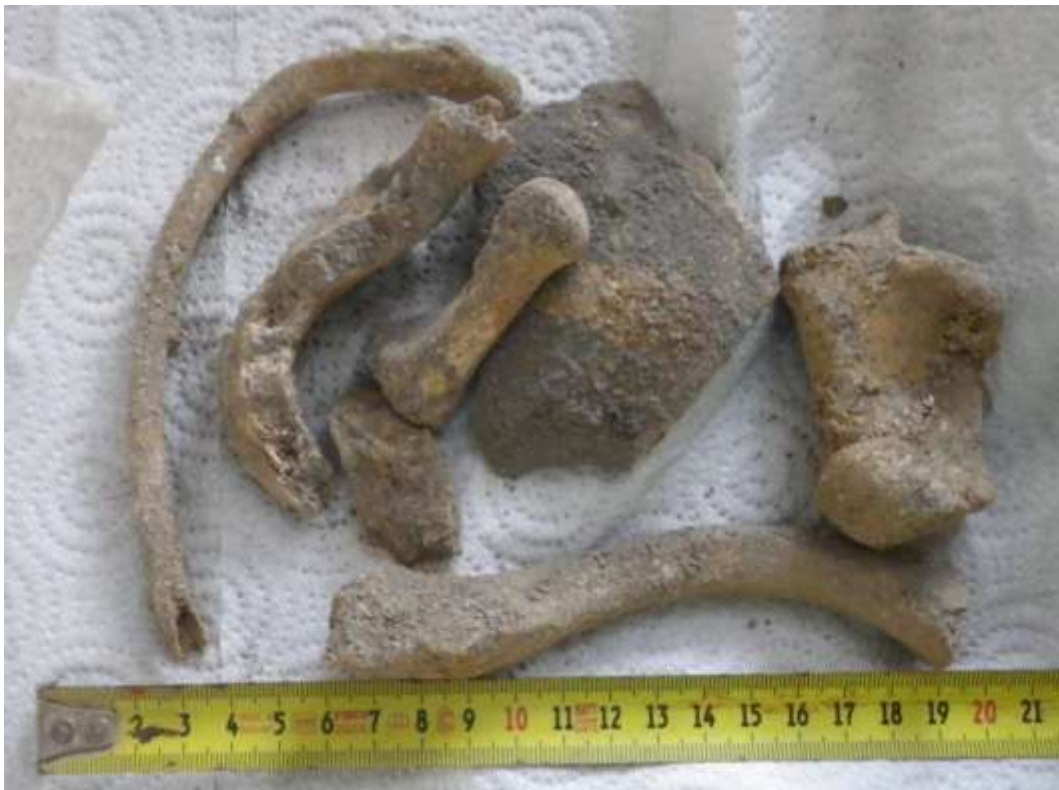
- 5.1.6 Adjacent to the door to its north, east and west, there was significantly more mortar in the deposit beneath the floor slabs, which could have been the remains of the font footings.
- 5.1.7 Overall in the west end of the church, the upper 0.25m of the deposit beneath the floor slabs was loosely compacted, becoming much firmer toward a depth of 0.3m. Some east-west aligned linear features were visible in the central area, which probably represent grave cuts. These were left in-situ and remained unexcavated and were not disturbed further.
- 5.1.8 At the east end of the church the floor slabs were removed revealing a possible earlier floor, or more likely part of the altar step (Photo 10). This deposit was excavated to a depth of approximately 0.3m. It was found to be loosely compacted, and several disarticulated human bones were found within the deposit (Photo 11).

Photo 11: Fragments of disarticulated human bone discovered at the east end of the church during excavation of the deposit beneath the floor slabs

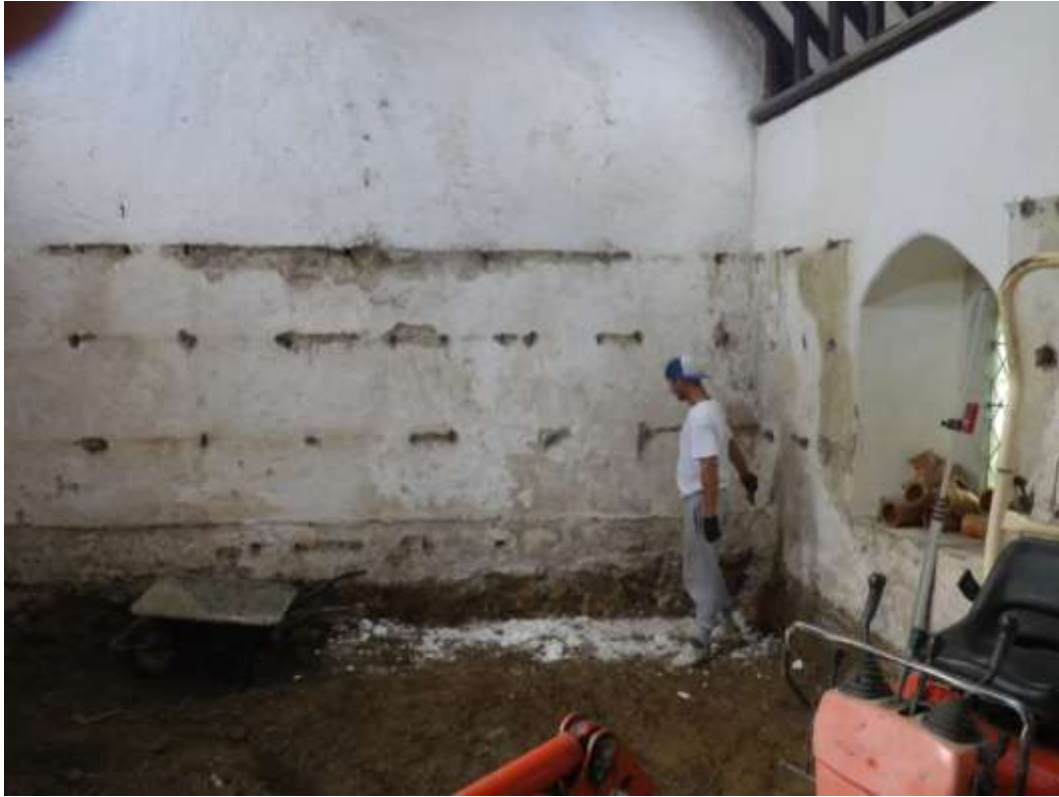
- 5.1.9 Plaster removal began on the south wall at the east end of the church where damp and decay was worst (Photo 12). Paintwork was revealed beneath the plain white coat of plaster or lime wash. These were identified as possible wall paintings, which could have been of medieval date (Photos 13 & 14).

Photo 12: Plaster removal begins on the south wall at the east end of the church

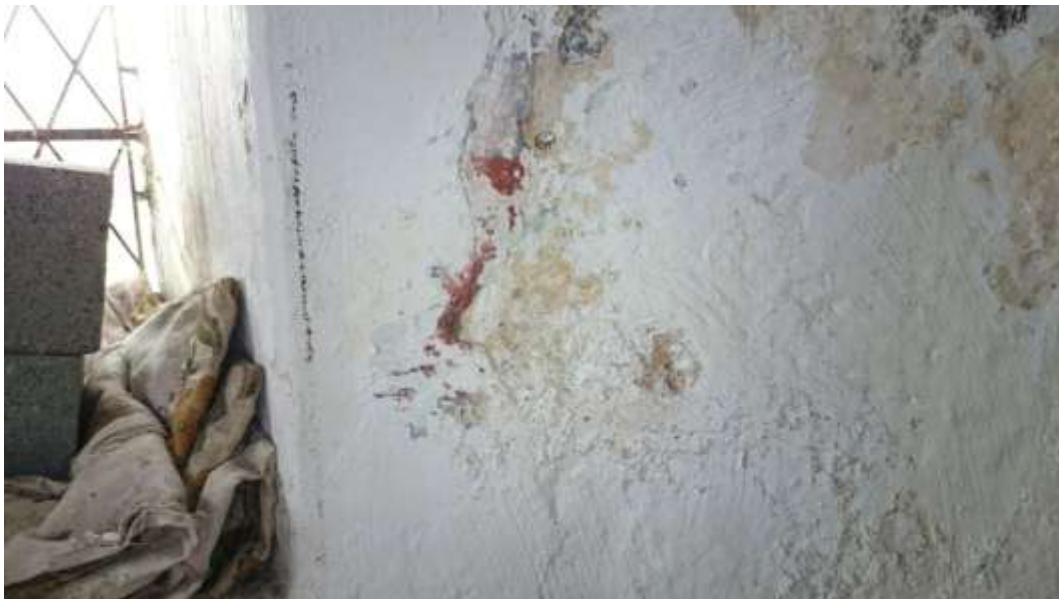
Photo 13: Possible medieval painted plaster around window on south wall of chancel, showing patches of red and blue/grey paint

5.1.10 On 17th September 2014, advice was sought from Jane Rutherford, a specialist in conservation and restoration, about the possible wall paintings. She was able to visit the site on 17th October 2014 and confirmed the possibility that they could be of medieval date. The results of this initial site visit are included in Appendix 1. She recommended that the church walls should be inspected in detail by uncovering some key sample areas such as the north wall of the nave. Banding (red and blue/grey) on the chancel wall was observed, with small patches of green and black paint (Photo 13), and green paint on the archway between the chancel and nave (Photo 14). Jane was then contracted directly by the site owner to undertake further evaluation of the remains and any further necessary recording (the results of which will be reported on separately).

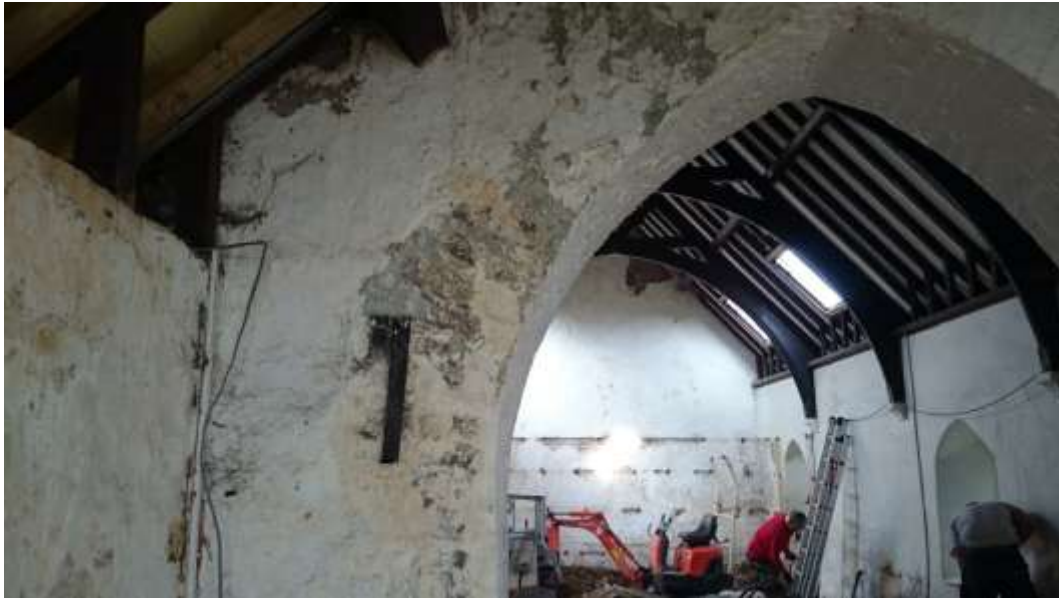
Photo 14: Possible medieval painted plaster south of chancel arch

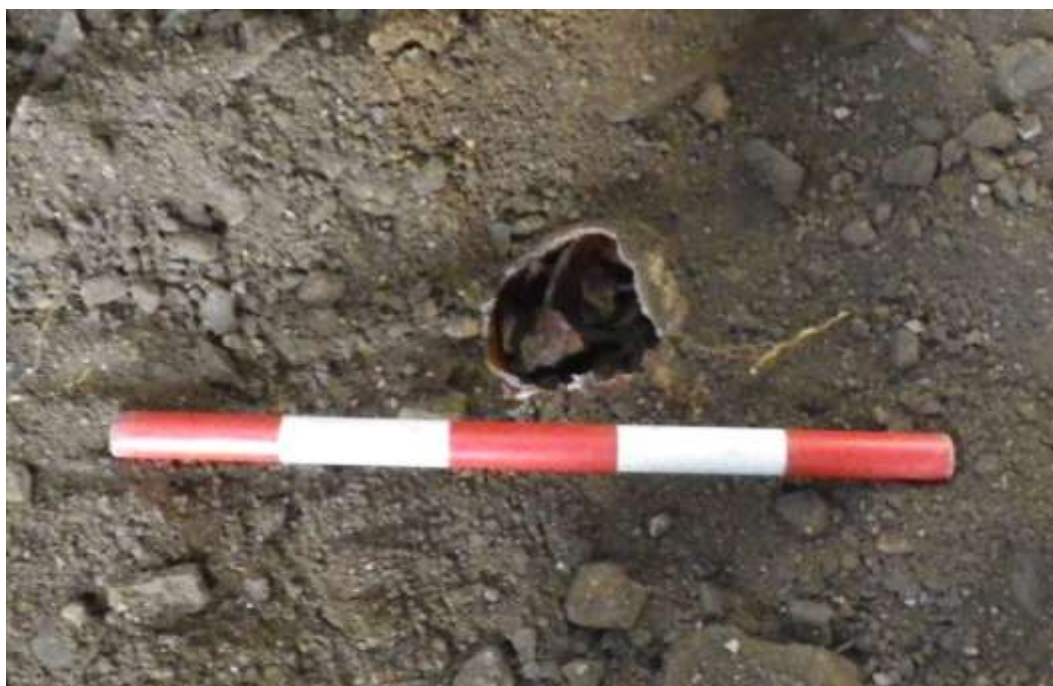
5.1.11 Groundworks continued to remove the last of the floor slabs and level the floor about 0.3m below the original ground surface, as was done across the floor of the church. Disarticulated human remains were recovered. A second skull that appeared to be in situ was disturbed underneath the cement footing of a pew, 0.4m south of the north wall and 4.75m east of the west wall. It was left in situ at a depth of roughly 0.3m below the former floor surface (Photo 15).

Photo 15: The second skull, probably in situ, discovered in the west end of the church near to the north wall

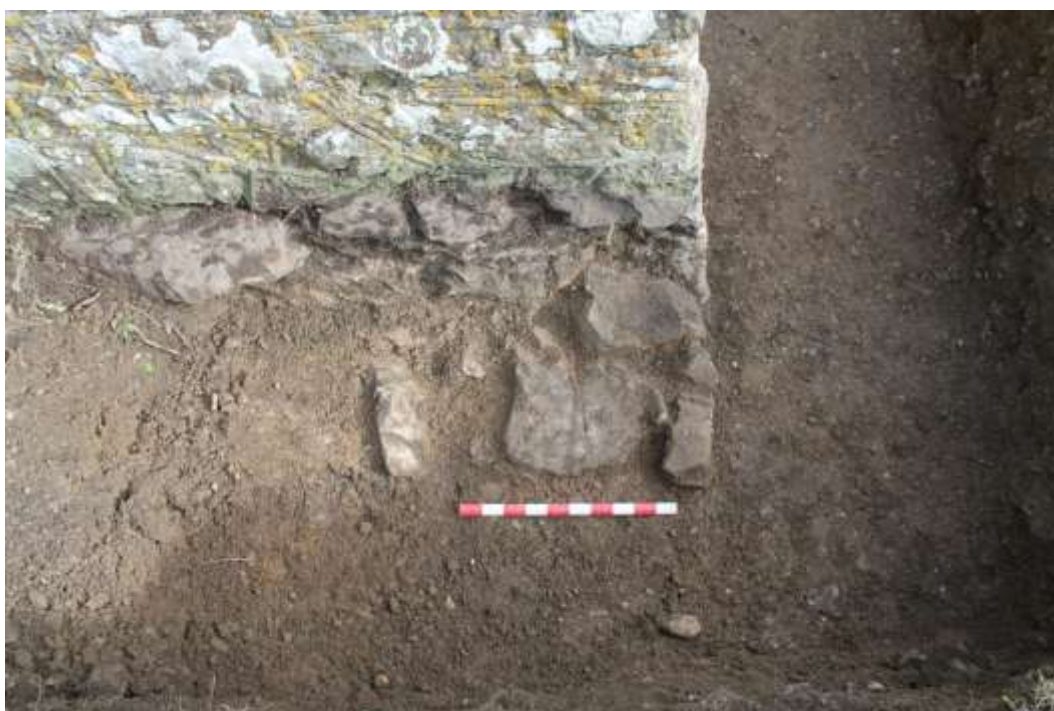
- 5.2.3 On the west wall of the church, in the south west and northwest corners, stone footings were observed projecting from the church walls (Photo 17). These probably served as supporting buttresses for the church which have since been removed (possibly during the 19th or early 20th century renovations).

Photo 17: Stone structure project from the southwest corner of the church, possible remains of a buttress.

- 6.10 On the southwest and northwest corner of the church two stone footings were recorded projecting from the building. These would appear to be buttresses on the two outer corners of the chancel. They may have been removed during repair and restoration works undertaken in the 19th or early 20th century.

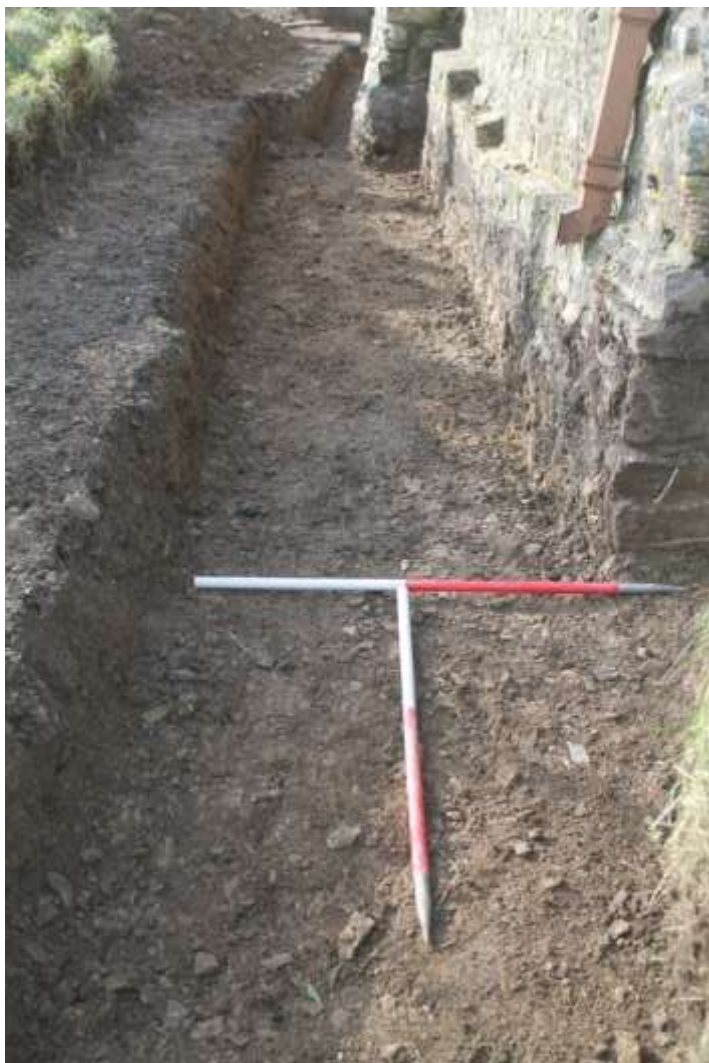
- 5.2.5 On the 26th February 2015 a DAT archaeologist returned to the site to watch the remainder of the service trench (Photo 18) to be excavated along the south wall of the church and along the footpath. Once again numerous fragments of disarticulated human bone were recorded.

Photo 18: View looking west along the former footpath now excavated for the service trench along the southern wall of the church.

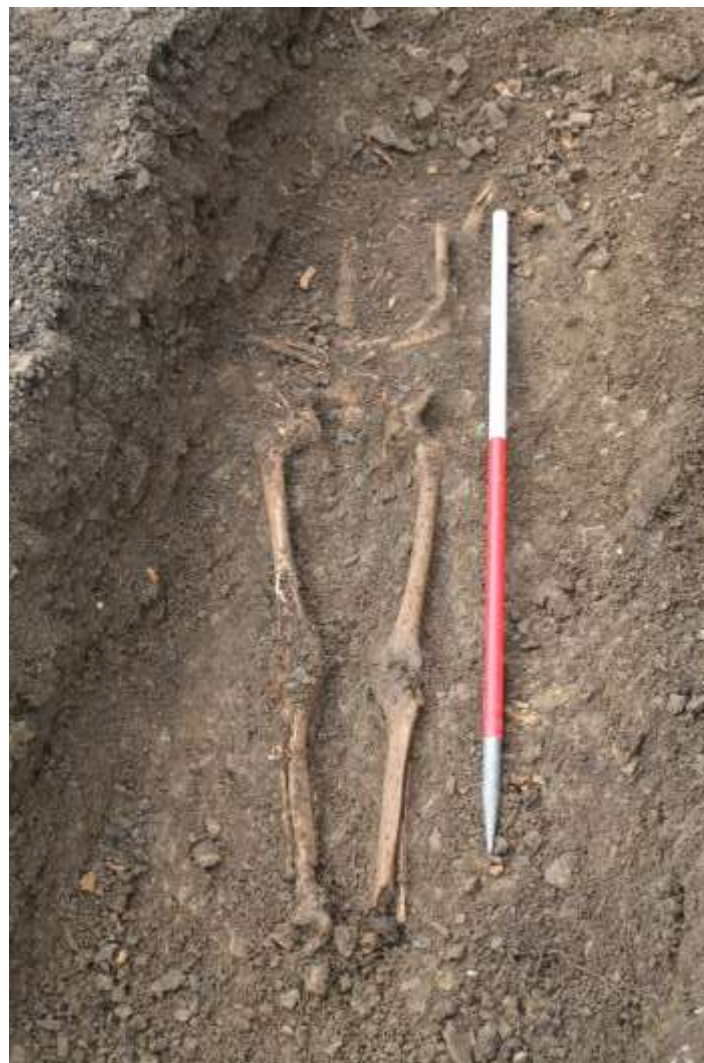
- 5.2.2 In-situ burials were exposed on the southwest corner of the church, two against the south wall and a further three near the north wall. In addition to this a further in situ burial may have been encountered near the east wall of the church, an intact skull was exposed along with a number of cervical (upper) vertebrae. However the remains exposed lay at the extent of the required excavation, but it is expected further associated remains were probably present beyond the excavated area. Minimal disturbance occurred to these burials and the remains were left in-situ where possible.

Photo 19: Inhumation recorded adjacent to the south wall of the church

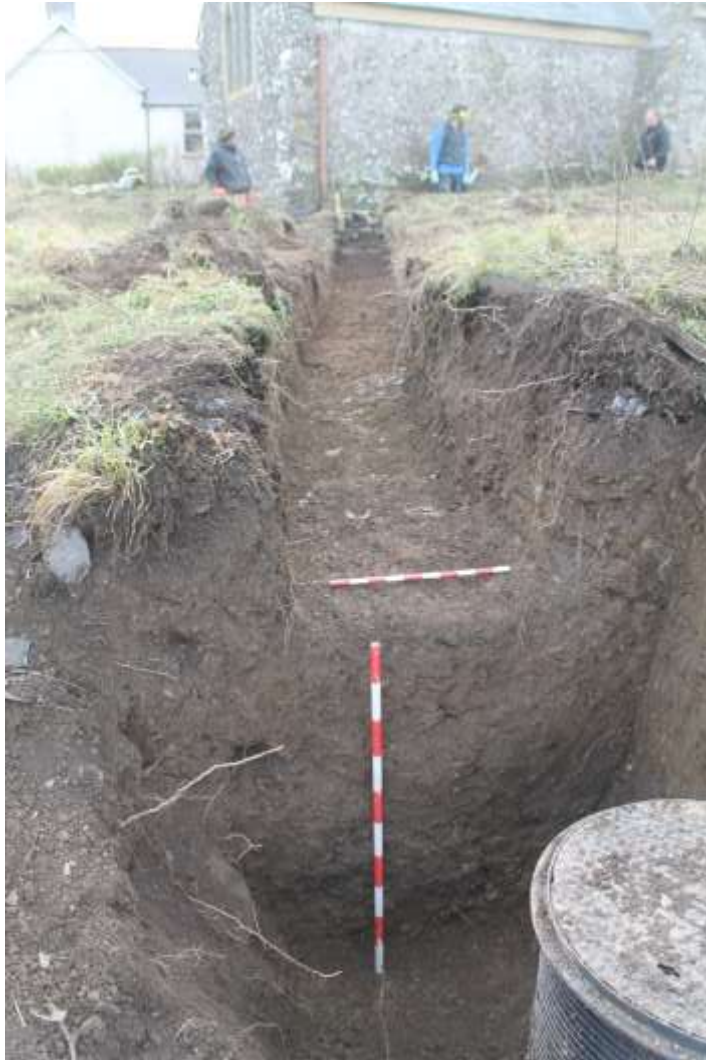
- 5.2.4 During excavation of the sewage trench across the churchyard at least two possible grave cuts were observed, one of which was partially excavated but contained no evidence of human remains. A third possible grave cut was also observed which contained what appeared to be badly degraded bone. At the far end of the sewage trench, towards the northwest boundary of the church a possible rubble dump containing fragmented slate and mortar was encountered within what appeared to be a cut feature. This probably represents an earlier phase of repair or restoration at the church, comprising a deposit of discarded or waste material.

Photo 20: Trench for sewer pipe projecting from the northwestern end of the church across the churchyard, viewing southeast

- 6.8 Three possible grave cuts were also identified in the sewage trench running to the northwest of the church. Where investigated either no or very fragmentary bone was recorded in the probable grave cuts. It is likely that these did represent graves, but that the bone had dissolved away caused by the acidity of the soils in this area. Bone survival was better within and around the church as the acidity of the soil is neutralised by the lime within the mortar of the church walls.
