ARCHAEOLOGICAL QUINQUENNIAL REVIEW: CASTLEMARTIN RANGE, MANORBIER RANGE AND PENALLY TRAINING AREA

CONDITION ASSESSMENT

Prepared by DAT Archaeological Services
For: Landmarc Support Services.

RHIF YR ADRODDIAD / REPORT NO. 2015/50
RHIF Y DIGWYLLIAD / EVENT RECORD NO. 108638

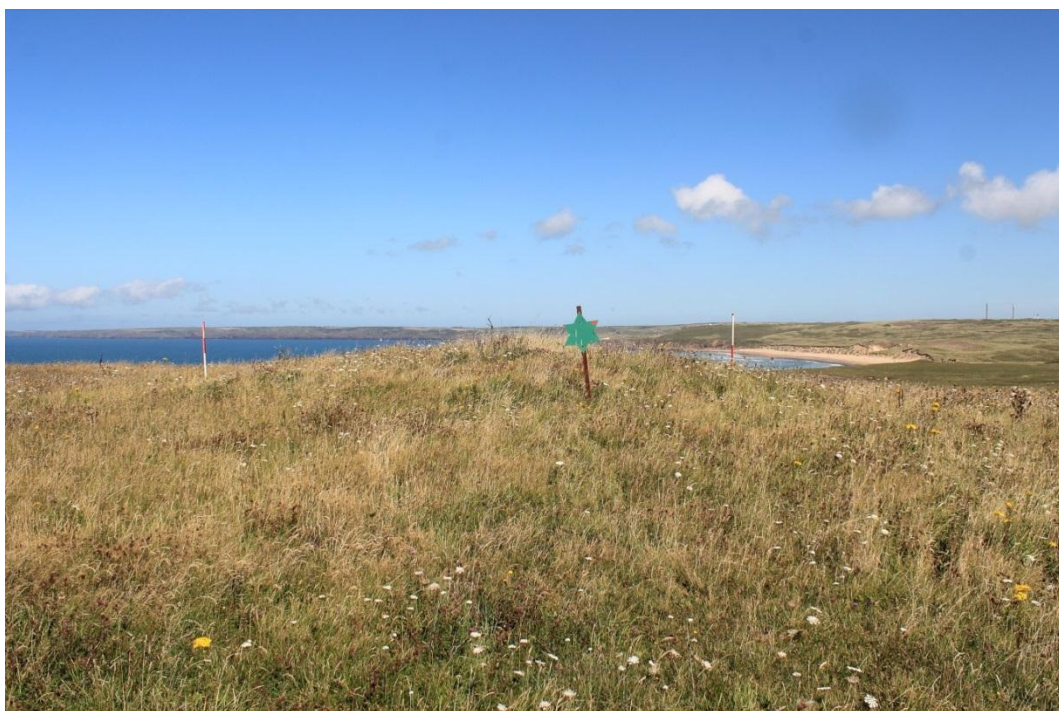
The tumulus earthwork appears as a low circular mound approximately 7.5m in diameter and 0.9m in height located on the coastal edge. A 'No digging' star is positioned on the monument (Photos 1 & 2) to indicate its significance and prevent damage to it. However, on the north side of the monument signs of recent digging or ground disturbance activity was observed (Photo 3), this appears to be scoop-like and maybe the result of impact from a projectile. Vegetation has grown back across the scoop so this probably occurred at least one year ago

Photo 1: General view north of Linney Head Tumulus showing 'no digging' star.

The 'no digging' star should also be replaced to increase its visibility and usefulness as a deterrent to prevent damage to the monument.

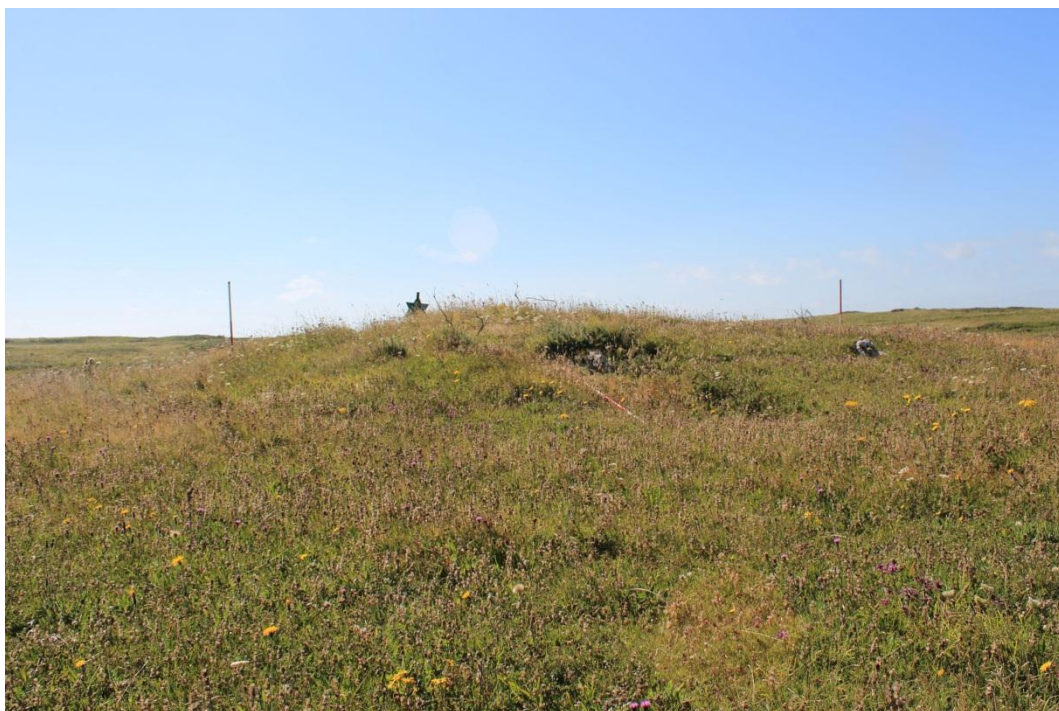
Photo 2: General view south of Linney Head Tumulus showing 'no digging' star to rear.

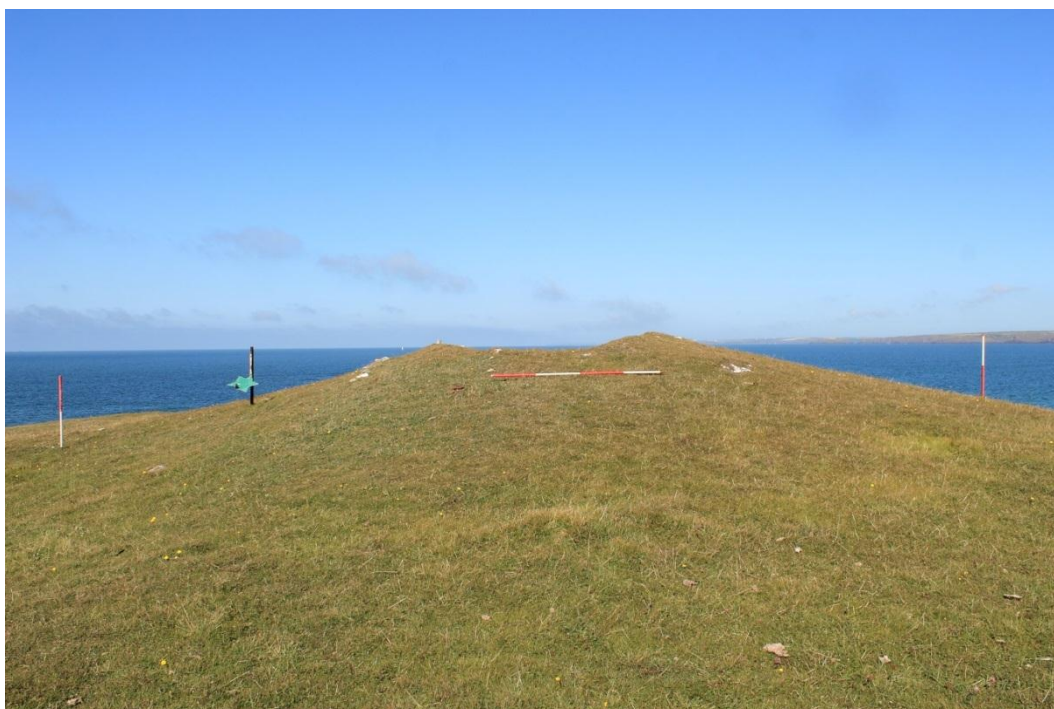
The earthwork stands at approximately 1.5m in height and 11m in diameter covered in short turf and was grazed by cattle at the time of the survey (Photos 5 & 6). Some erosion was observed on the monument and appears to be the result of burrowing animals and cattle. A wooden peg had also been inserted directly into the monument on the southwestern side, although there was no obvious function for this.

Photo 5: General view looking west across Crowback Tumulus, with depression from 19th century excavations clearly visible on its summit and damaged sign.

The 'No digging' star is in very poor condition and should be replaced as a matter of urgency. Tank/vehicle tracks were visible a little over 10m from the monument, all persons who may be driving vehicles within the vicinity of the monument should be made aware of its presence – replacing the 'No digging' star with one (or more) that is more visible should ensure this.

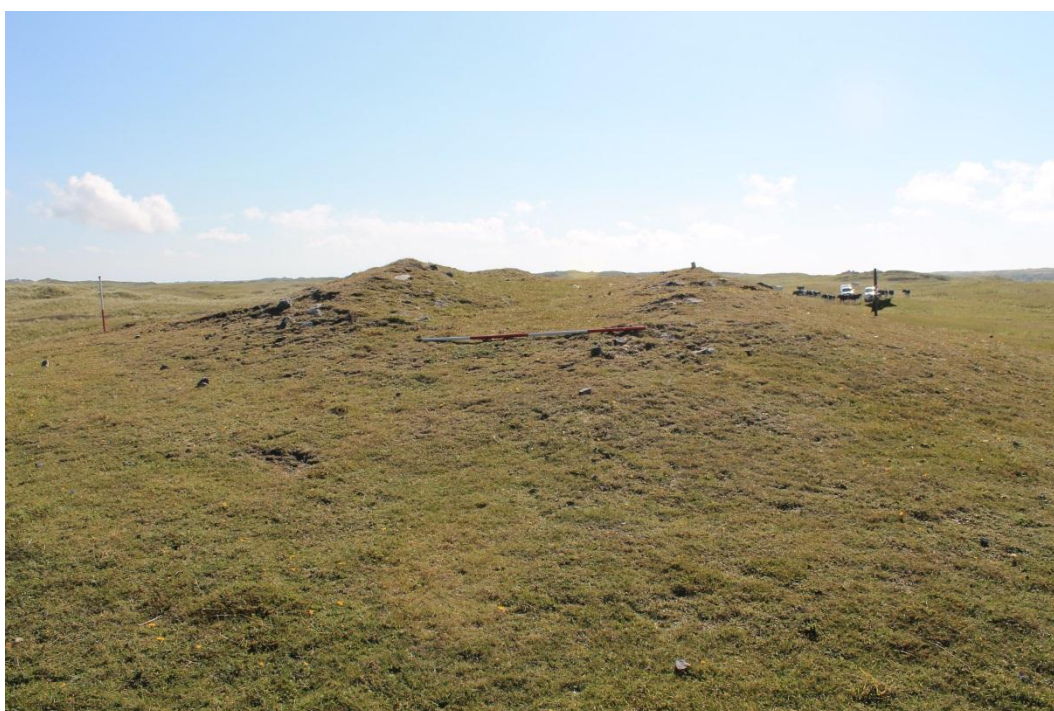
Photo 6: General view looking east across monument, showing depression from 19th century excavations and wooden post on right hand side

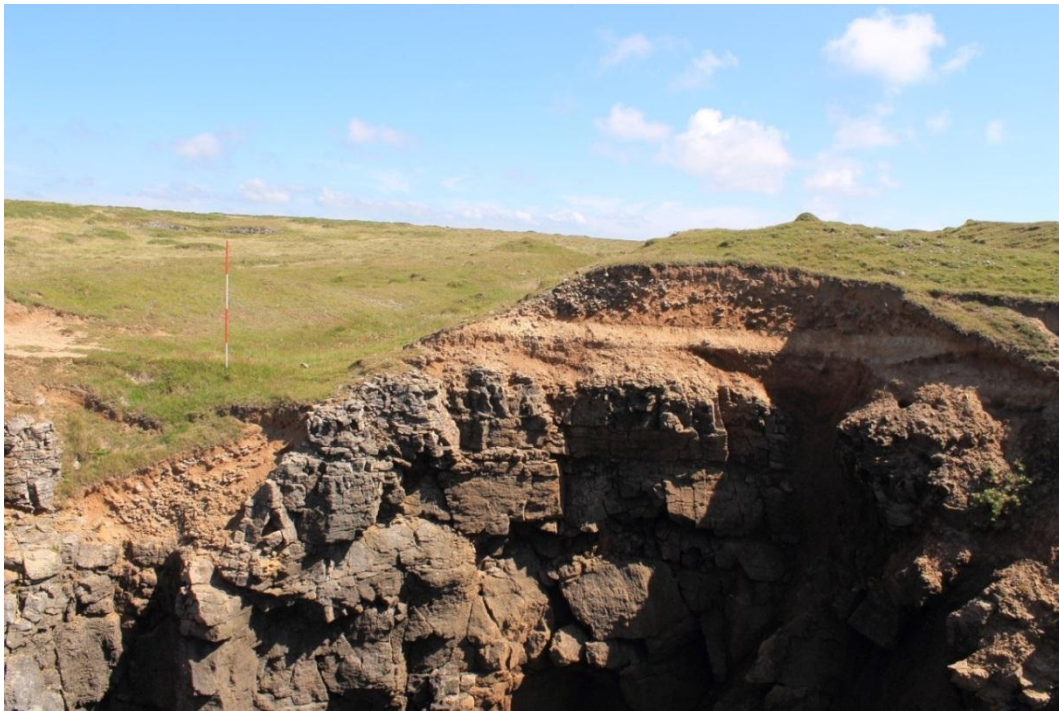
(Photo 7). This clearly shows a rock cut ditch filled with buried soil as well as the make-up material for the bank. The section through this bank and ditch has been noted for a number of years, but it is not known if any detailed records have been made (this might be safely done through reflectorless EDM survey or photogrammetry).

Photo 7: Cliff collapse at the western end of the outer bank has exposed a cross section through the defences.

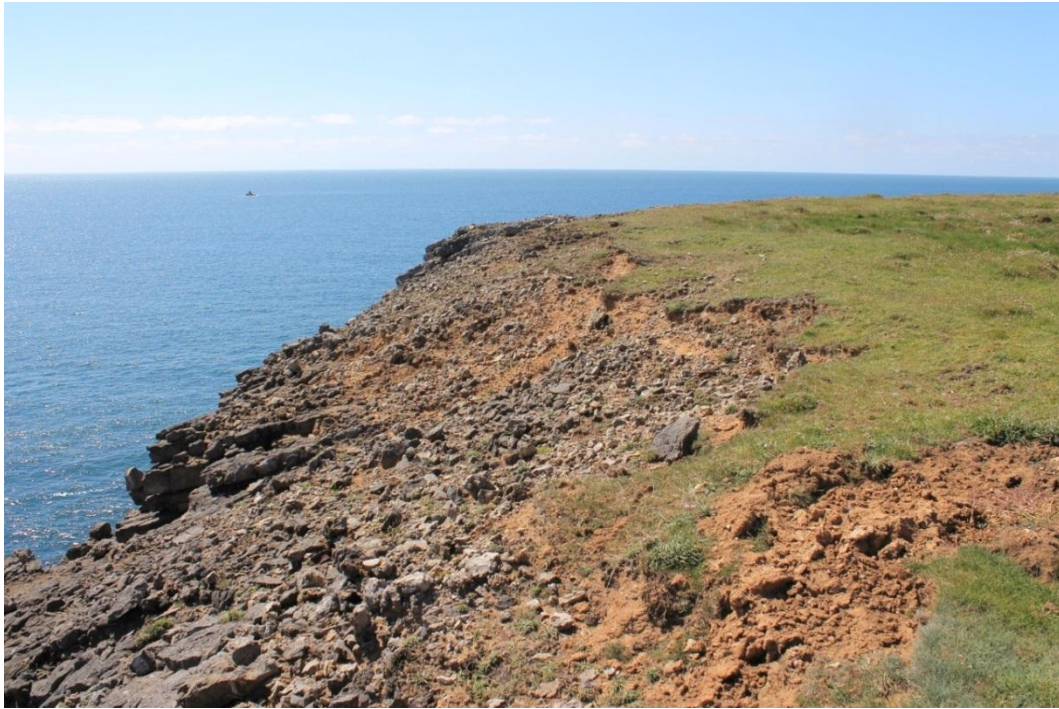
Photo 9: Exposed bedrock and ongoing soil slippage on southeastern side of the monument

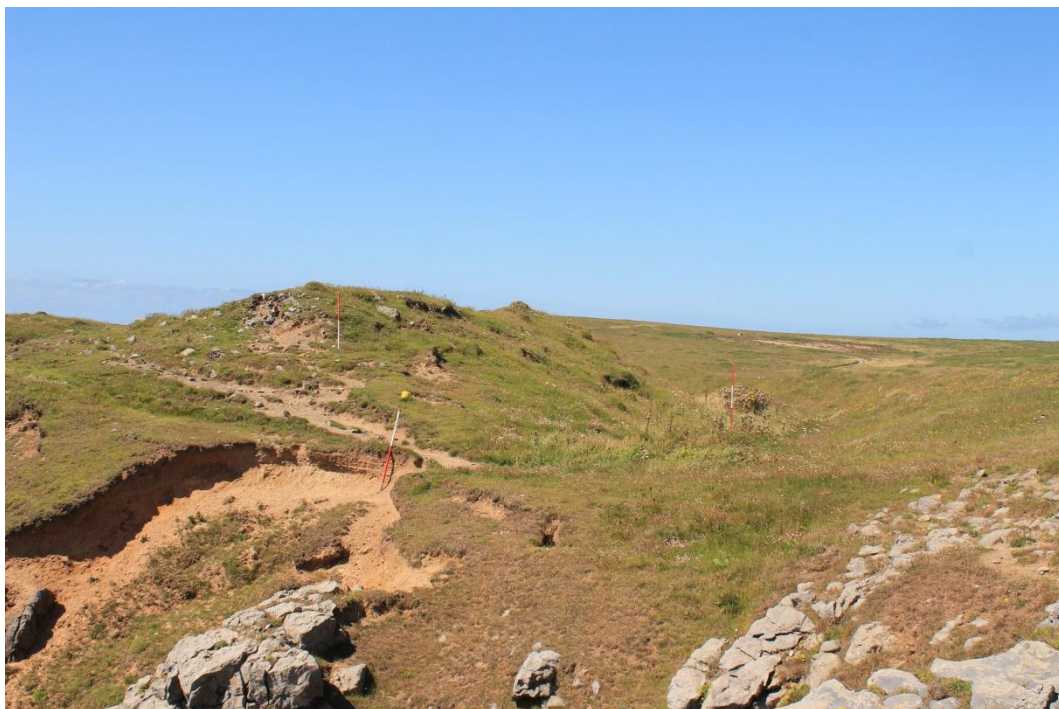
In places the earth banks of the monument have suffered some slippage and collapse, particularly nearer the coastal edges (Photo 10). Footpath erosion is also visible across the monument which has also caused damage to the defensive banks (Photos 10 & 11).

Photo 10: Earthwork slumping near cliff edge and footpath erosion on eastern side of defences

In order to reduce damage to the monument footpaths should be diverted away from archaeological features and the erosion scars caused should be repaired. If possible firing targets should be positioned so that the monument is no longer under threat from impact damage.

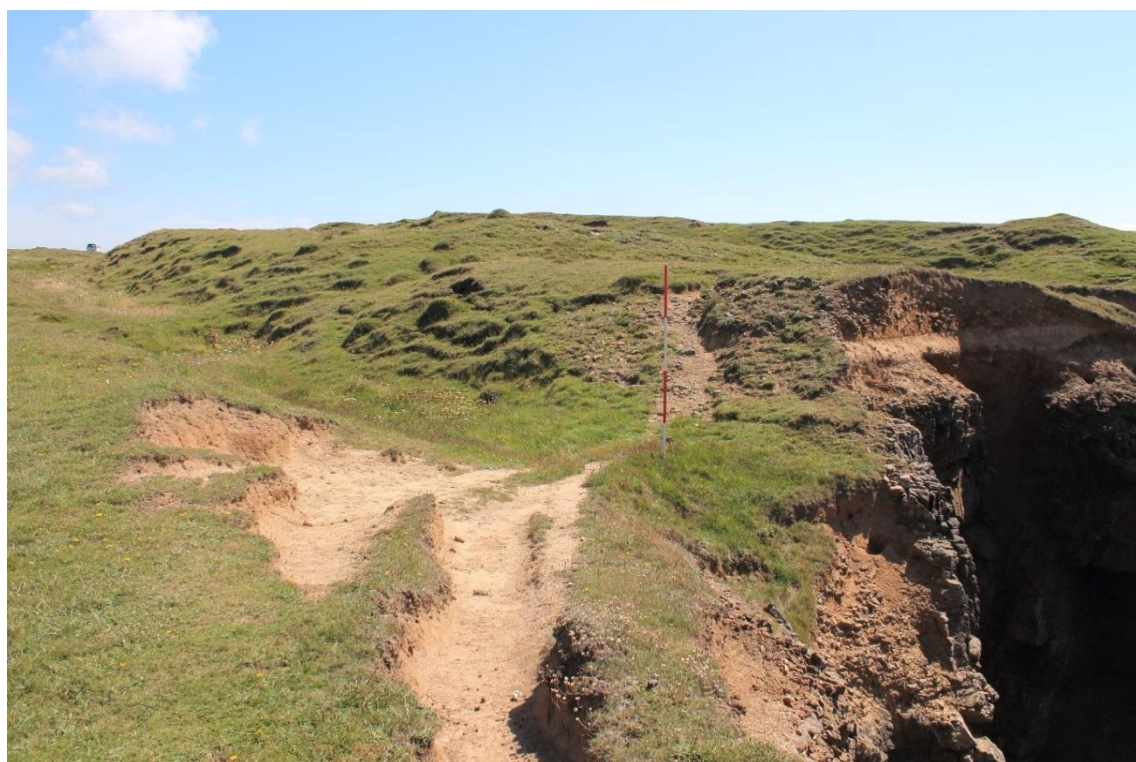
Photo 11: Footpath erosion on western end of defensive banks.

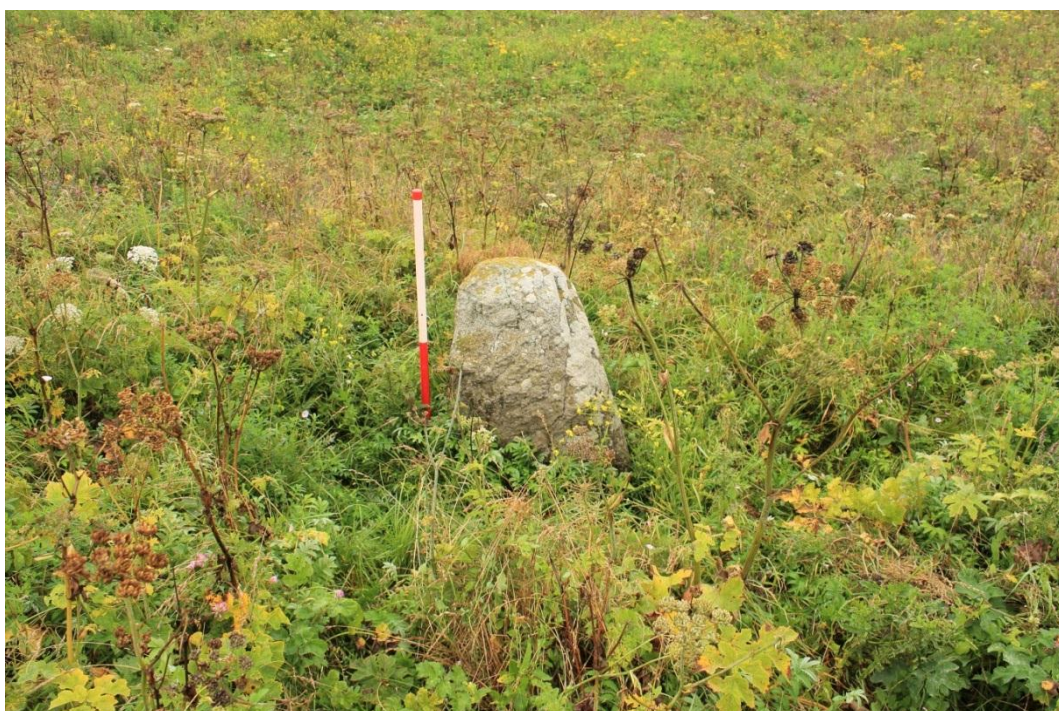
As well as the barrow itself there may be other areas of interest within the immediate vicinity including a small standing stone that was observed (Photo 13), the stone stands at approximately 0.70m tall with a tapered top. Other stones may be buried within the vegetation.

Photo 13: View looking west at standing stone.

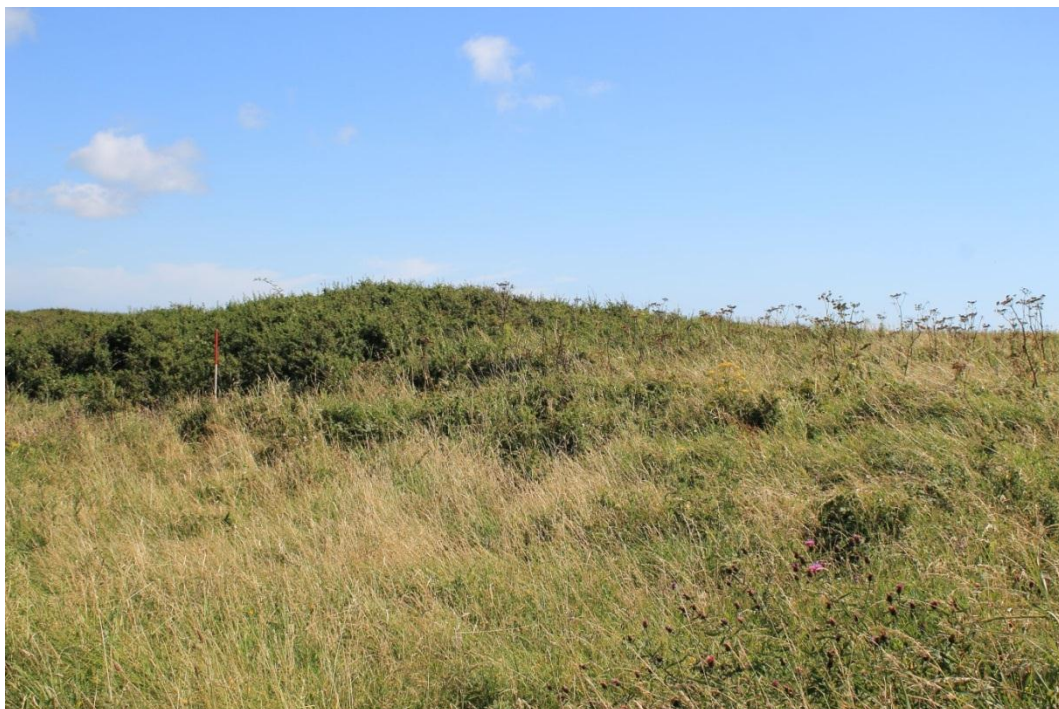
Photo 19: Viewing east showing scrub encroachment towards site.

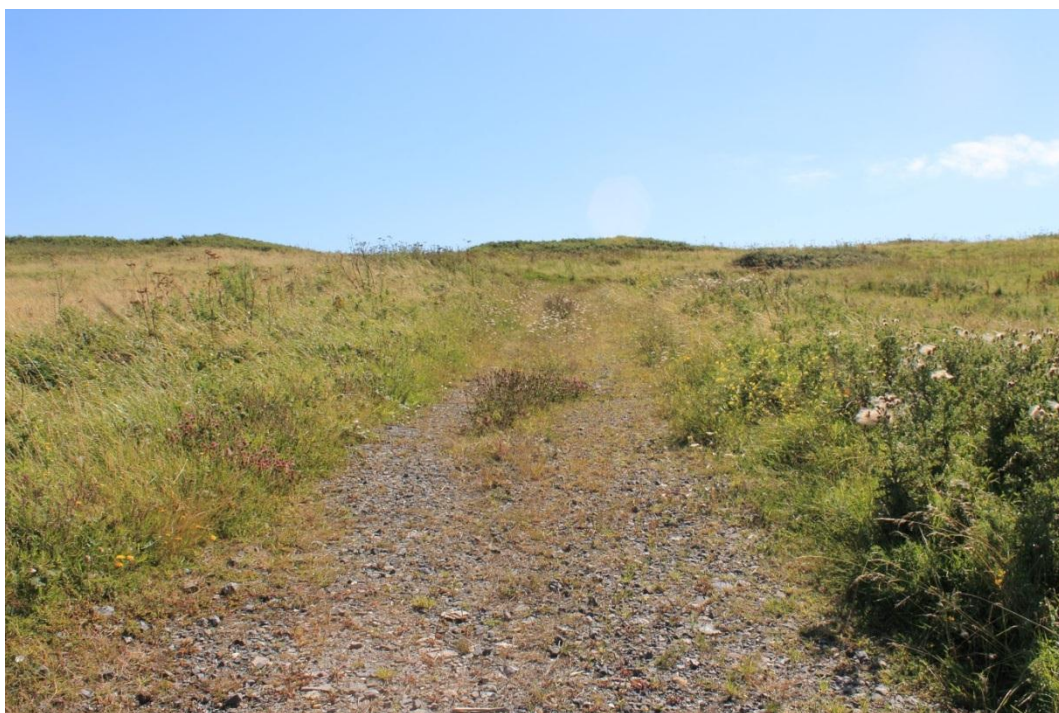
Photo 20: Trackway encroaching into site.

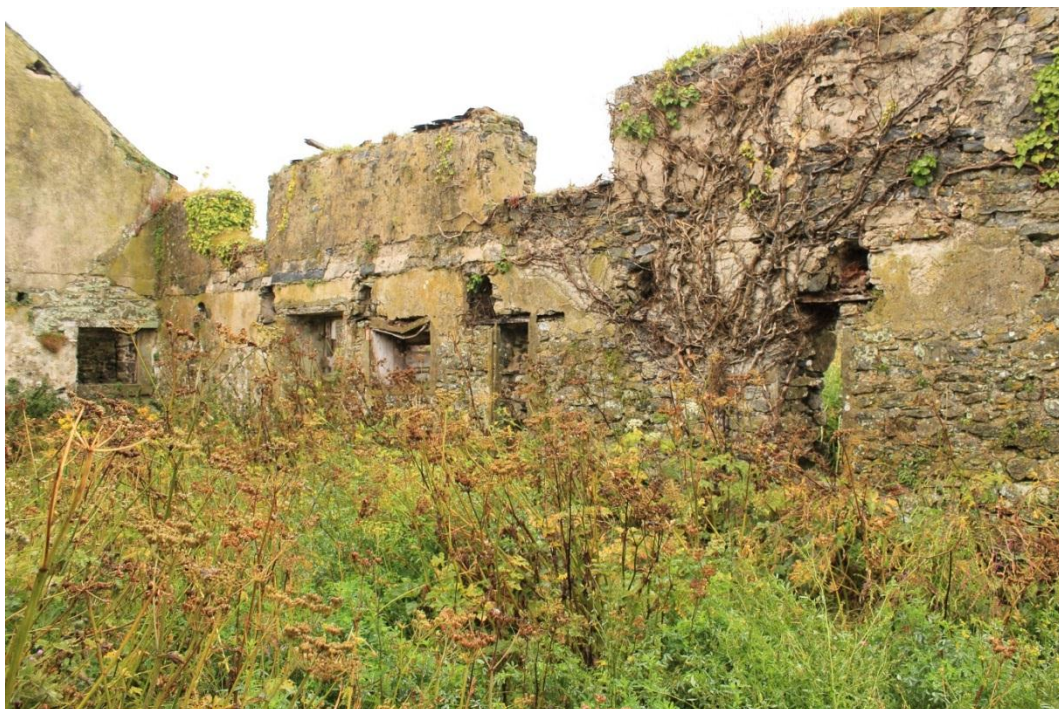
Photo 26: East facing wall of northeastern range, showing damage to internal wall by vegetation.

Where possible invasive plants should be carefully removed from the walls of the building and wooden lintels should be inspected and replaced where necessary. A regime of regular cutting of vegetation within the courtyard should also be carried out. The grounds staff could also undertake basic monitoring of the structures at the same time, noting any collapsed lintels or note where structures may be about to fail in order that remediation works may be carried out.

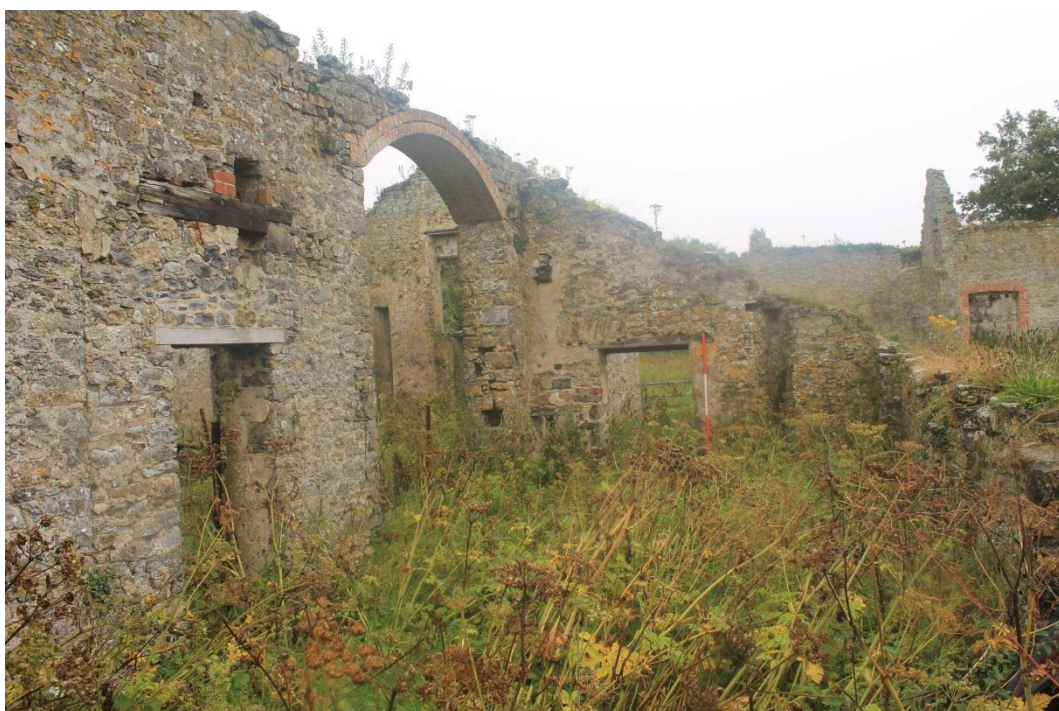
Photo 27: Photo viewing southwest across original façade of southeastern range, showing vegetation and condition of masonry

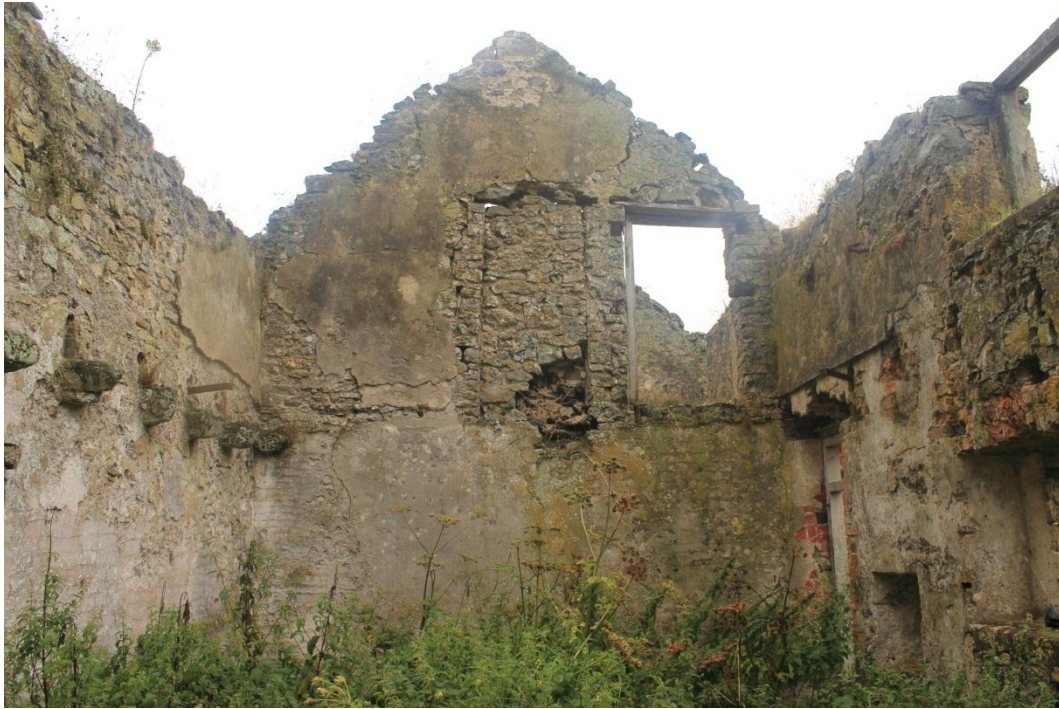
Photo 28: Photo viewing northwest within building on southwestern range, showing vegetation and condition of masonry

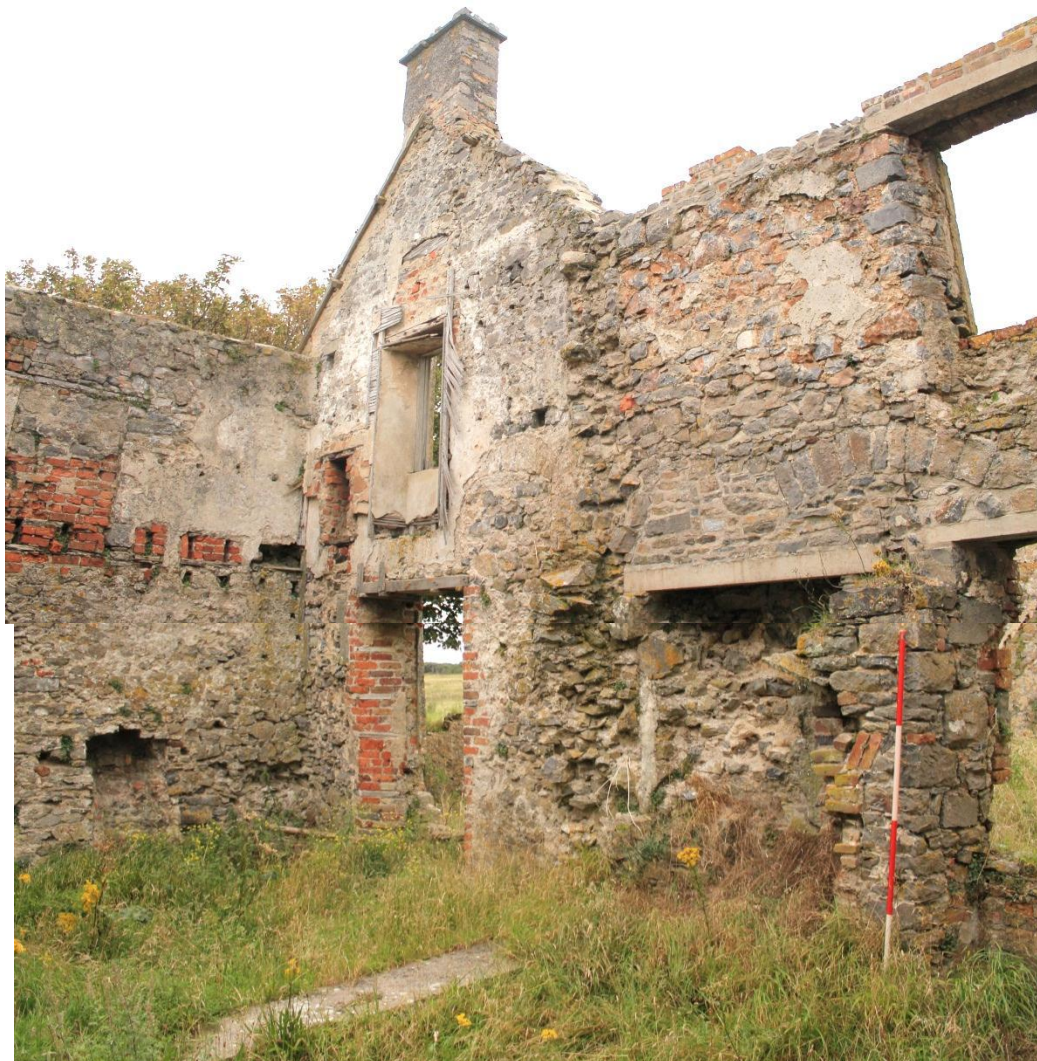
Photo 42: View northeast within northern room of Flimston farmhouse, showing concrete lintel repairs within building

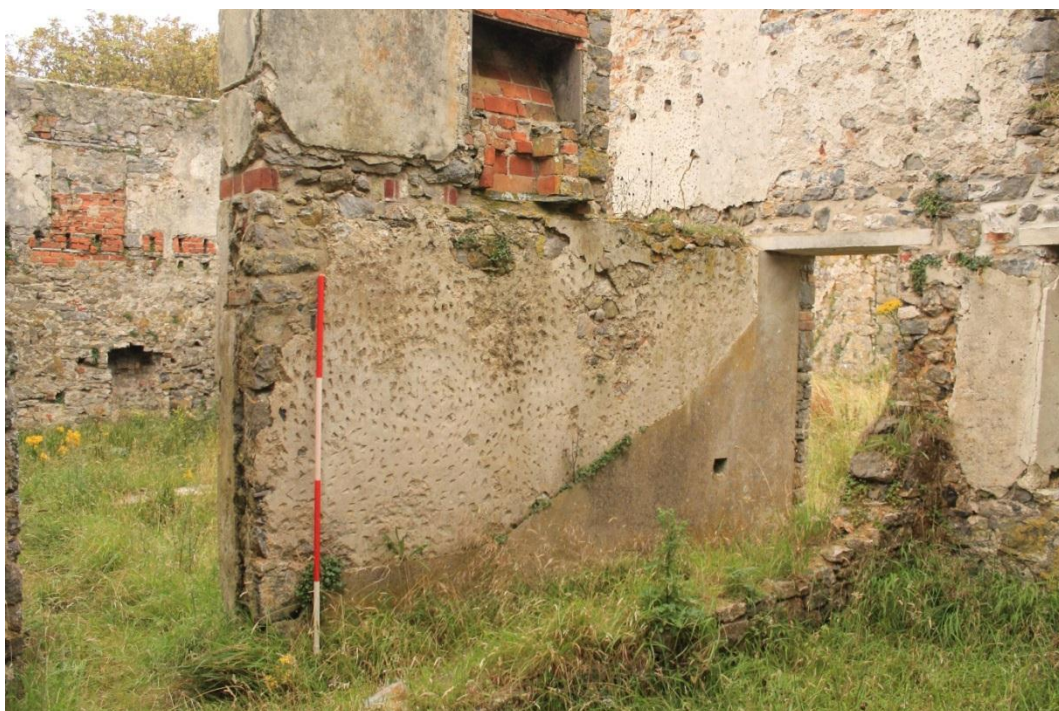
Photo 43: Internal wall showing some plaster damage.

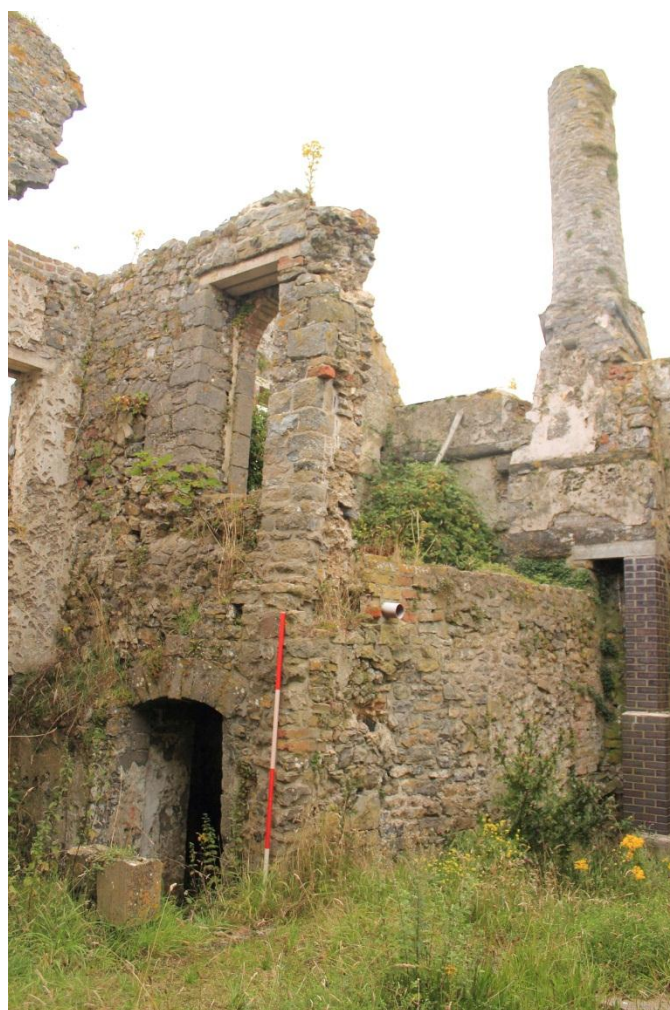
Photo 44: Vegetation encroachment onto walls and upper floor of Flimston farmhouse

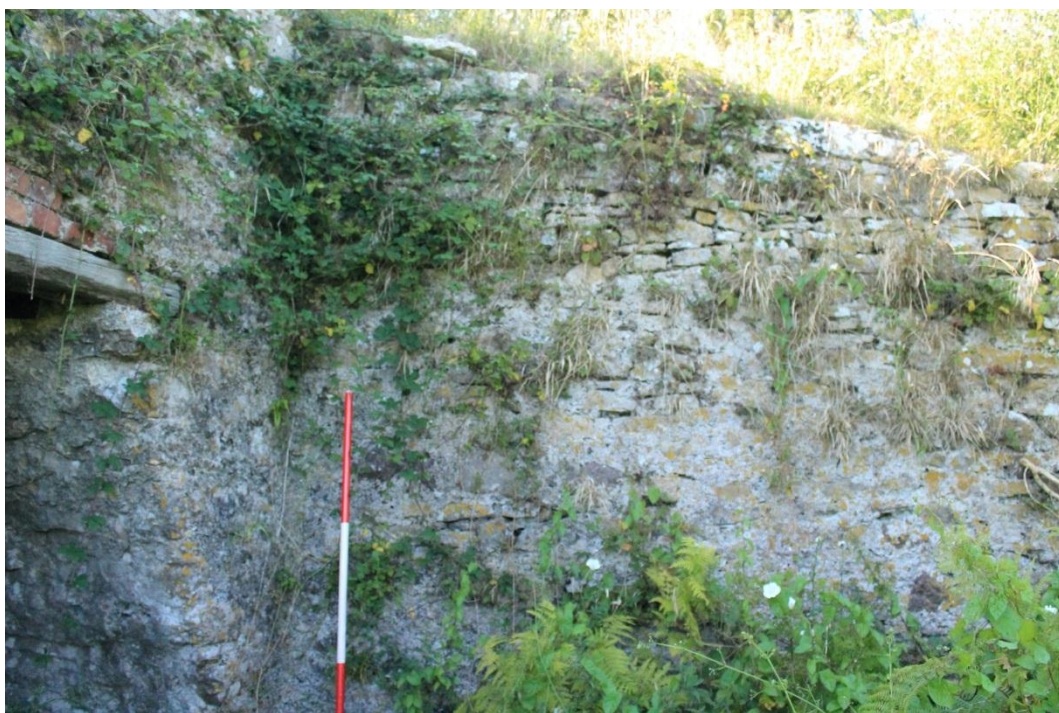
Structurally the kiln is in a good and stable condition, although the lintels are probably in need of replacing (Photos 48 & 49).

Photo 48: Rear wall of Lime kiln on eastern side showing earlier growth of ivy.

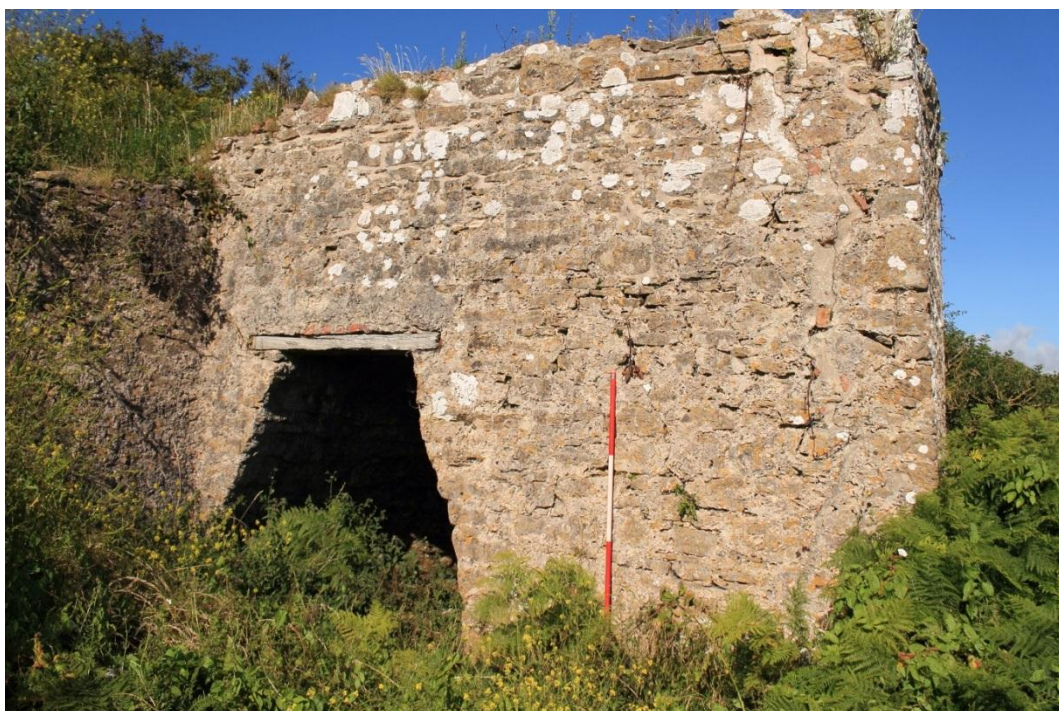
Photo 49: West facing wall of limekiln showing very dry lintel in need of replacement.

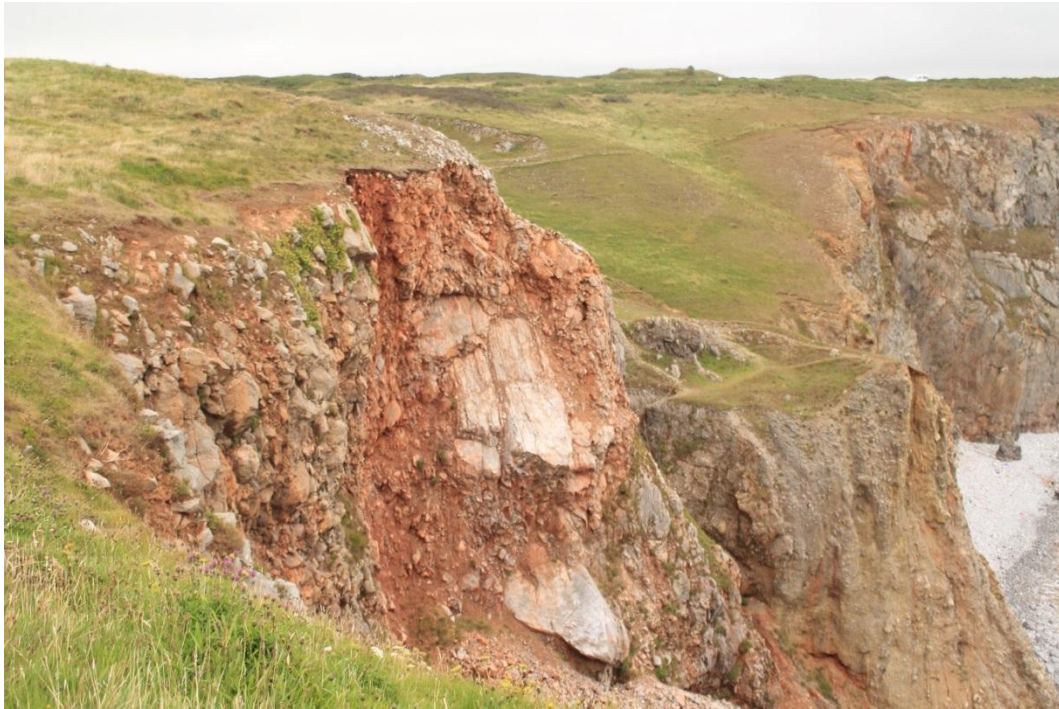
Photo 50: Coastal erosion on eastern edge of Flimston Bay fort.

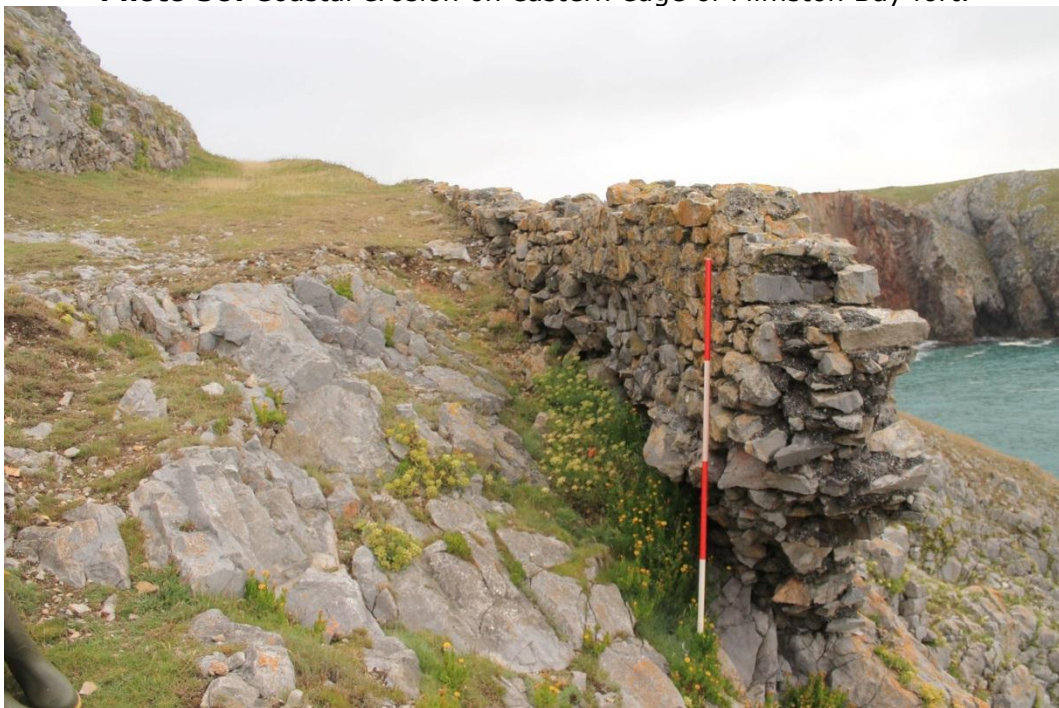
Photo 51: Damage to wall near the medieval quay.

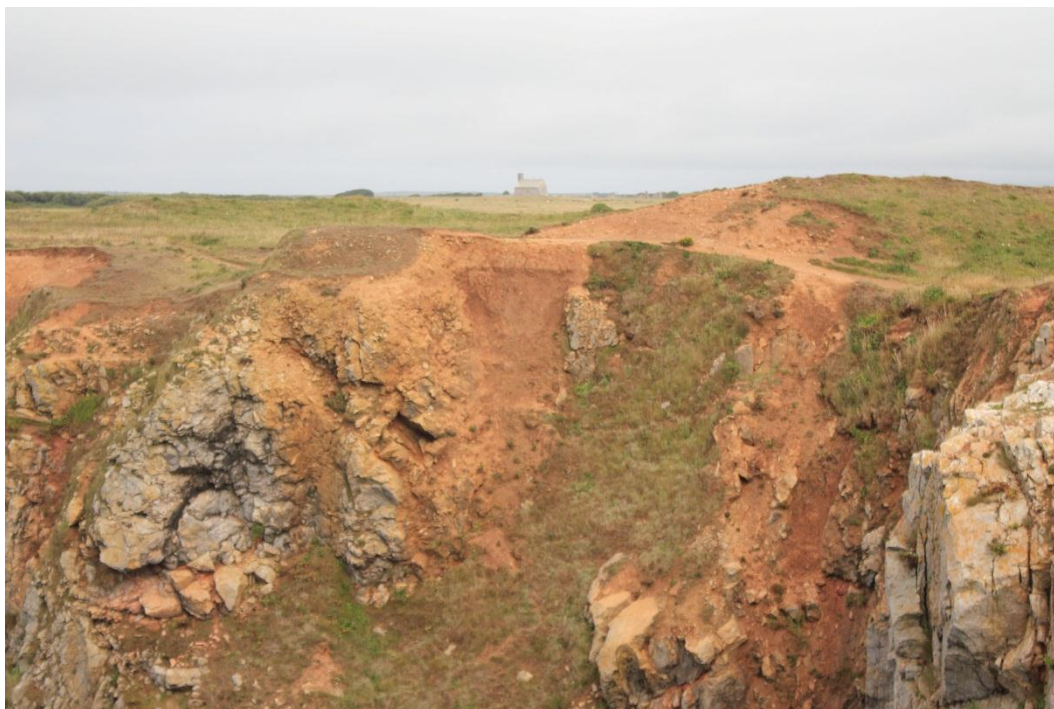
Photo 52: Footpath erosion near coastal edge on western edge of fort badly damaging the banks of the fort and erosion on cliff face.

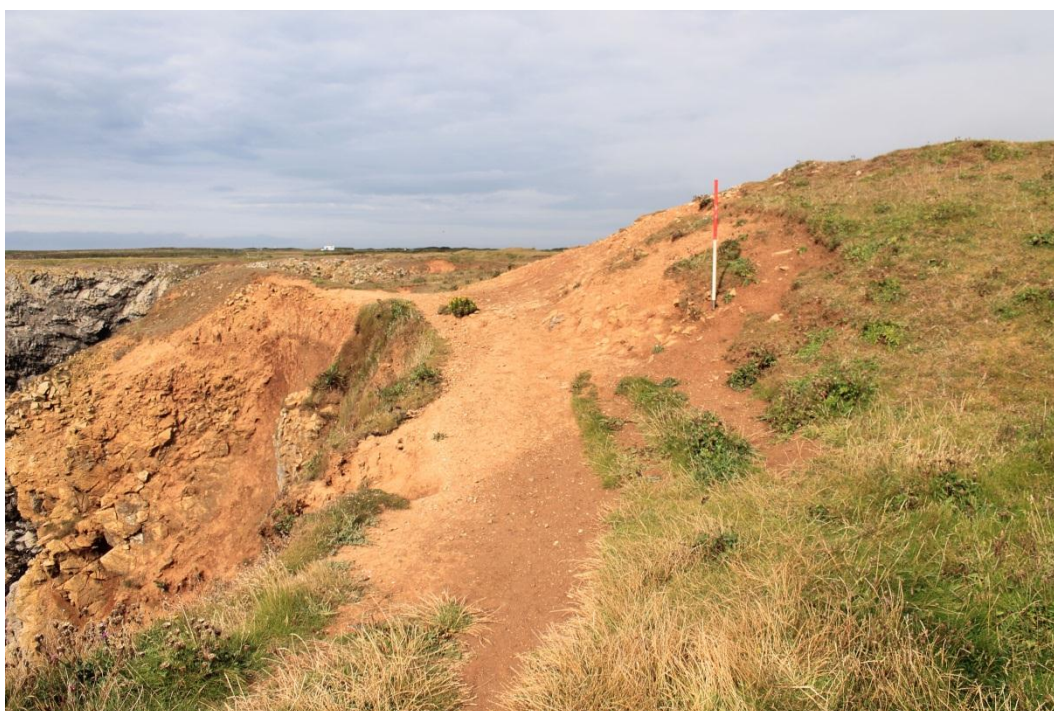
Photo 53: Footpath erosion badly affecting the banks. Past remediation efforts have now failed and are exposed in the bank.

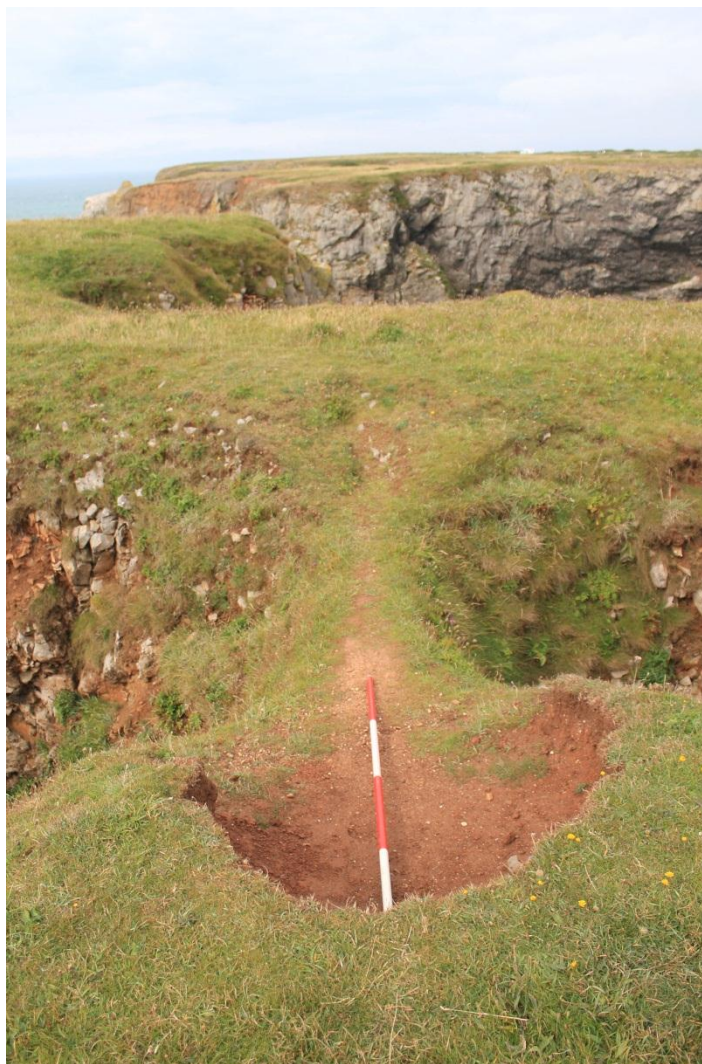
Photo 54: Footpath damage within interior of fort.

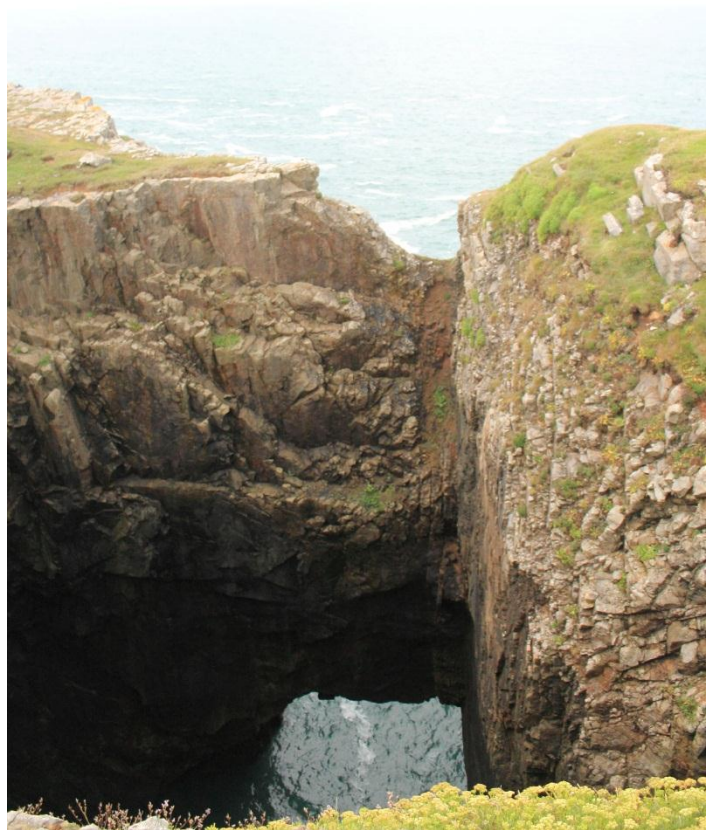
Photo 59: Western side of sink hole showing area likely to collapse in the medium term, which could exacerbate erosion in the area

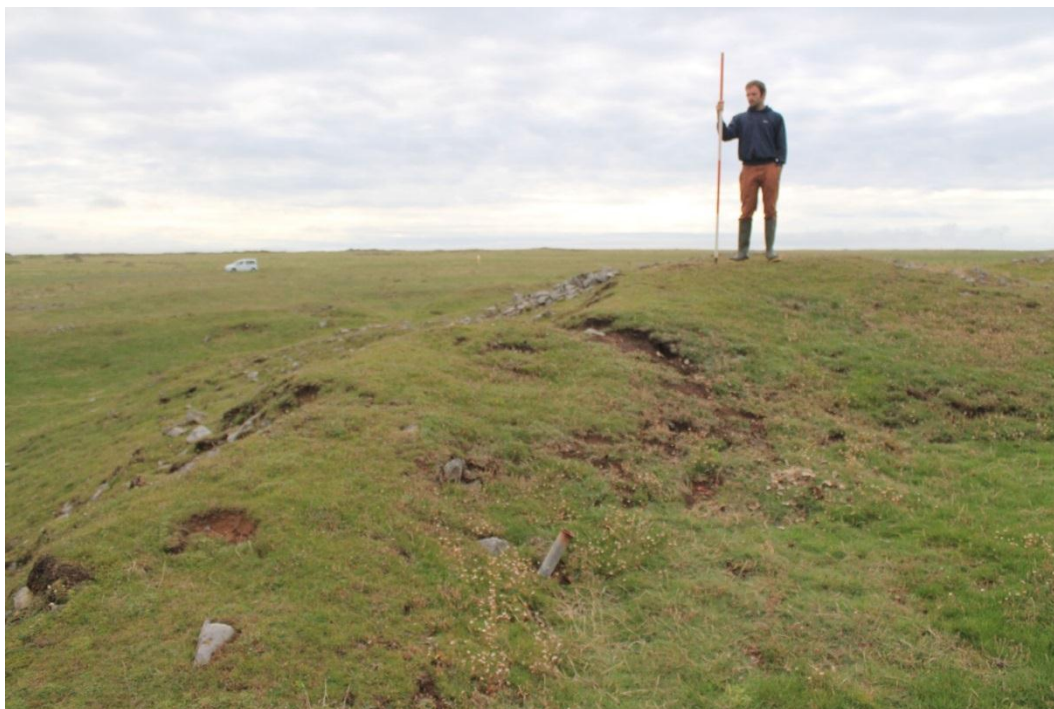
Photo 60: Example of erosion to banks caused by cattle and general members of the public within the northeastern defences, viewing northeast

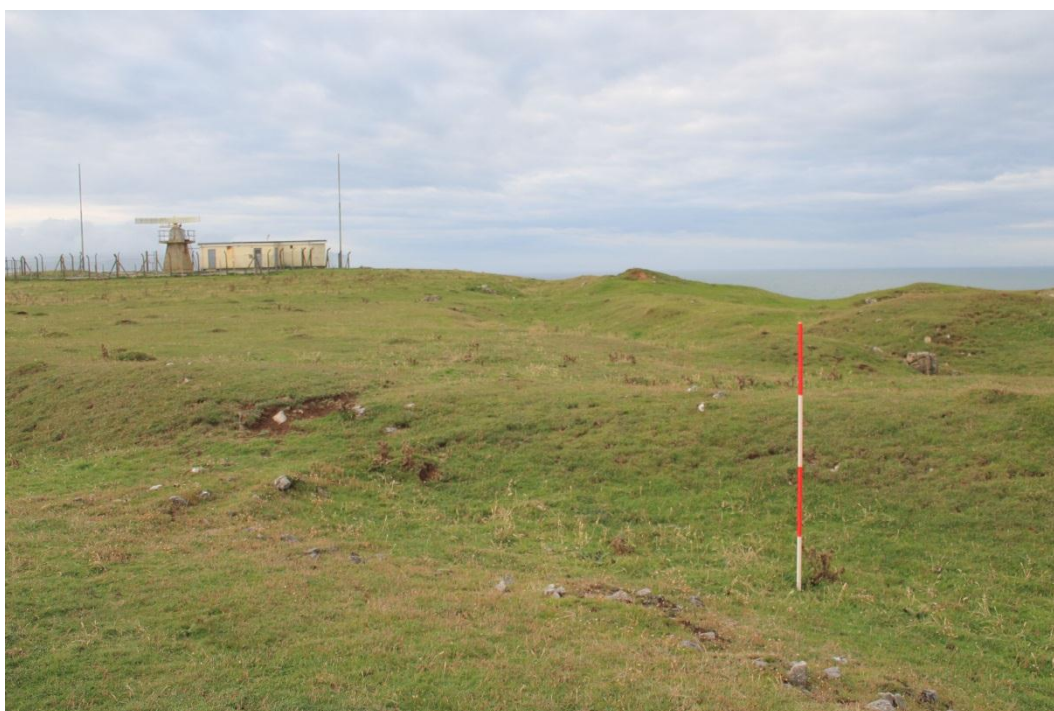
Photo 61: Further examples of erosion on the banks of the northeastern defences, with radar station behind, viewing south

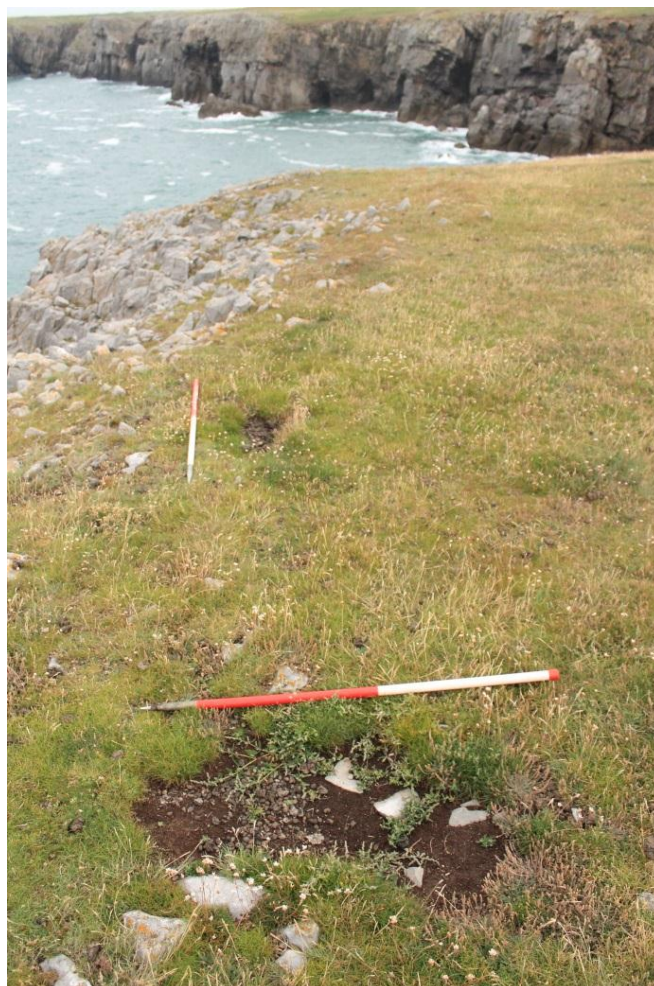
Photo 62: Example of a number of scrapes observed in interior of fort, viewing northeast from southern part of the interior
