ARCHAEOLOGICAL QUINQUENNIAL REVIEW: CASTLEMARTIN RANGE, MANORBIER RANGE AND PENALLY TRAINING AREA

CONDITION ASSESSMENT

Prepared by DAT Archaeological Services
For: Landmarc Support Services.

RHIF YR ADRODDIAD / REPORT NO. 2015/50
RHIF Y DIGWYLLIAD / EVENT RECORD NO. 108638

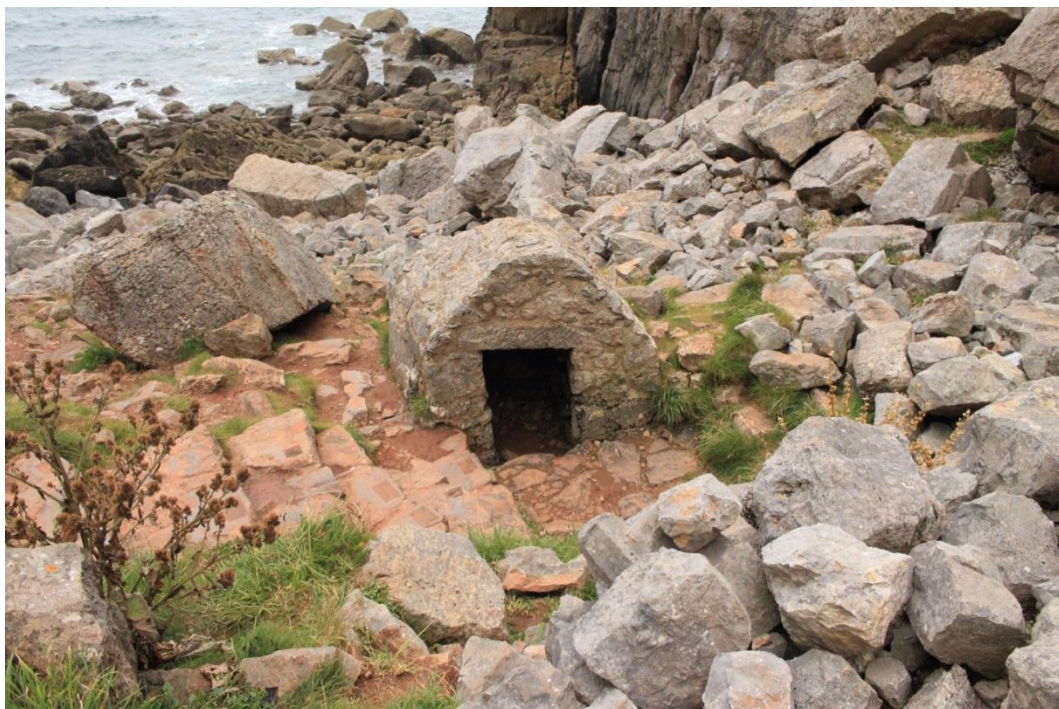
The holy well appears to be in a good and stable condition at this time with no obvious need for concern, evidently being monitored and maintained (Photo 70). The condition of the well should continue to be monitored and taking remedial works undertaken as necessary.

Photo 70: View south of St Govans Holy Well.

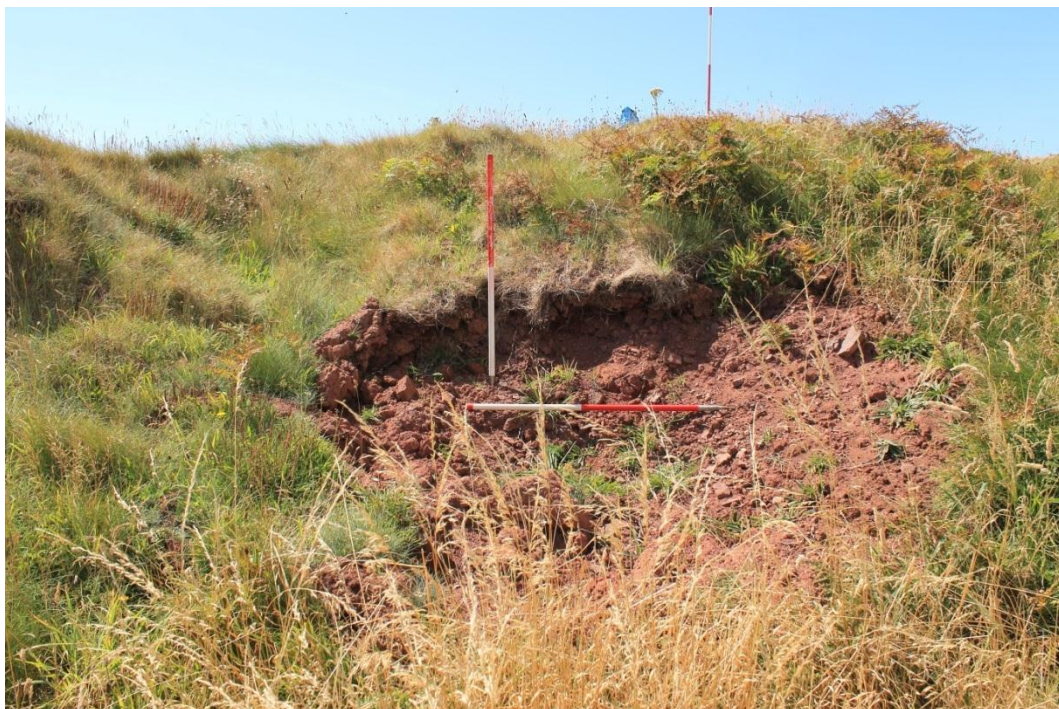
Photo 73: Recent impact damage caused by live firing across the fort.

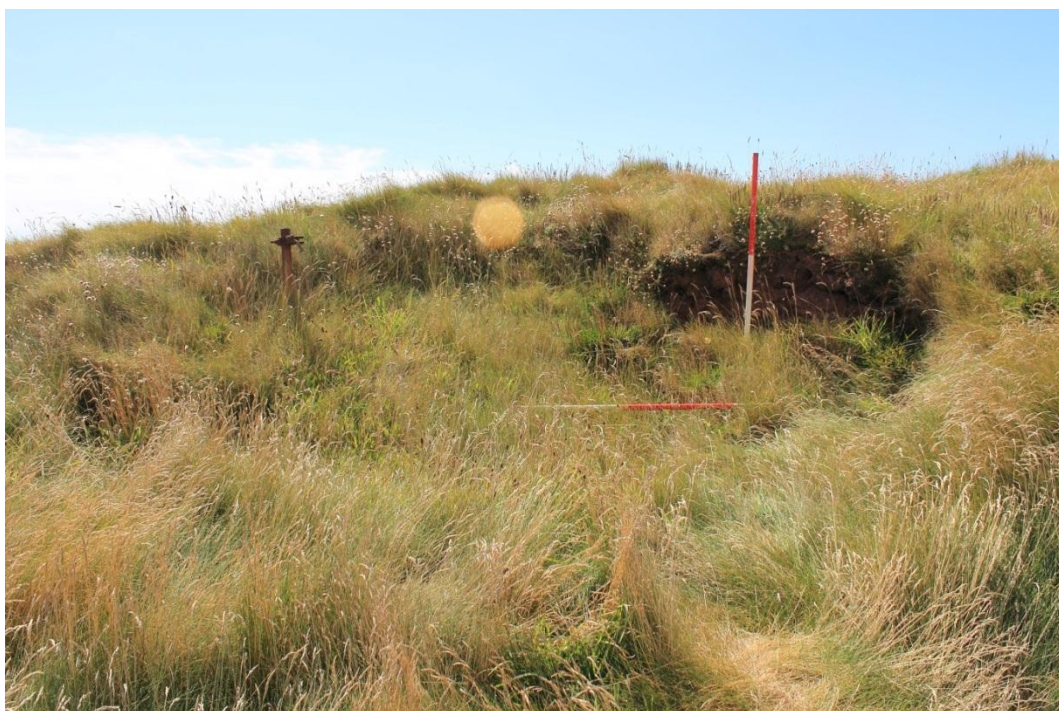
Photo 74: Evidence of older impact craters in same group as Photo 73

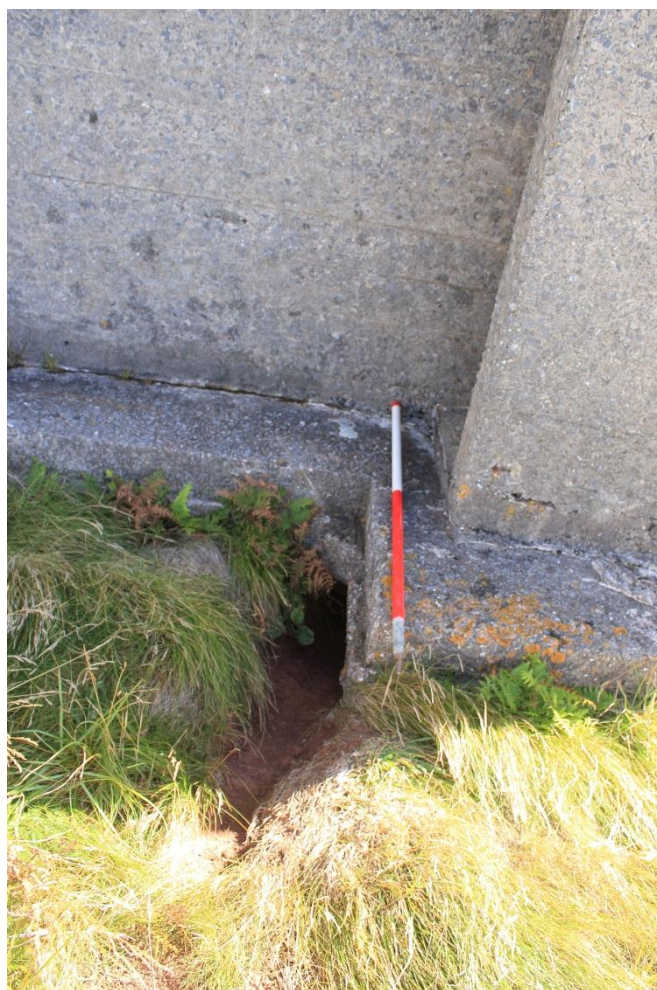
A large animal burrow was noted under the southeastern corner of the western building (PE493C) (Photo 80).

Photo 80: Animal burrow under southeastern corner of PE493C

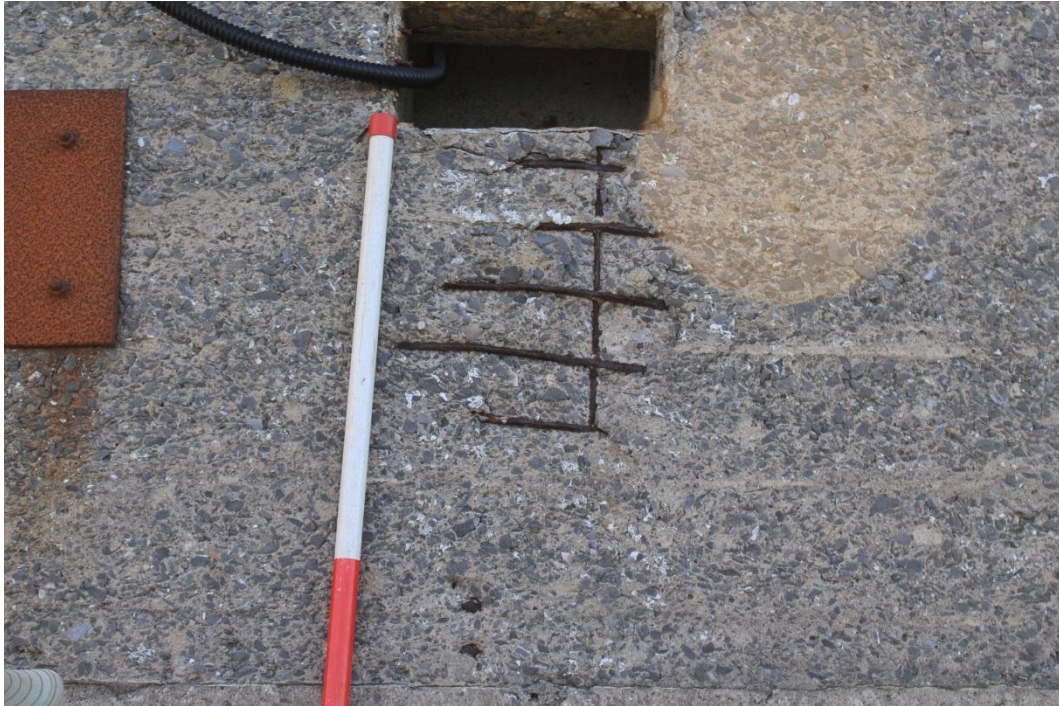
Photo 81: Area of blown concrete on northwestern wall of PE493C showing exposed reinforcing bars underneath

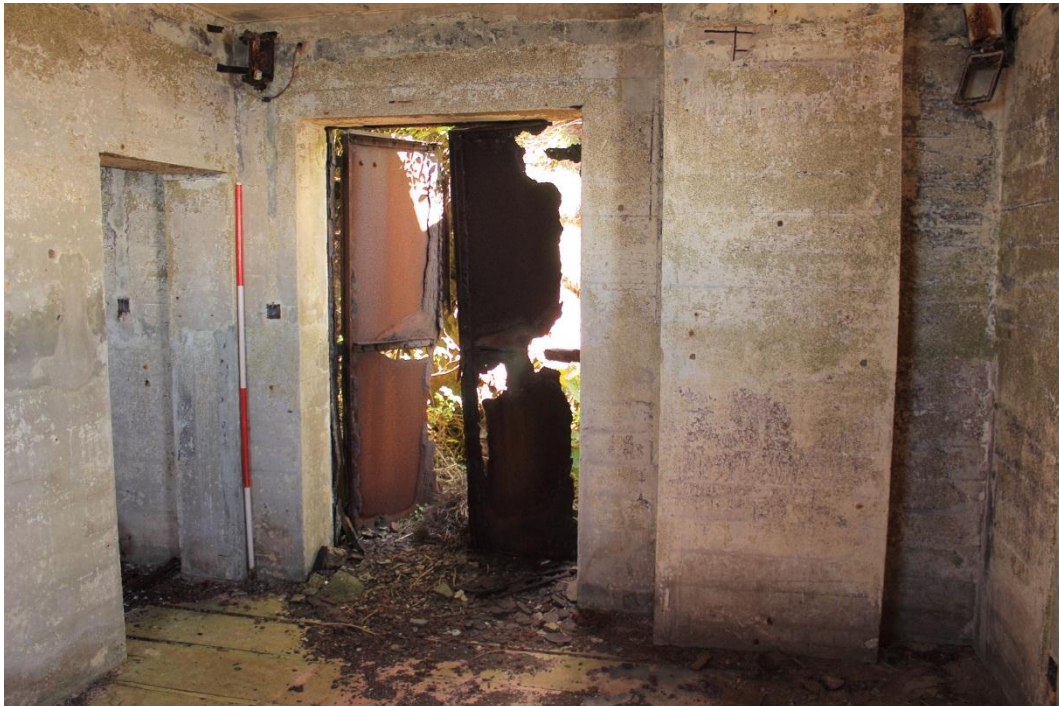
Photo 82: Interior of Transmitter / Receiver Building PE493A, showing badly corroded iron doors on northeastern side

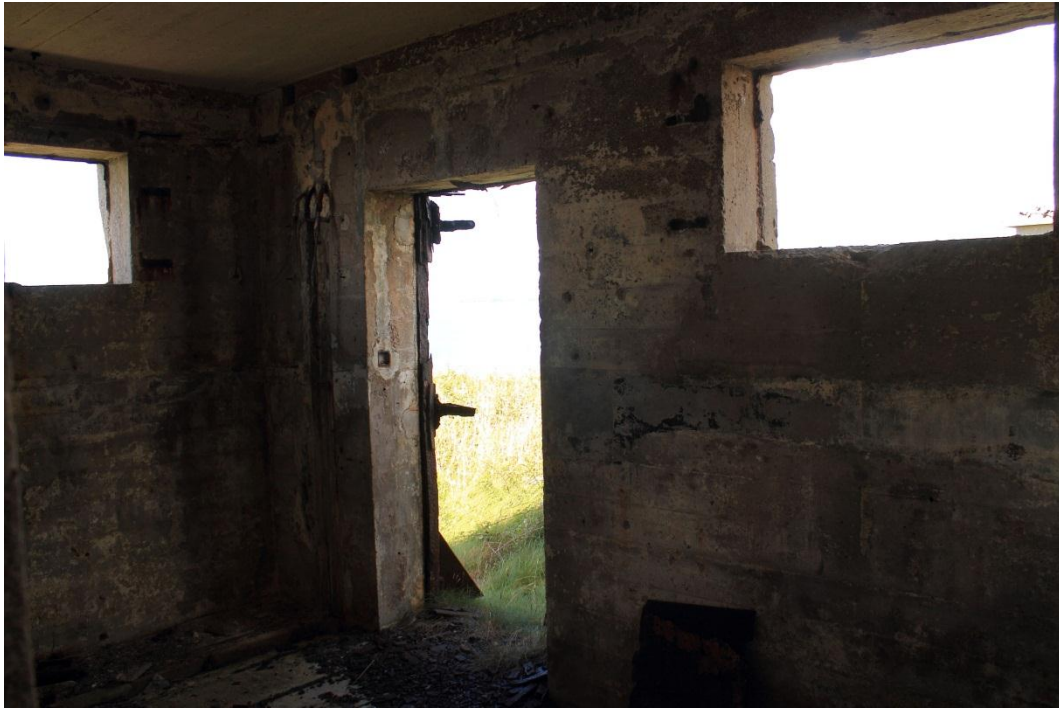
Photo 83: Interior of Transmitter / Receiver Building PE493A, showing almost totally corroded iron doors on northwestern end

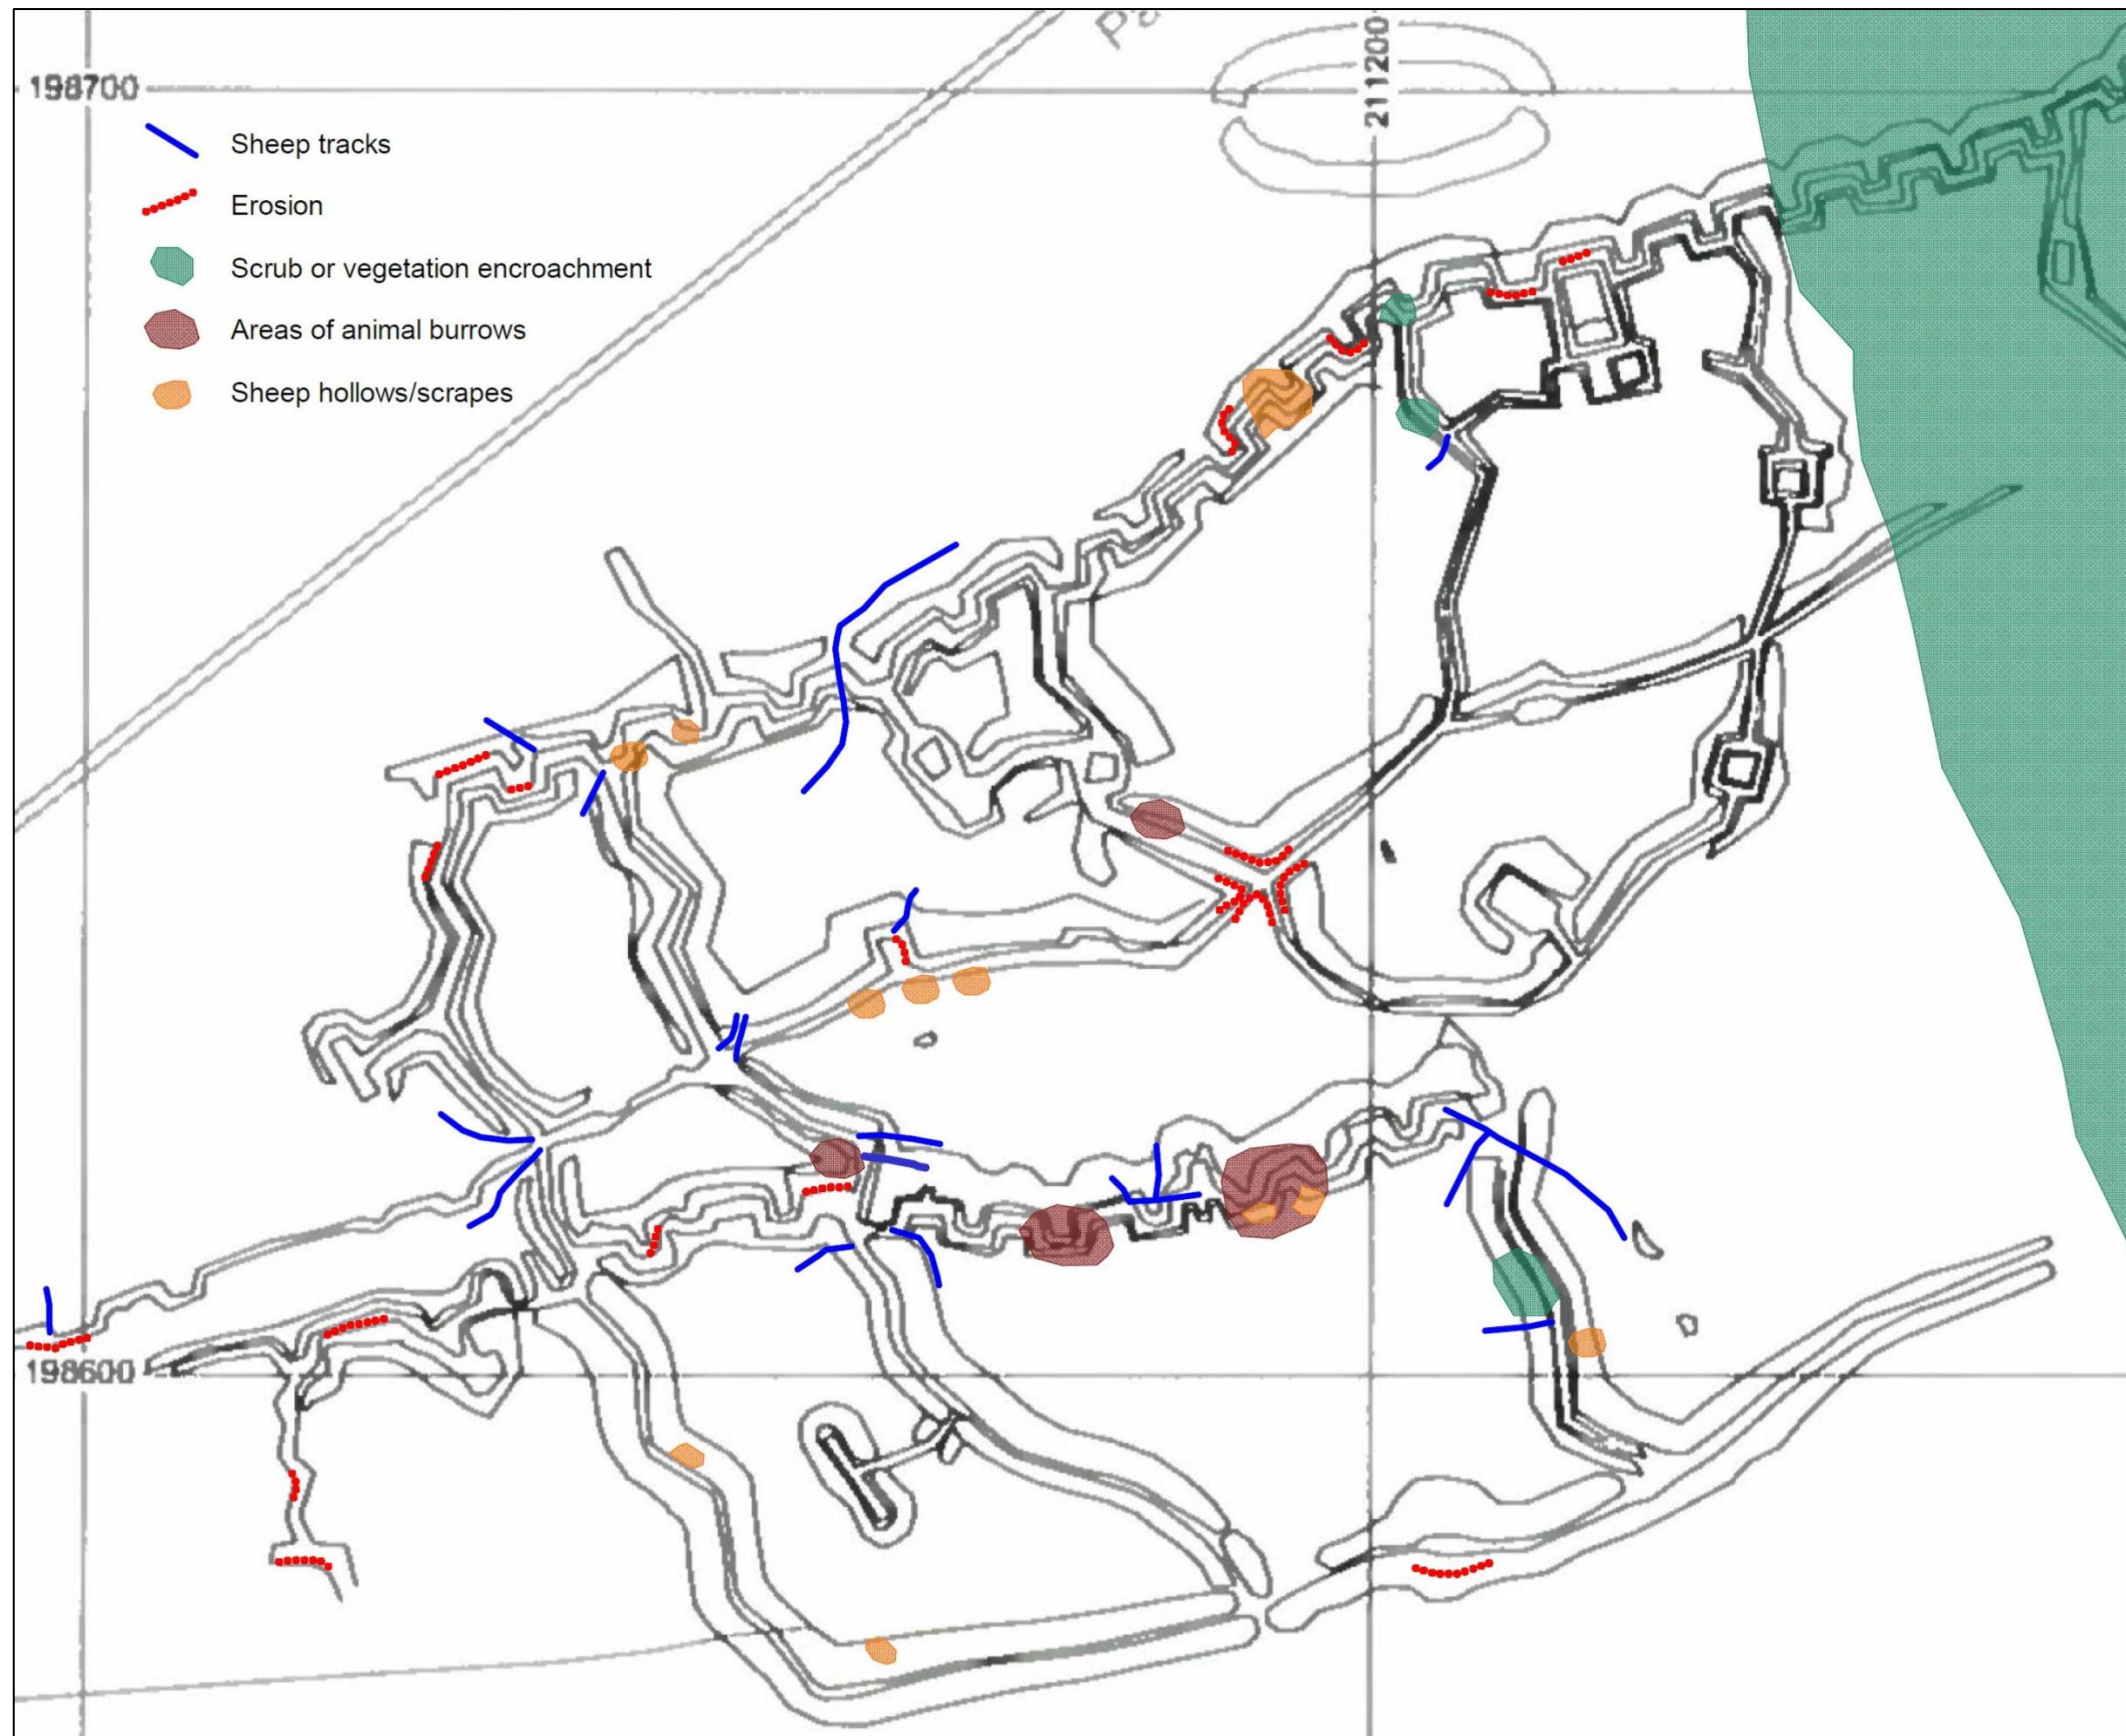
Figure 15: Areas of erosion and other damage to the Penally World War I practice trenches, PE483 recorded on 28/08/2015
Overlaid on outline plan of the main trench system from Wessex Archaeology 2004
