**WALL CORRECTION WORKS AT ST
GWYNOG'S CHURCH, LLANGENNECH,
CARMARTHENSHIRE
ARCHAEOLOGICAL WATCHING
BRIEF
(NGR SN 56040 01880)**

RHIF YR ADRODDIAD / REPORT NO. 2015/55
RHIF Y DIGWYLLIAD / EVENT RECORD NO. 108785

WALL CORRECTION WORKS AT ST GWYNOG'S CHURCH, LLANGENNECH, CARMARTHENSHIRE

ARCHAEOLOGICAL WATCHING BRIEF

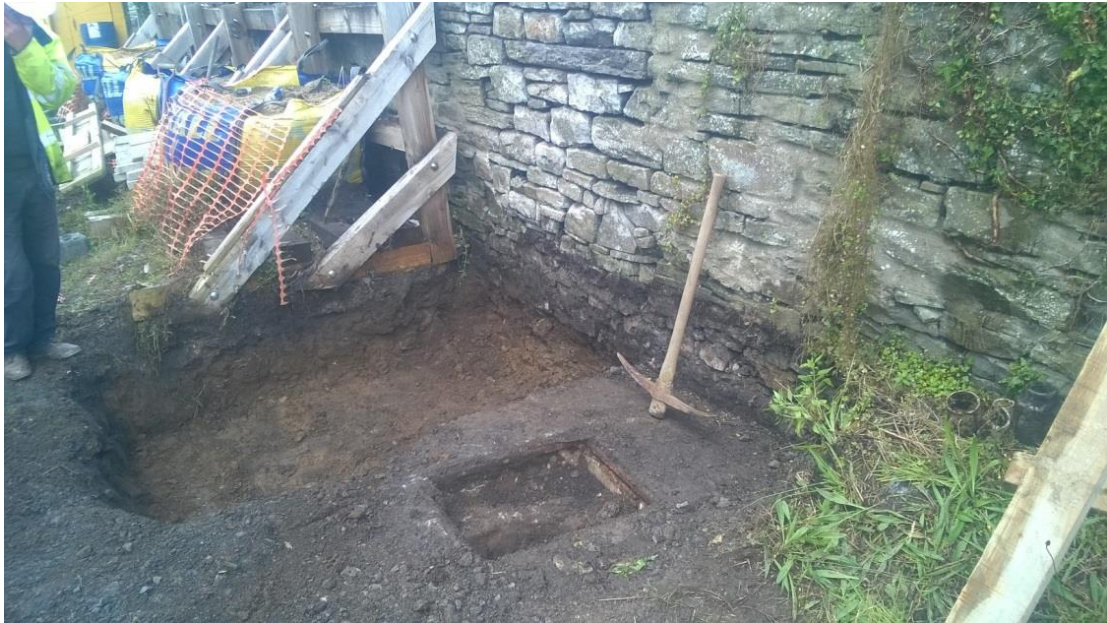
- 5.1.4 During the excavation of Buttress 1 (Figure 2, Photo 1) a concreted area surrounding a brick foul-water manhole was encountered on the western edge of the excavation area. This was not excavated, only exposed during the groundworks. Visible on the ground nearby were narrow brick foundations, level with the ground surface. The construction materials were modern in appearance and style and may previously have been used as toilets given the presence of the foul-water drain, but could also have been linked to houses which had previously existed on the site.

Photo 1: Excavation of Buttress 1. Note the exposed manhole in the foreground.

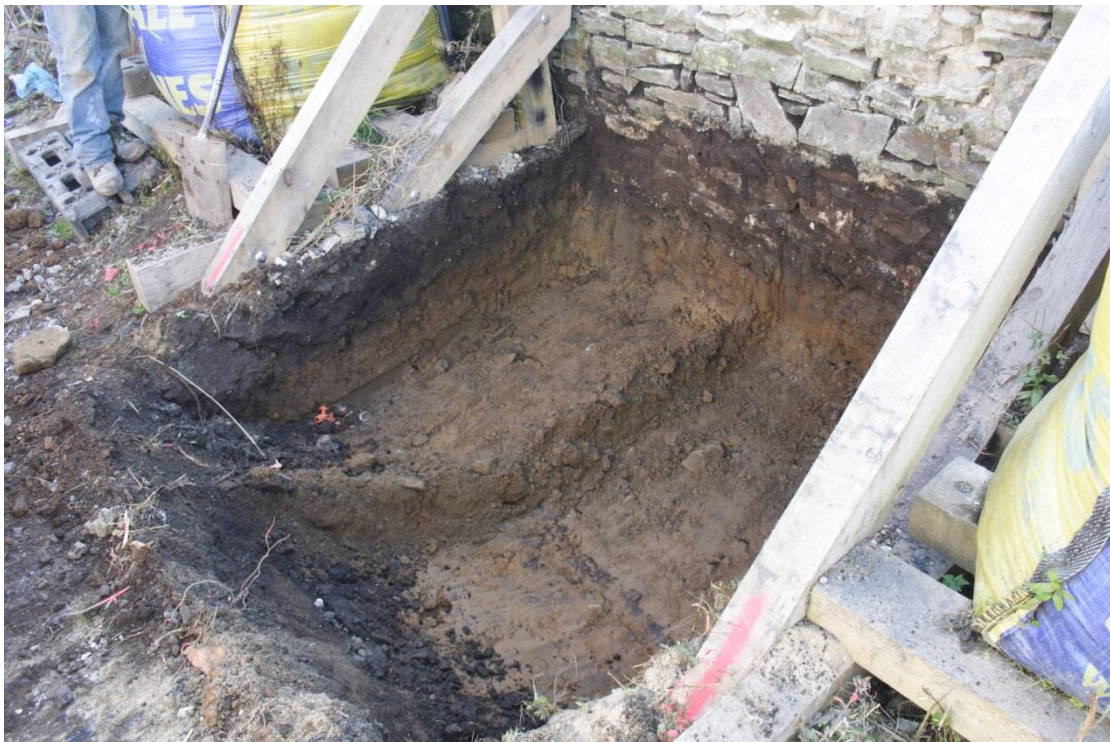
Photo 2: Mid-excavation shot of Buttress 2, showing clearly the relationship of the base of the wall and the encountered deposits.

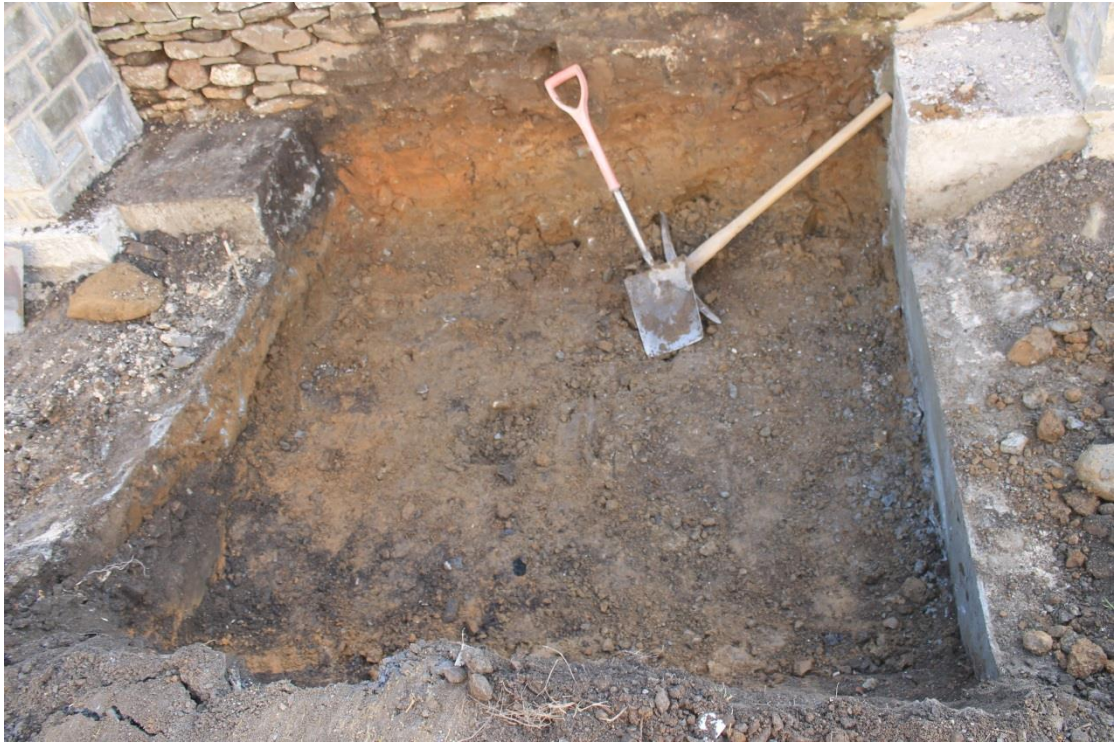
Photo 3: Post-excavation of Buttress 3.

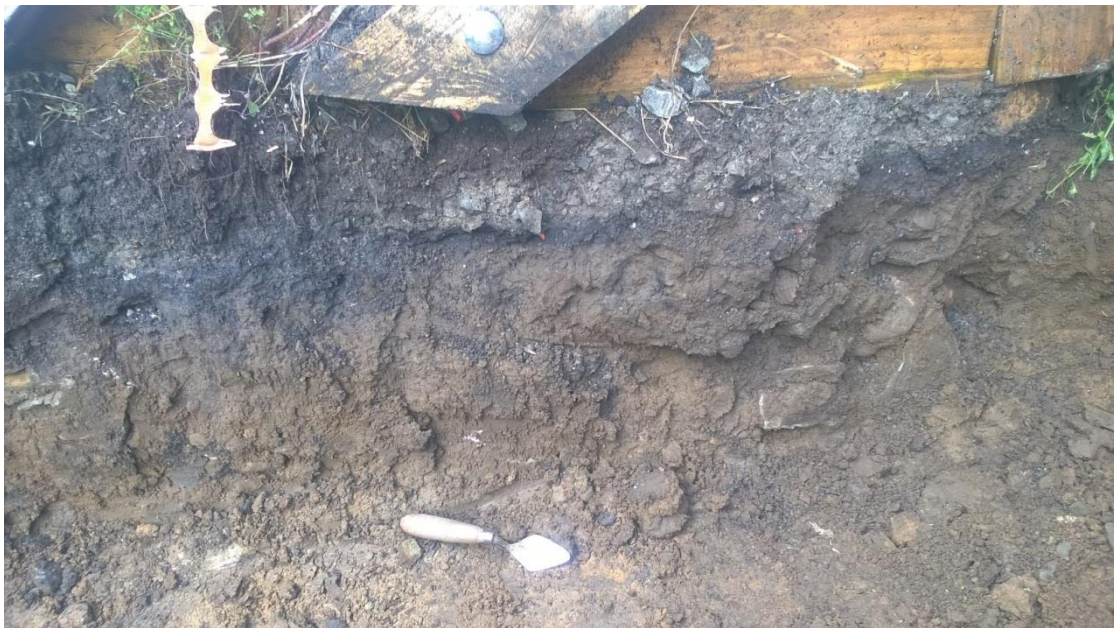
- 5.1.2 In each case the ground level was reduced by approximately 0.45m-0.5m, in a trench 1.9m by 1.9m in size. No features were identified at this level and the ground consisted of 2 observable deposits in all three foundations. The uppermost layer (01), was a mixture of tarmac, gravels and soils forming a black layer over the site. This was 0.25m thick adjacent to the churchyard wall, but reduced in thickness to 0.15m across the majority of the excavated areas for the bases of the buttresses. This deposit contained all of the recovered finds, which included modern glass, pottery, animal bone and metal rubbish. Beneath that layer was a deposit of dark yellow-brown, silty-clay (02) which had occasional jumbled, angular stone up to 0.2m in length.

Photo 4: Detail of section through the excavated area for Buttress 1 showing the two layers (01) and (02) seen in all three observed trenches

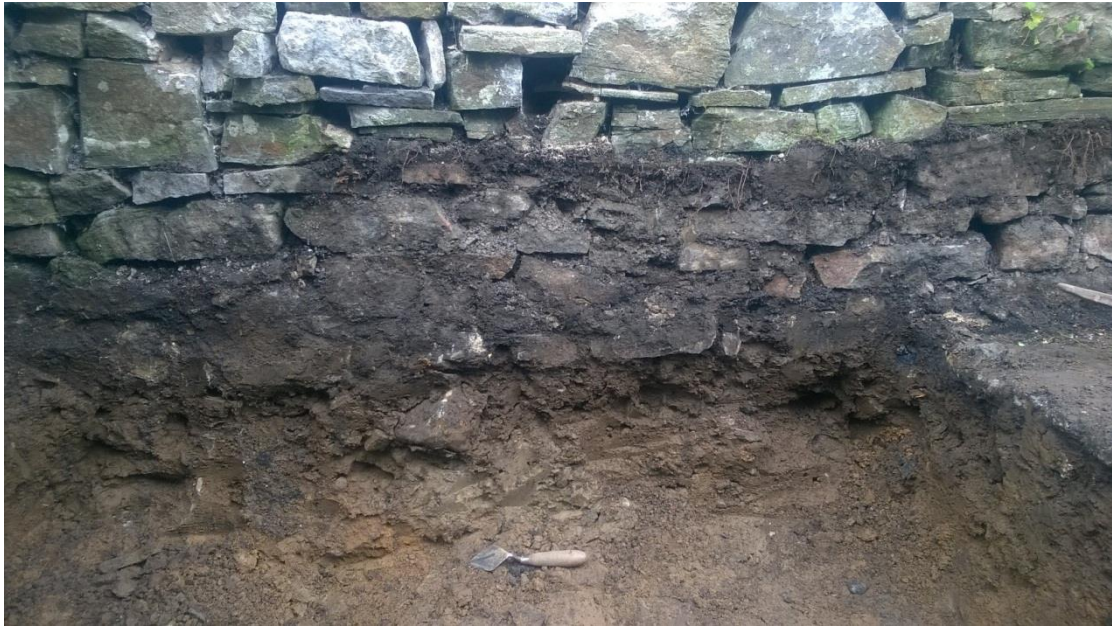
- 5.1.6 There was no visible construction cut for the churchyard wall observed in any of the buttress bases, which strongly indicates that it was originally constructed up against a bank or terraced into the hilltop and built at or slightly below that ground level, with the ongoing soil/ground surface formation processes occurring afterwards.

Photo 5: Detailed view of the base of the churchyard wall within area of Buttress 1 showing lack of any foundations, indicating it was built on or close to the original ground level

- 6.2 The construction of the churchyard wall would appear to be a very simple revetment wall, with little or no foundation evident from the excavations. This lack of foundations has, at least partially, been the cause of the failing of the wall necessitating the repairs.

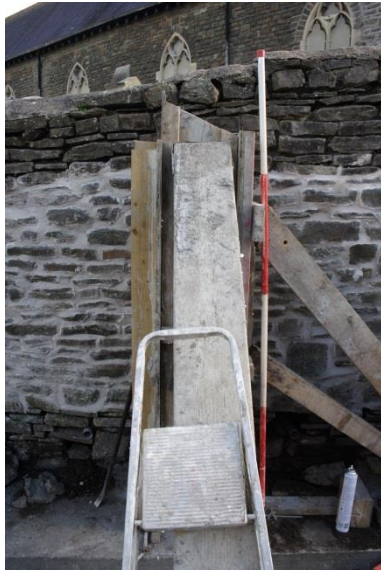
Buttress 4 (not completed)

Photos 6 - 9: Sample photographs of the north face of the north wall (east to west) showing extent of surviving wall work, note the repointing work and buttresses already completed on lower section.

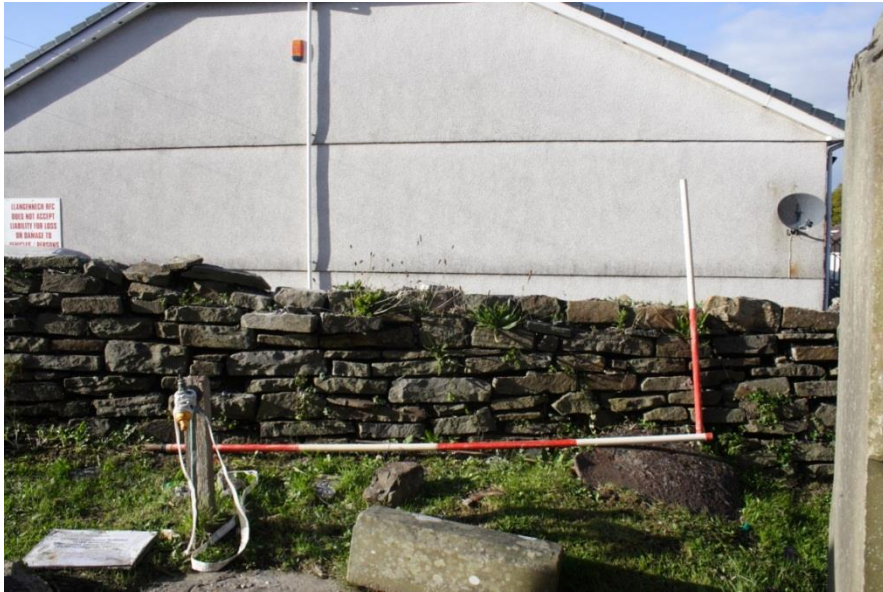
East side

Photos 10 and 11: Sample photographs of the south face of the north churchyard wall
